DEPARTMENT OF ECOLOGY  
INSPECTION REPORT

FACILITY: Longview Fiber  
ADDRESS: 5901 E. Marginal Wy. S.  
CITY: Seattle ZIP: COUNTY:

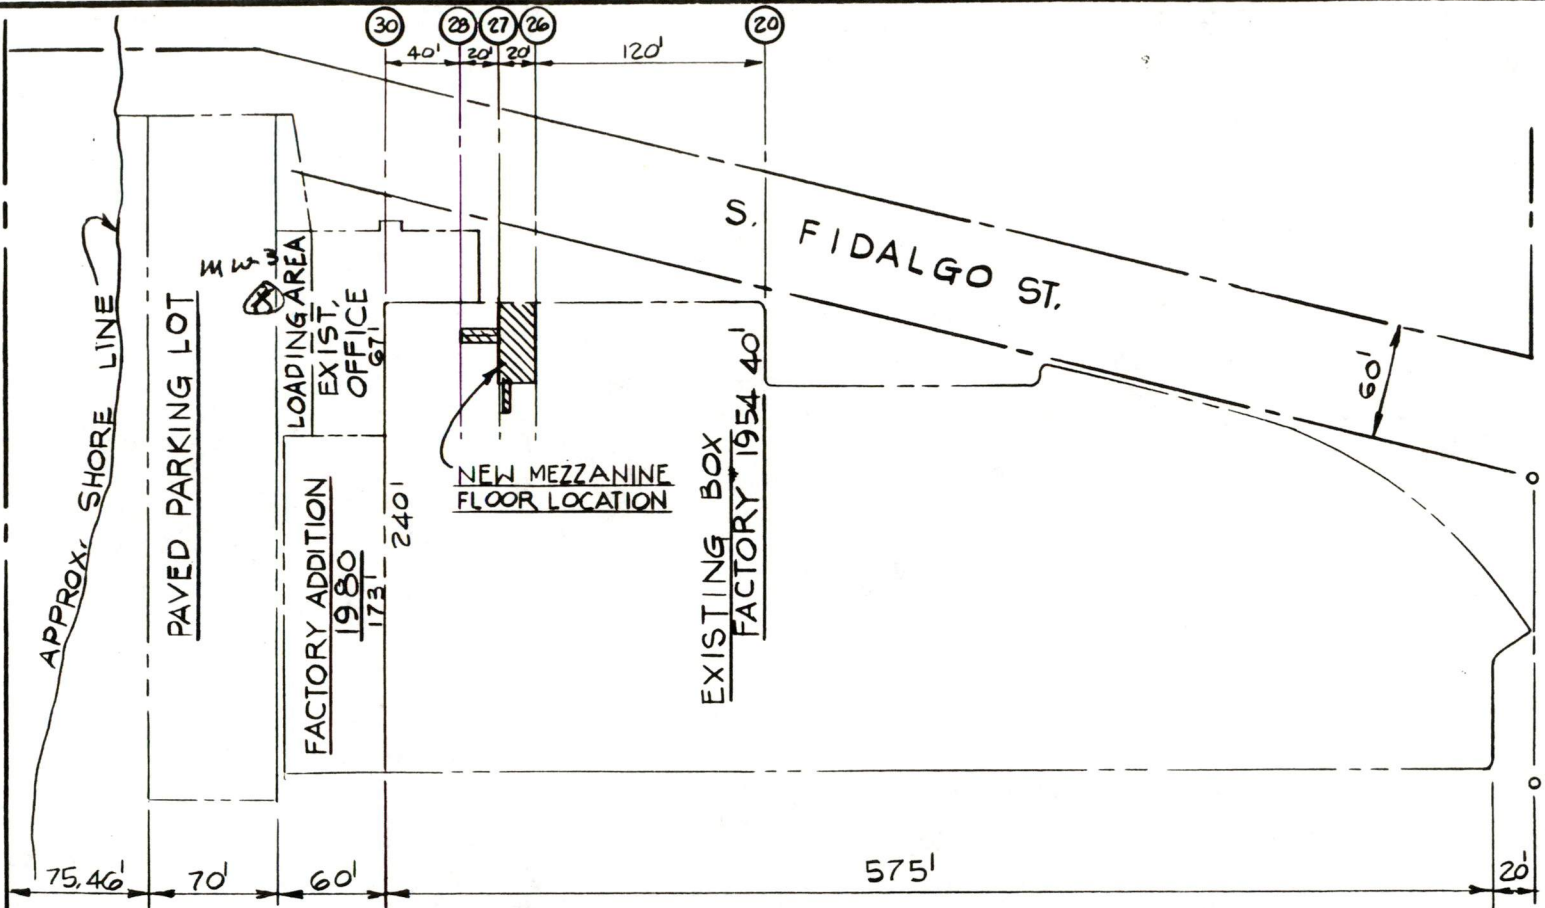
# SITE PLAN

Tank #1 is at the front on the north side of the building. It is 12,000 gal. and was used for bunker. The excavation was visually the cleanest I have ever seen. A composite sample was taken and analyzed for total hydrocarbons to verify the HNU readings. I allowed the fill to be returned to the same hole. Groundwater was barely hit at about 20' at the bottom of the hole.

Tank #2 is at the center and on the north side also. It is under the truck dock area. It is 7,500 gal. and contained gasoline, then diesel. The soil was visually contaminated and several loads of soil went to Cedar Hills. The HNU readings were 0 on the soil where the excavation stopped. The area was very moist and there were problems with slope stability. The tank itself was intact so we assumed all leaks had come from the pipe. Clean fill was used to rebuild the area. During the time this work was being done, Incon did steam cleaning and the discharge came out into the street end. I went to Mr. Coburn's office and showed him the problem. He had his staff clean the area.

Tank #3 is at the rear of the building. It is close to the building itself but only about fifty feet from the river. It is a 600 gal. tank which was used for gasoline, then diesel. The soil was visually contaminated and the contaminated soil went to Cedar Hills. The tank was intact. The visual contamination clearly followed the pipe. Excavation

was stopped before the area was shown to be clean by the HNU, because the contaminated area was under the building itself. Clean fill was put in the hole.

The staff from Longview Fiber and CH2M Hill met and agreed to install three wells. One well is to be between the river and #3. One well is to be between the river and #2. A third well is to be installed at the front of the building as a control. Richard and I agreed to this plan.
