STATE OF WASHINGTON
DEPARTMENT OF ECOLOGY

Re: No Further Action opinion for the following contaminated Site

Site Name: Carpenter Road Olympia PD Shooting Range
Site Address: 6530 Martin Way E, Lacey, Thurston County, WA 98516
Cleanup Site ID: 14692
Facility/Site ID: 50400
VCP Project ID: XS0008

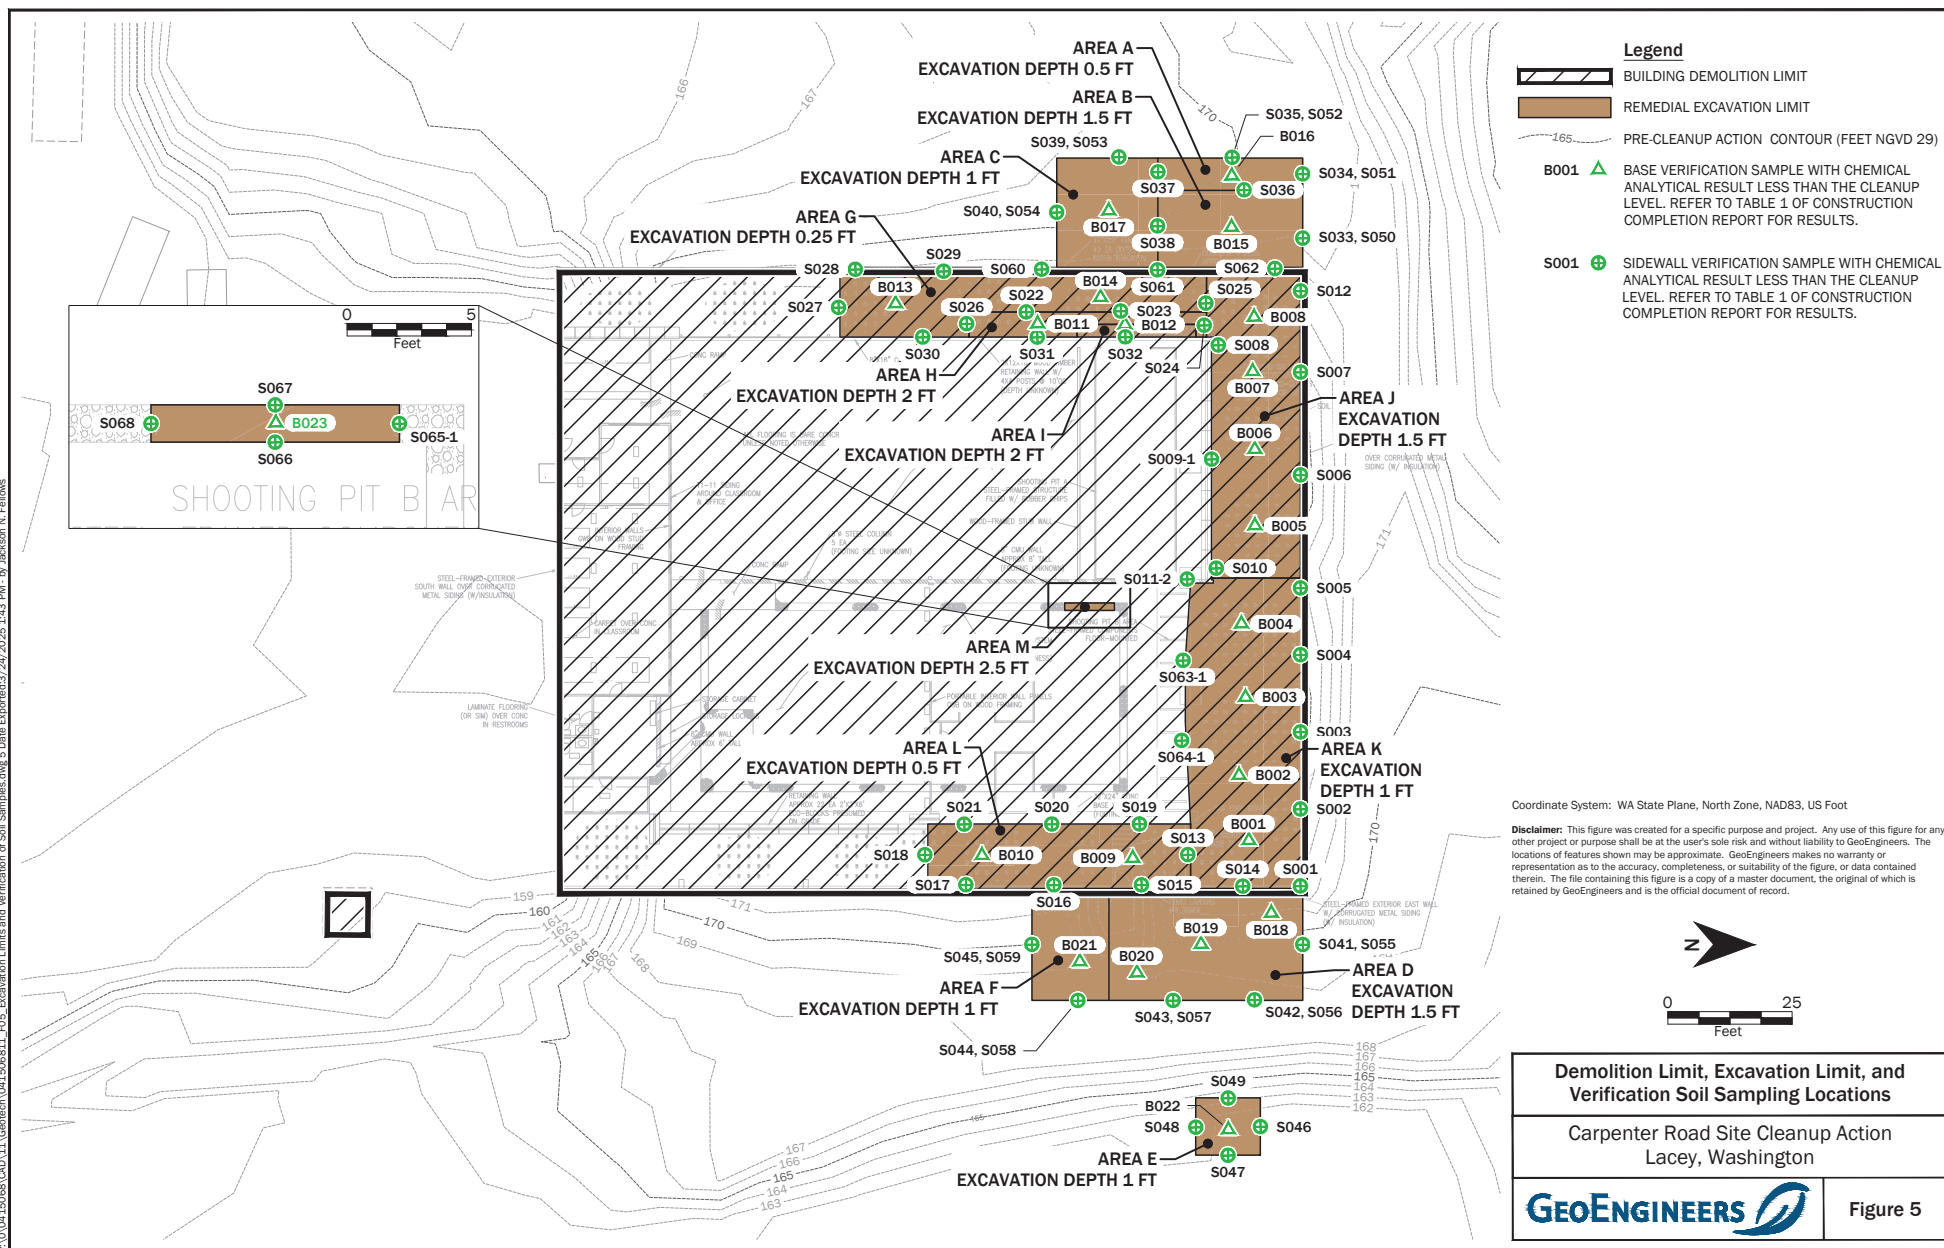
Figure 5Demolition Limit, Excavation Limit, and Verification Soil Sampling Locations

Excavation and offsite disposal of contaminated soil and construction materials took place between September 2024 and January 2025. Excavation areas are shown in Figure 5 in Enclosure A and included areas within, and areas to the north, northwest, and northeast of the former shooting range building. The depths of the excavations ranged from 0.5 to 2.5 ft bgs.

Sufficiency of soil cleanup was verified through confirmation soil sampling. A total of 68 excavation sidewall and 23 excavation base (91 samples total) confirmed the sufficiency of the cleanup work, with no remaining soil samples having lead concentrations exceeding the Method A cleanup level of 250 mg/kg.
