# Project Completion Report

Dickman Mill Piling and Debris Removal Project

Water Quality Certification Order No. 22587

Prepared by  
Herrera Environmental Consultants, Inc.

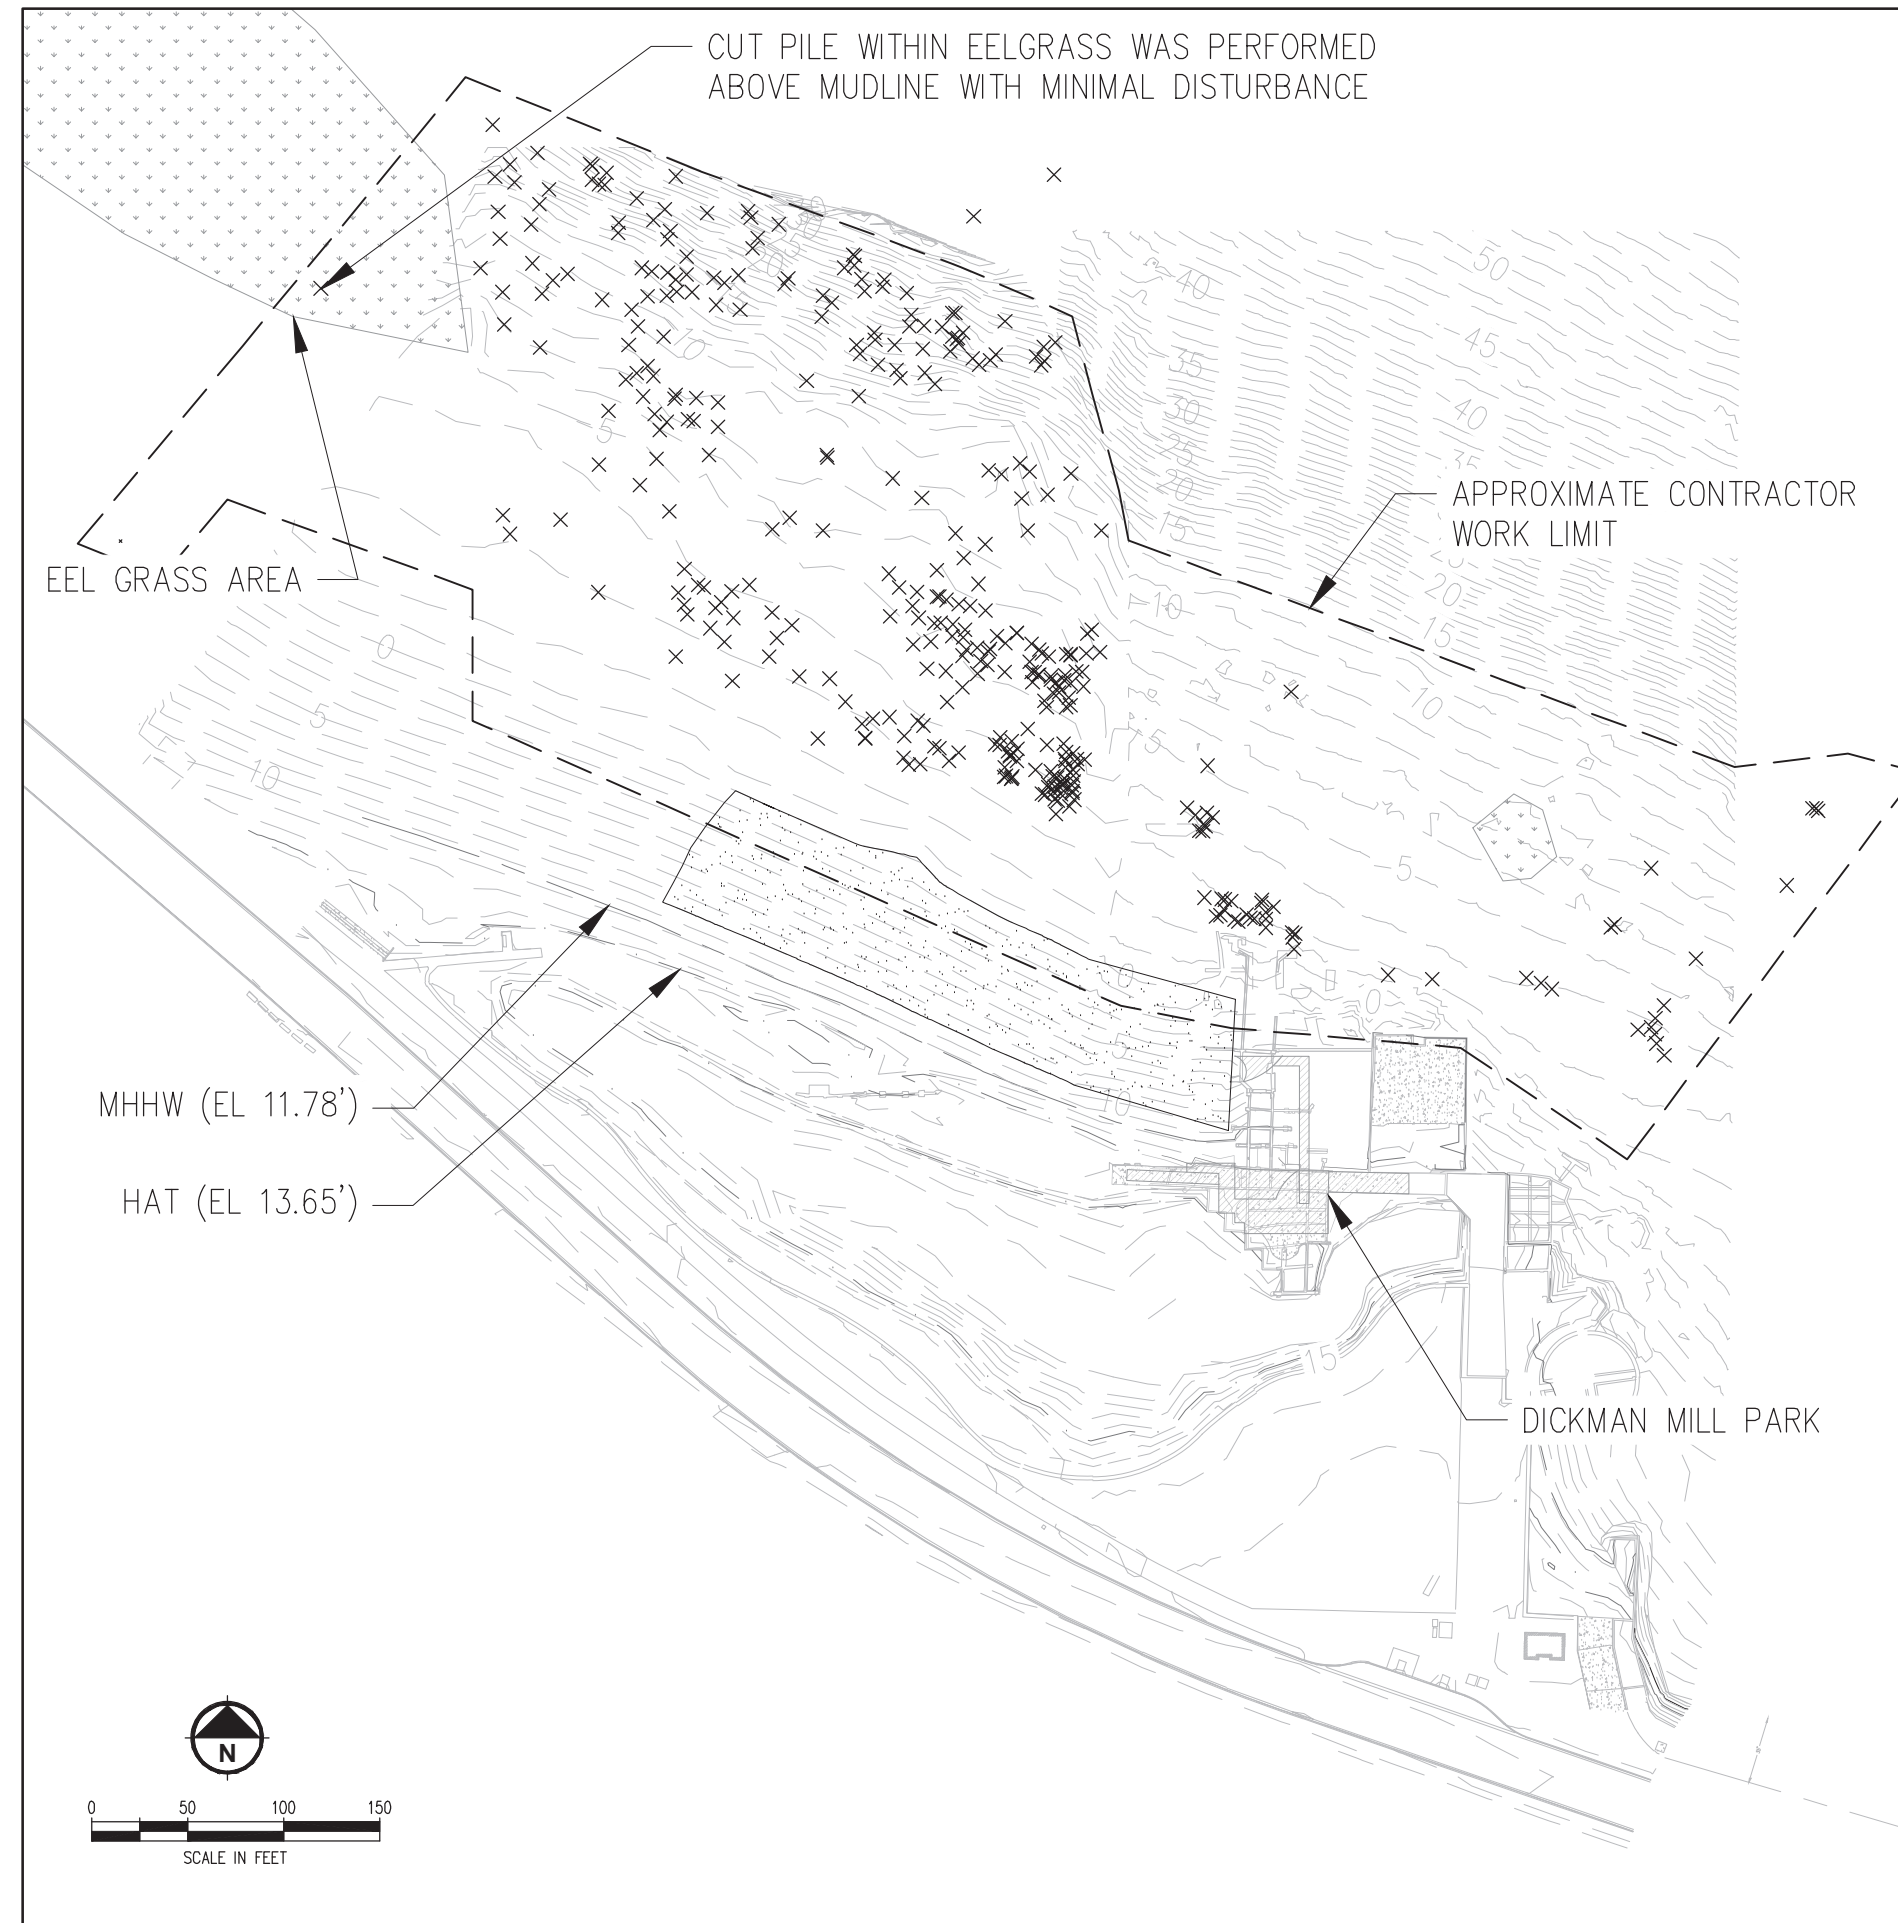
Crux Diving, as a subcontractor to Orion, performed all diving-assisted work, including debris removal and cutting piles below the mudline. Diver-assisted cutting of pilings below mudline required divers to excavate 2 feet below the mudline before cutting piles with an underwater pneumatic saw, followed by covering the resulting holes with the sand and gravel habitat mix. A total of 379 pilings required cutting below the mudline, largely because their condition had deteriorated, and they broke off during extraction attempts. Cut pile locations are shown in Figure 4.

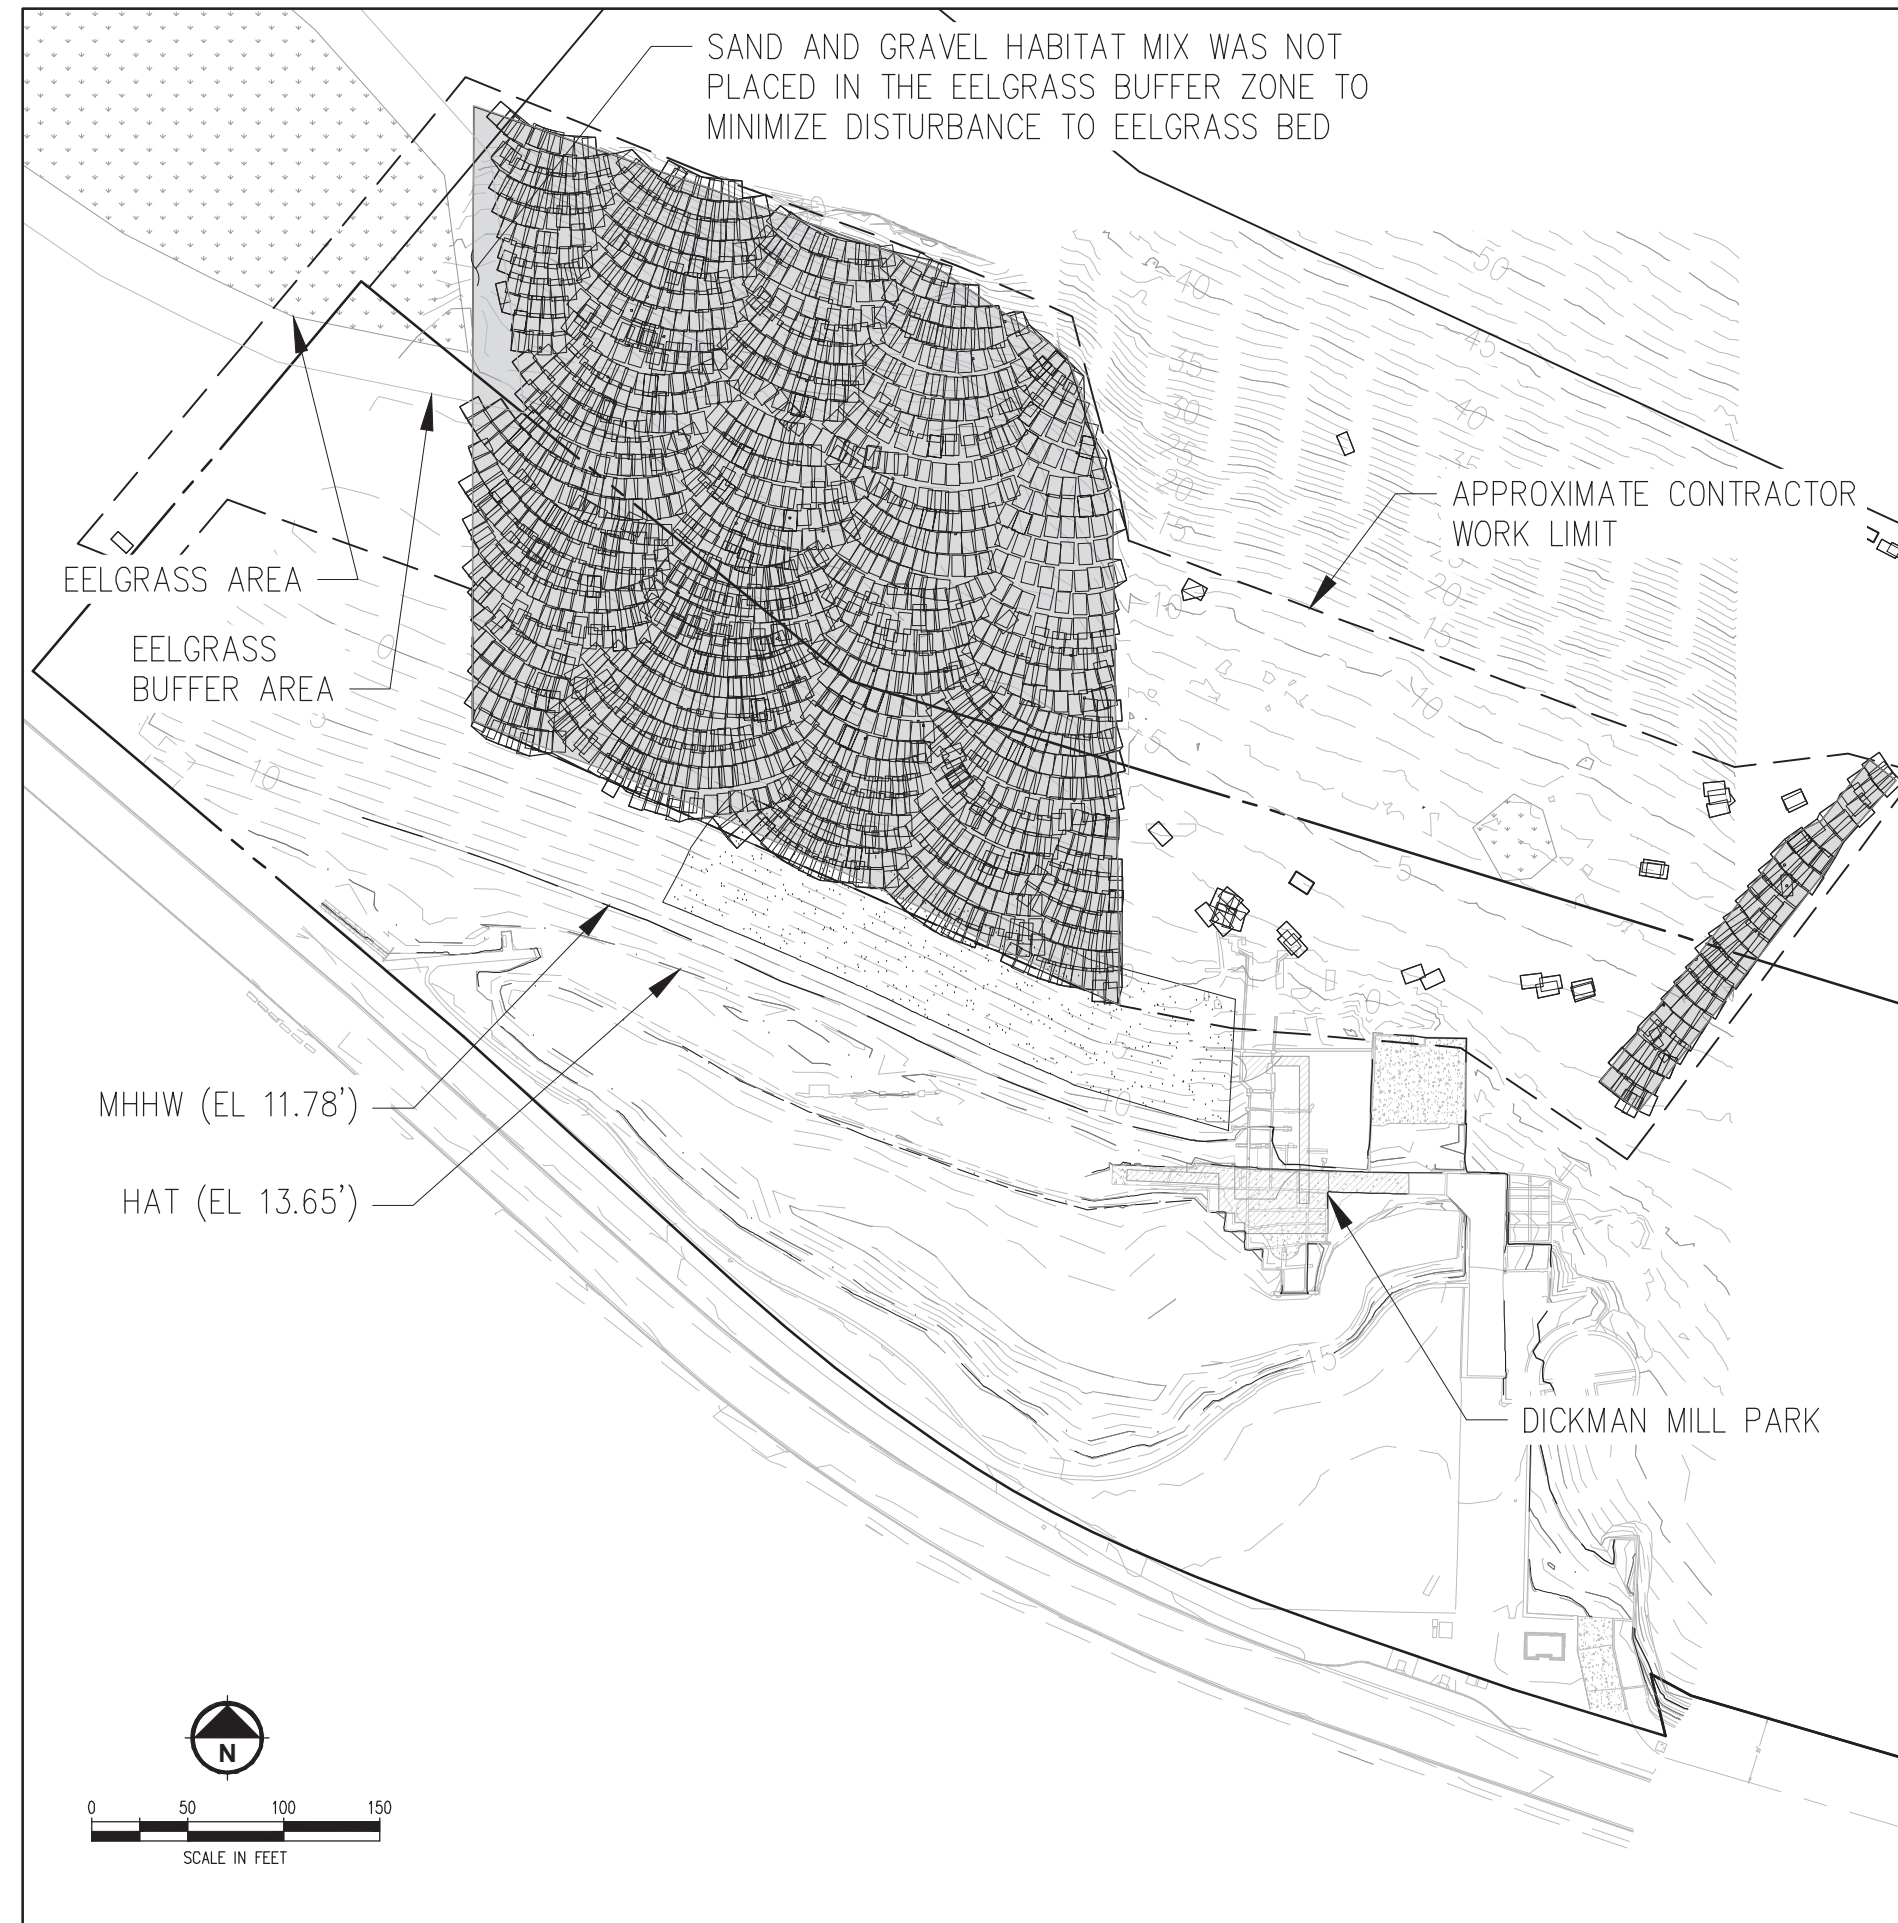
The contractor's initial method of placing the sand and gravel habitat mix was to open the doors of the Bombay box several feet above the water surface. However, due to visual turbidity observations on January 30 and 31, 2025, the contractor revised their operations for the second week of placement by lowering the Bombay box into the top of the water column before opening the doors. Additionally, Herrera obtained a second 5-gallon bucket sample of the sand and gravel mix on February 4, 2025 from the contractor's barge, and submitted it to HWA Geosciences, Inc. for testing to assess the fines content. The test results confirmed that the sample met the project specification of not to exceed 1 percent fines.

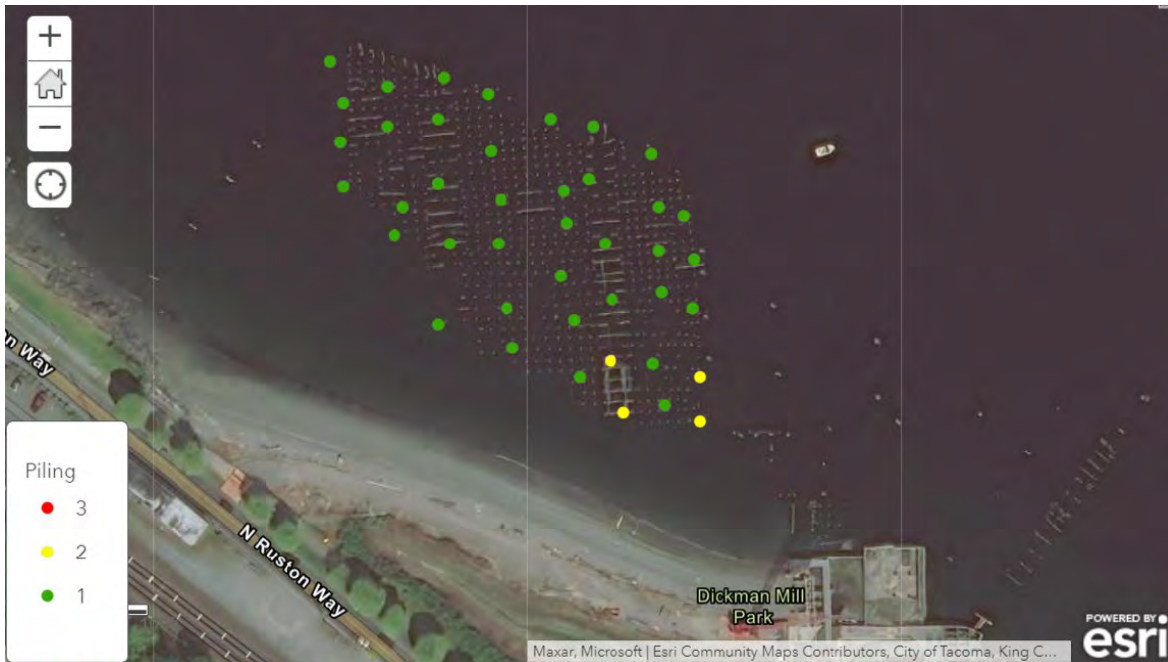
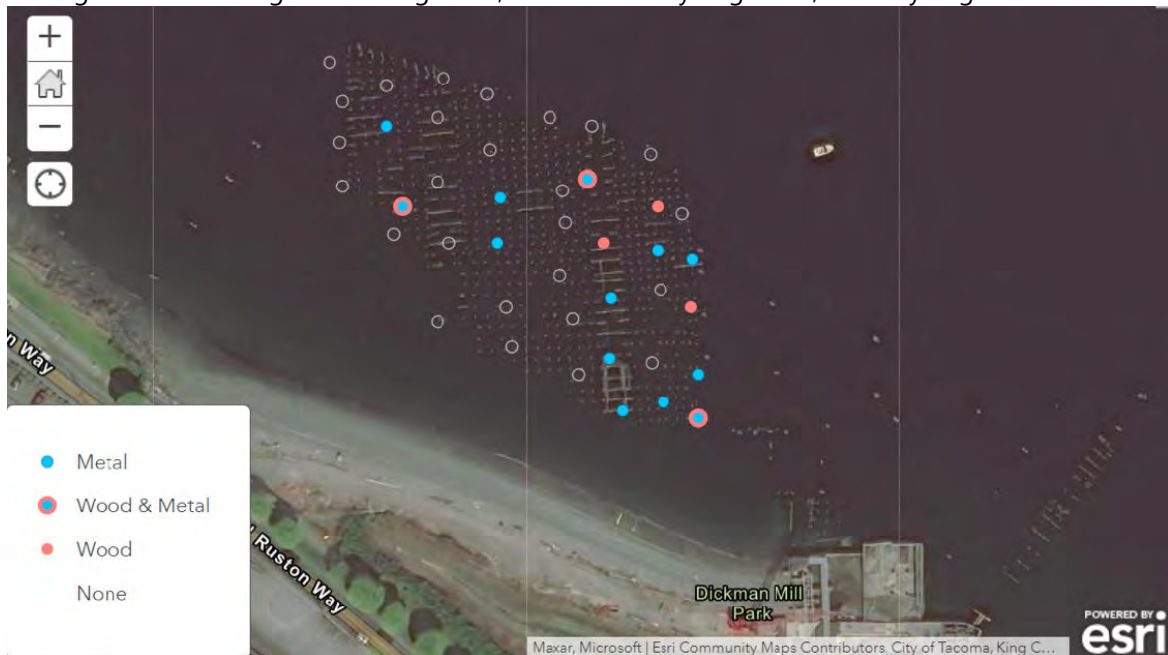
Figure 2. Pile Condition (top) and Debris (bottom) Observed During 2022 DNR Diver Survey (Source: DNR 2022).

DNR divers recently surveyed a subsampling of existing pilings within the northwest piling field, in support of their work to characterize the sediment, the condition of pilings, and the presence of eelgrass and benthic vegetation, as well as any debris. Figure 2 presents pile condition and debris observations. More than 90 percent of the 42 pilings surveyed were observed to be intact and in good condition with minimal degradation (DNR 2022).

Piling condition rating: 1= not degraded, 2 = moderately degraded, 3 = very degraded

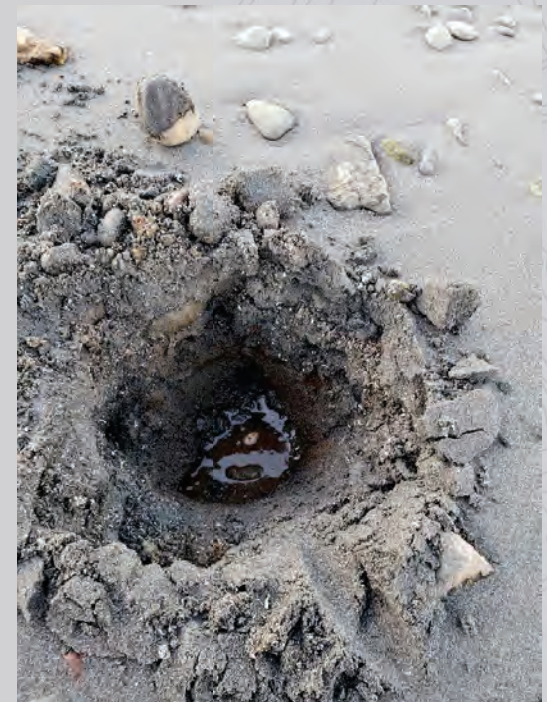
4. Test pit outside (west) of cap had no gravel cap material and was primarily sand and minor shell hash indicating depositional conditions in this area.
5. Test pit at east end of cap area had no gravel cap material and was primarily anoxic silty sand that was likely deposited on top of the cap material.

One test pit outside (west) of cap area without gravel

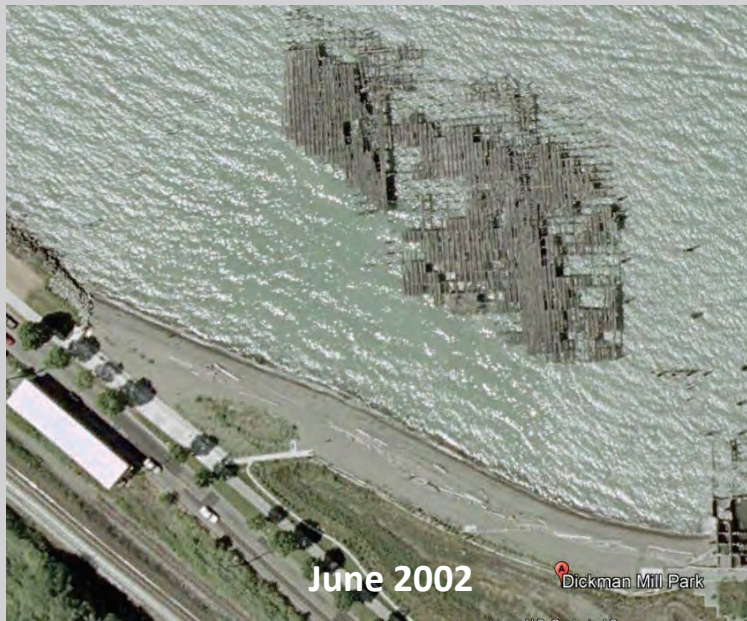
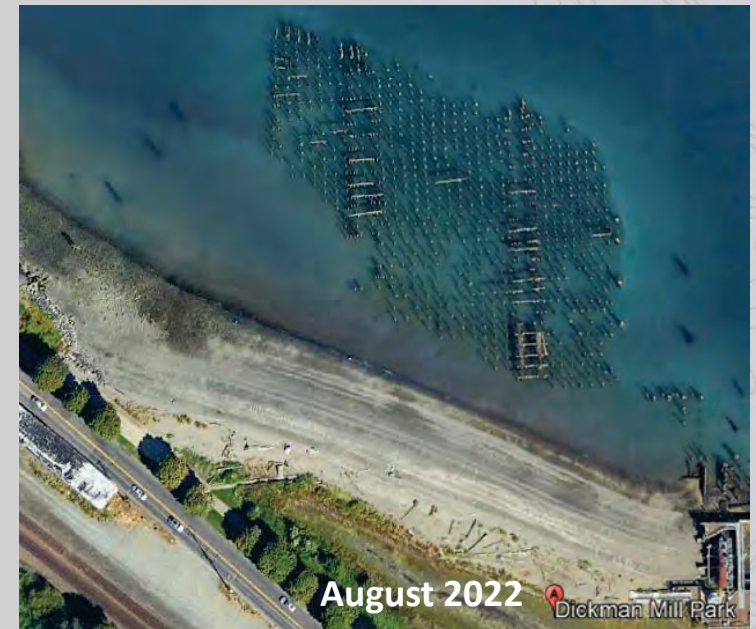
7. Google Earth images show the beach has not significantly changed position since placement of the cap 23 years ago both within and west of the cap area when 38% chance of 50-year storm event in that period..

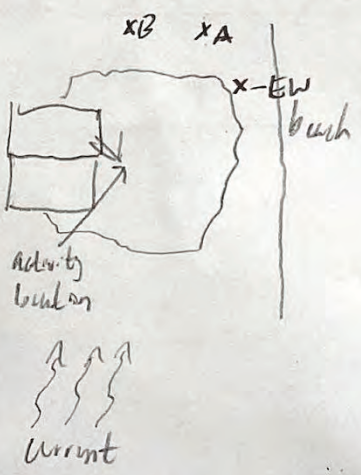
sheen observed outside boom @ EW station. Origin not immediately identified  
 + sheen was contained with additional boom.

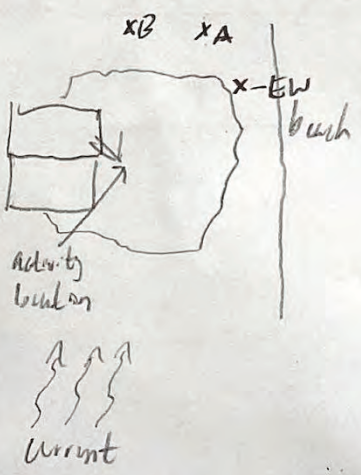
sheen observed outside boom @ EW station. Origin not immediately identified + sheen was contained with additional boom.
