# **Harris Avenue Shipyard In-water Condition Assessment Report**

**Port of Bellingham  
Harris Avenue Shipyard**

**November 2022**

**WSP USA  
33301 Ninth Avenue South, Suite 300  
Federal Way, Washington 98003-2600**

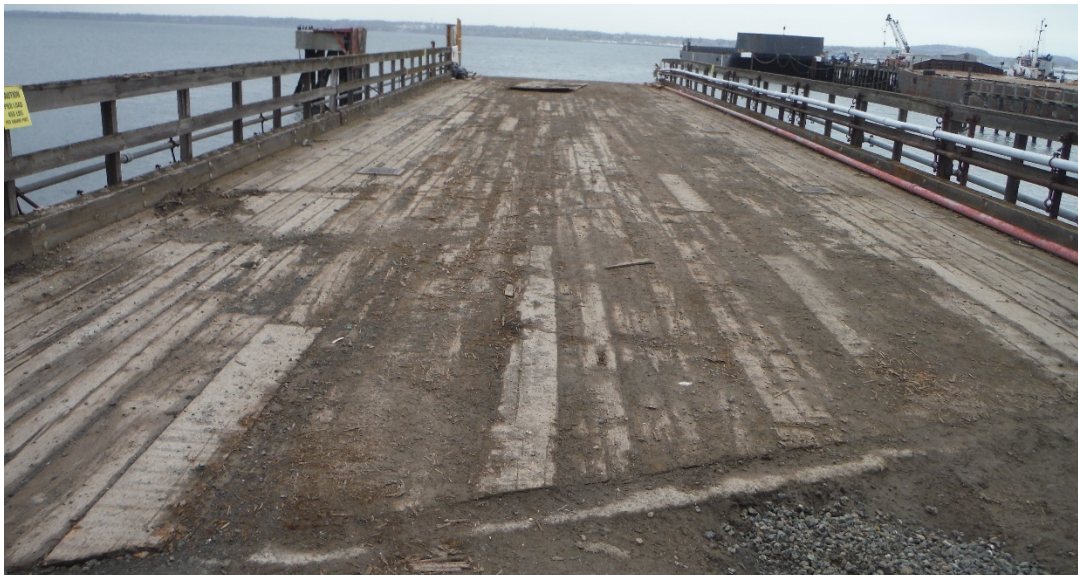
Photo 1 – West Dock Deck Surface

In general, the timber decking is in **fair/poor** condition. The first layer of deck boards are worn down in multiple areas of the dock. (See Photo 1 in Appendix A.)

- Replace or post the timber piles that have major/severe damage.
- Address material loss/undermining at bulkhead/approach wall and backfill.
- Replace pile caps with severe damage.
- Replace damaged deck boards.
- Reestablish cross bracing at outboard pile bents.

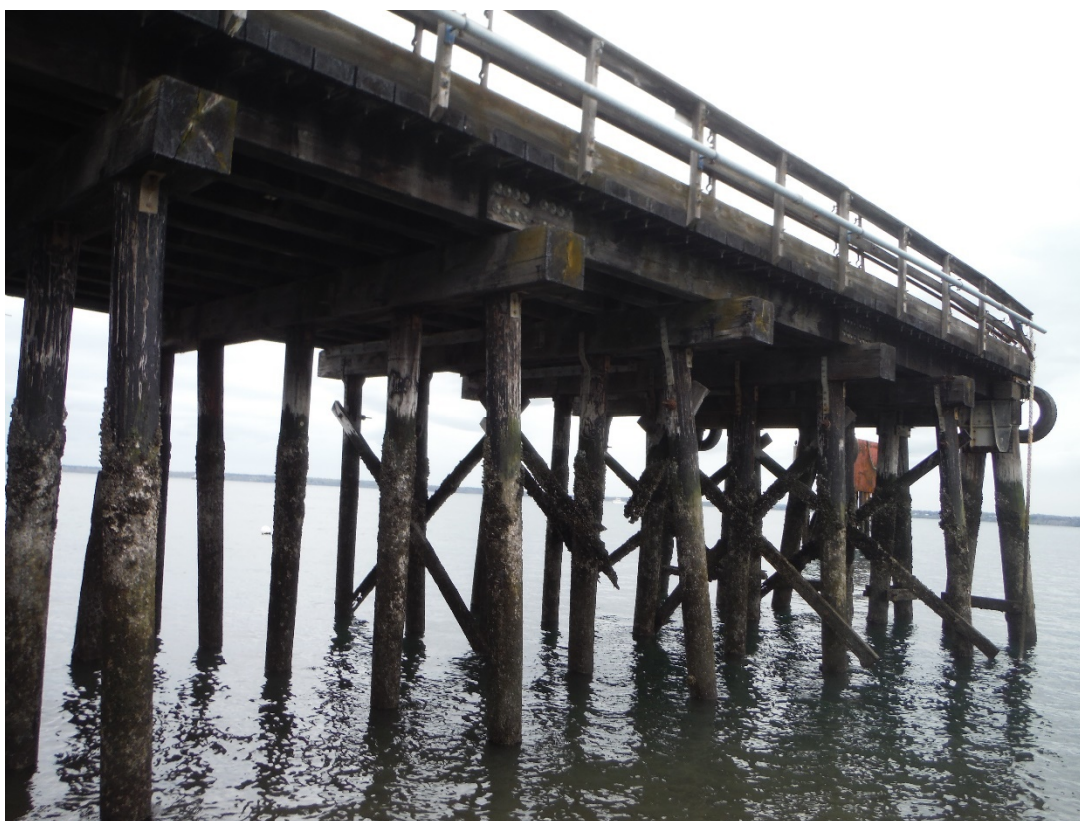
Photo 2 – West Dock Below Deck

The timber piles are in **fair** condition. The piles generally showed minor to moderate signs of deterioration, including a few locations with splits and checks present. Pile 2D located at the second pile bent has experienced 80 percent section loss. (See Photos 2 through 5 in Appendix A.)

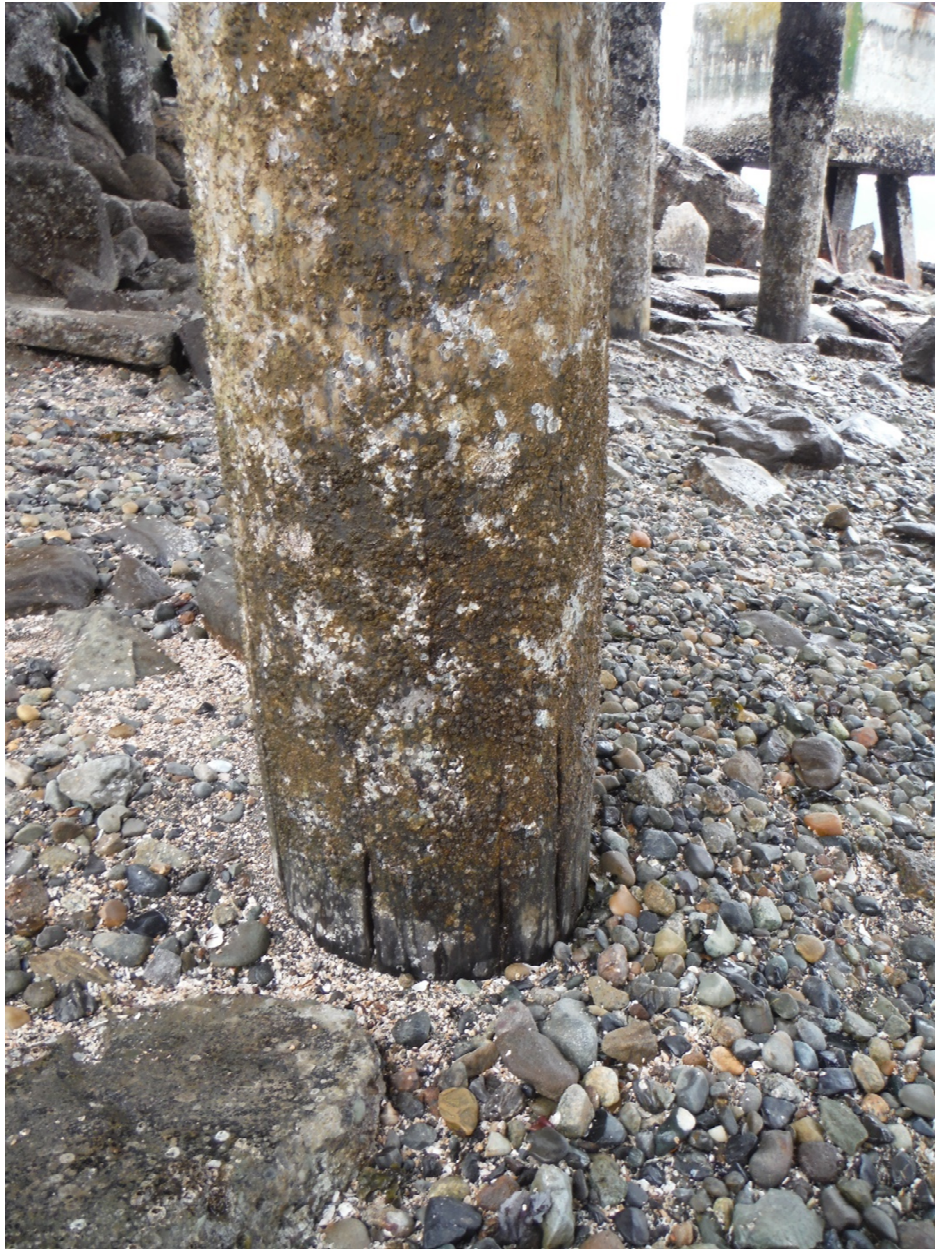
Photo 3 – Typical Pile with Minor Damage

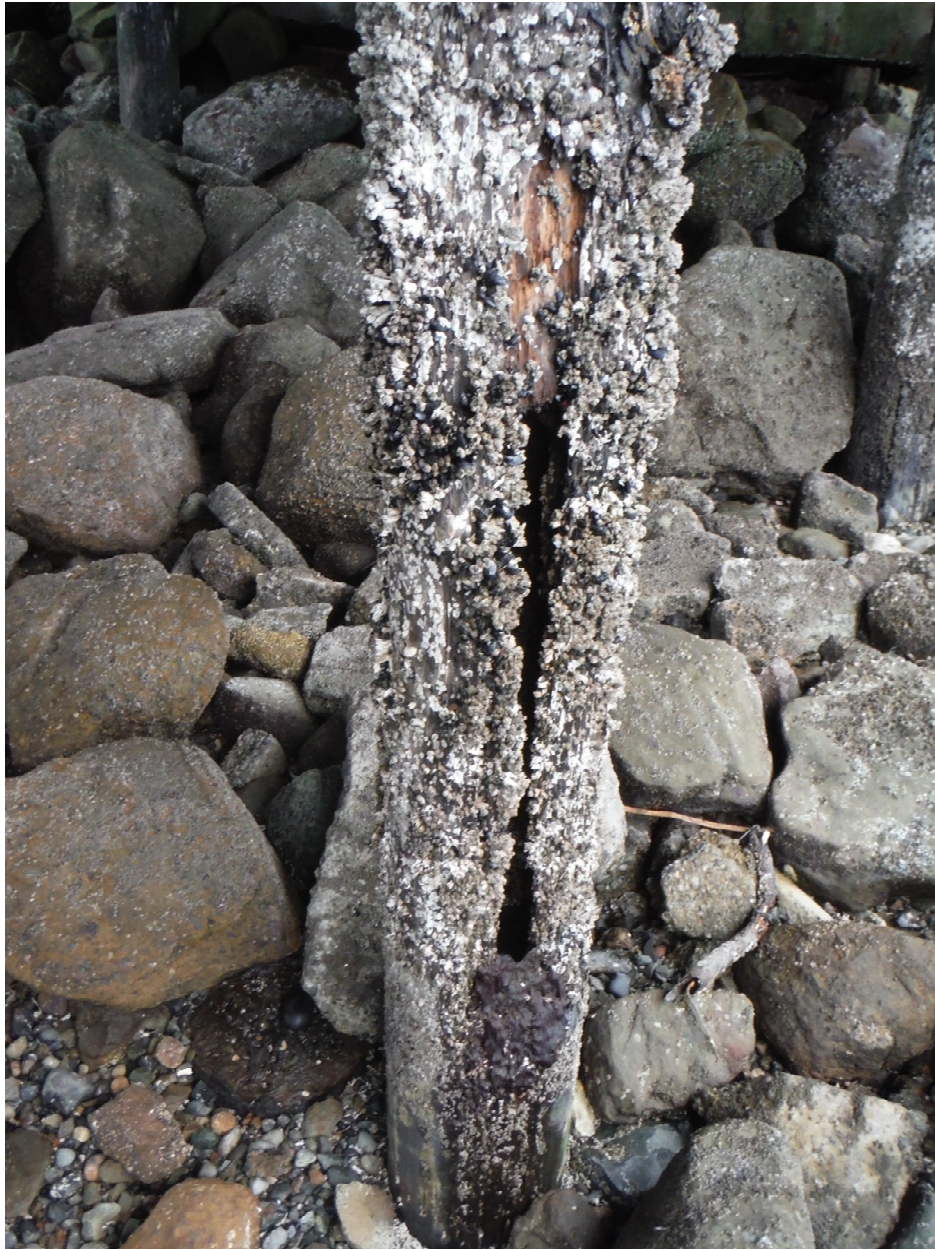
Photo 4 – Bent 2 Pile D (80% Section Loss)

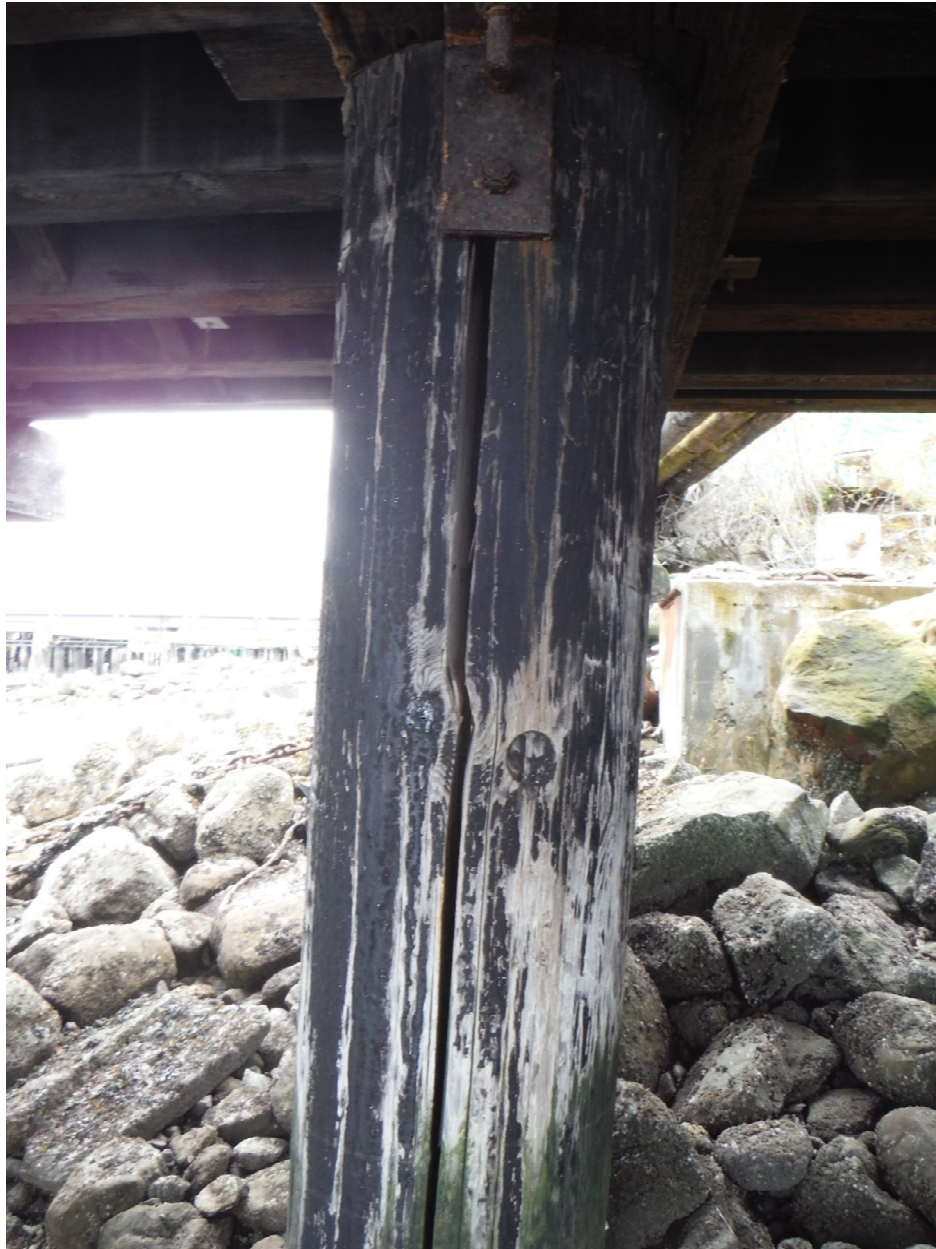
Photo 5 – Bent 2 Pile C (Mechanical Split)

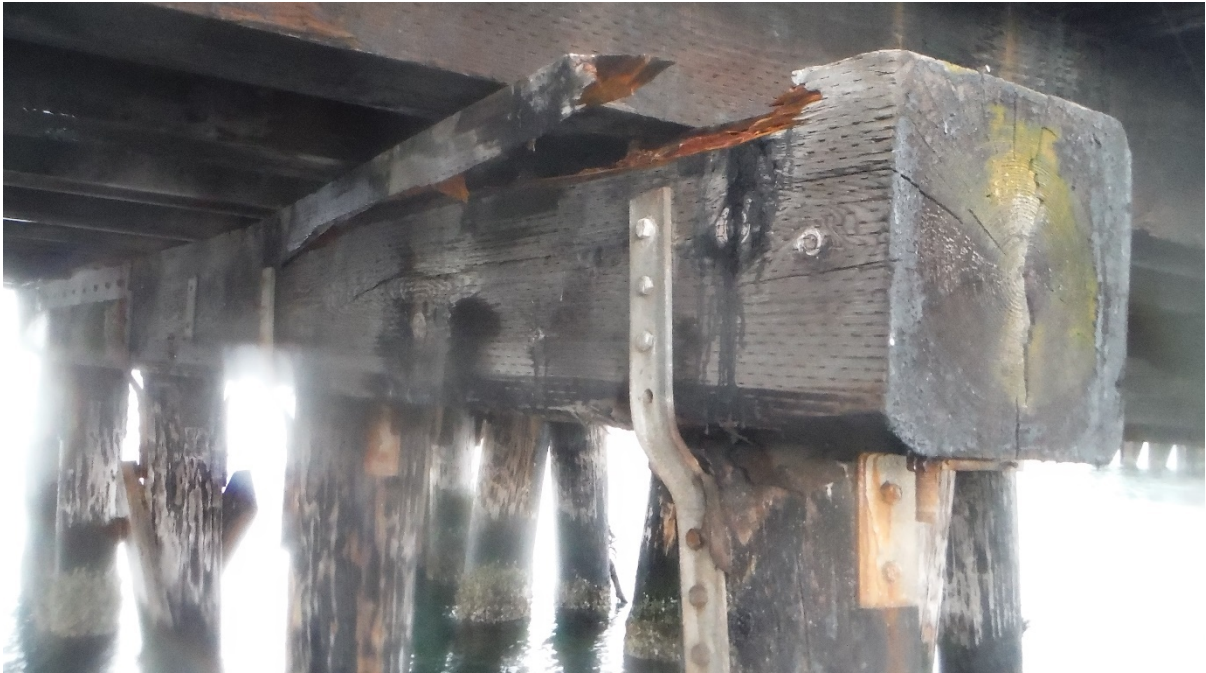
The timber pile caps are in **poor/fair** condition. Severe damage was observed at Bent 2 Pile D, Bent 4 Pile D, Bent 7 Pile B, Bent 8 Pile C, Bent 9 Pile A, and Bent 10 Pile B. These locations are severely crushed and/or are hollow. Checking and splitting were observed at multiple locations. (See Photo 6 in Appendix A.)

Photo 6 – Bent 10 (Splitting and Crushing)

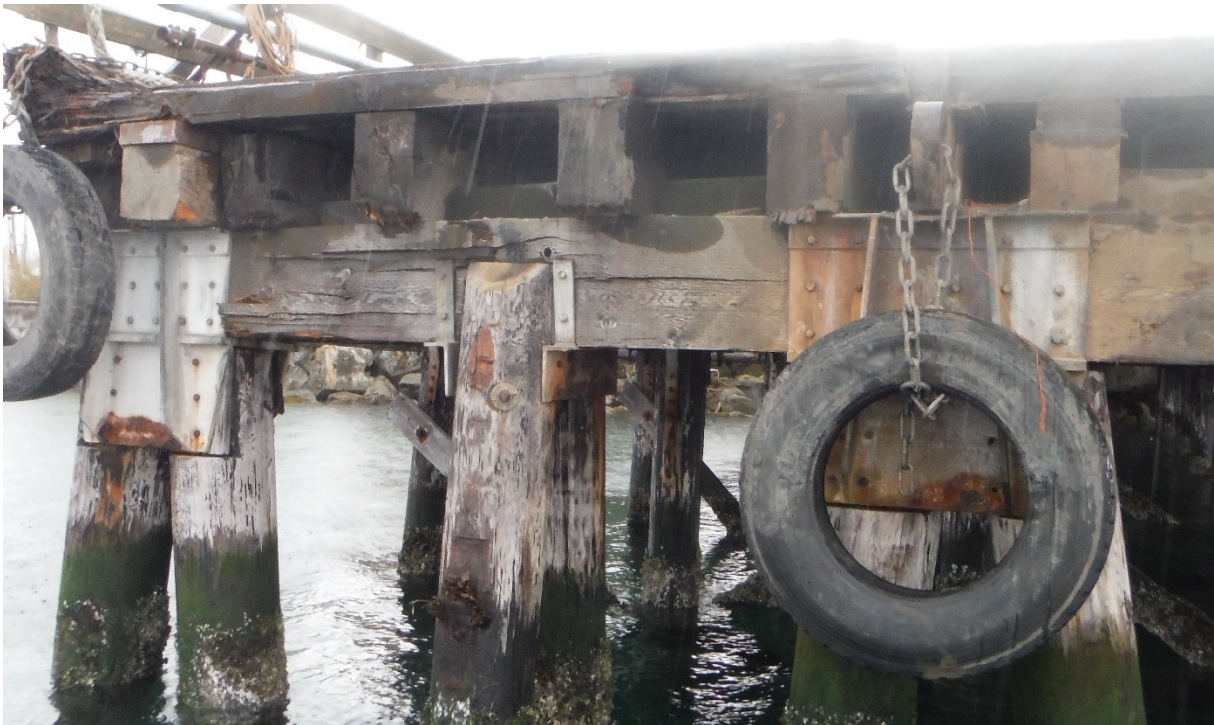
The fender system is in **poor** condition as the system only consists of three large rubber tires on the north outboard face of the dock, attached by chain to timber elements of the dock. The tires were not effective for a fender system as mechanical damage to the pier structure was noted in that region. (See Photo 7 in Appendix A.)

Photo 7 – Bent 11 (Mechanical Damage)

In addition, it is recommended that a new fender system be installed at the outboard end of the pier prior to installation of a floating dry dock.

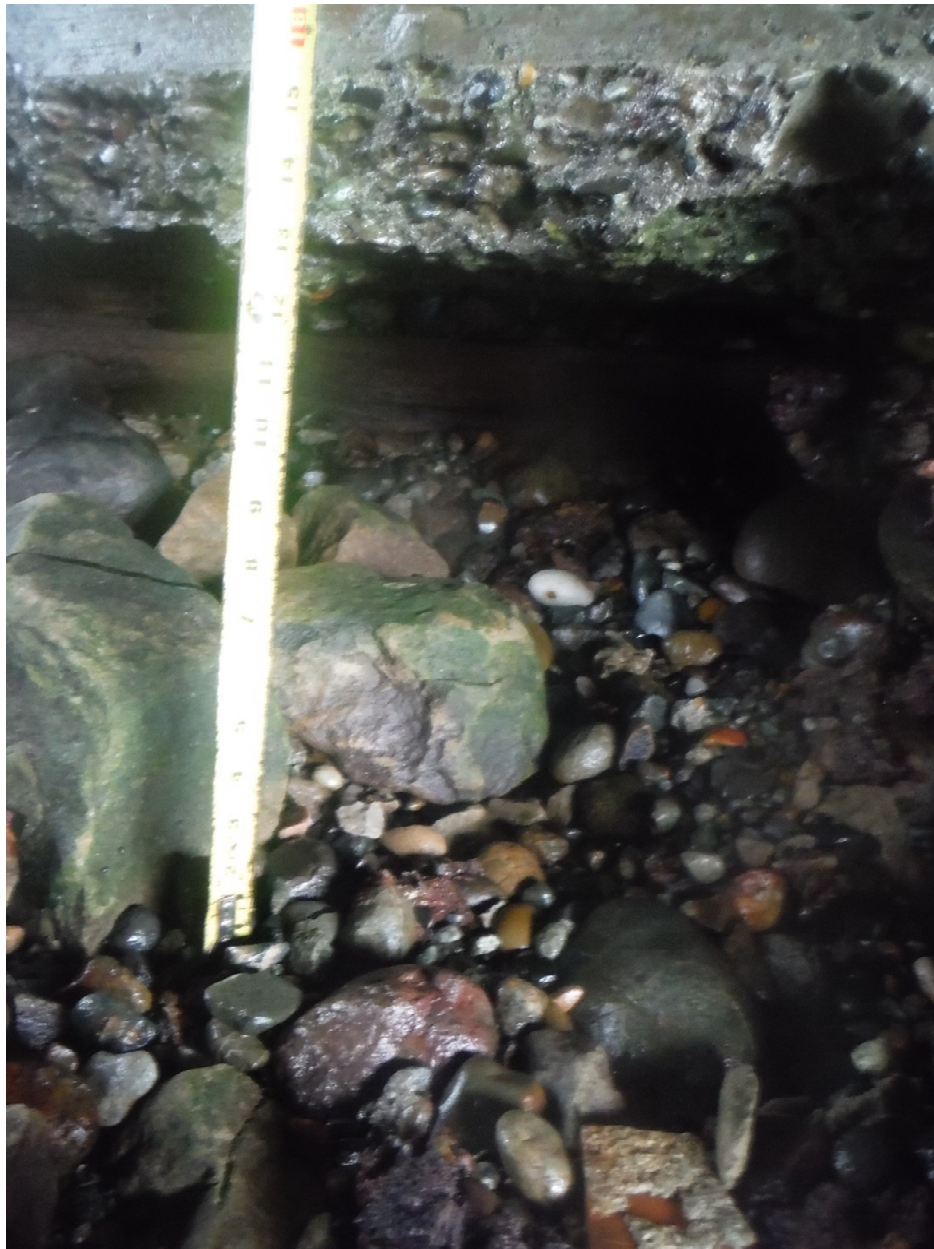
The bulkhead wall is in **fair** condition. Minor cracking is present on the wall face. A void is present under the wall that is approximately 20 feet wide. At the most severe location, the void is 3.5 feet deep and 14 inches high. (See Photo 8 in Appendix A.)

Photo 8 – Soil Undermining Bulkhead Wall

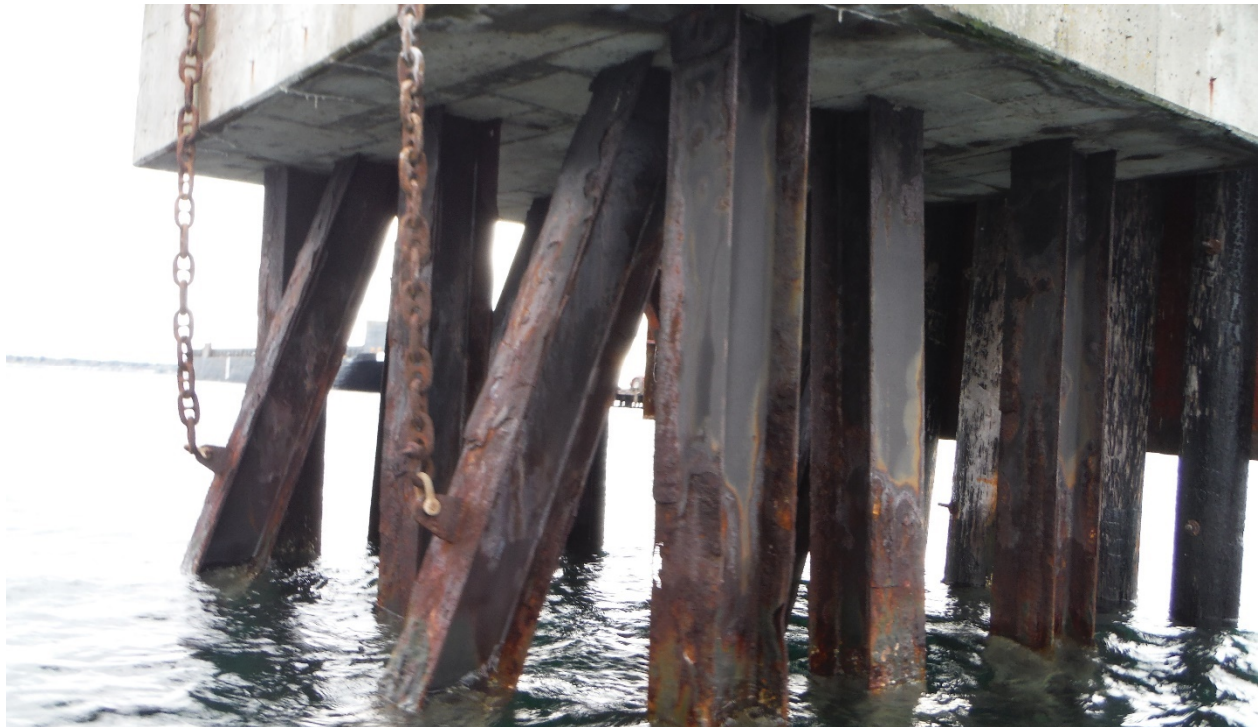
The steel piles are in **poor/fair** condition. Major corrosion and/or local buckling are present in two of the piles. Remaining piles have moderate corrosion concentrated within the tidal zone. (See Photo 9 in Appendix A.)

Photo 9 – Northwest Dolphin Corroded and Buckled Pile

- Perform repairs to the pile coating system.
- Install sacrificial anodes on piles.
- Repair steel piles that have buckled and have flanges that have corroded through the member.
- Replace fender system with new steel piles and fender panel system.

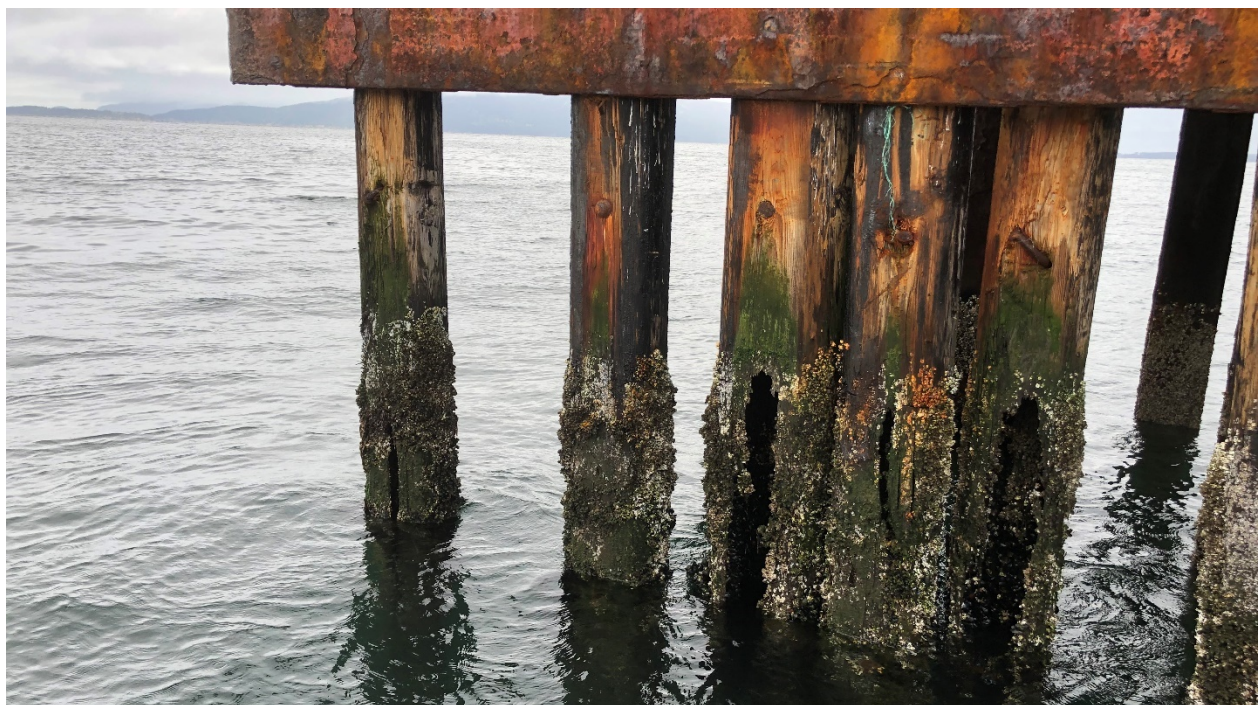
The timber fender piles are in **critical/serious** condition. Multiple piles have broken off and detached from the dolphin. Eight piles with major damage remain. (See Photo 10 in Appendix A.)

Photo 10 – Northwest Dolphin Fender Piles

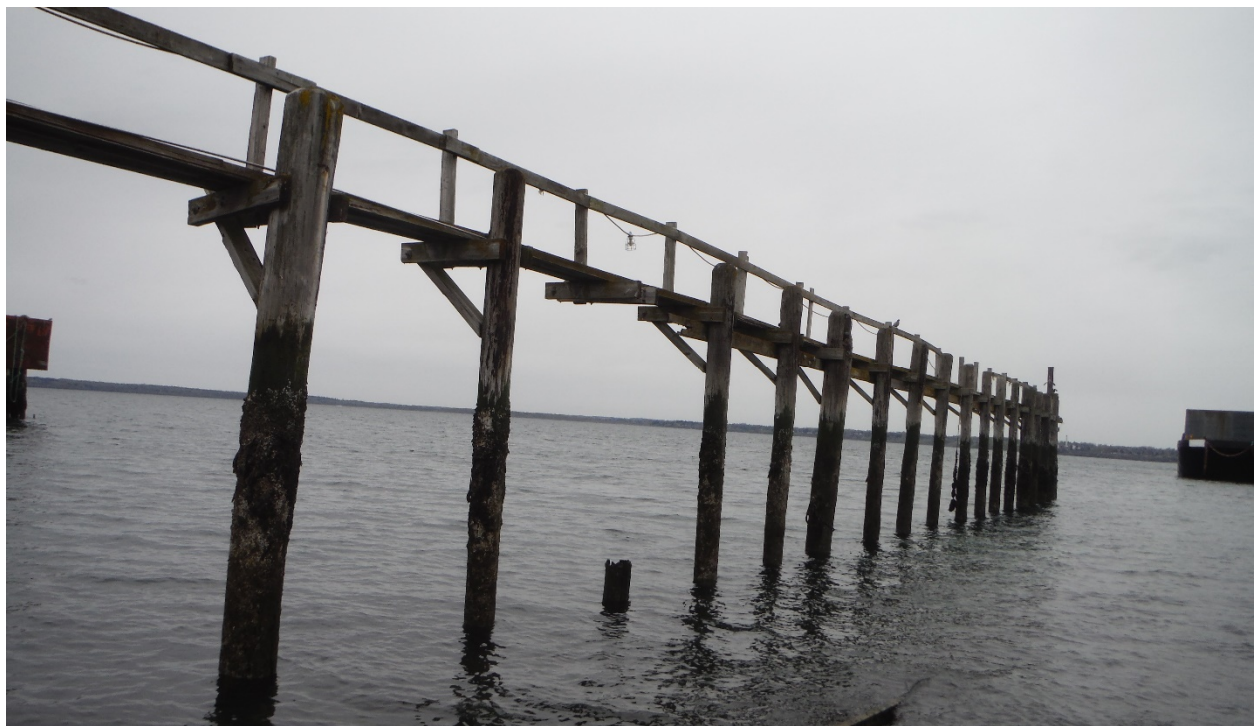
Photo 13 – West Marine Walkway

The timber piles are in **serious/poor** condition. Significant lateral displacement (leaning) was observed for many of the piles. One of the piles had broken off and was missing. (See Photo 13 in Appendix A.)

The West Marine Walkway does not function in its current state and would be hazardous if used during marine railway operation. The structure should not be used in its current state. If marine railway operations are still desired, it is recommended that the structure in its entirety be replaced with a new walkway similar to the East Marine Walkway.

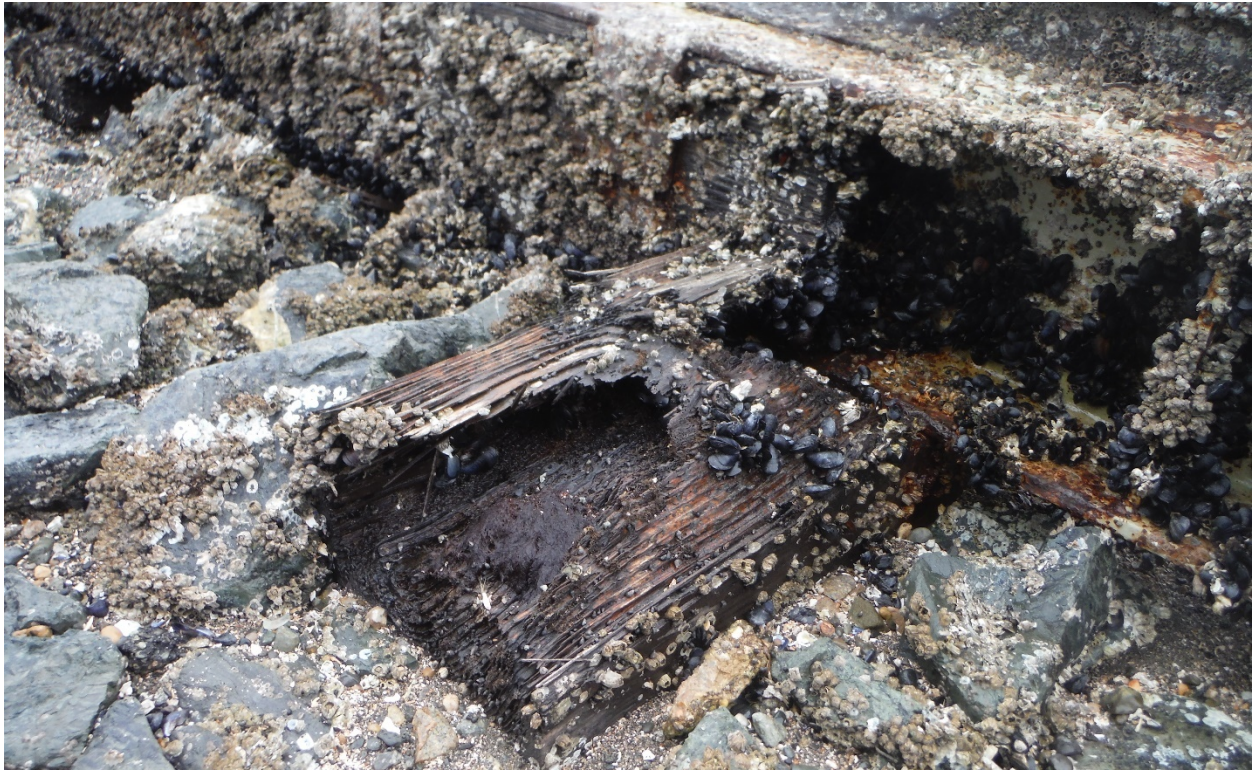
The timber beams and ties are in **fair** condition. Some timber ties and beams located within the tidal zone show signs of advanced deterioration, such as open cavities due to marine borer activity. (See Photo 15 in Appendix A.)

Photo 15 – Rotted Timber Tie

- Install sacrificial anodes on rail system.
- Replace timber sections that were rated as major or severe.
