APPENDIX A

PHOTOGRAPHS

West Dock

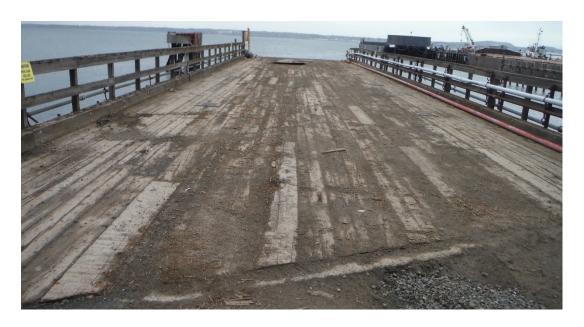
Photo 1 – West Dock Deck Surface

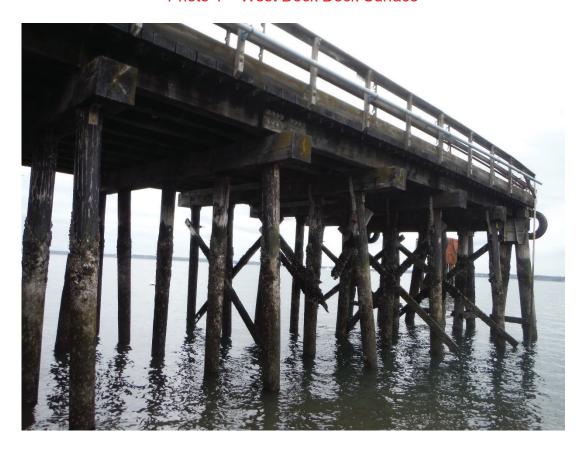
Photo 2 – West Dock Below Deck

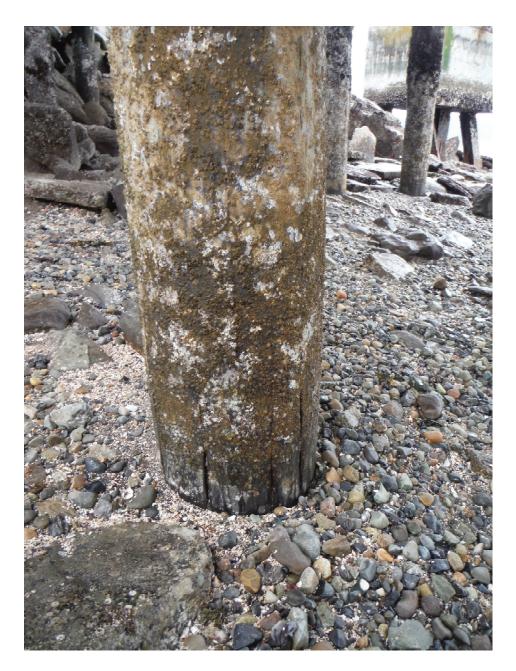
Photo 3 – Typical Pile with Minor Damage

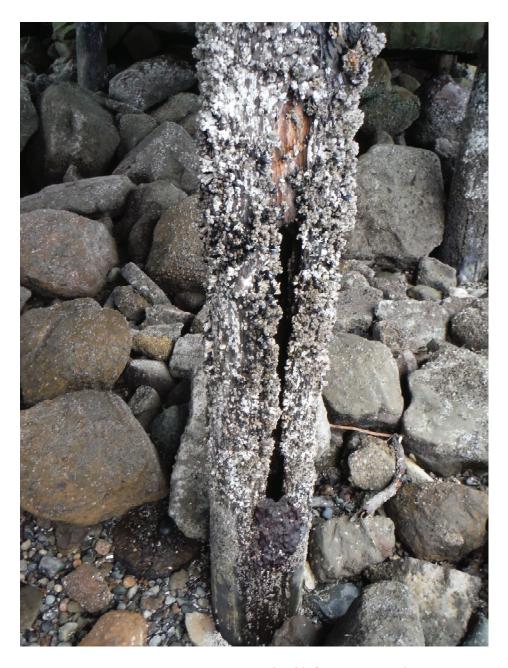
Photo 4 – Bent 2 Pile D (80% Section Loss)

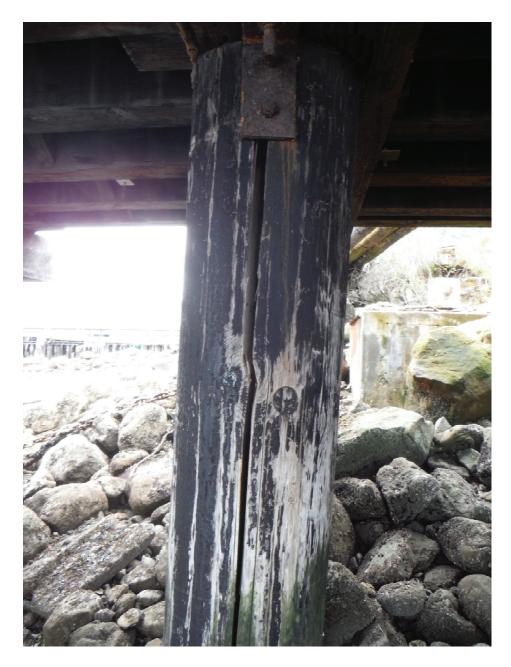
Photo 5 – Bent 2 Pile C (Mechanical Split)

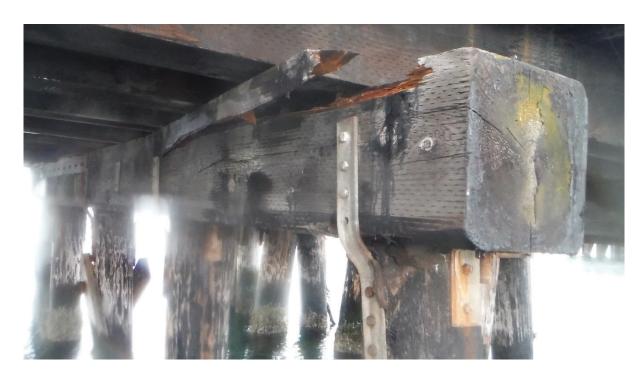
Photo 6 – Bent 10 (Splitting and Crushing)

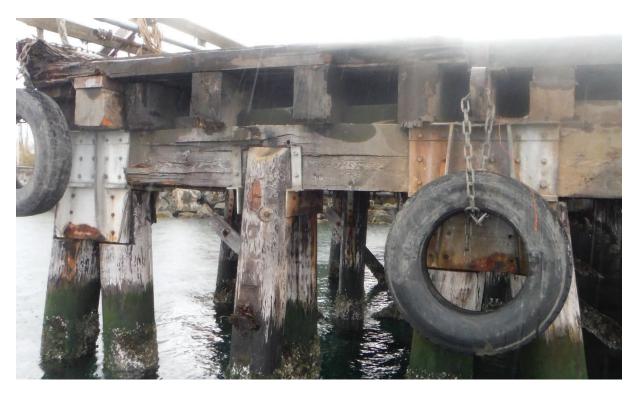
Photo 7 – Bent 11 (Mechanical Damage)

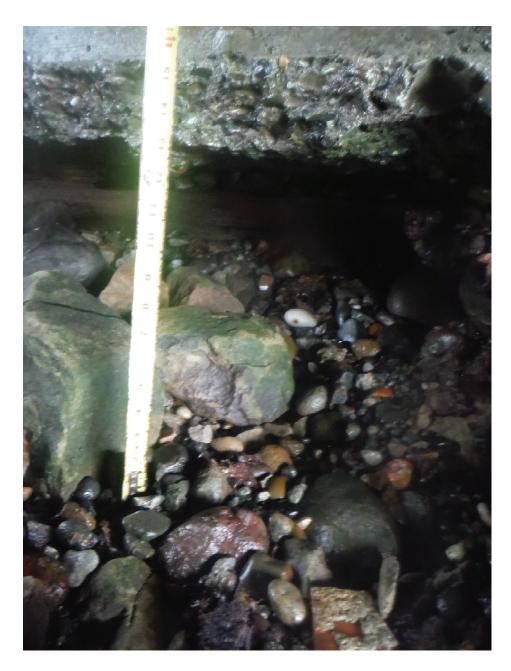
Photo 8 – Soil Undermining Bulkhead Wall

Asset Information			Damage Information						
Туре	Material	Bent	Grid Line	Description	Approximate Size	From	То	Rating	Comments
Bulkhead Wall	Conc	0	С	Vertical crack				MN	Soil undermining bulkhead wall
Bulkhead Wall	Conc	0	D	Vertical Crack				MN	Soil undermining bulkhead wall
Decking	Timber			Worn elements in many spots around deck	1" worn away			MD	Worn regions allow for water to pool

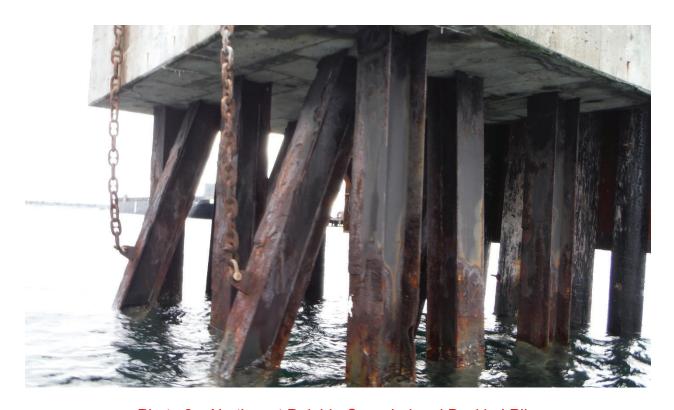
Photo 9 – Northwest Dolphin Corroded and Buckled Pile

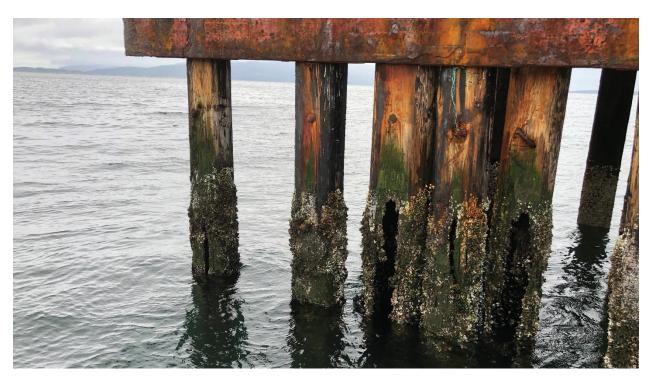
Photo 10 – Northwest Dolphin Fender Piles

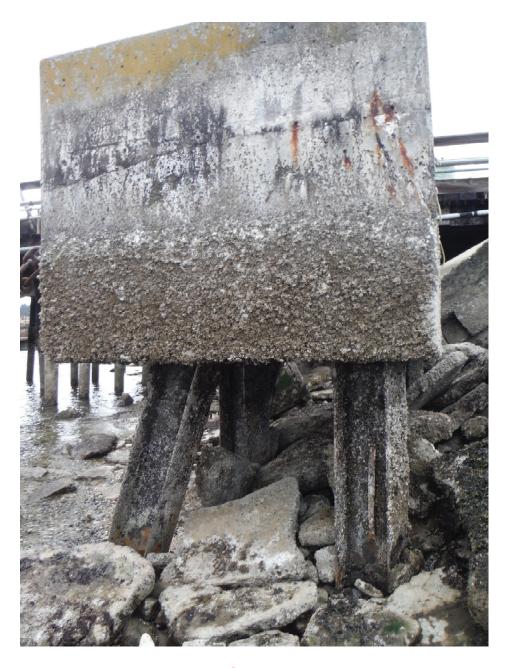
Photo 11 – Southwest Dolphin

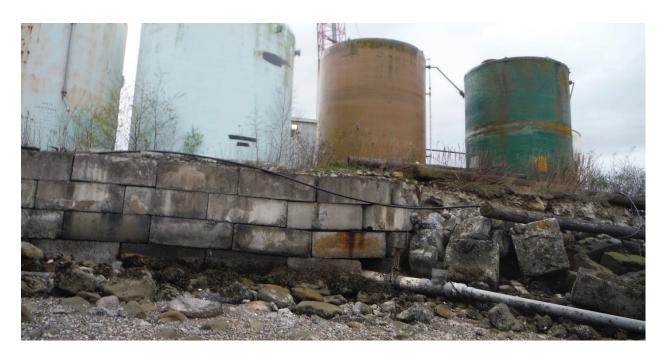
Photo 12 – Ecology Wall

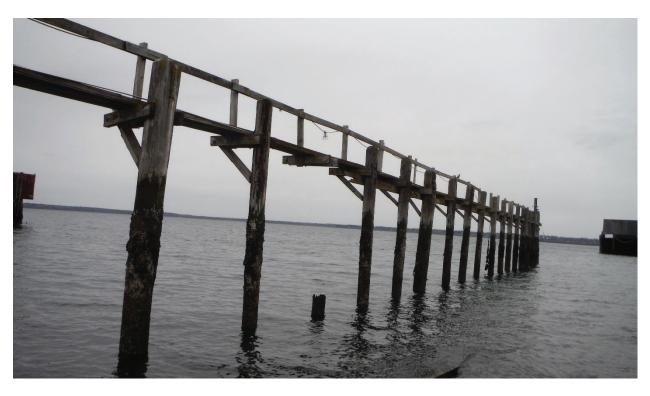
Photo 13 – West Marine Walkway

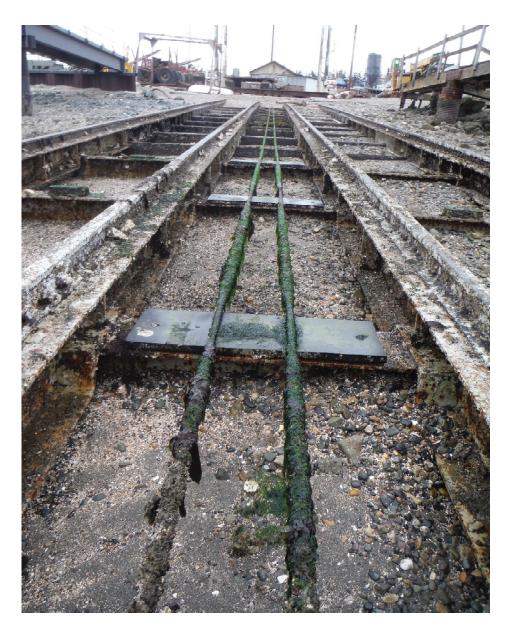
Photo 14 – Marine Railway

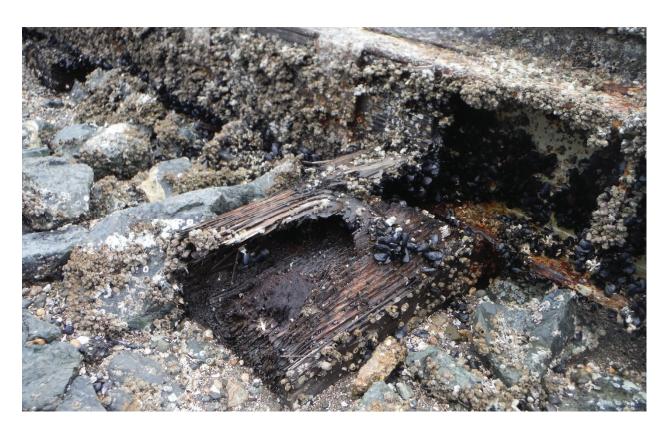
Photo 15 – Rotted Timber Tie
