# Monthly Progress Report

August 18, 2023

## Re: **Former Reynolds Metals Remediation – Monthly Progress Report, July 2023**

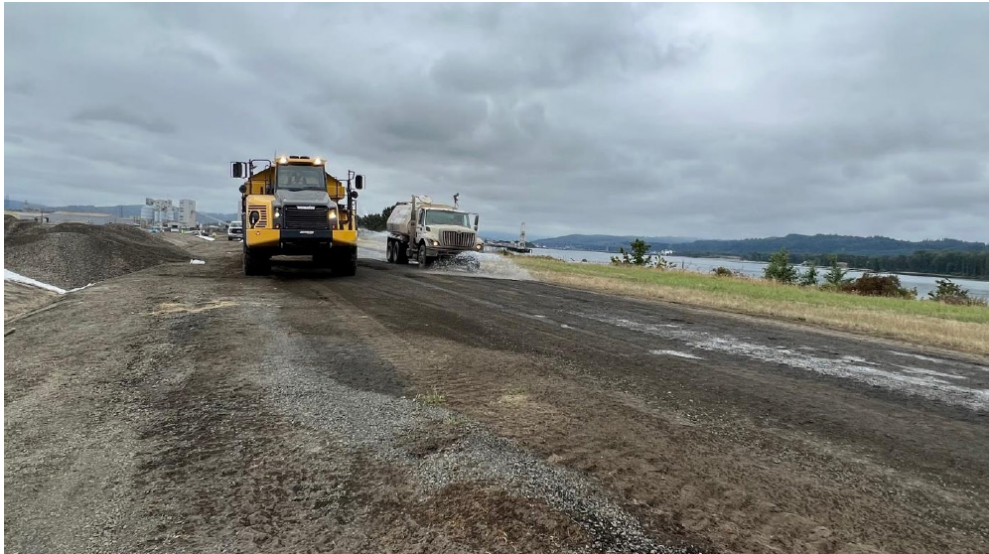
**Photograph 1**  
**Dust Suppression**

Envirocon, Inc., performing dust suppression control along Dike Road (facing southeast).

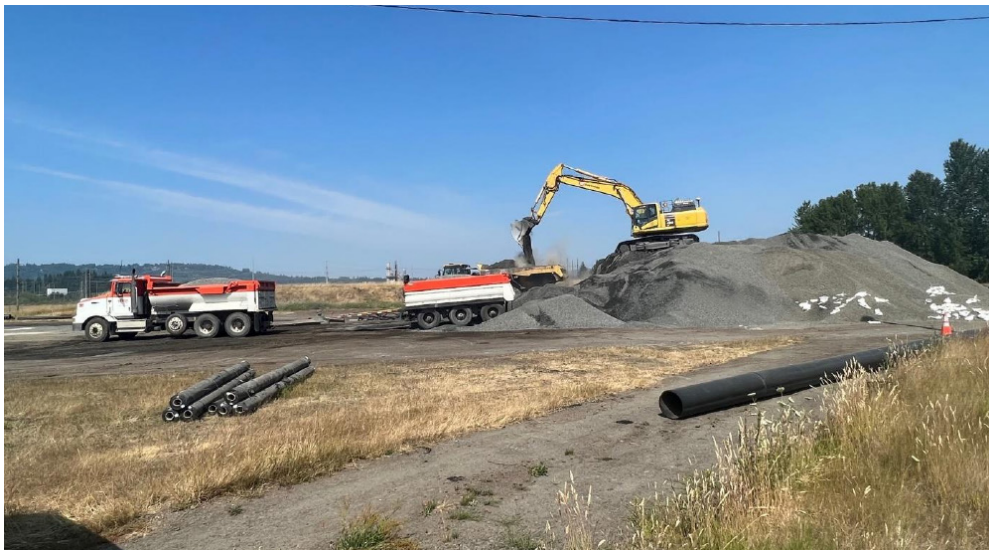
**Photograph 2**  
**Import Material**

Select Fill import material was delivered to the East Staging Area where it was received and managed by Envirocon (facing east).

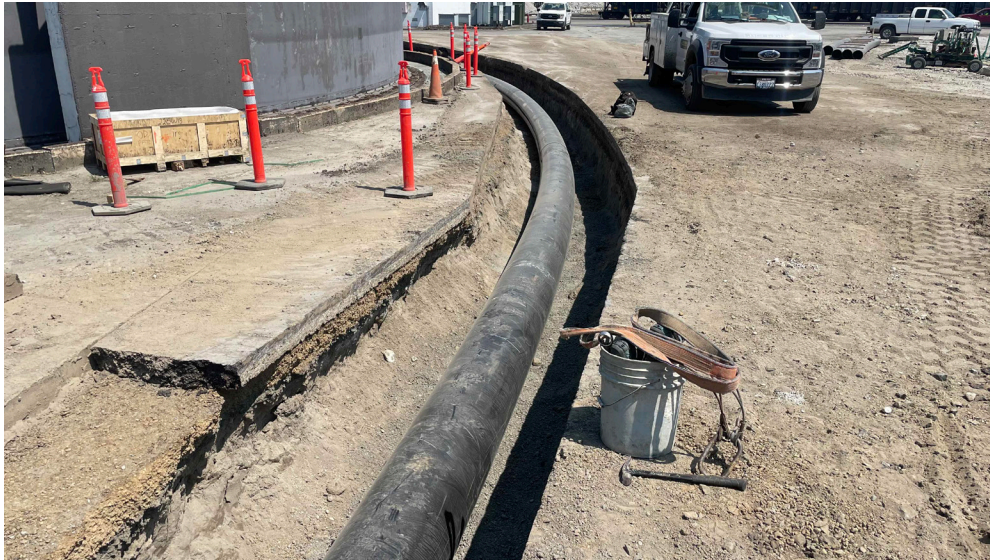
**Photograph 3**  
**East Force Main Piping**

Envirocon installing East Force Main 16-inch-diameter high-density polyethylene (HDPE) piping near Facility 77.

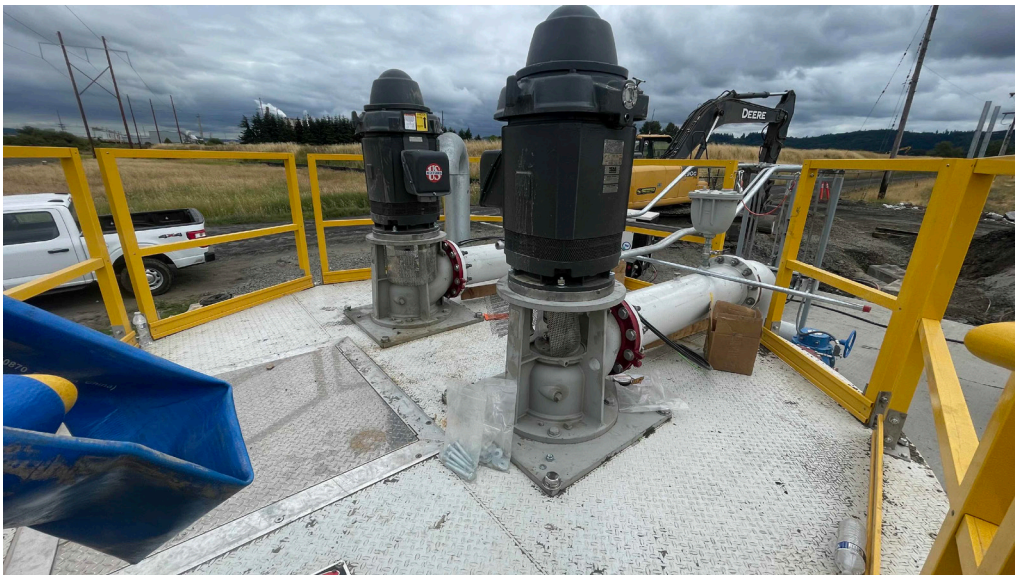
**Photograph 4**  
**East Force Main Pump**

Catworks Construction installed a mechanical electrical pump at the East Force Main wet well (facing south).

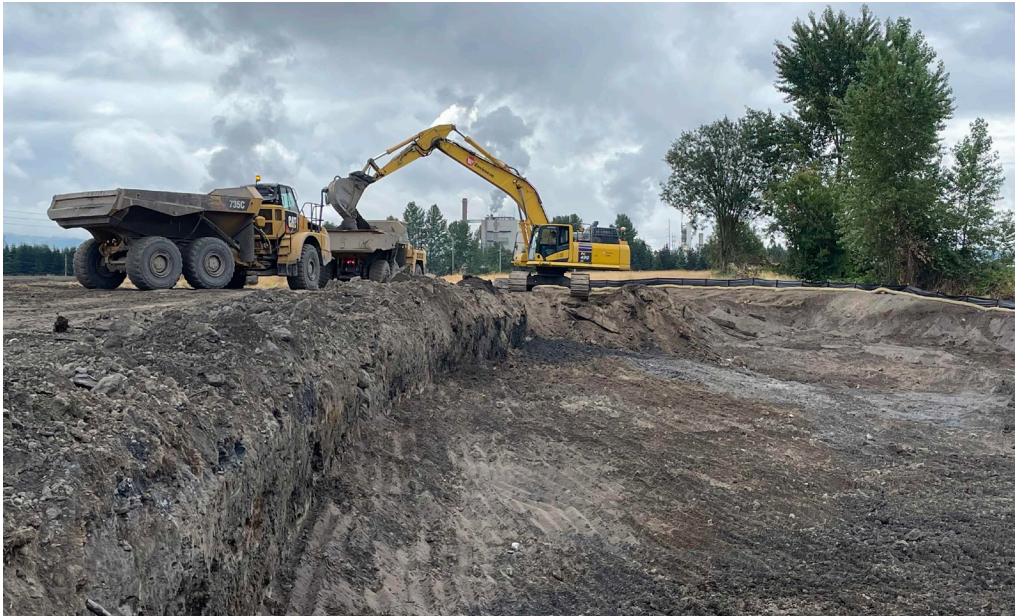
**Photograph 5**  
**SU10 Excavating**

Envirocon excavating material from Site Unit (SU) 10. Generated material was placed in East Landfill No. 1 (facing east).

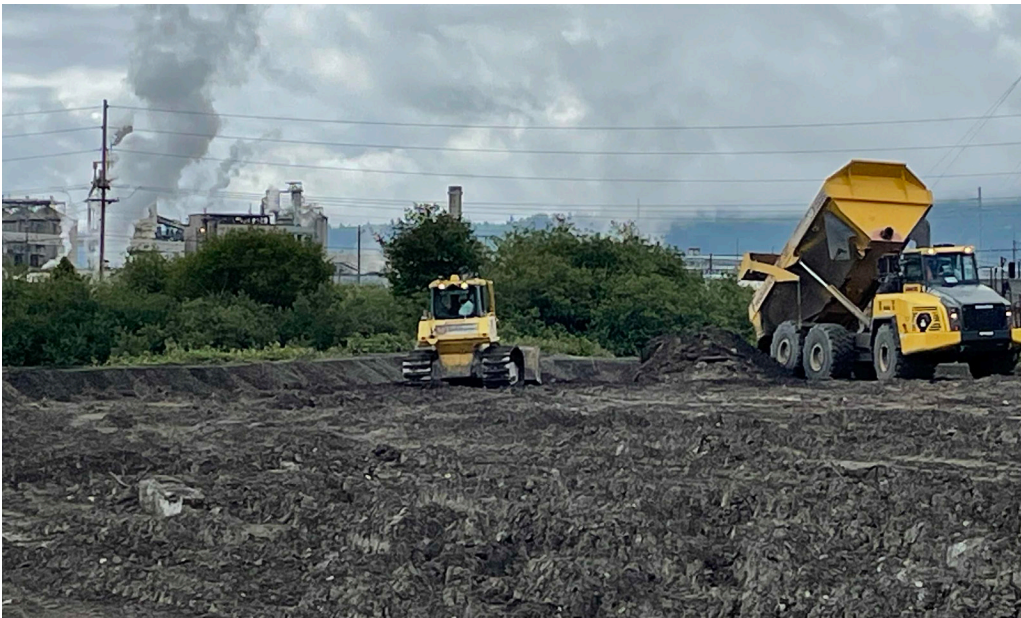
**Photograph 6**  
**East Landfill No.1**

Envirocon placing material generated from SU10 excavating into East Landfill No. 1 (facing southeast).

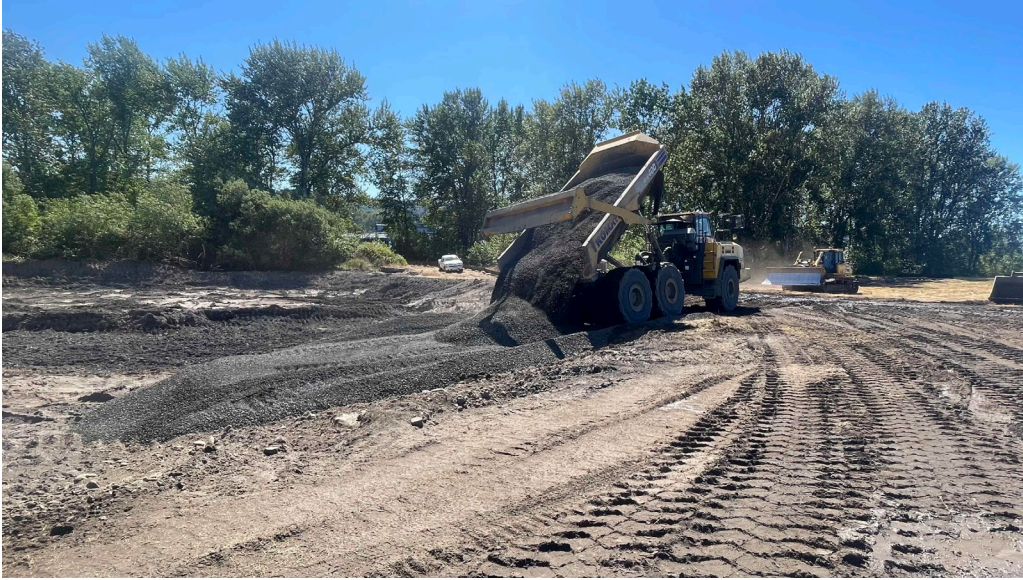
**Photograph 7**  
**SU10 Backfilling**

Envirocon backfilling the SU10 excavation with Select Fill (facing southeast).

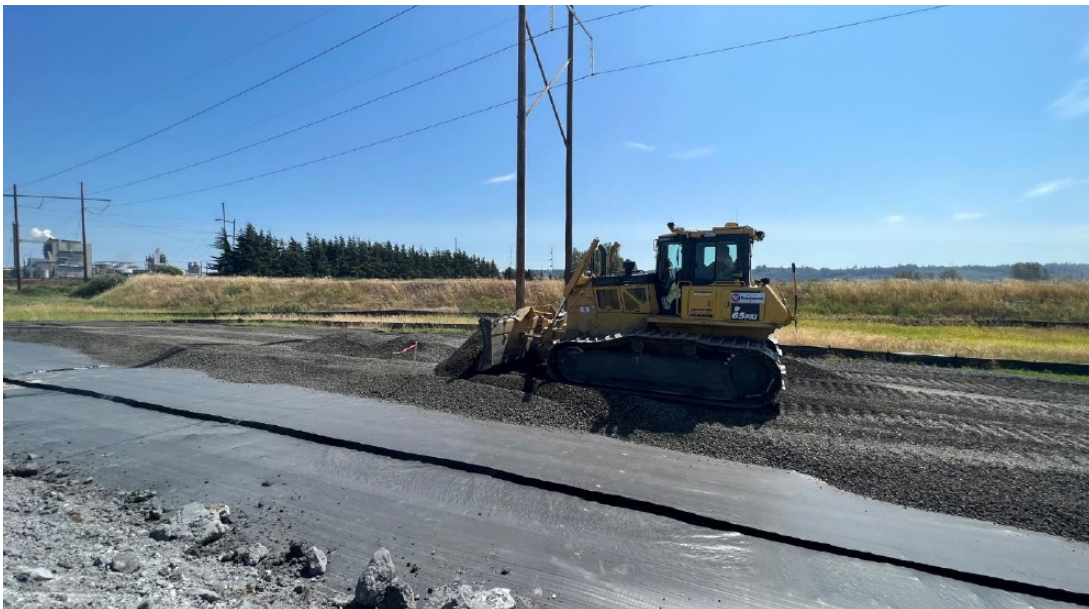
**Photograph 8**  
**East Landfill No. 1 – Berm Construction**

Envirocon installing Select Fill berm around the perimeter of East Landfill No. 1. Material was placed above geotextile fabric (facing east).

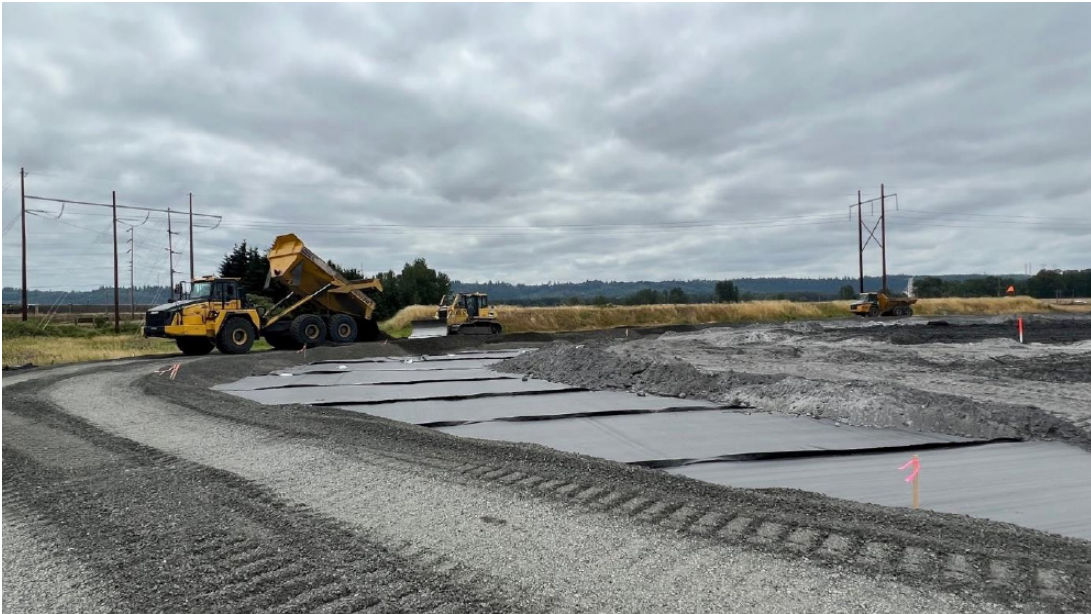
**Photograph 9**  
**East Landfill No. 1 – Berm**

Envirocon installing Select Fill berm around perimeter of East Landfill No. 1. (Facing southwest).

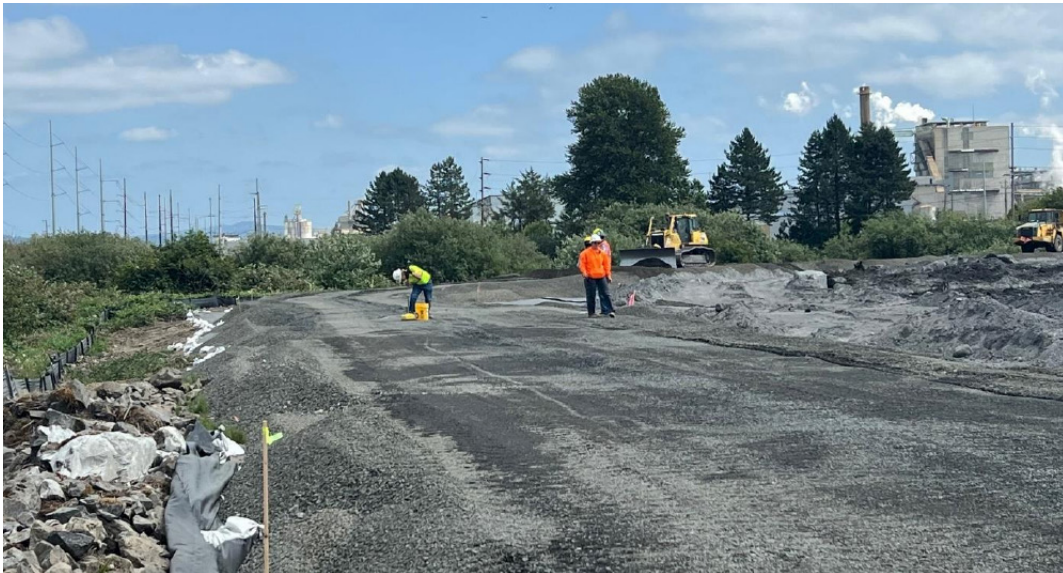
**Photograph 10**  
**East Landfill No. 1 – Berm Compaction Testing**

Professional Service Industries, Inc., performing compaction testing of Select Fill berm material (facing southeast).

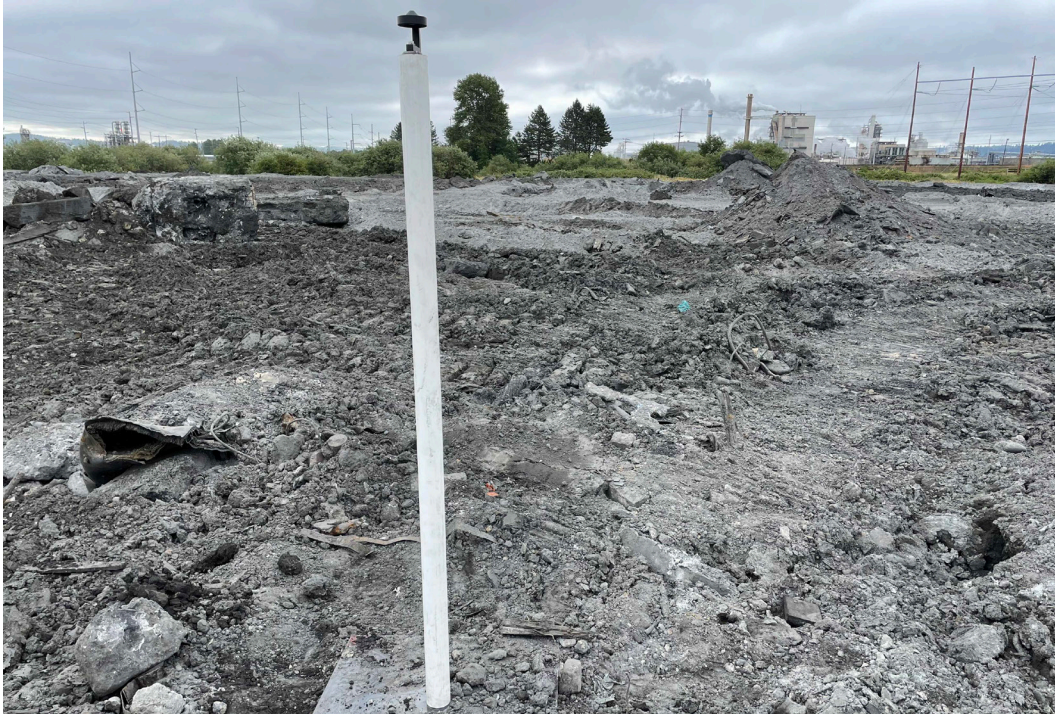
**Photograph 11**  
**East Landfill No. 1 – Settlement Plates**

Seven settlement plates were installed in East Landfill No. 1 to monitor for potential settlement (facing east).

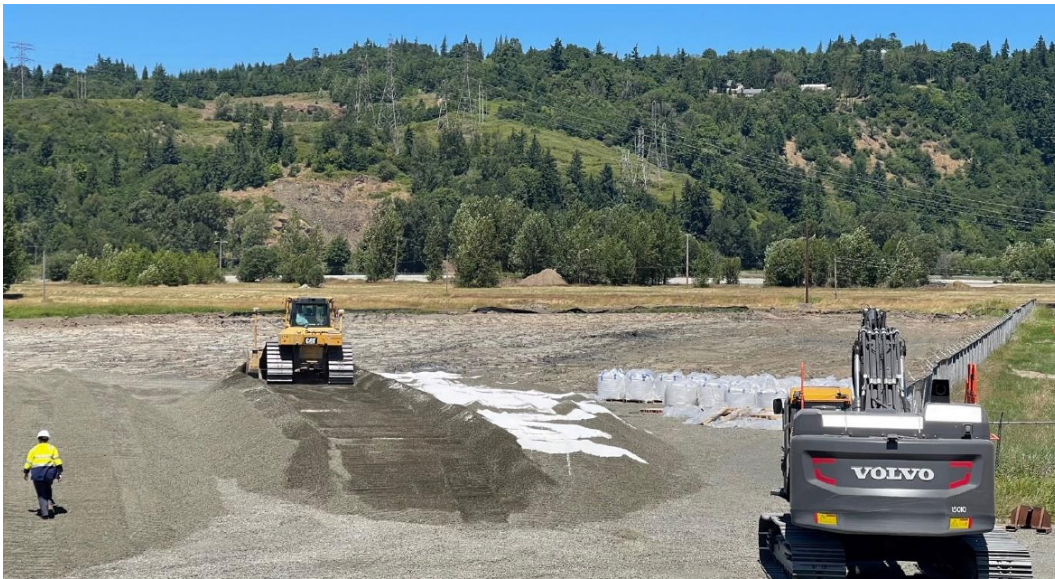
**Photograph 12**  
**West Landfill – Reactive Backfill Mixing**

Envirocon mixing the activated alumina and Select Fill materials for use as reactive backfill in West Landfill (facing north).

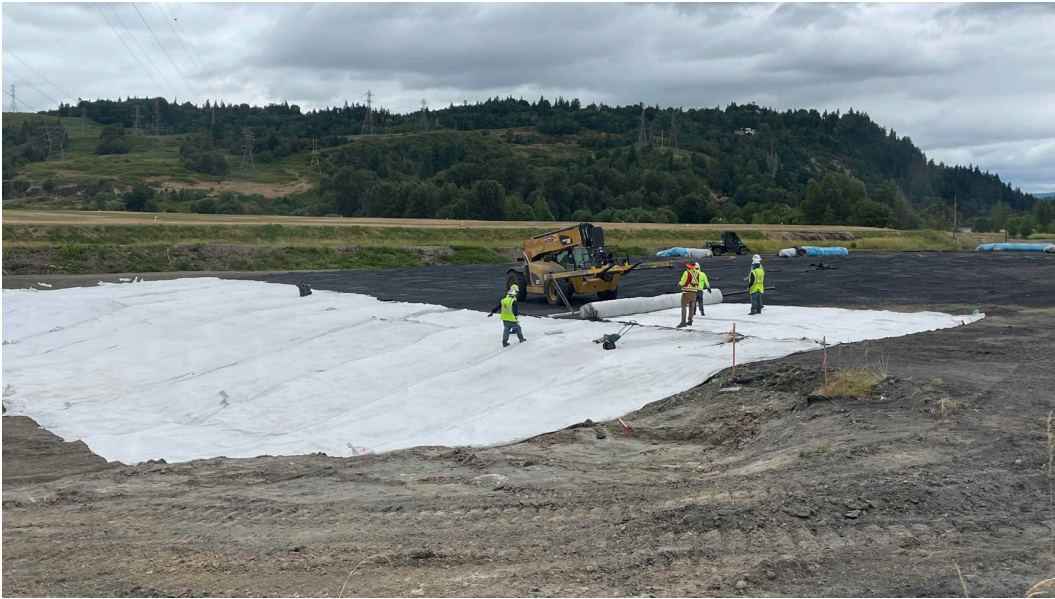
**Photograph 13**  
**West Landfill – GCL Placement**

Northwest Linings & Geotextile Products, Inc., placing geotextile clay layer (GCL) membrane in West Landfill (facing northeast).

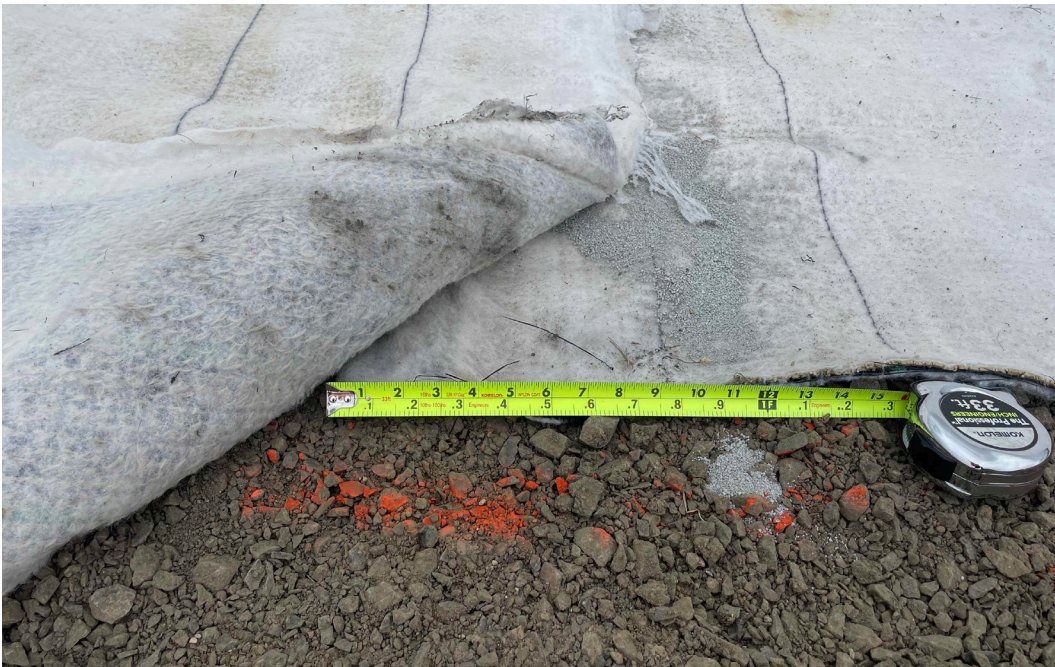
**Photograph 14**  
**West Landfill – GCL Placement**

Granular bentonite used as a seal along the GCL 9-inch overlap seam.

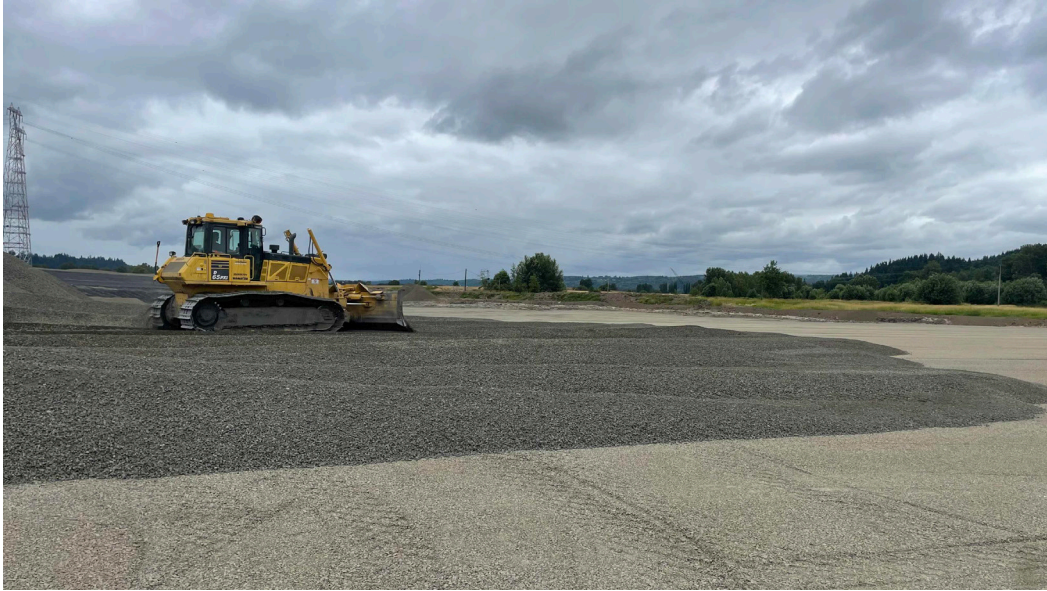
**Photograph 15**  
**SU2 – Select Fill Placement Over Reactive Backfill**

Envirocon placing select fill on top of reactive backfill in SU2 (facing east).
