Monthly Progress Report

October 20, 2023

Re: Former Reynolds Metals Remediation – Monthly Progress Report, September 2023

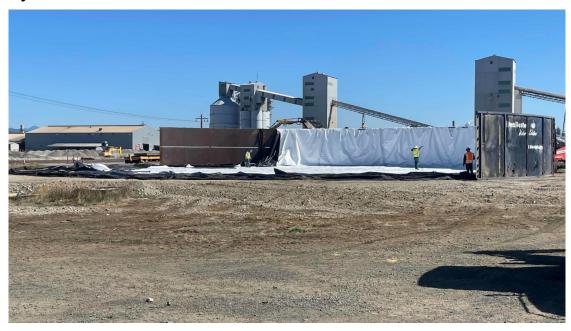
Photograph 1 Facility 77

Denbeste Water Solutions installing 1-million-gallon water tank extension at Facility 77.

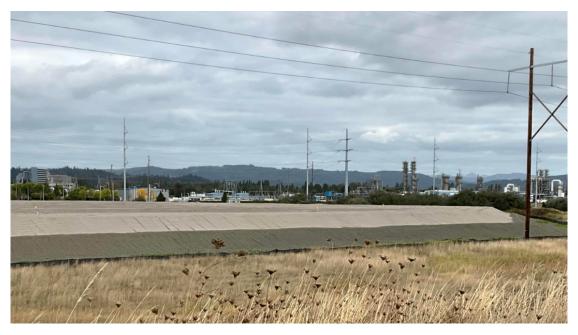
Photograph 2 East Landfill No. 1

Placement of general fill over compacted, consolidated waste material in East Landfill No. 1.

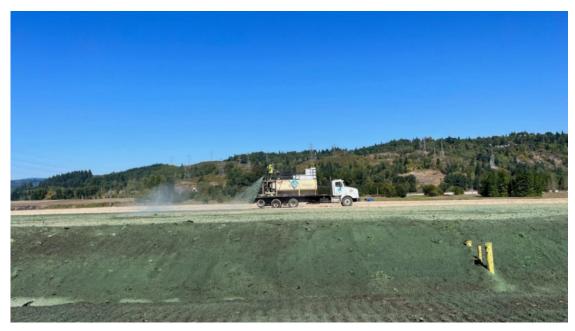
Photograph 3 West Landfill

Application of Hydroseed Mix No. 2 over topsoil in West Landfill.

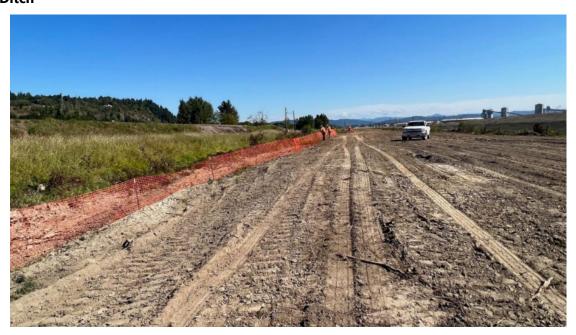
Photograph 4 U-Ditch

Installation of temporary construction fence along southern edge of U-Ditch.

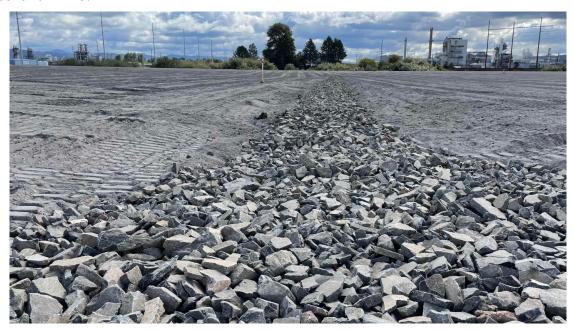
Photograph 5 East Landfill No. 1

Construction of Season 1 drainage channel in East Landfill No. 1.

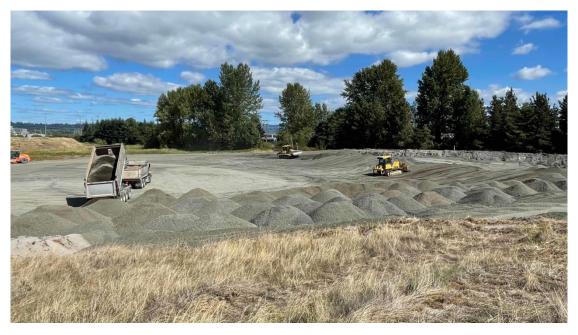
Photograph 6 SU8

Delivery, placement, and compaction of select fill in SU8.

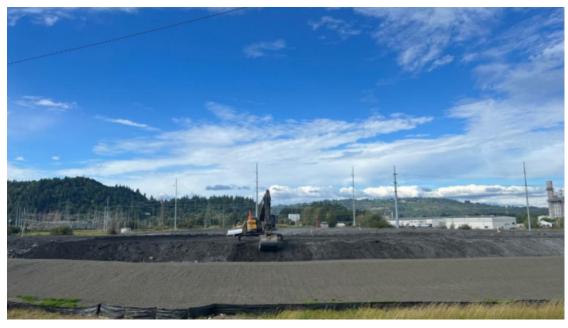
Photograph 7 East Landfill No. 1

Final grading of consolidated waste material in East Landfill No. 1.

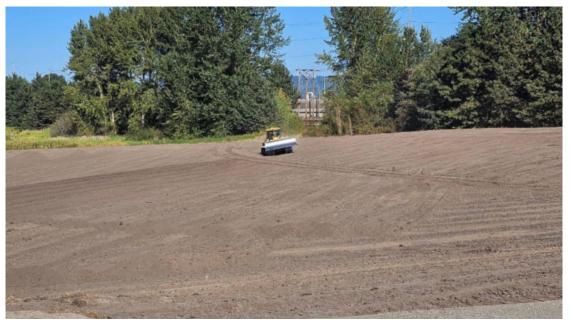
Photograph 8 Site Unit 8

Envirocon, Inc., placing general fill above geotextile fabric at SU8 (facing east).

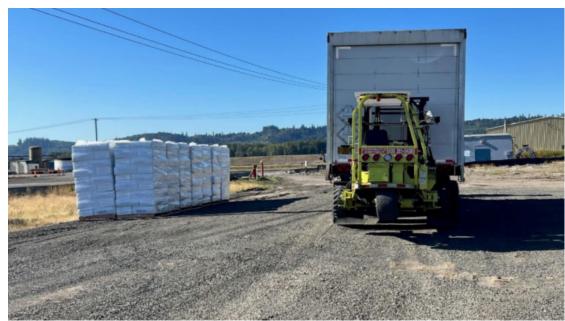
Photograph 9 Delivery and Staging Hydroseed

Northwest Hydro-Mulchers, Inc., staging hydroseed mixes near West Staging Area.

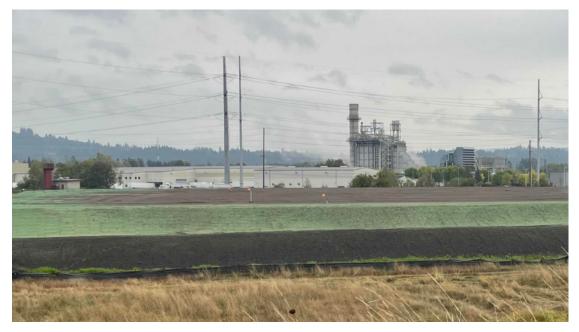
Photograph 10 East Landfill No. 1

Application of bonded fiber matrix (Hydroseed Mix No. 1) at East Landfill No. 1.
