Monthly Progress Report

July 20, 2023

Re: **Former Reynolds Metals Remediation – Monthly Progress Report, June 2023**

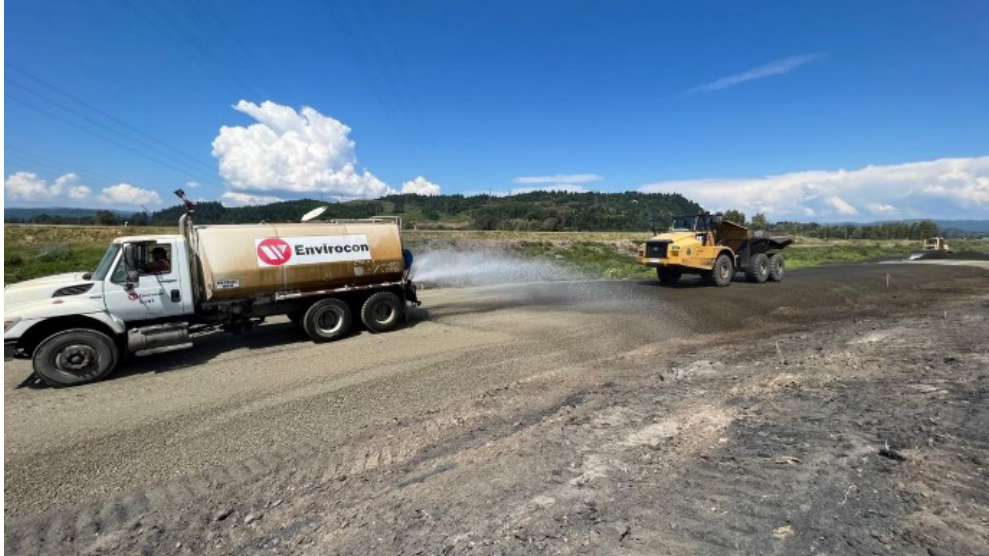
Photograph 1
Dust Suppression

Envirocon, Inc., performing dust suppression control near U-Ditch (facing east).

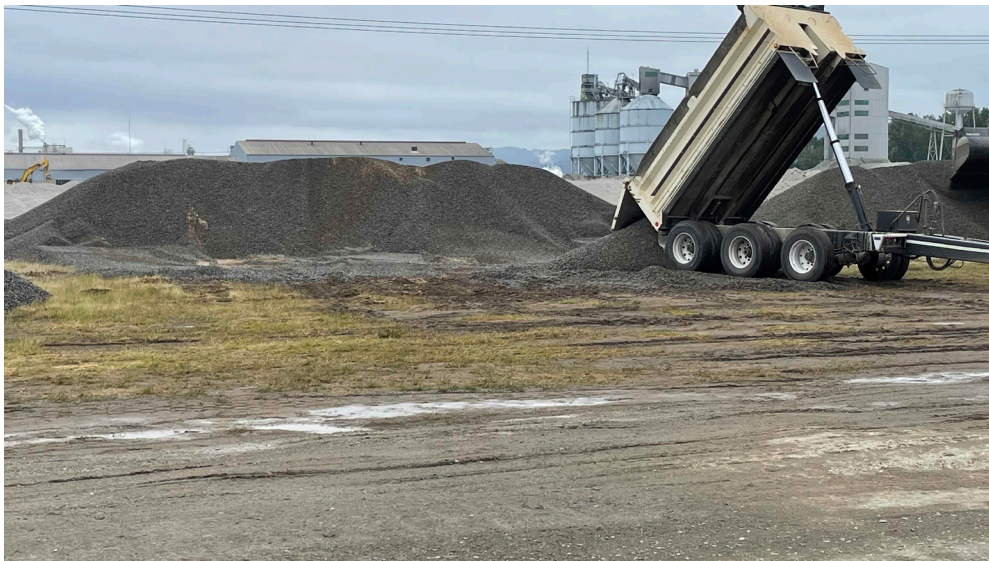
Photograph 2
Import Material

Select fill import material was delivered to the West Staging Area where it was received and managed by Envirocon (facing northeast).

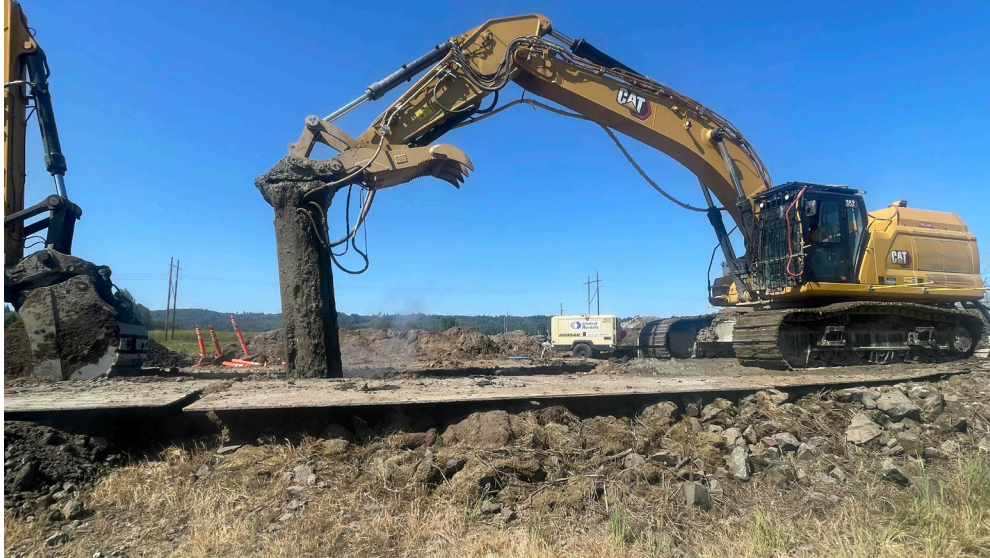
Photograph 3
East Landfill No. 1 – Ground Improvement

- **Ground improvement**
 - Keller Management Services, LLC, completed ground improvement measures at East Landfill No. 1. All verification samples were tested with results meeting established geotechnical criteria.

Keller Management Services, LLC, completed ground improvements at East Landfill No. 1 (facing northwest).

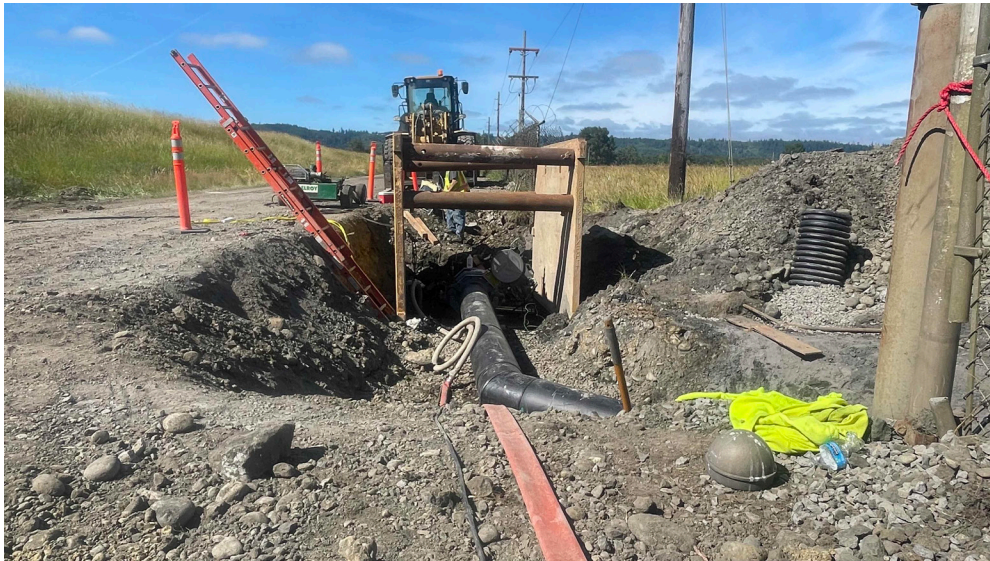
Photograph 4
East Force Main – HDPE Pipe Fusing

Envirocon performing fusing of 16-inch-diameter East Force Main high-density polyethylene (HDPE) piping near STA 201+00 (facing southwest).

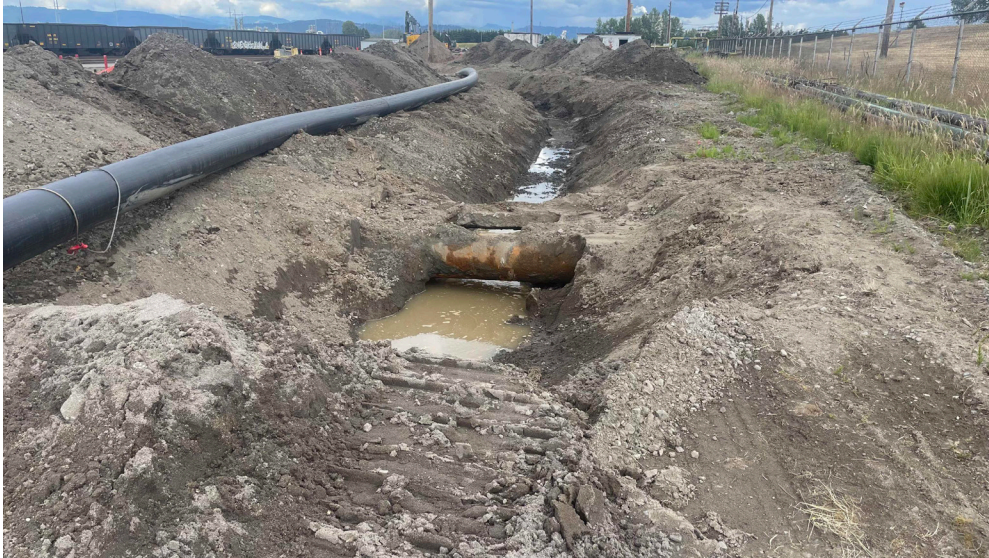
Photograph 5
East Force Main – Pipe Installation

Trenching for East Force Main pipe installation near Outfall 001S (facing southeast).

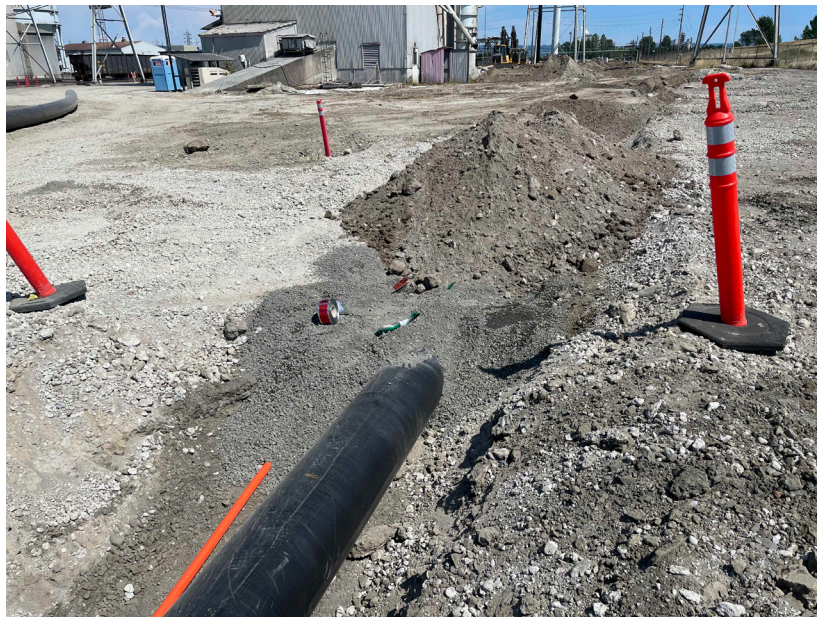
Photograph 6
East Force Main Pipe Installation

Envirocon installing 16-inch-diameter HDPE East Force Main piping approaching Facility 77. Note orange tracer line (facing east).

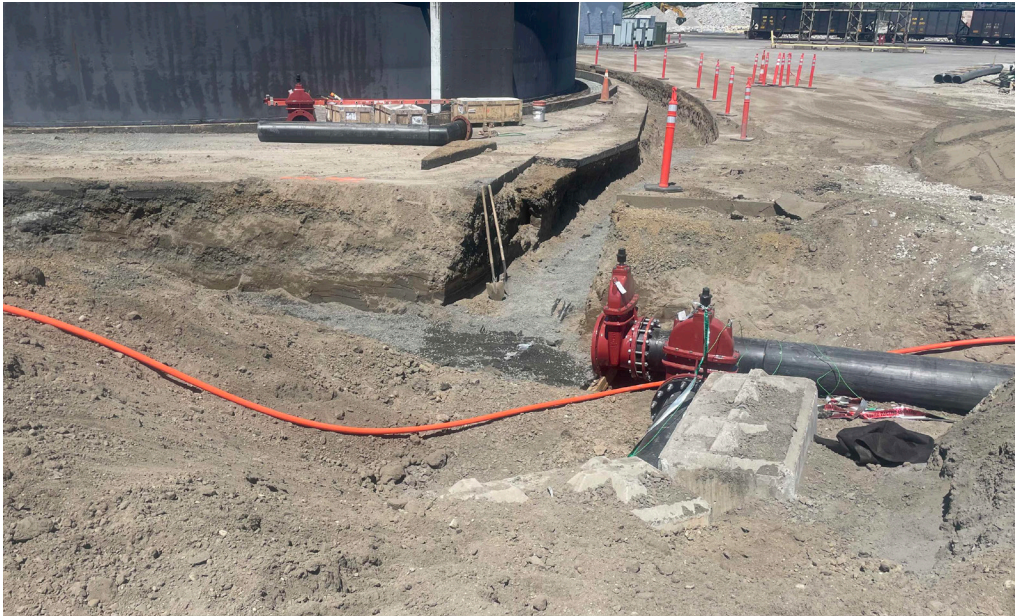
Photograph 7
East Force Main – Gate Valve Installation at Facility 77

East Force Main piping being installed with gate valve near STA 236+51 (facing north).

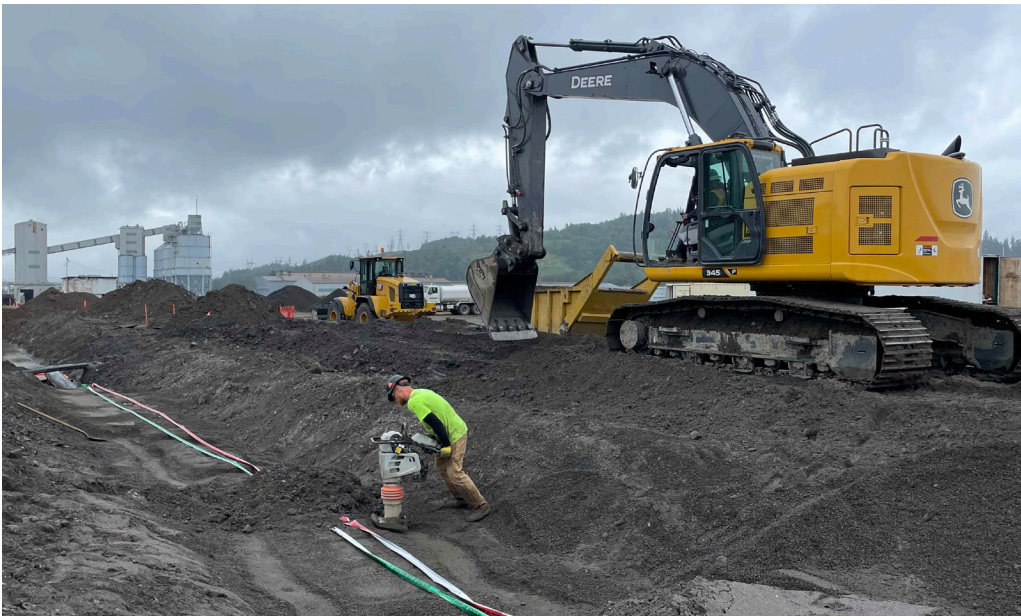
Photograph 8
East Force Main Piping – Compaction

Envirocon performing compaction along East Force Main piping alignment (facing north).

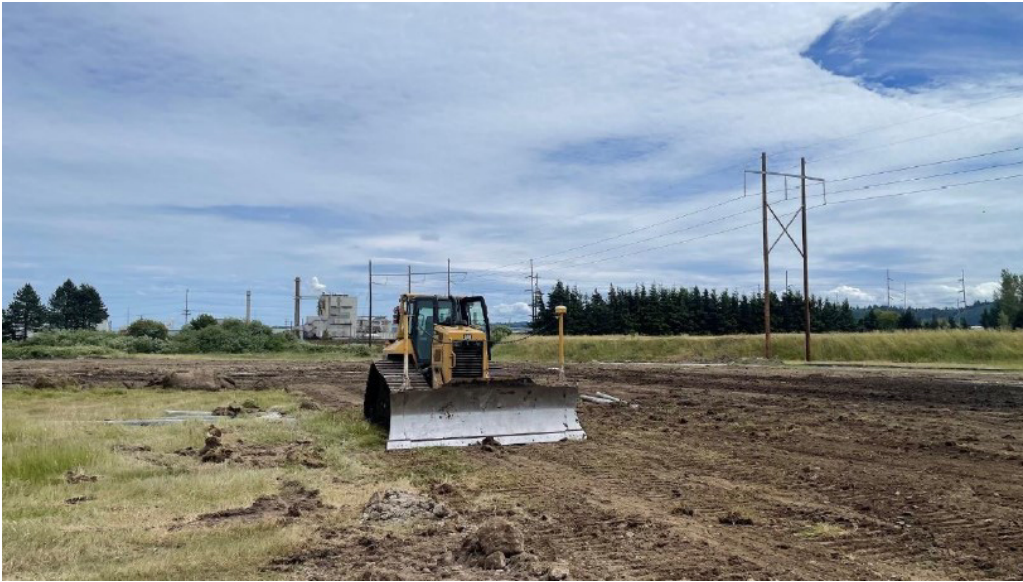
Photograph 9
East Landfill No.1 – Vegetation Removal

Envirocon removing surface material in preparation of geotextile fabric placement at East Landfill No. 1 (facing southeast).

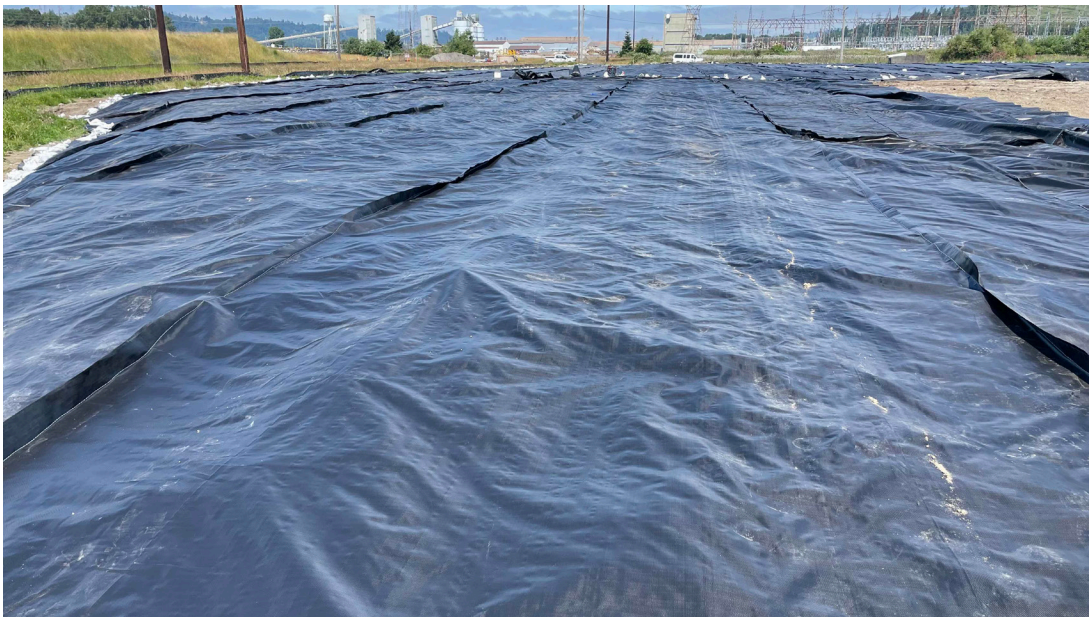
Photograph 10
East Landfill No. 1 – Geotextile Fabric

Envirocon installed geotextile fabric along a portion of the surface of East Landfill No. 1. Ground surface was grubbed prior to fabric placement (facing northwest).

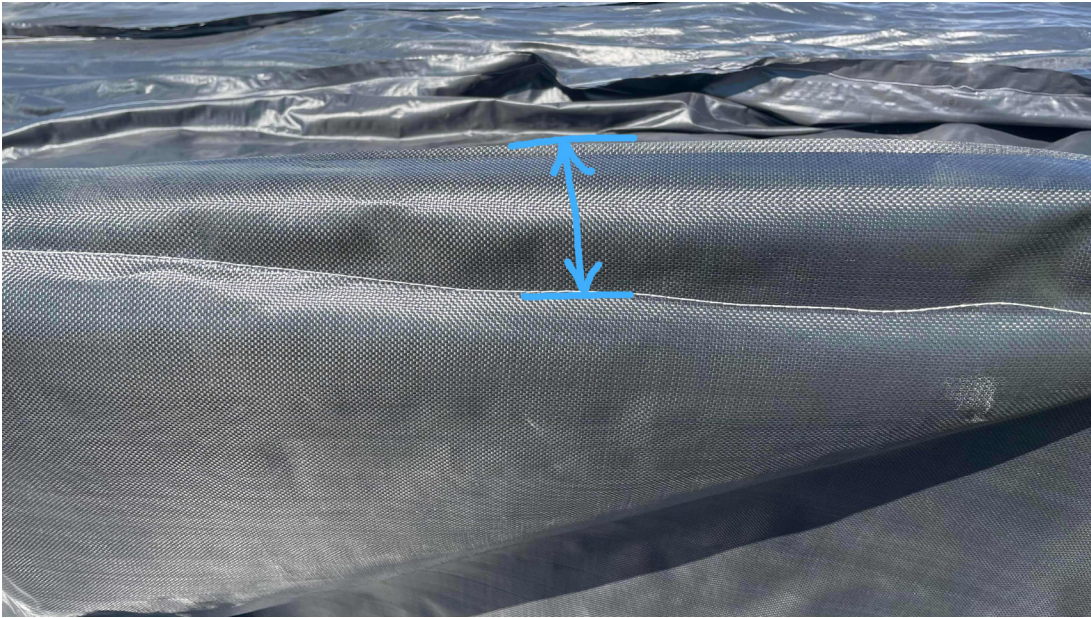
Photograph 11
East Landfill No. 1 – Geotextile Fabric

Overlap of geotextile fabric at East Landfill No. 1, as per project specifications.

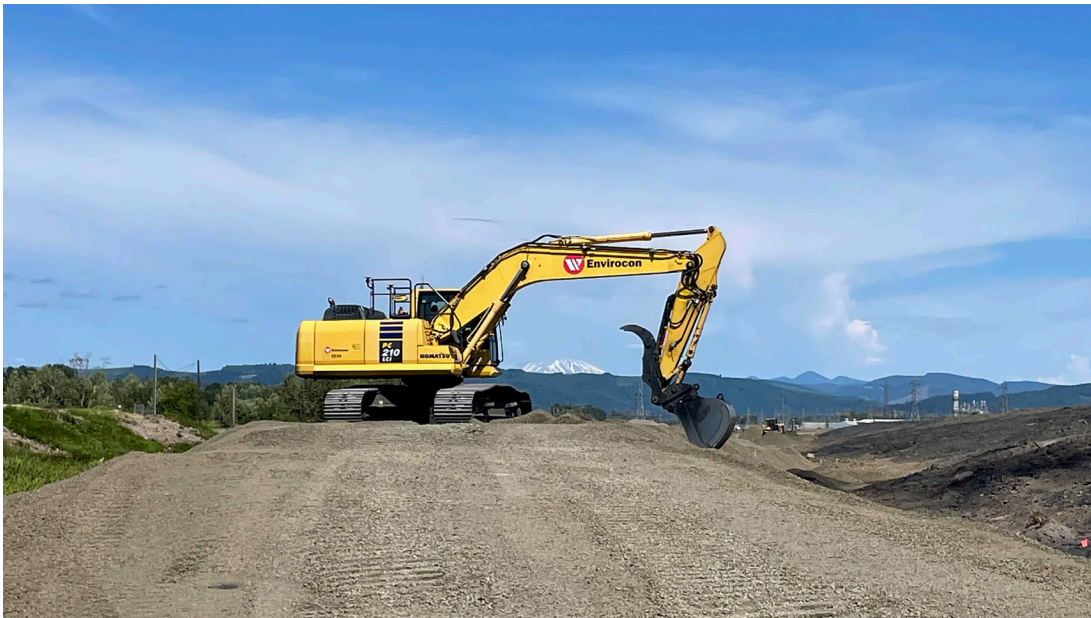
Photograph 12
U-Ditch – Berm Construction

Envirocon constructing berm along the south side of the U-Ditch (facing southeast).

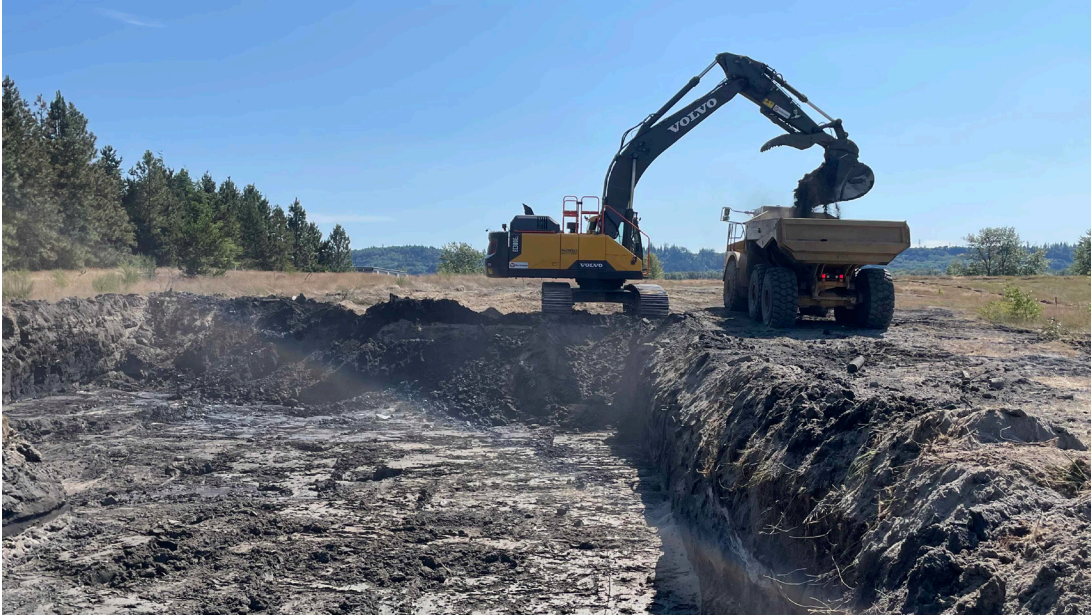
Photograph 13
SU8 Excavating

Envirocon commenced excavating at SU8. Generated material was stockpiled at East Landfill No. 1 (facing southwest).

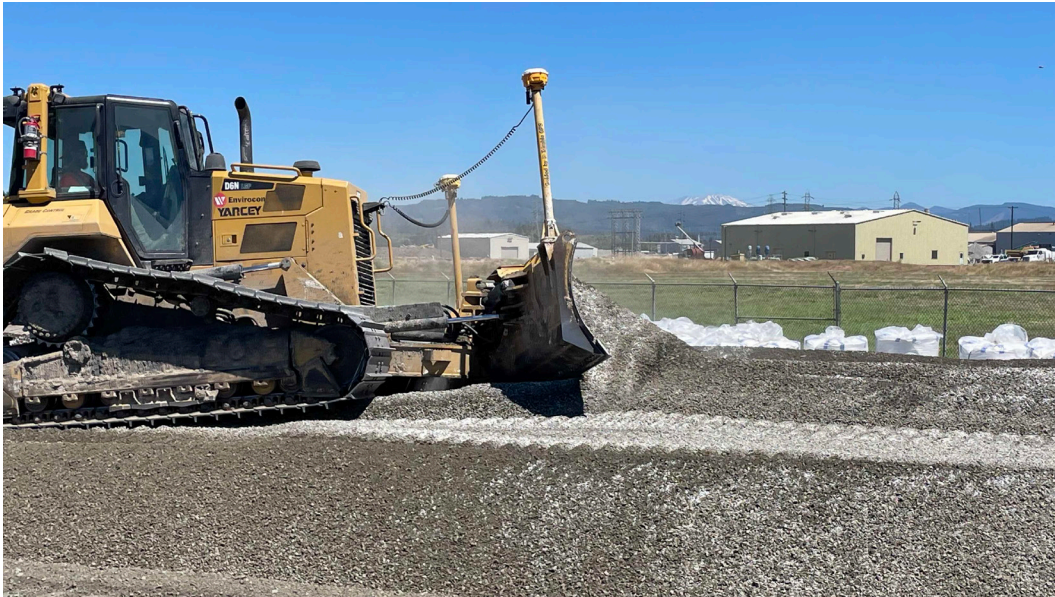
Photograph 14
West Landfill – Reactive Backfill Placement and Mixing

Envirocon mixing activated alumina reactive backfill into the excavations around the West Landfill (facing east).

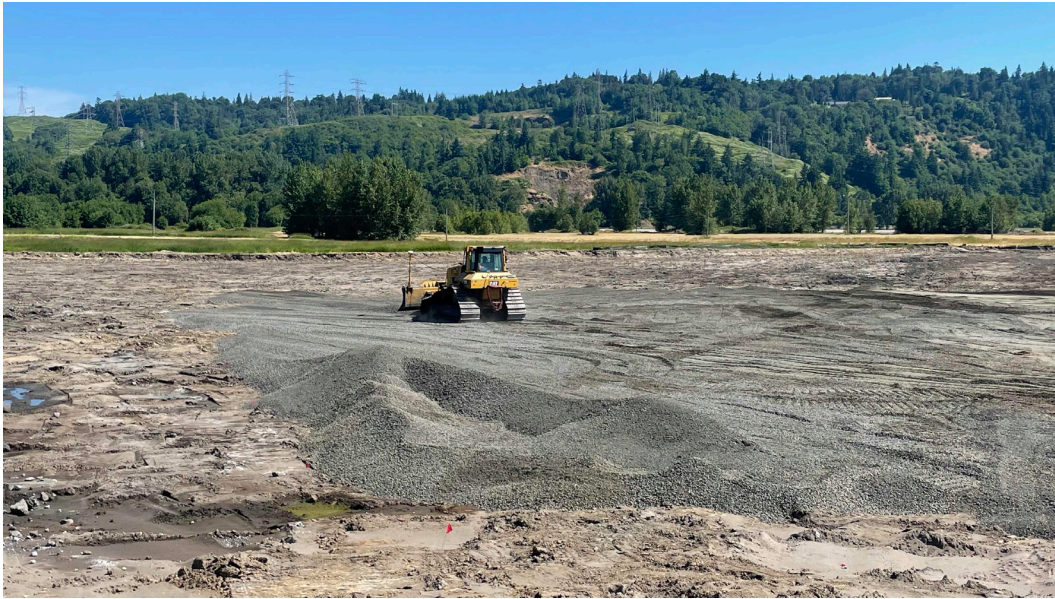
Photograph 15
West Landfill – Select Fill Placement

Envirocon placing select fill at West Landfill. Material was placed in 12-inch lifts. Compaction was performed after each 12-inch lift.

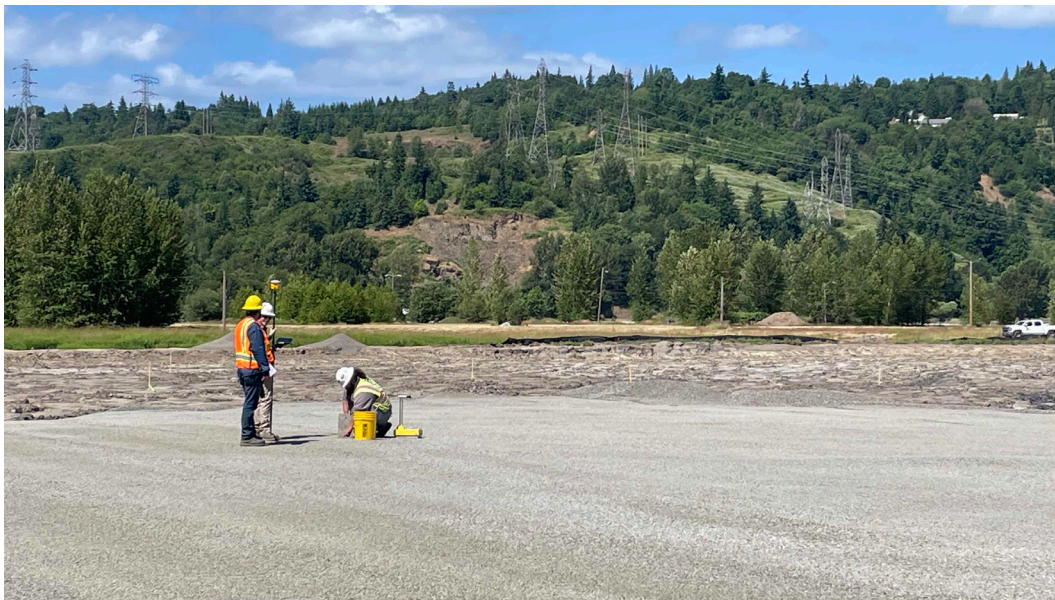
Photograph 16
West Landfill – Compaction Testing

Professional Service Industries, Inc., performing West Landfill compaction testing of select fill. Testing performed after each 12-inch lift (facing east).
