Monthly Progress Report

July 18, 2024

Re: Former Reynolds Metals Remediation – Monthly Progress Report, June 2024

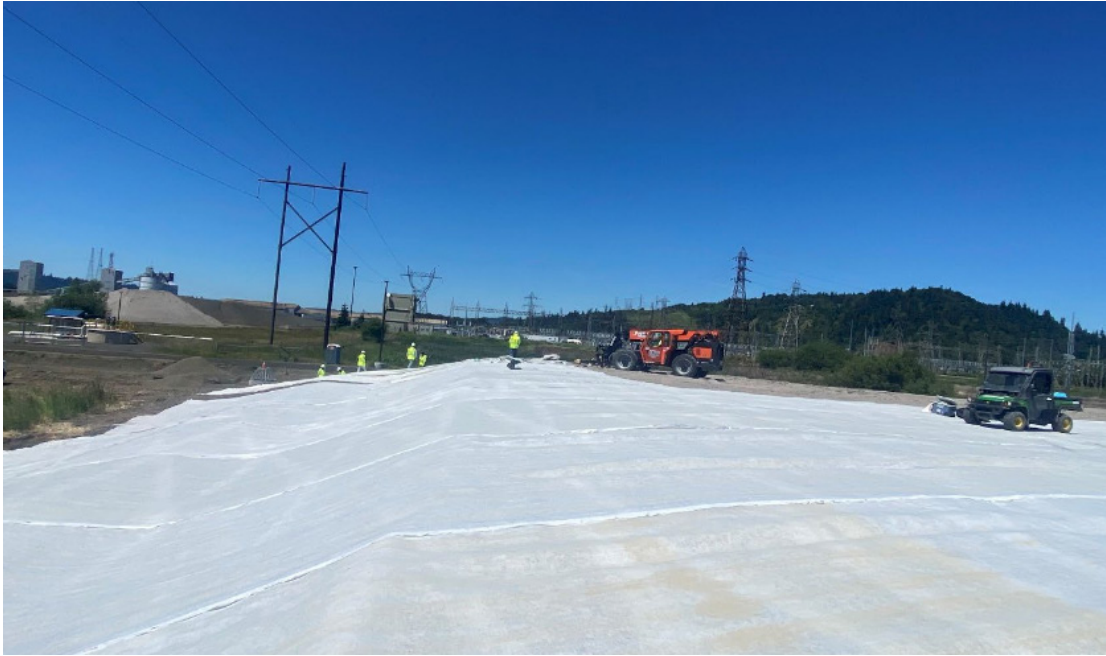
Photograph 1
East Landfill No. 1

- Deployment of the geosynthetic clay layer (GCL) over subgrade was completed. Seams were sealed with granular bentonite at 9-inch overlaps as per project specifications.

GCL deployment along southern slope

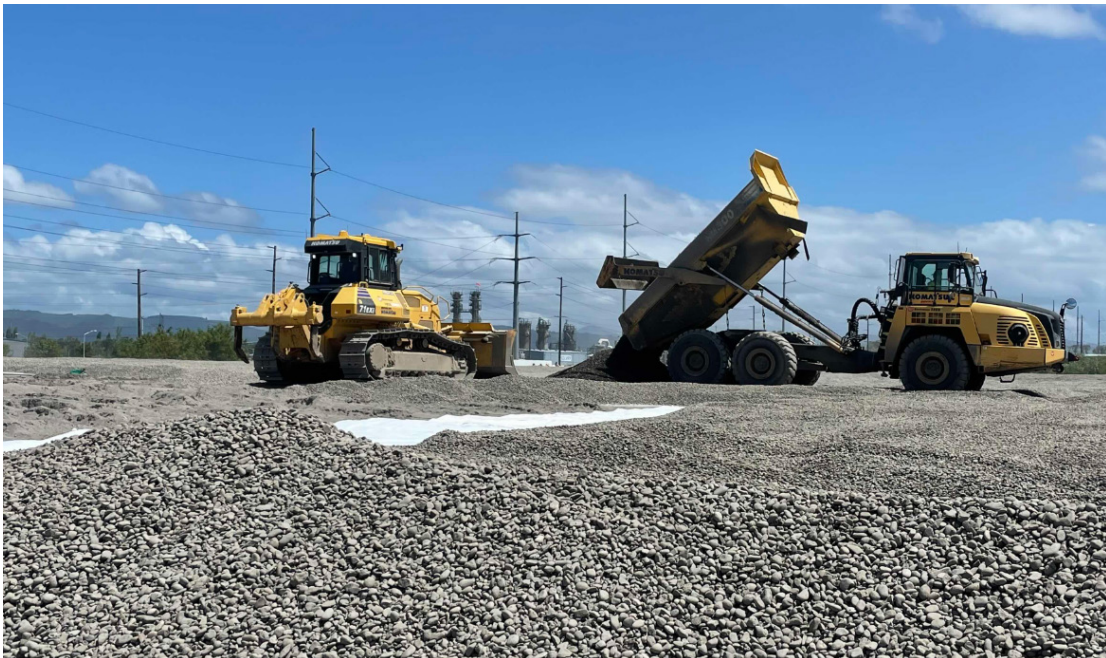
Photograph 2
East Landfill No. 1

- Envirocon began placement of material components of the East Landfill No. 1 low-permeability cap, including the following:
 - 12 inches of drainage layer material over the GCL

Placement of drainage layer material over GCL

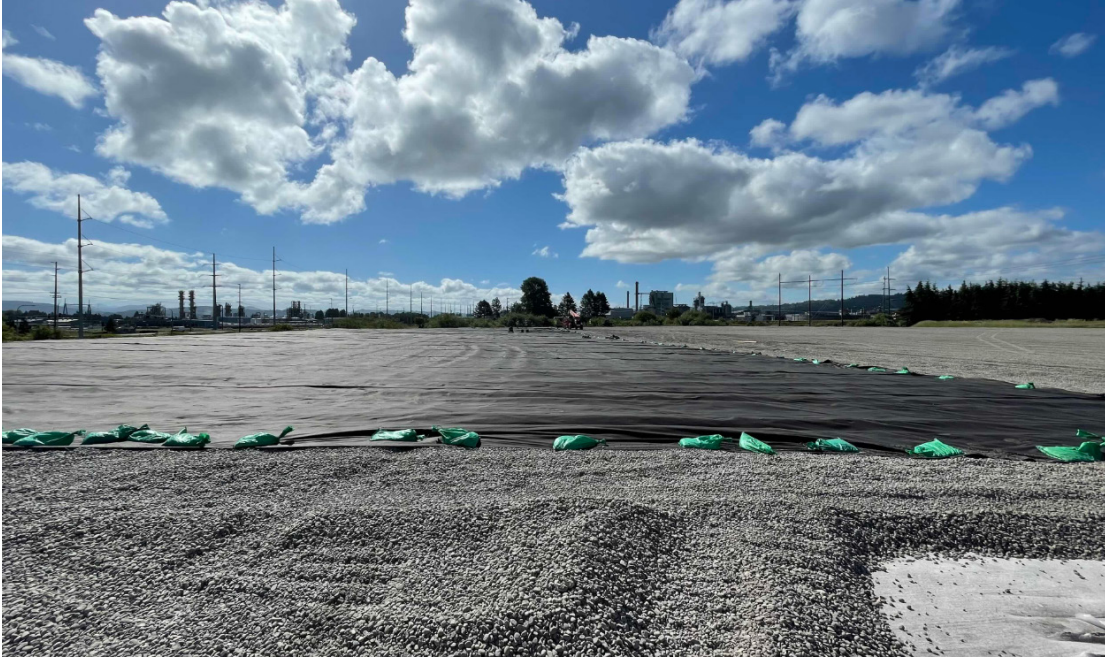
Photograph 3
East Landfill No. 1

- Deployment of the non-woven geotextile over drainage layer material in East Landfill No. 1 begun. Seams were sewn with a minimum 3-inch overlap as per project specifications.

Deployment of non-woven geotextile over drainage layer material

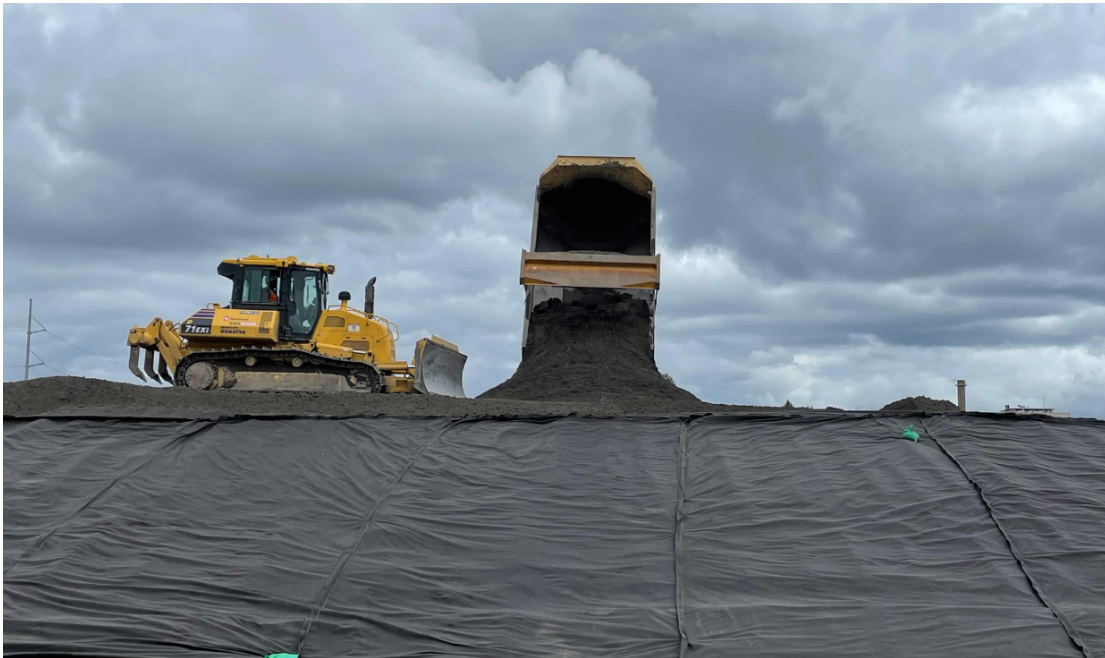
Photograph 4
East Landfill No. 1

Placement and distribution of general fill over non-woven geotextile

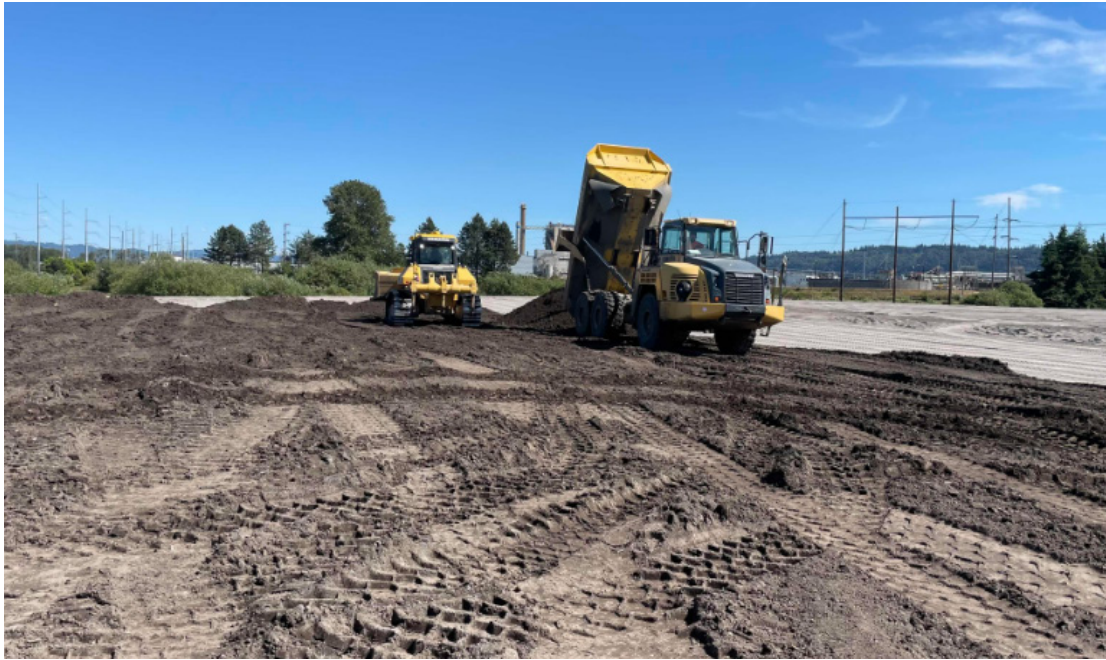
Photograph 5
East Landfill No. 1

Placement and distribution of topsoil over general fill

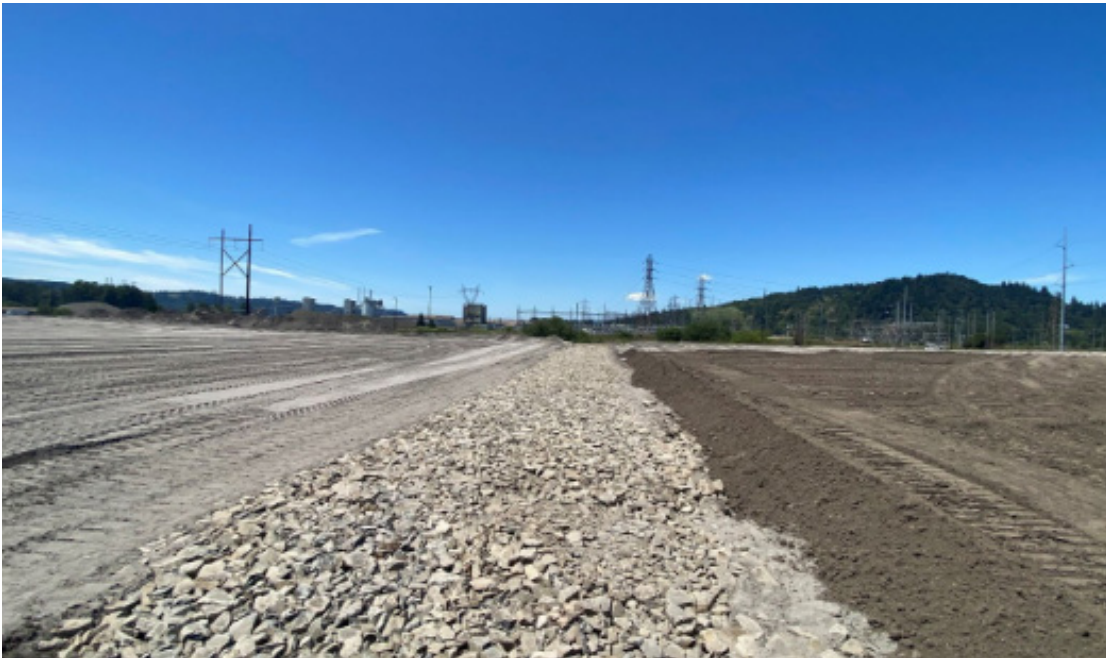
Photograph 6
East Landfill No. 1

Quarry spalls within on-landfill stormwater conveyance channel

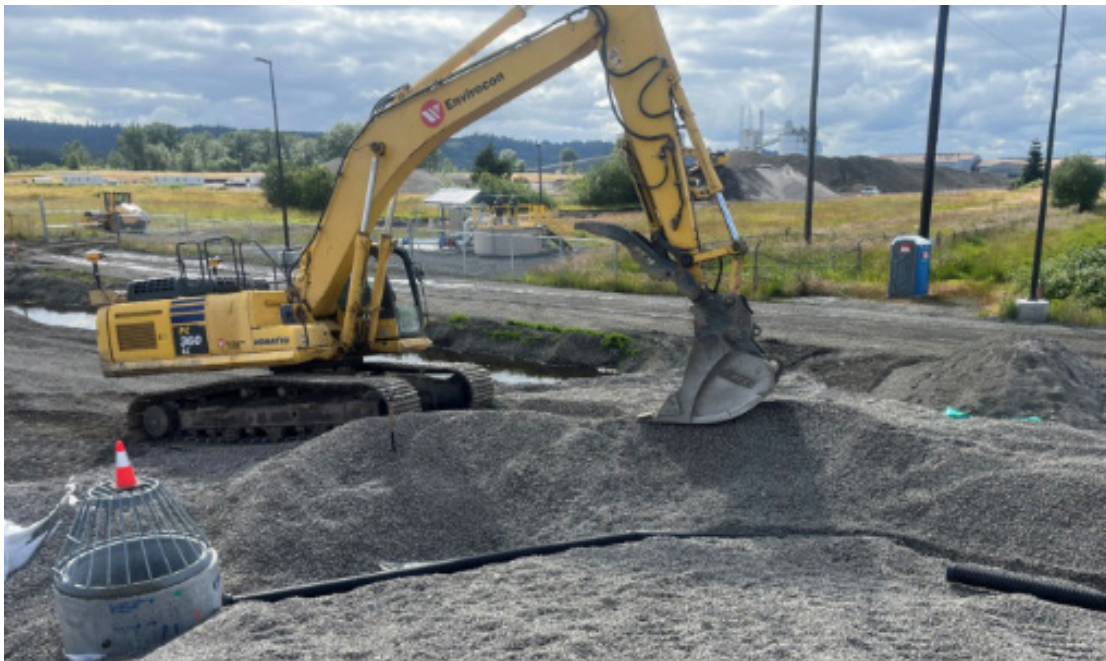
Photograph 7
East Landfill No. 1

- Berth Road perimeter ditch
 - Placement of 6-inch slotted drainage pipe connection to manhole at Control Point 14
 - Stormwater conveyance drainage channel located on the landfill

Berth Road perimeter ditch and 6-inch slotted drainage pipe

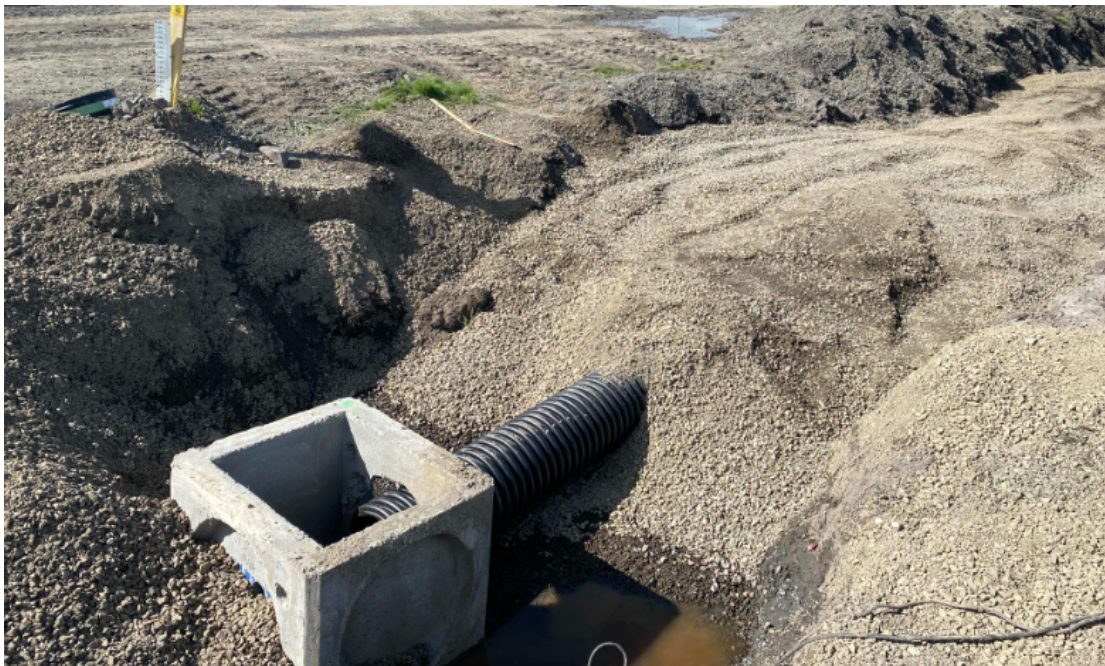
Photograph 8
Berth Road Stormwater Infrastructure

- **Stormwater infrastructure**
 - Berth Road stormwater improvements
 - Envirocon installed one Type I catch basin and approximately 100 linear feet of 12-inch corrugated polyethylene (CPE) pipe within the storm drain alignment along Berth Road.

- Trenching and backfilling were completed per project specifications. Compaction testing was performed per specifications and the contractor's quality control plan.

Installation of Type I catch basin and 12-inch CPE pipe

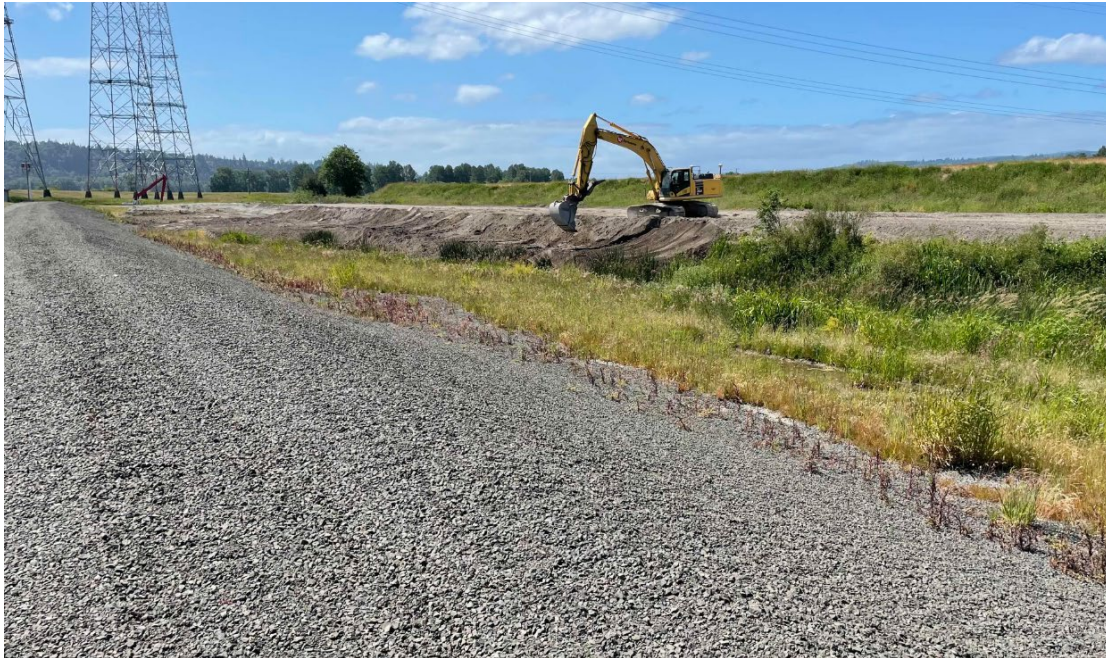
Photograph 9
U-Ditch

Excavation within southern flow channel

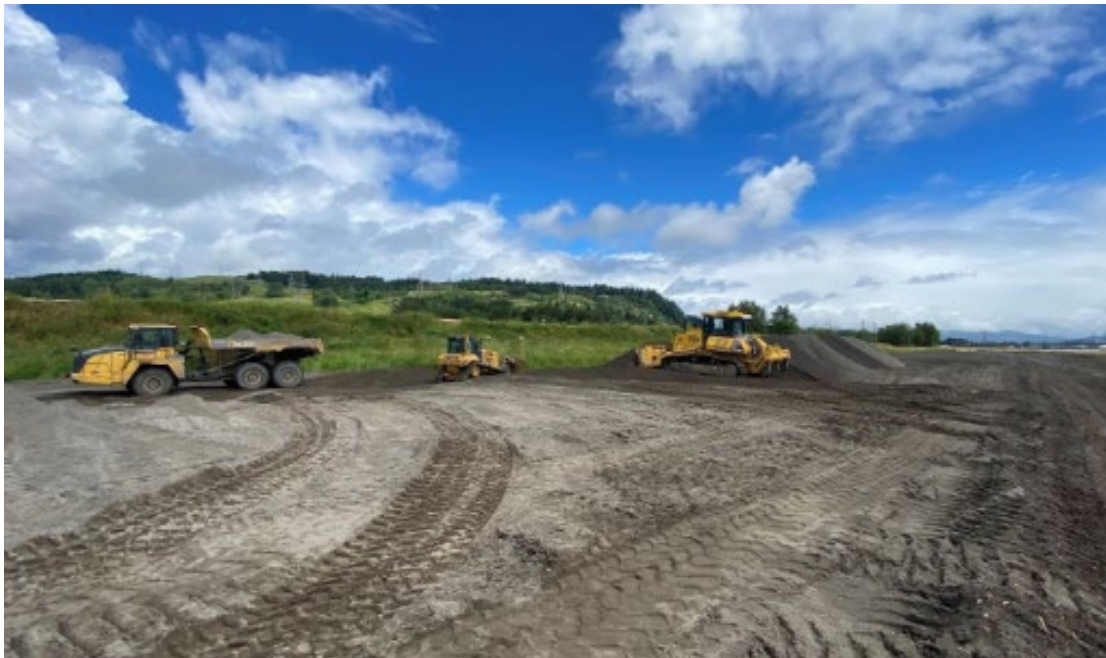
Photograph 10
U-Ditch

- Envirocon continued final regrading of the U-Ditch, including the following:
 - Fencing, culverts, and staff gauges were removed.
 - Grades below design elevations within the main ditch were backfilled with general fill.

Backfill with general fill to design elevations within northern flow channel

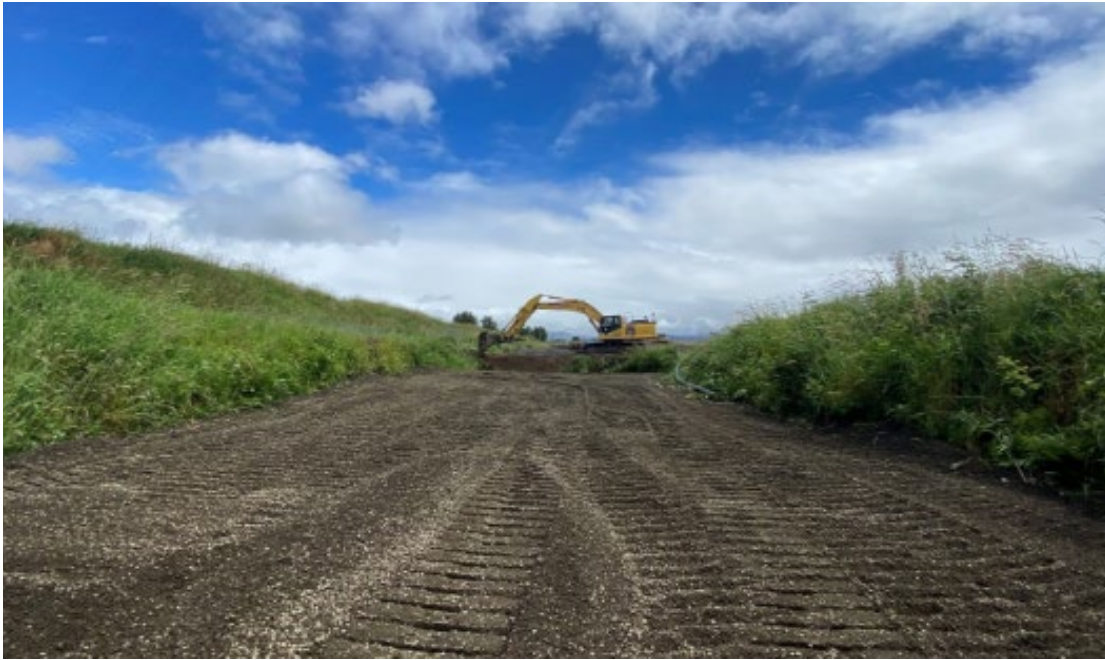
Photograph 11
U-Ditch

- The portion of the ditch west of the Outfall 006 reroute discharge line was backfilled with select fill.
 - **Site Unit 8, Site Unit 10, and East Landfill No. 1**

Backfill with select fill within ditch west of Outfall 006 reroute discharge line

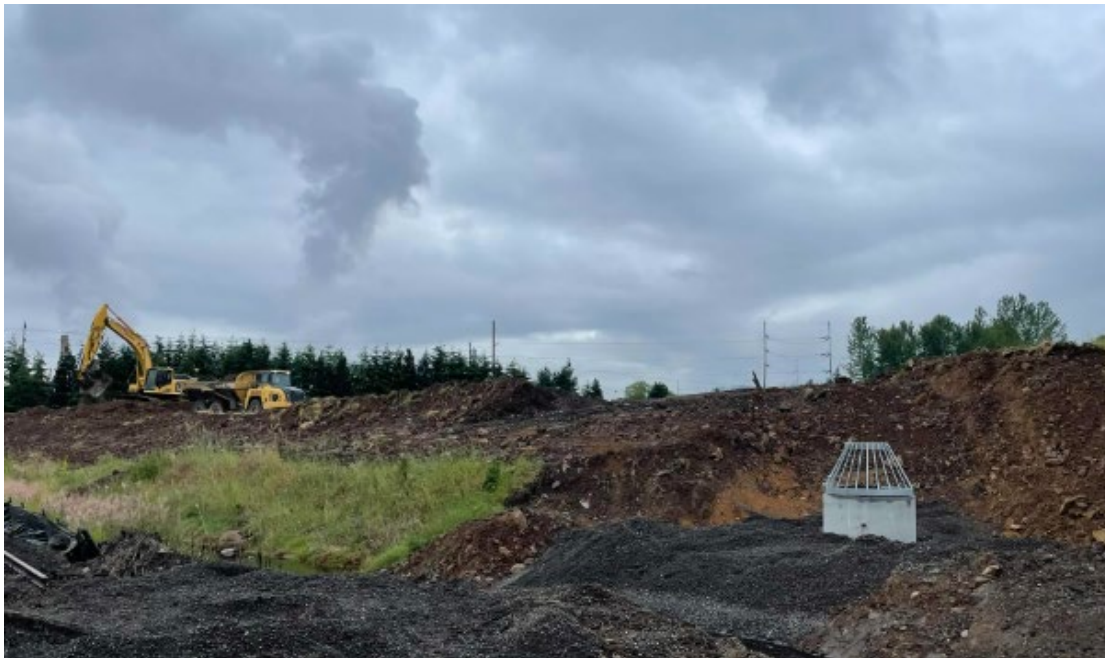
Photograph 12
East Landfill No. 2

- Envirocon began preparation work within the footprint of the existing landfill, including the following:
 - Clearing and grubbing of vegetation
 - Harvesting and stockpiling clean cover soil

Clearing vegetation and harvesting clean cover soil
