STATE OF WASHINGTON
DEPARTMENT OF ECOLOGY

May 11, 2018

Re: Further Action at a Property associated with a Site:

- **Property Address:** Kelly's Furniture Refinishing
- **Site Address:** 19230 Highway 99, Lynnwood, WA 98036
- **Facility/Site No.:** 21932318
- **Cleanup Site ID No.:** 11735
- **VCP Project No.:** NW2555

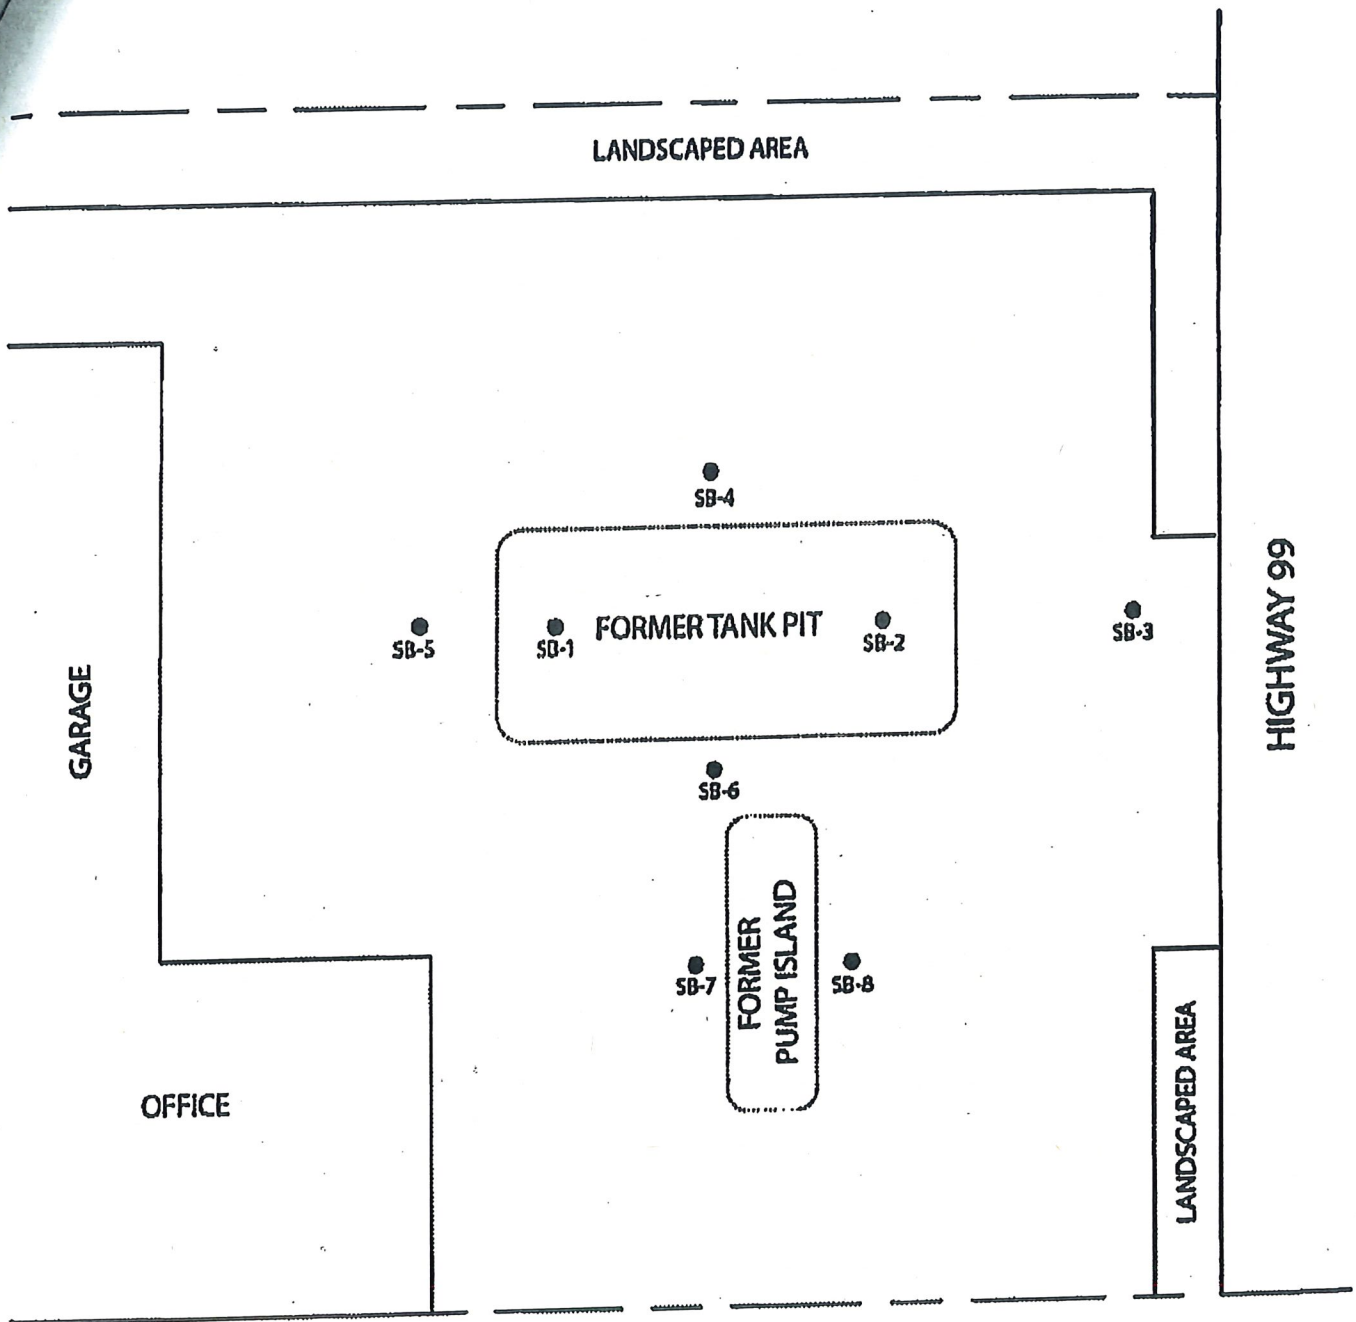
ENCLOSURE B, FIGURE 7

Shallow ground water was encountered on the Property at depths of approximately 12 feet bgs. Four locations (SB-01-W, SB-03-W, SB-04-W SB-07-W) were sampled and found to have TPH-G and TPH-D levels above MTCA Method A cleanup levels:

• SB-01-W	TPH-G: 59,000 ug/l	TPH-D: 400,000 ug/l
• SB-03-W	TPH-G: 2,000 ug/l	TPH-D: 30,000 ug/l
• SB-04-W	TPH-G: 8,700 ug/l	TPH-D: 6,900 ug/l
• SB-07-W	TPH-G: 190,000 ug/l	TPH-D: 190,000 ug/l

Petroleum hydrocarbons (TPH-G, TPH-D) are the known contaminants present in shallow ground water at the Site. Perched ground water was present inside the former UST pit at approximately 11 to 13 feet bgs. Perched ground water contamination was confirmed at four locations (SB-01-W, SB-03-W, SB-04-W SB-07-W) which were sampled and found to have TPH-G and TPH-D levels above MTCA Method A cleanup levels (**Enclosure B Figure 8**).

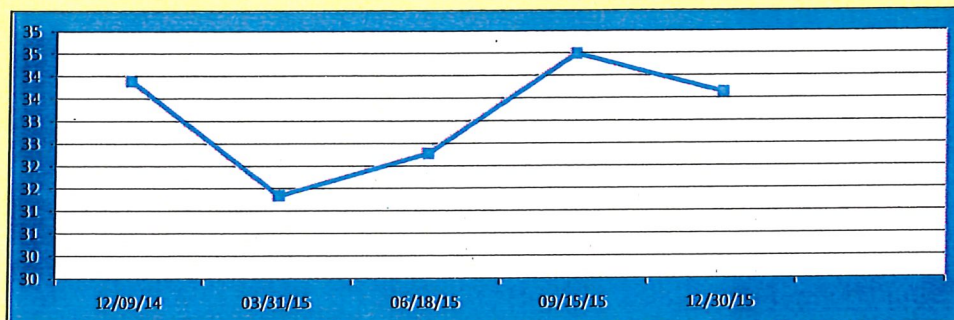
The deeper aquifer was assessed through the installation of groundwater monitoring well MW-1. This well is located in the former tank basin area, was drilled to a depth of 55 feet bgs, and was constructed with a screened interval set between depths of 40 and 55 feet bgs in order to document groundwater conditions below the glacial till. Monitoring well MW-1 was monitored for four consecutive quarters of sampling and no COCs above the MTCA Method A cleanup levels were found. Additional information and verification is needed to confirm that the glacial till unit penetrated by monitoring well MW-1 is continuous beneath the Site.

A single deep ground water monitoring well (MW-1) was installed in the former tank basin area to a depth of 55 feet bgs, with a screened interval set between depths of 40 and 55 feet bgs in order to document conditions below the till. Monitoring well MW-1 was tested for TPH-G, TPH-D, TPH-O, lead, chlorinated volatile organic compounds (VOCs) and polycyclic aromatic hydrocarbons (PAHs), none of which was found above MTCA Method A cleanup levels. Monitoring well MW-1 was sampled for four consecutive quarters with no exceedances above MTCA Method A cleanup levels for TPH-G and TPH-D.
