**2024 LAND USE CONTROL INSPECTIONS TECHNICAL MEMORANDUM  
SITES 302 303 AND 304 AND TANK 50 NAVAL BASE KITSAP MANCHESTER  
KITSAP COUNTY WASHINGTON  
04/28/2025  
LIBERTY JOINT VENTURE (JV)**

# **2024 Land Use Control Inspections Technical Memorandum**

**Sites 302, 303, and 304 and Tank 50**

**Naval Base Kitsap Manchester, Kitsap County,  
Washington**

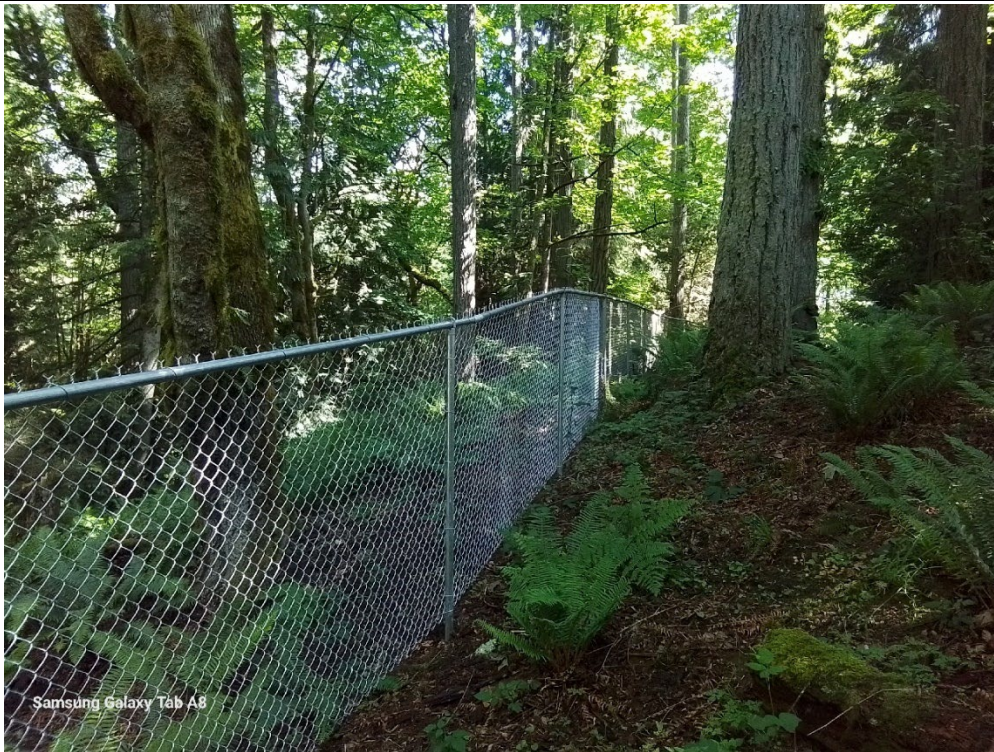
**Photograph 13**

Fence that has been fixed near southwest corner of site, facing north.

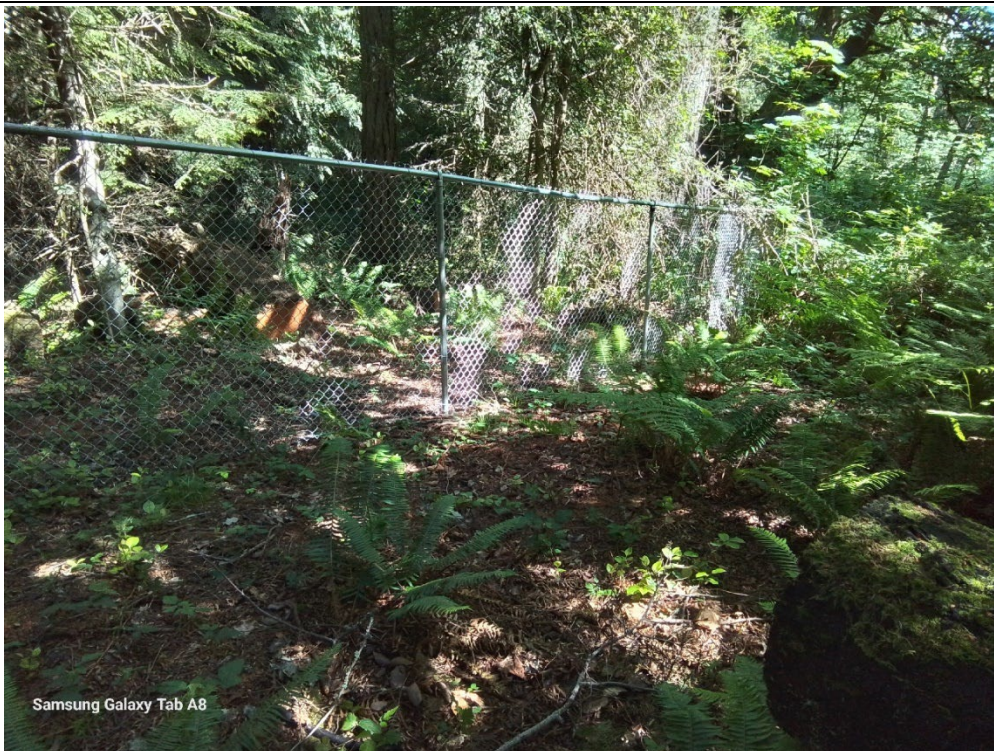
**Photograph 14**

Fence that has been fixed along west perimeter, facing north.

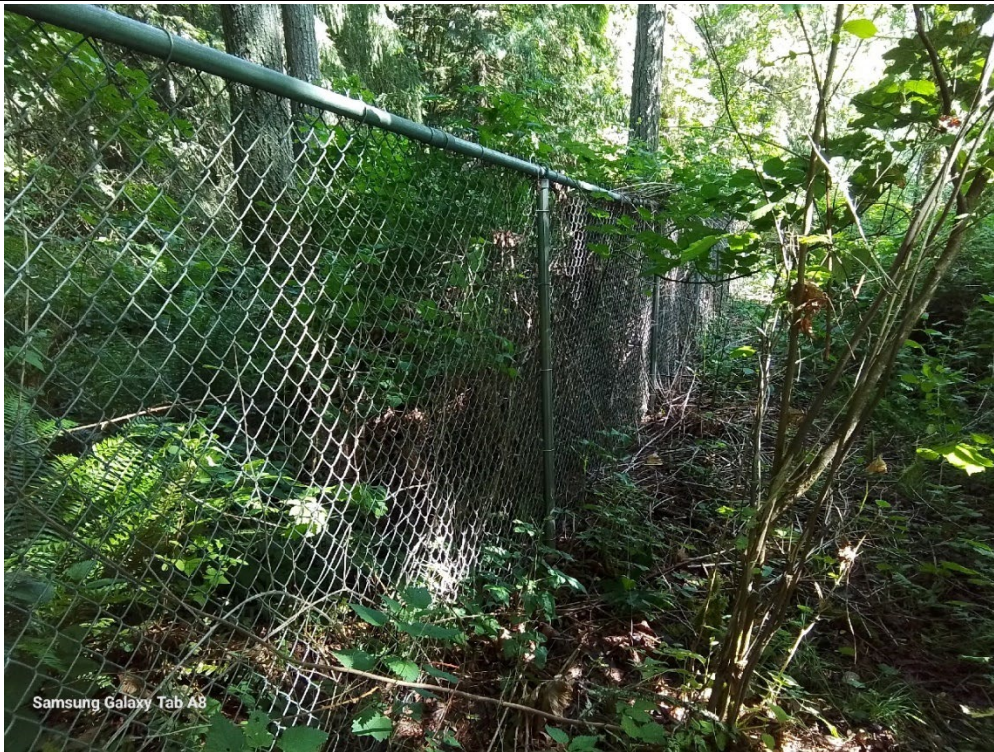
**Photograph 15**  
West perimeter fence line, facing northwest.

- **Finding 1:** Approximately 100 linear feet of fencing on the northwestern side of the site was observed to be heavily overgrown with vegetation and the area was inaccessible. Additionally, the fence appeared to be leaning over slightly and requires support in order to stand upright.

The Navy plans to conduct the vegetation maintenance for item 1 above and the sign replacement was completed during the LUC inspections. The Environmental Restoration, Navy (ERN) group will coordinate with NBK Manchester on implementation.

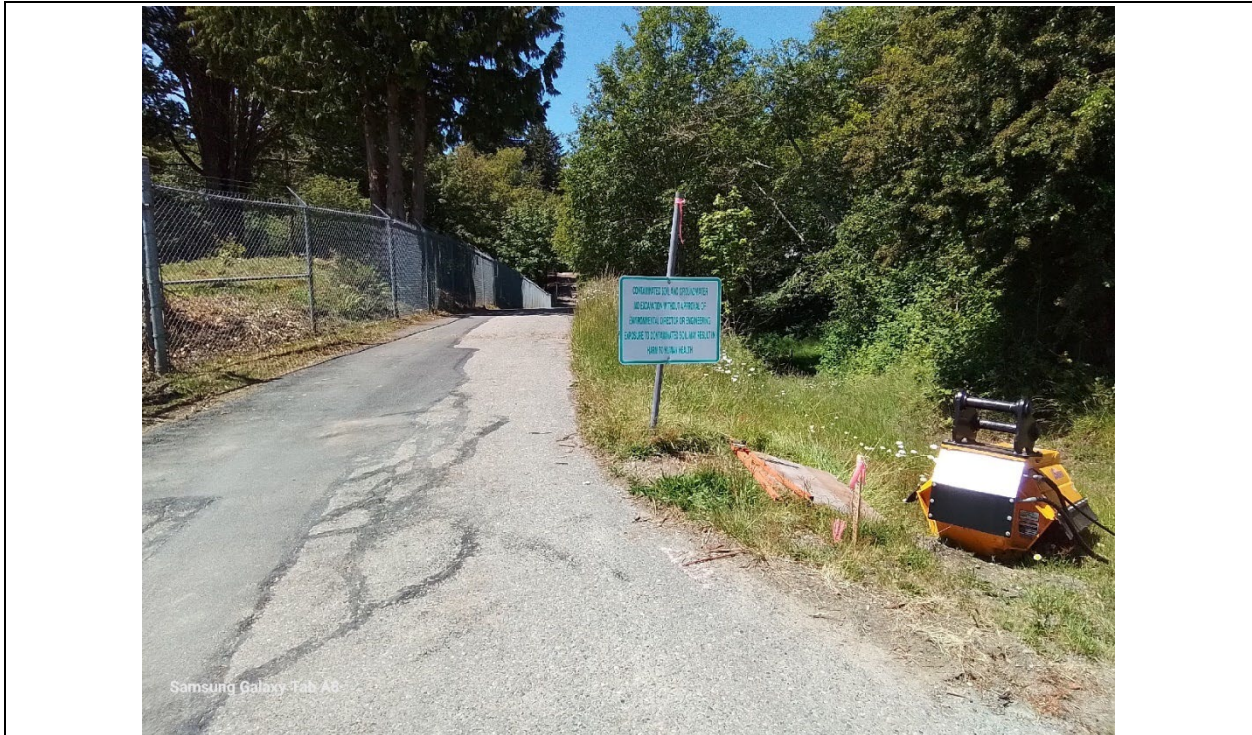
**Photograph 7**

- **Finding 2:** LUC signage southwest of Tank 22 was found on the ground. During the LUC inspection, the sign was reinstalled by the field team (see Appendix D, Site 303 Photograph 7). A new sign was received, and the Remedial Project Manager (RPM) replaced the older sign with the new sign after the site inspection.

LUC signage along southeast perimeter, facing west. Sign was down on initial arrival and placed back on the pole temporarily.

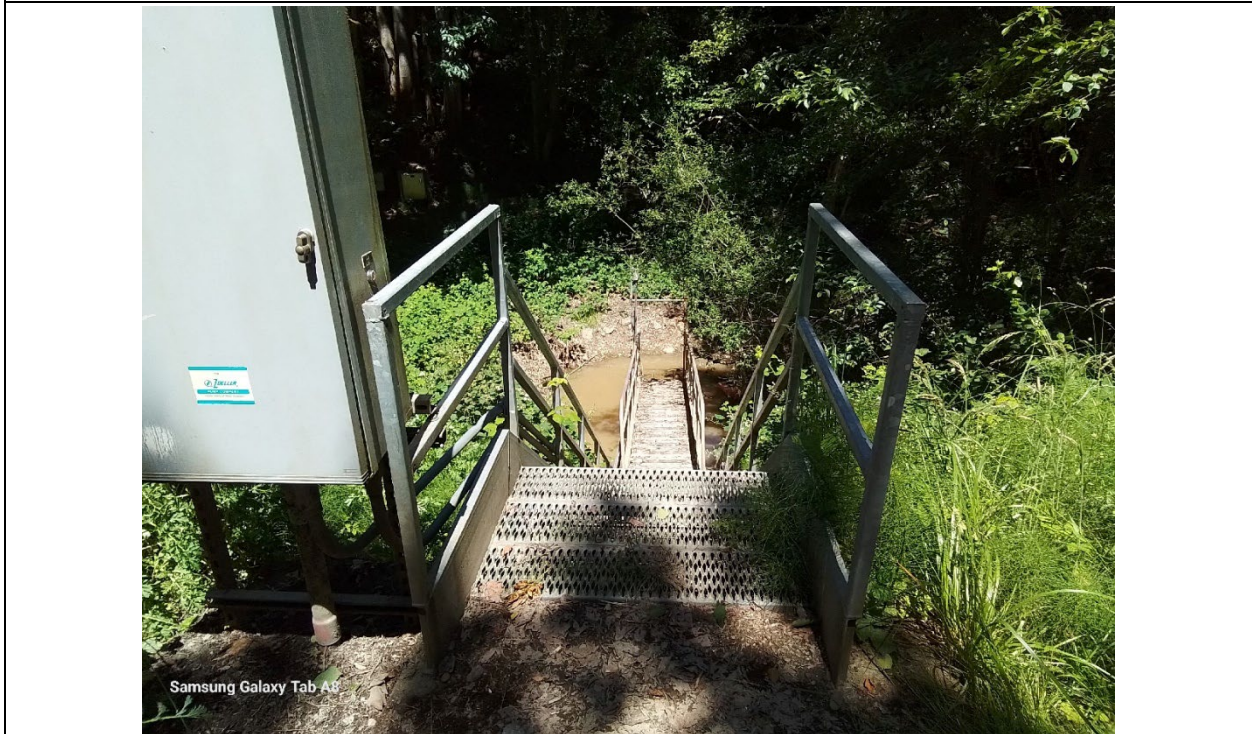
**Photograph 8**

Stairway and ponded water south of Tank 24, facing north.

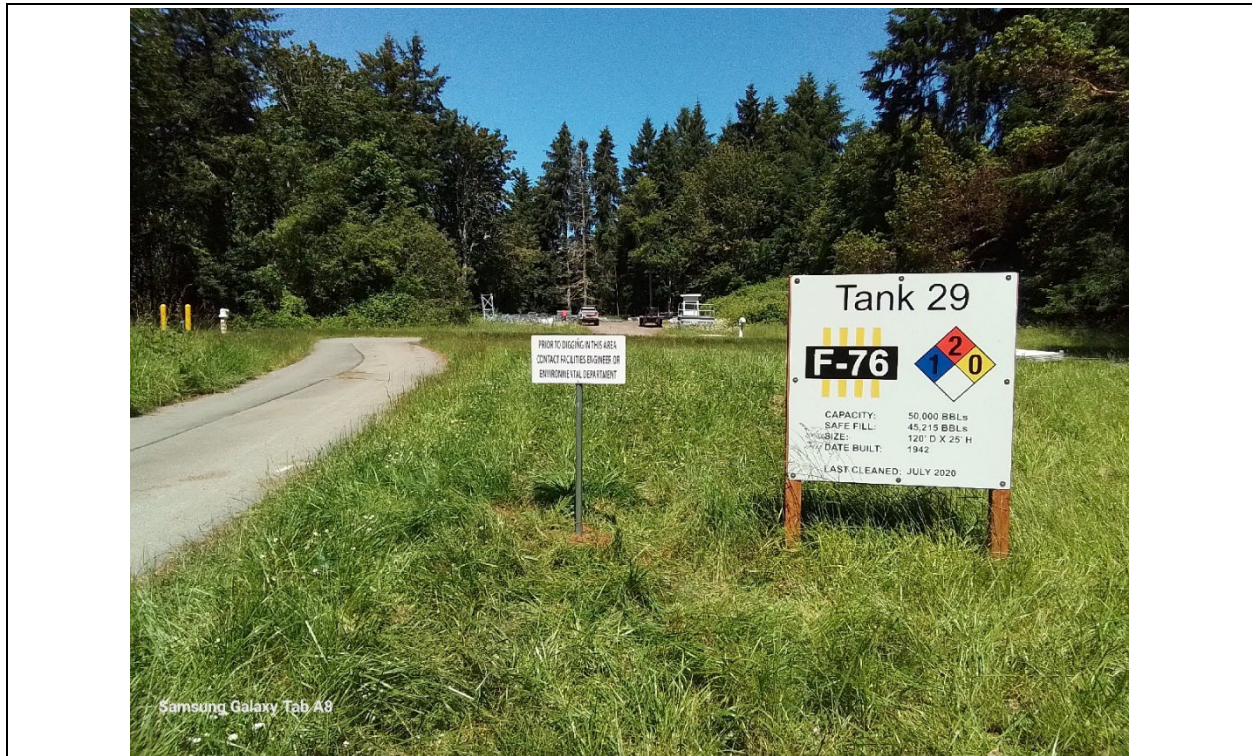
**Photograph 17**

During the 2023 LUC inspection, it was noted that the signage at Tank 29 had been removed. During the 2024 LUC inspection, a new sign was installed. Additional work is necessary to meet LUC requirement 2. The most salient finding during the 2024 LUC inspections associated with Site 303 was as follows:

Overview of Tank 29 and newly installed LUC Signage, facing north.

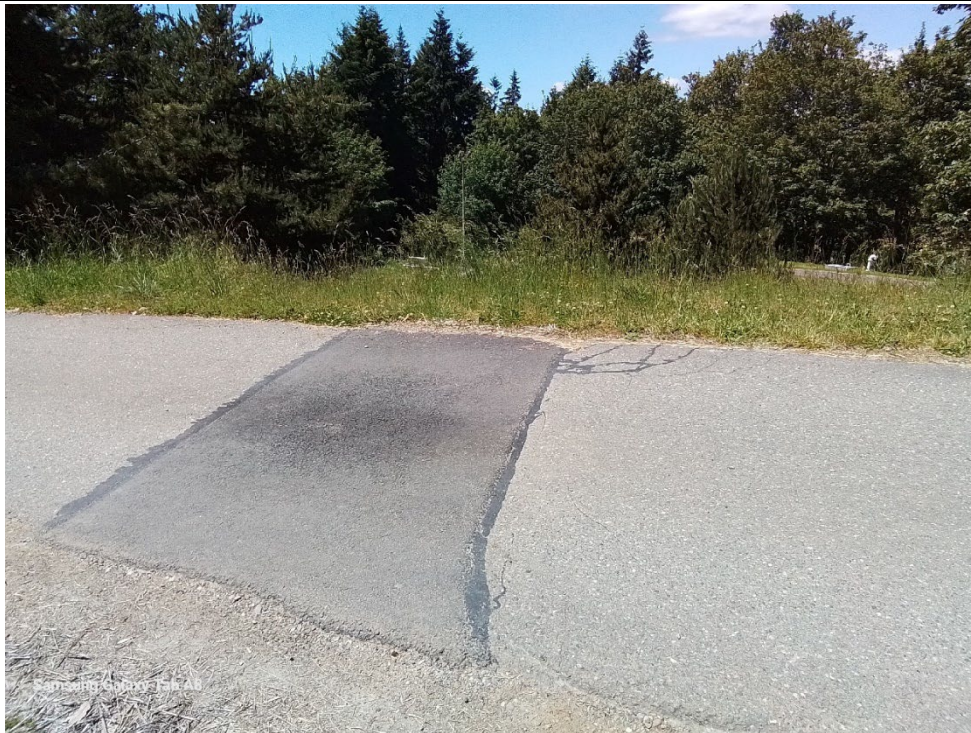
**Photograph 21**

Repaired cut in road related to former construction access road near Tank 30, facing northwest

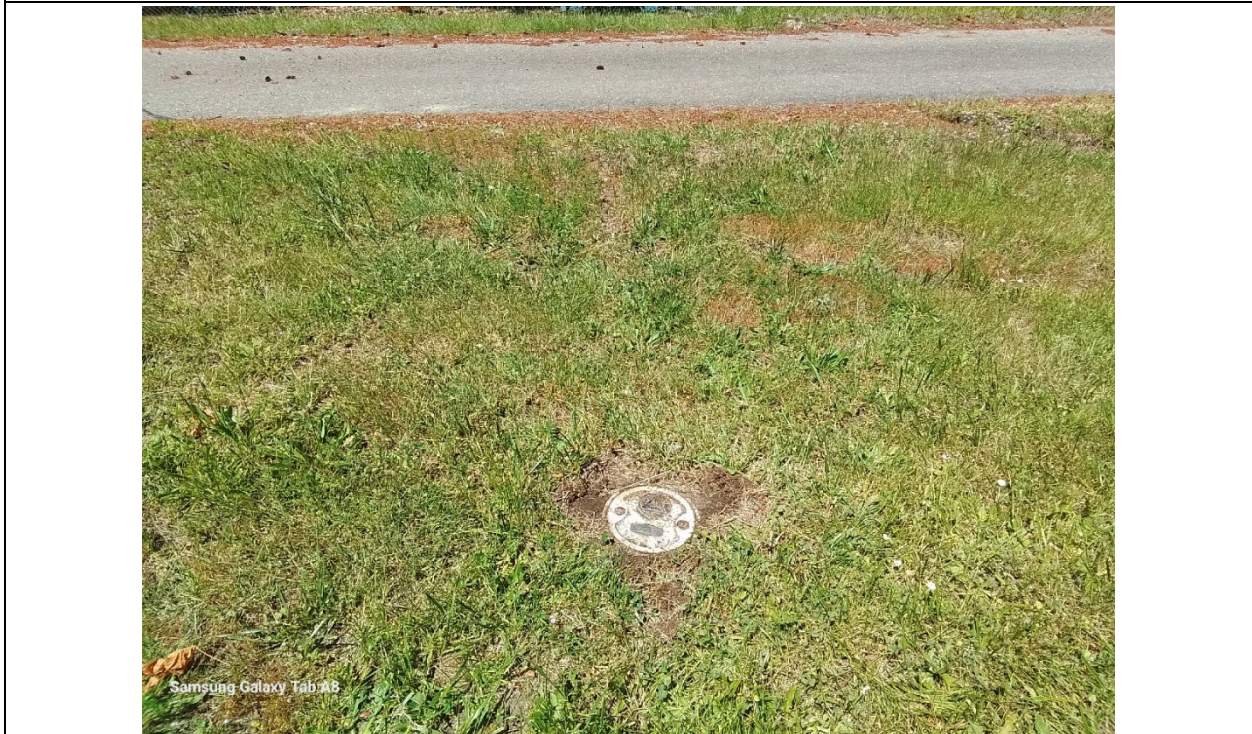
**Photograph 24**

Monitoring wells MW-1 and MW-3 north of Tank 30 and MW-1 south of Tank 24 were located as part of the 2024 LUC inspection (see Appendix D, Site 303 Photographs 9, 24, and 25). Monitoring well MW-1 north of Tank 30 was visually located behind a fence with a locked gate; therefore, it was inaccessible and not opened and inspected. The monitoring well was recorded to be in moderate condition because the well monument was observed to be rusted with moss growing over it and not clearly labeled. Monitoring wells MW-3 north of Tank 30 and MW-1 south of Tank 24 were opened and inspected. Monitoring well MW-3 north of Tank 30 was recorded to be in good condition. Monitoring well MW-1 south of Tank 24 was recorded to be in moderate condition because the monument apron was cracked and not clearly labeled, but the outer and

Groundwater monitoring well MW-3, north of site boundary, facing north.

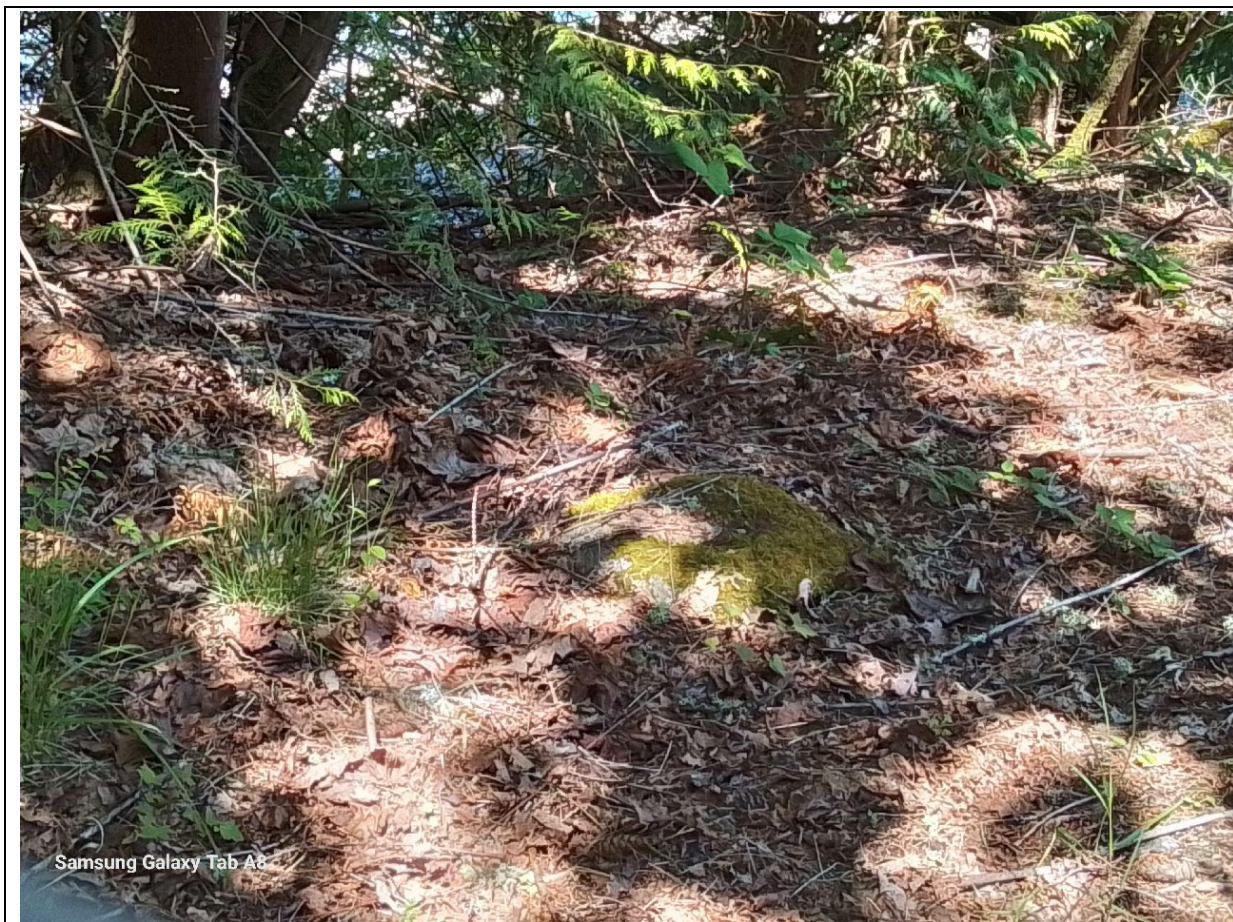
**Photograph 25**

Groundwater monitoring well MW-1 (located behind fence), north of site boundary, facing north.

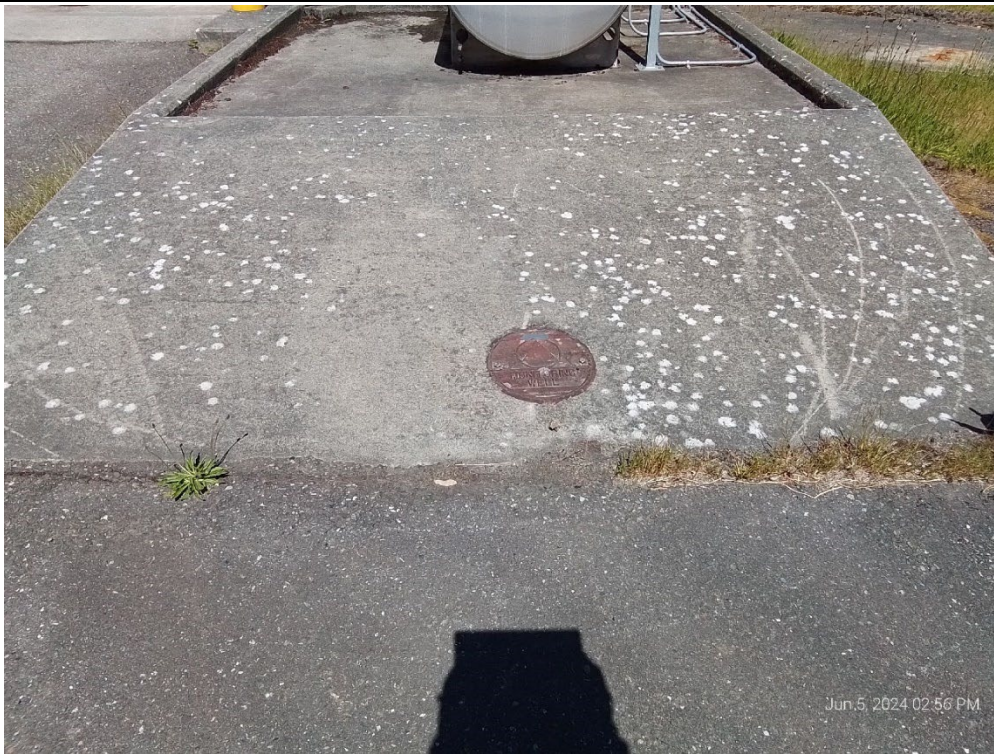
**Photograph 11**  
Groundwater monitoring well MW-2, facing northeast.

Well ID	Northing <sup>1</sup>	Easting <sup>1</sup>	Well Located?	Comments from 2024 Inspections
MW-2	64106.184	371804.246	Yes	Well located and opened. Well was in good condition, but not clearly labeled.
MW-4	64054.635	371808.329	Yes	Well located but not opened. Well was in moderate condition and not clearly labeled.

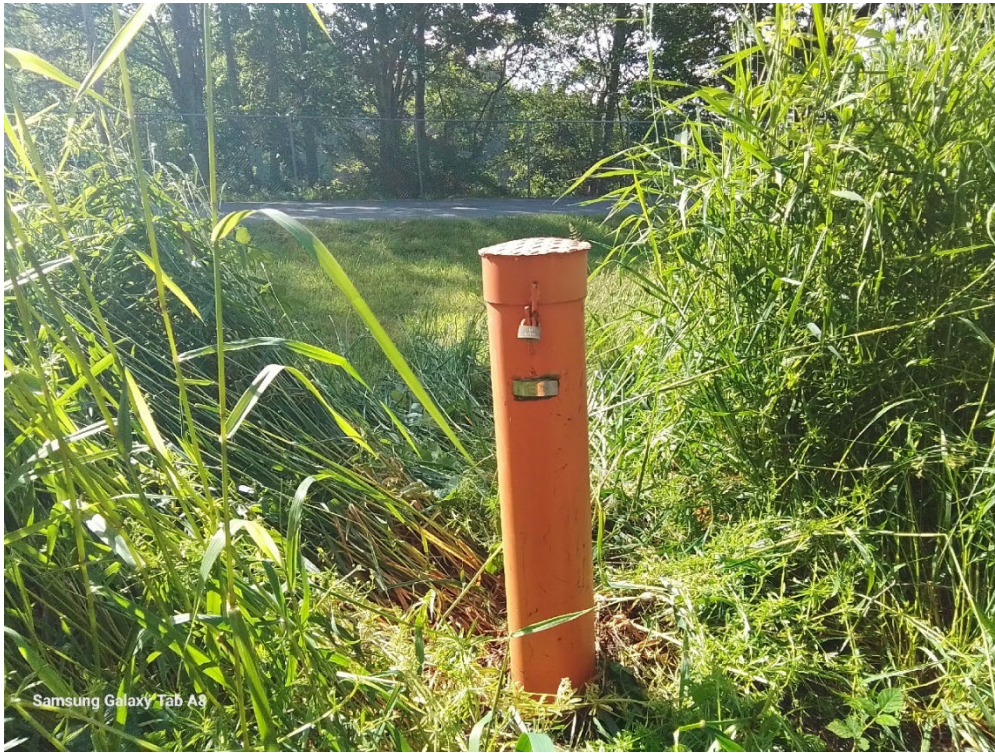
**Photograph 5**

Well ID	Northing <sup>1</sup>	Easting <sup>1</sup>	Well Located?	Comments from 2024 Inspections
MW-1	64407.051	370946.014	Yes	Well located but not opened. Aboveground monument and external casing in good condition.

Monitoring well MW-1, located along the southeast boundary, facing southeast.
