FINAL
APRIL 2022

2021 Land Use Controls Inspection Report

Naval Air Station Whidbey Island, Oak Harbor, Washington

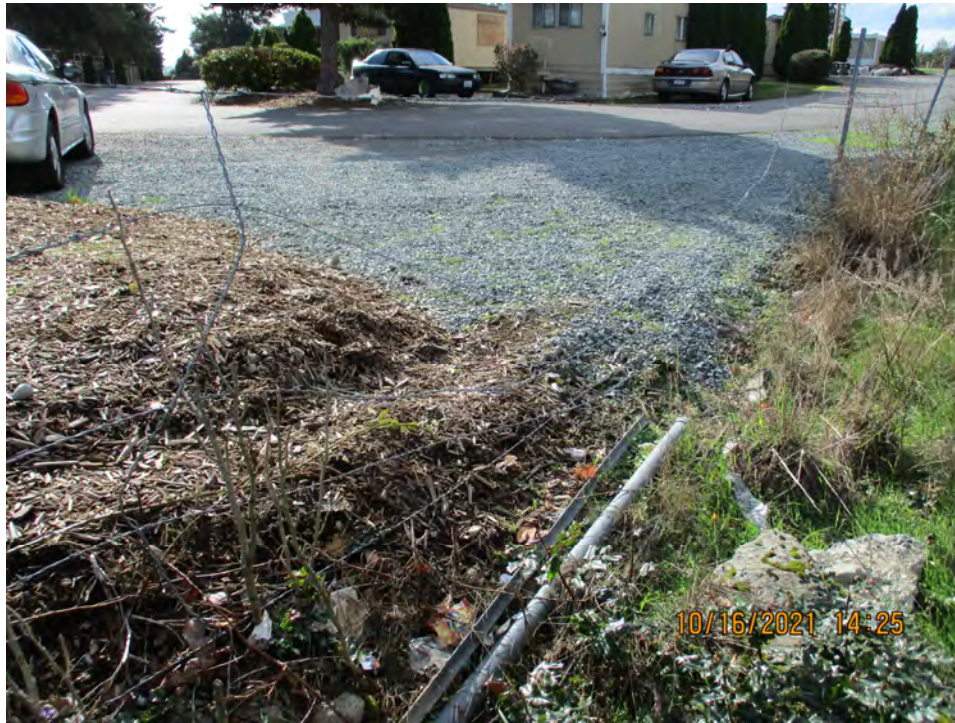
B35: Compromised fenceline at southeast corner

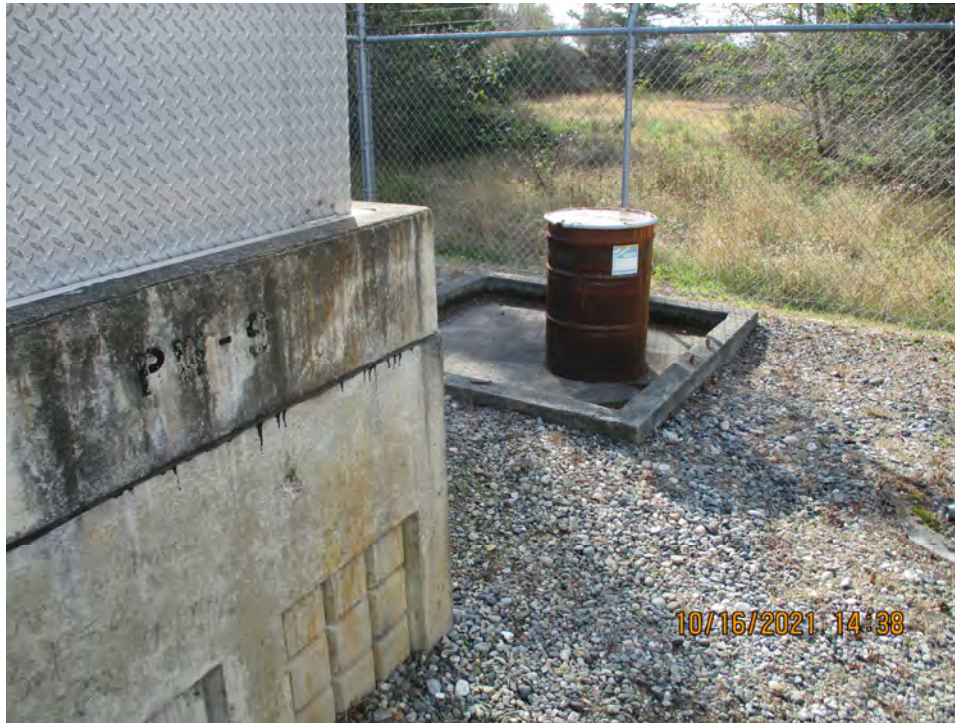
B41: PW-9 and Drum stored within PW-9 fencing and secondary containment

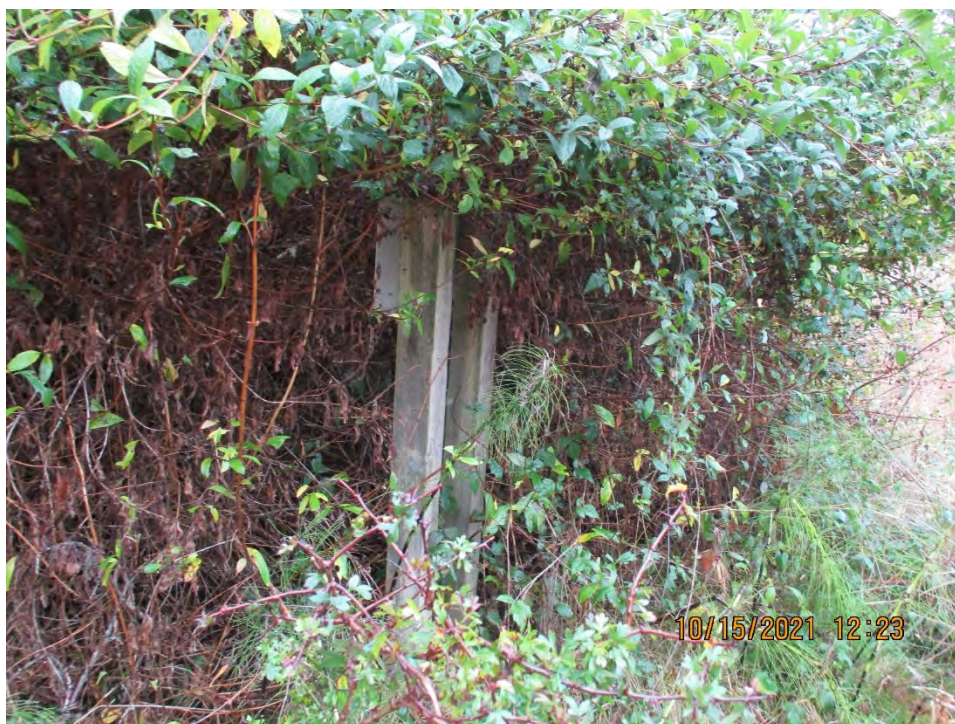
F8: Obscured signage along southern boundary

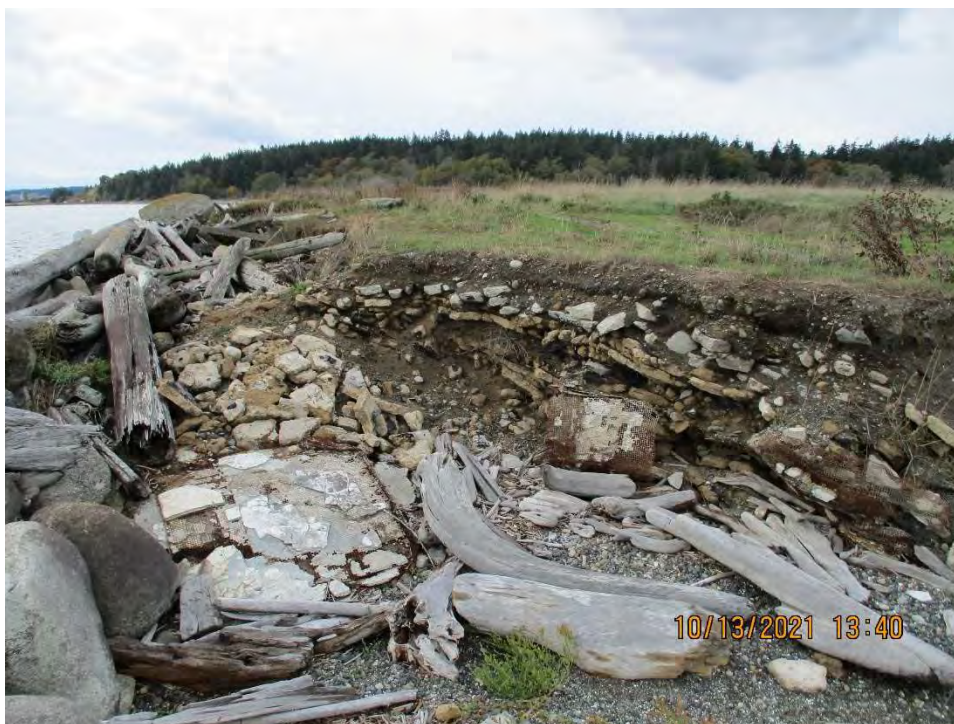
H6: Potential Erosion
along South Side

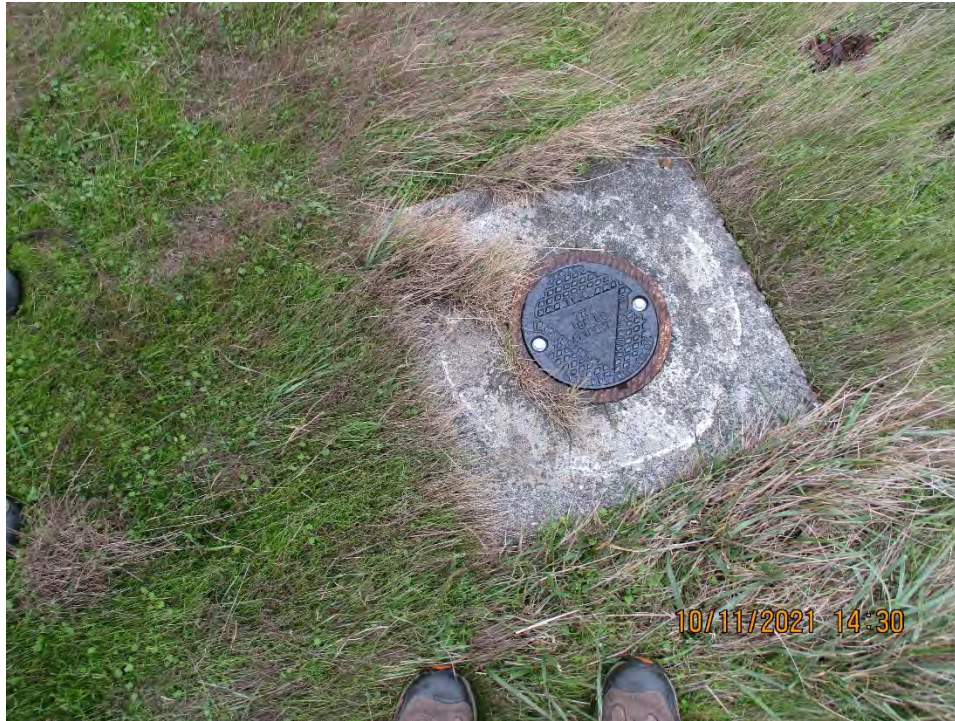
K13: Repaired flush
mount cover of
observed monitoring
well

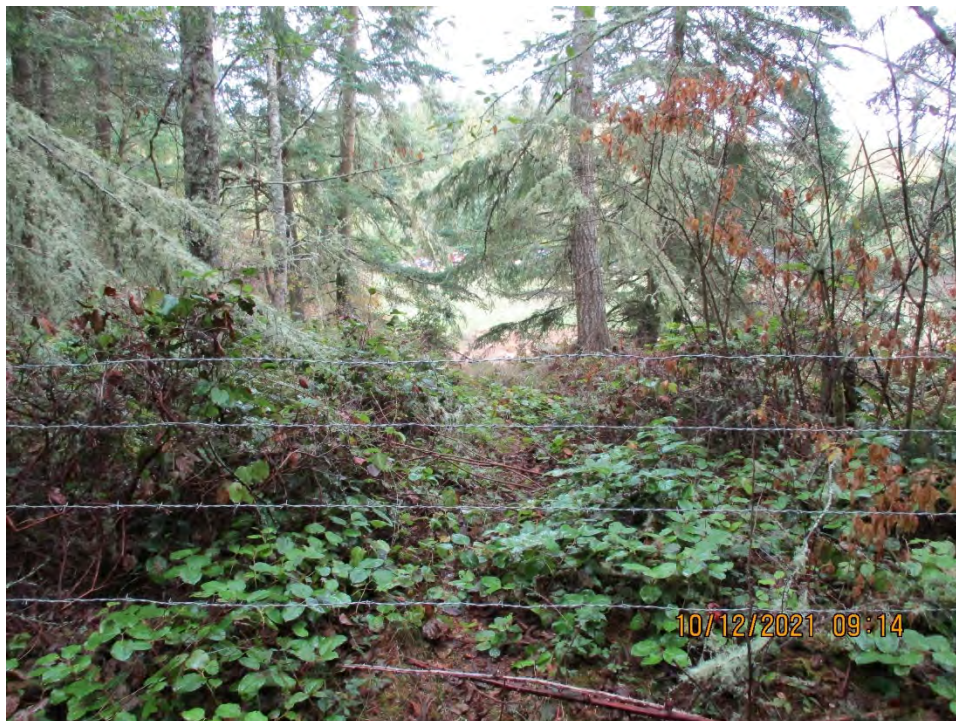
O4: Trail and fencing
repair

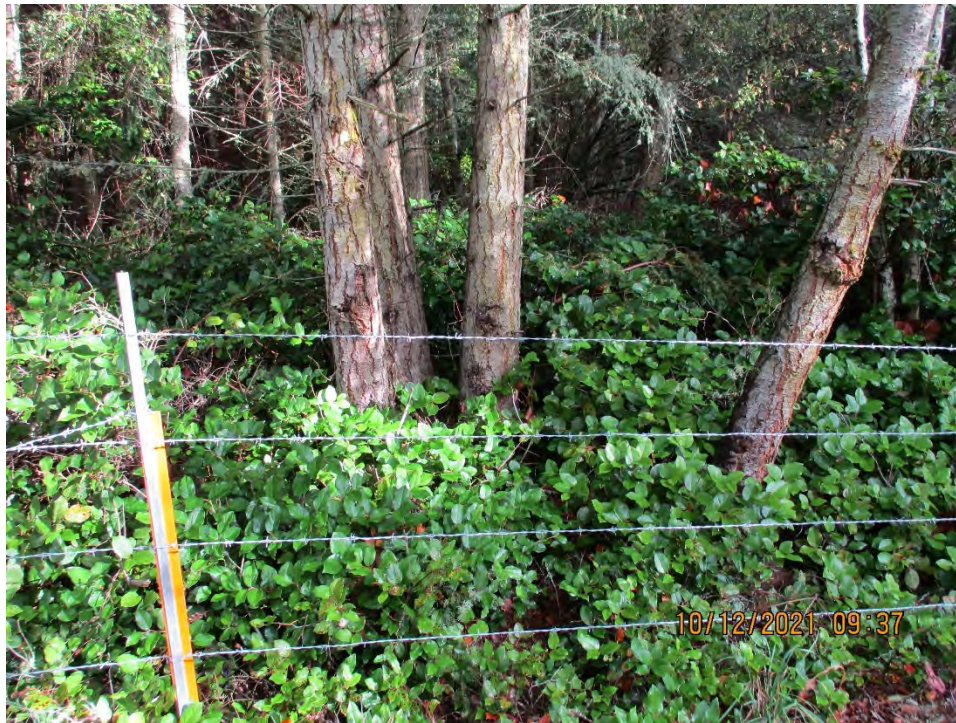
O9: New fence along
northern boundary

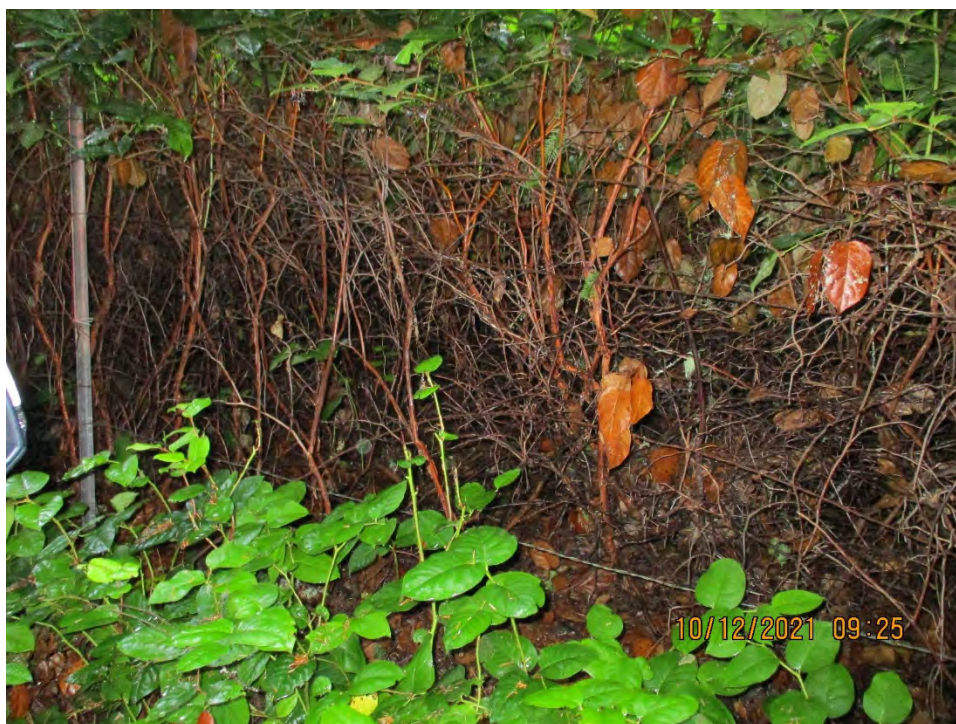
O10: Compromised
fencing along northern
boundary

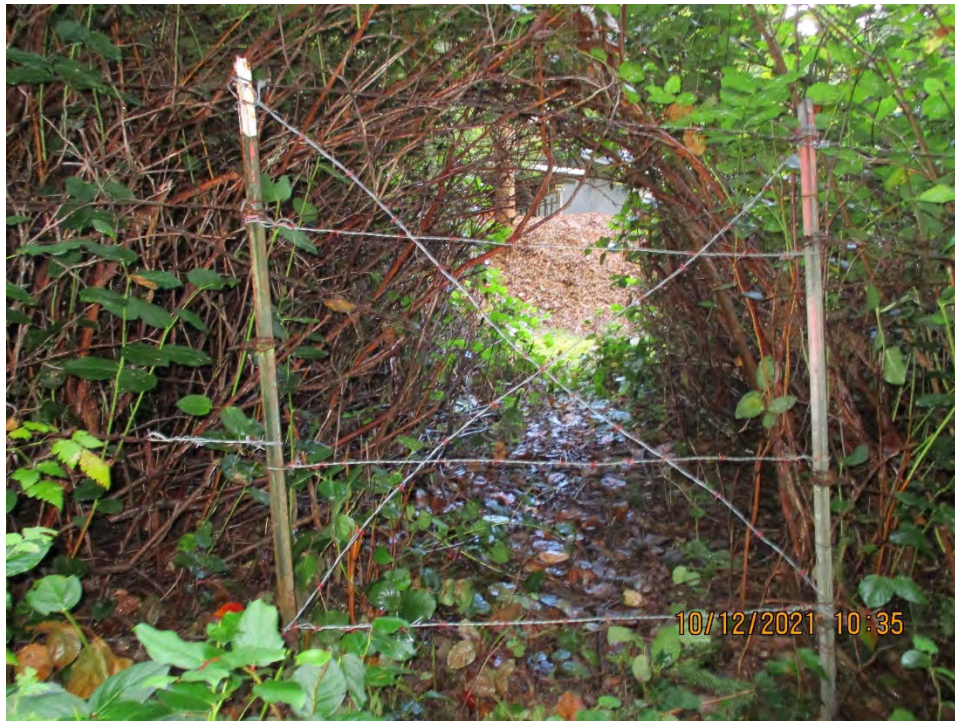
O11: Repaired point of
trespassing

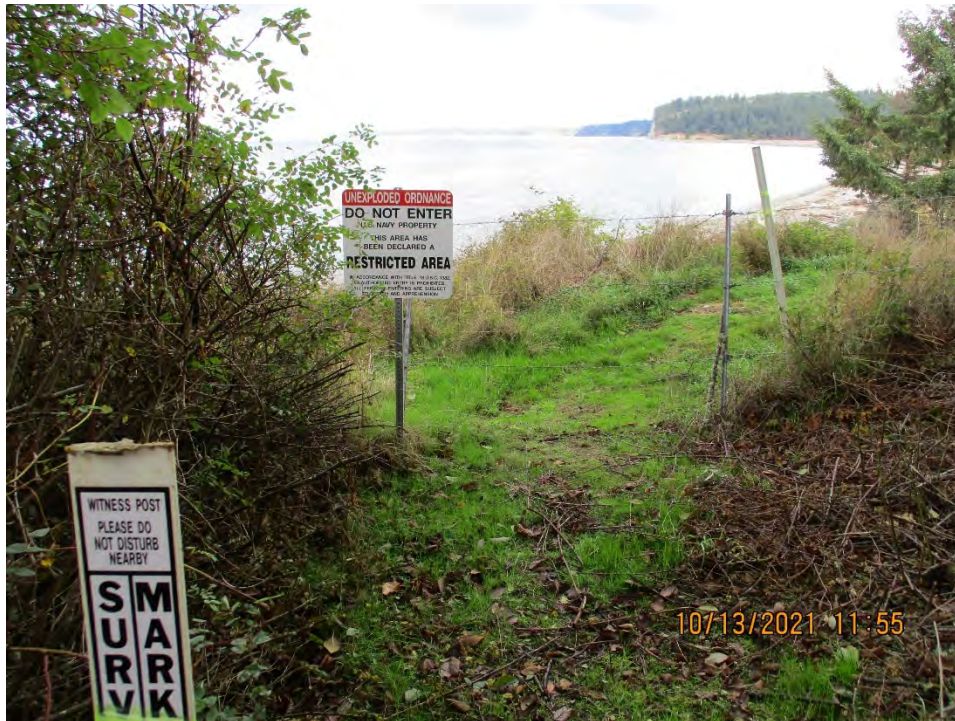
O27: Repaired point of
trespassing in
southwest corner

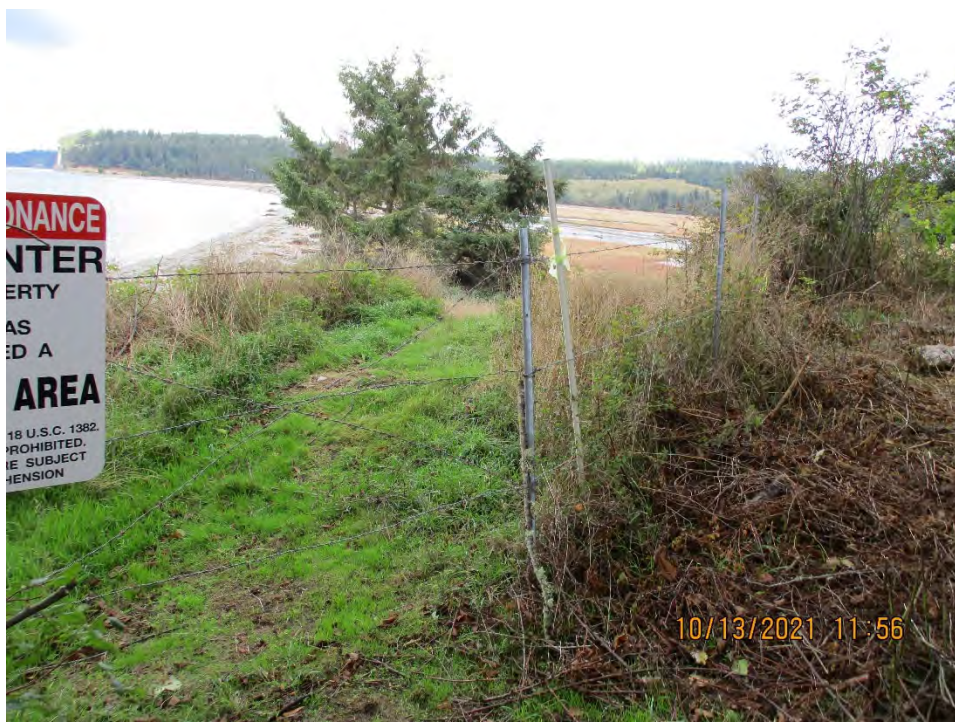
O28: Repaired fencing
in southwest corner

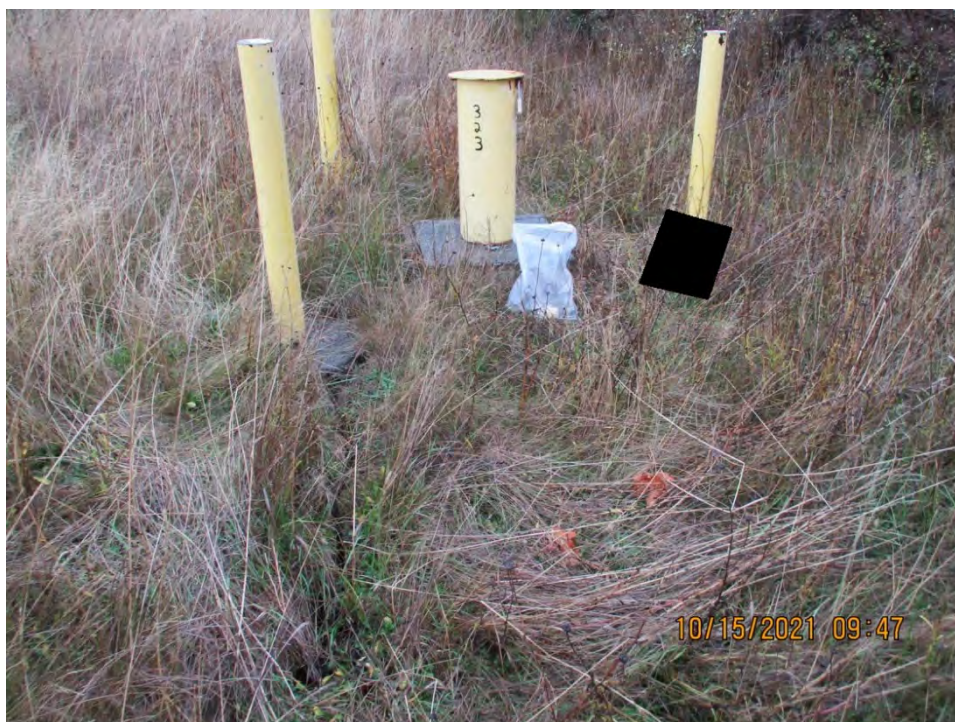
P26: Earthen crack
near MW-323 - likely
land subsidence
