2 May 2017

Subject: Cap Integrity Monitoring
BNSF Railway Company, Parkwater Rail Yard
Spokane, Washington
K/J 1796110.00

East and West Debris Area
2017 Cap Integrity Monitoring
Parkwater Rail Yard Site

Former Koch Asphalt Lease Area
2017 Cap Integrity Monitoring
Parkwater Rail Yard Site

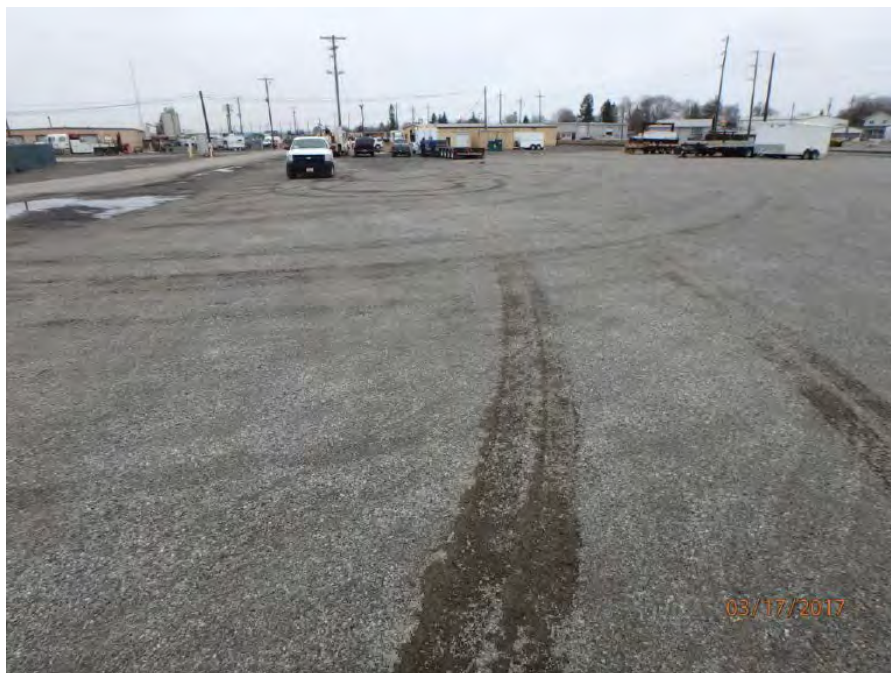
Photograph 3 – Looking to west. Note puddling is off of the cap (between cap and access road).
