Subject: Cap Integrity Monitoring  
BNSF Railway Company, Parkwater Rail Yard  
Spokane, Washington  
KJ 1896110.00

This letter provides the results of the June 2018 cap integrity monitoring at the BNSF Railway Company (BNSF) Parkwater Rail Yard (Site) located at 5302 East Trent Avenue in Spokane, Washington. The Site is in the cleanup process under the Model Toxics Control Act (MTCA) through the Washington State Department of Ecology (Ecology). The cleanup is being implemented by BNSF under Consent Decree No. 12202548-1, dated 19 July 2012.

Cap integrity monitoring included walking the perimeters and surfaces of the capped areas and inspecting for damage, degradation, or vandalism; puddles or other depressions; and animal burrows. Based on the field activities performed on 28 June 2018, the following conditions were noted:

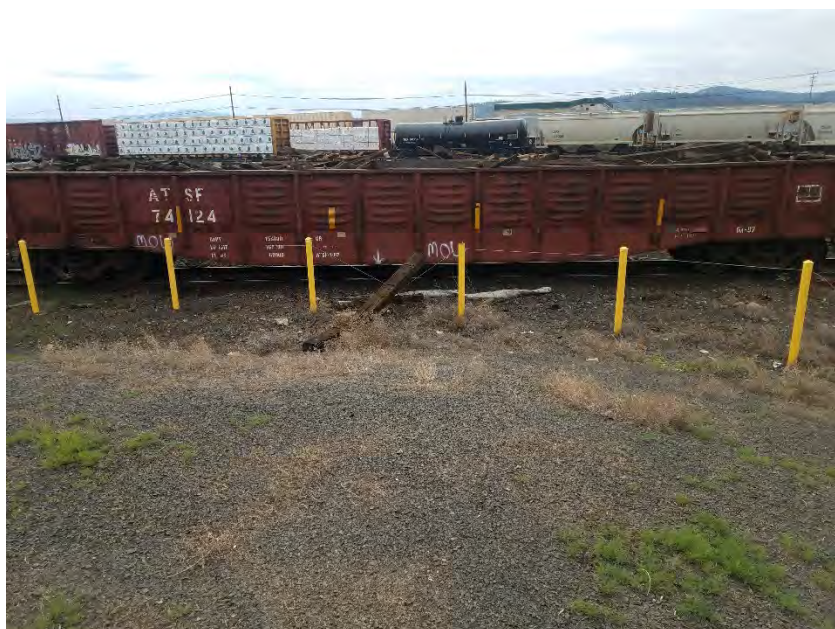
- For the East and West Debris Area:
  - No indications of settlement or erosion of the cap were observed.
  - No indications of damage, degradation, or vandalism of the cap were observed.
  - No puddles or other depressions were observed.
  - Limited vegetation was noted on the cap.
  - The perimeter fencing was observed to be in good condition apart from minor damage to the cable on the southwestern corner of the fence, which was repaired on 28 June 2018.

**Photograph 5** – damage to southwestern fence corner.  
6/28/2018

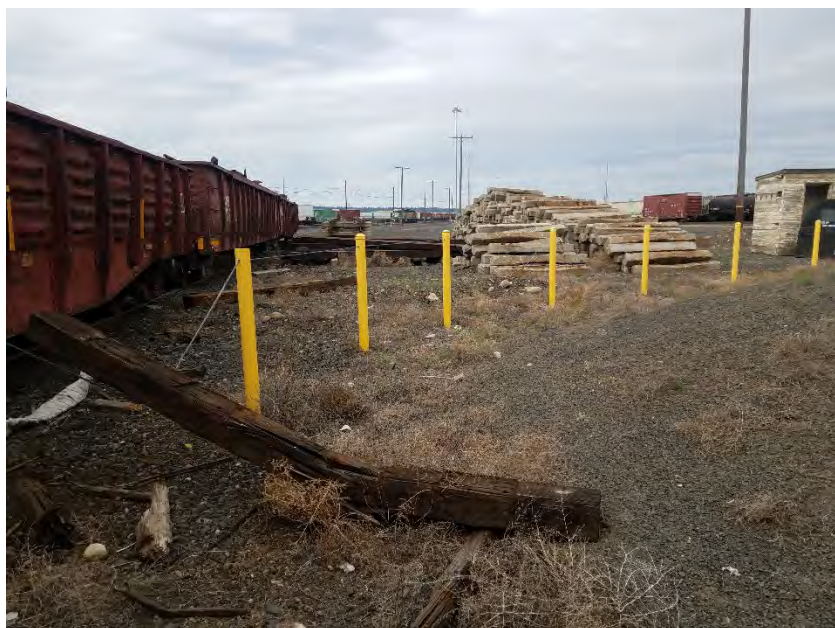
**Photograph 6** – damage to southwestern fence corner.  
6/28/2018
