10 February 2020

Subject: Cap Integrity Monitoring  
BNSF Railway Company, Parkwater Rail Yard  
Spokane, Washington  
KJ 1996110.00

Site Photographs, East and West Debris Area

Site Photographs, Former Koch Asphalt Lease Area

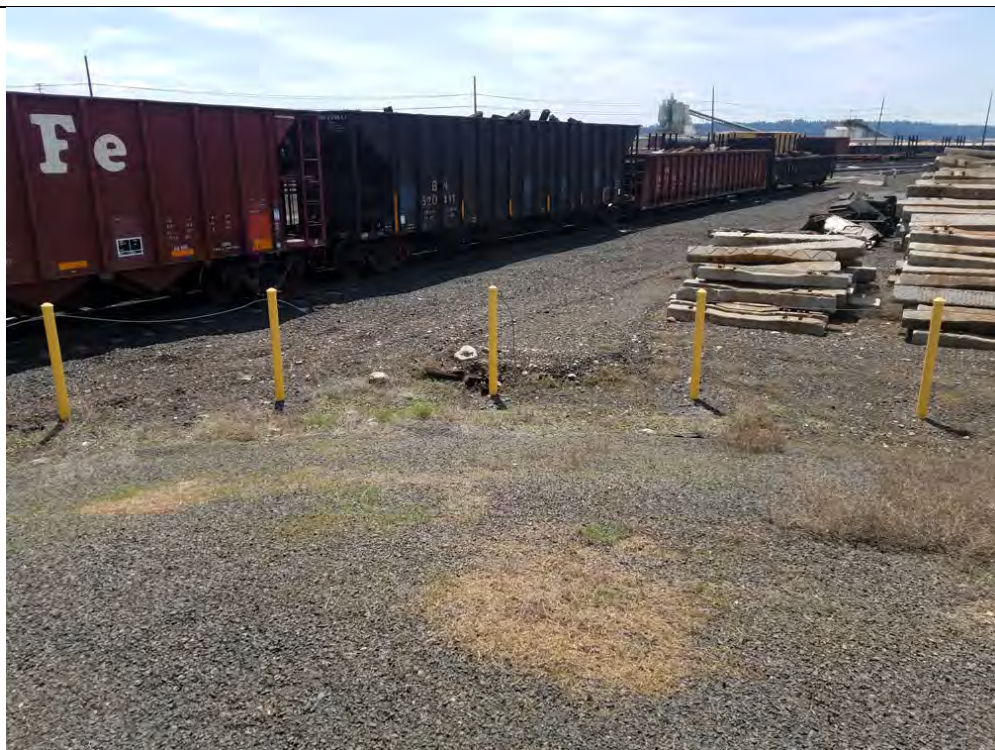
- For the East and West Debris Area:
  - No indications of settlement or erosion of the cap were observed.
  - No indications of damage, degradation, or vandalism of the cap were observed.
  - No puddles or other depressions were observed.
  - No vegetation was noted on the cap.
  - The perimeter fencing was observed to be in good condition apart from damage to the cable on the southwestern corner of the fence.
  - A small storage shed was observed in the center of the cap.

**Photo #4:** Damage to southwestern fence corner.
