14 August 2020

Subject: Cap Integrity Monitoring  
BNSF Railway Company, Parkwater Rail Yard  
Spokane, Washington  
KJ 2096110\*00

Site photograph logs from the field inspection for the East and West Debris Area and the Former Koch Asphalt Area have been included as Attachments A and B, respectively.

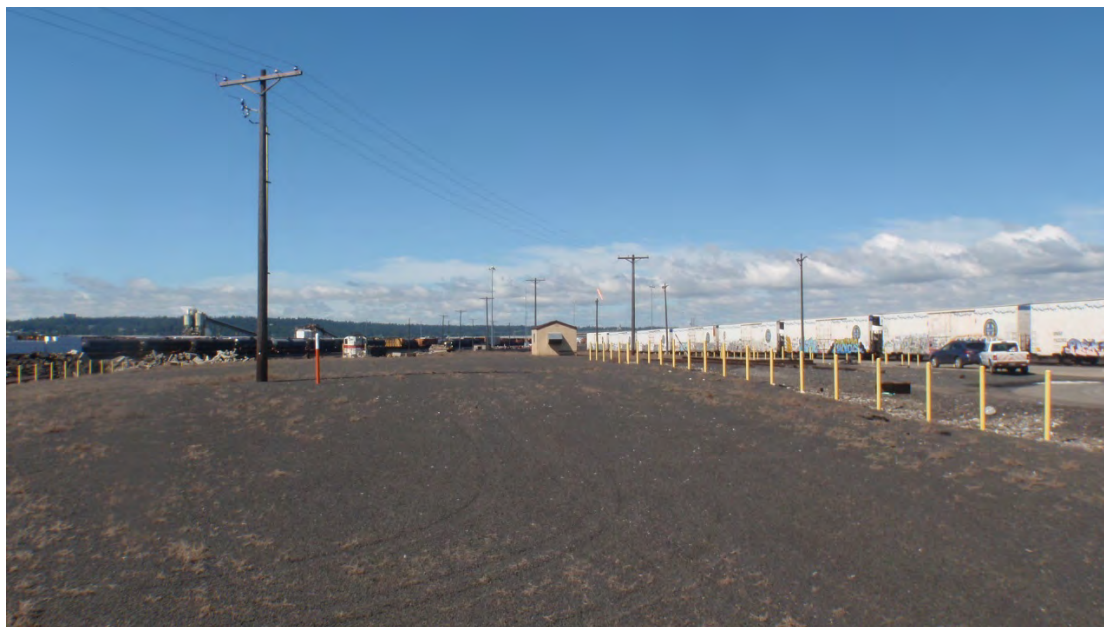
**Photo #1:** Looking to the southwest.

- For the East and West Debris Area:
  - No indications of settlement or erosion of the cap were observed.
  - No indications of damage, degradation, or vandalism of the cap were observed.
  - No puddles or other depressions were observed.
  - Scattered weeds were noted growing on the cap, but were not sufficient to warrant removal.

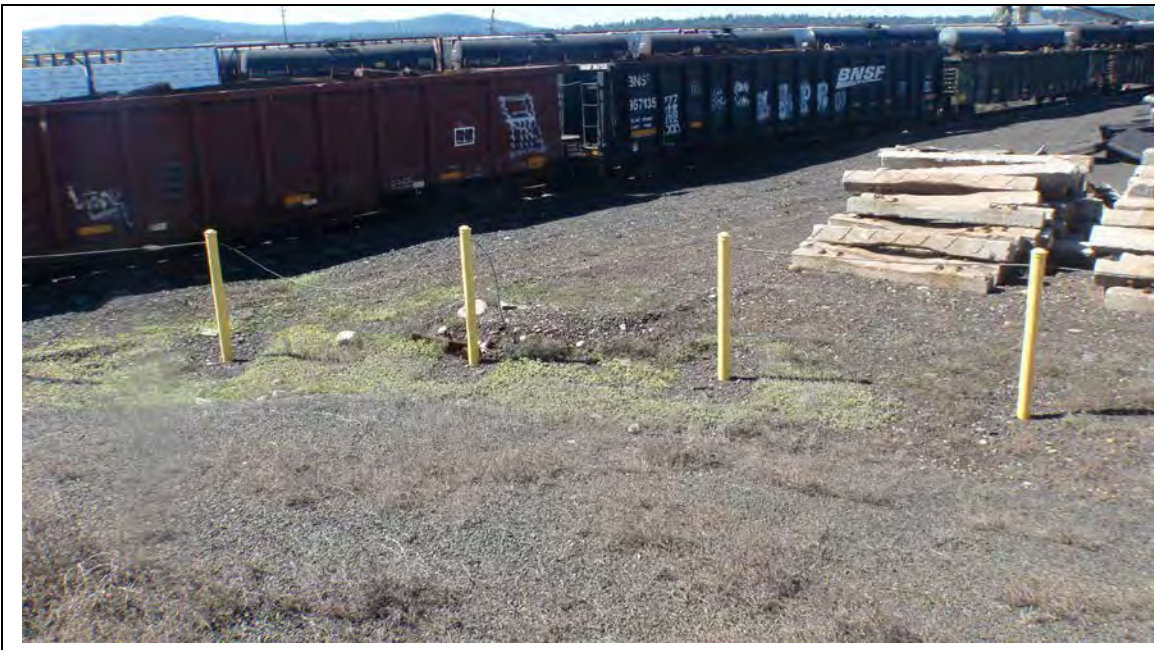
- The perimeter fencing was observed to be in good condition apart from damage to the cable on the southwestern corner of the fence. Cap integrity in the southwestern corner has not been affected by the fence cable damage.
- A small storage shed was observed in the center of the cap.
- For the Former Koch Asphalt Area:
  - No indications of settlement or erosion of the cap were observed.
  - No indications of vandalism of the cap were observed.
  - No puddles or other depressions were observed on the cap.
  - No vegetation was noted on the cap.
  - BNSF is utilizing the area to store equipment/trailers as intended.

**Photo #3:** Damage to southwestern fence corner.
