18 May 2022

Subject: Cap Integrity Monitoring
BNSF Railway Company, Parkwater Rail Yard
Spokane, Washington
KJ 2296110*00

Site Photographs, East and West Debris Area

Site Photographs, Former Koch Asphalt Lease Area

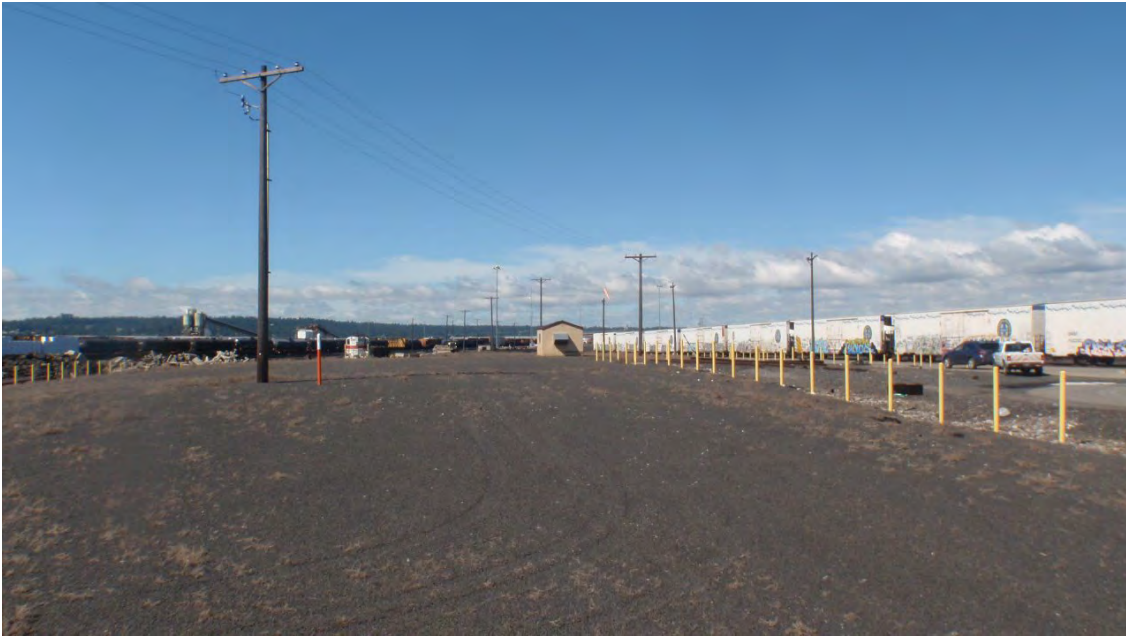
Photo #1: Looking to the southwest.

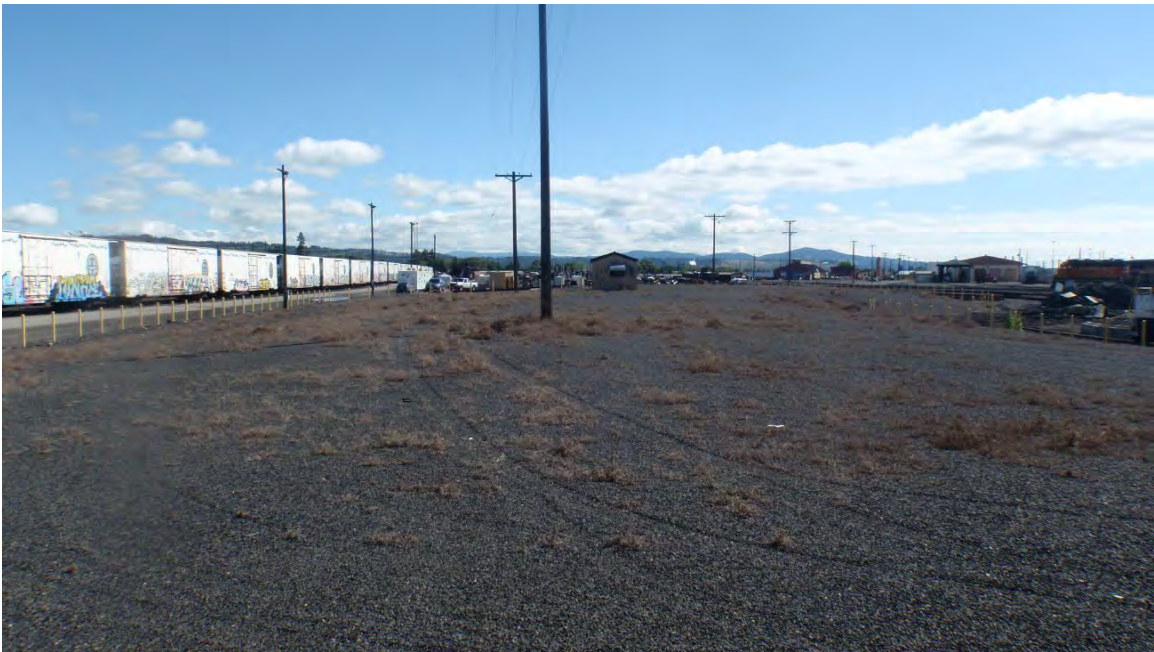
Photo #2: Looking to the northeast.

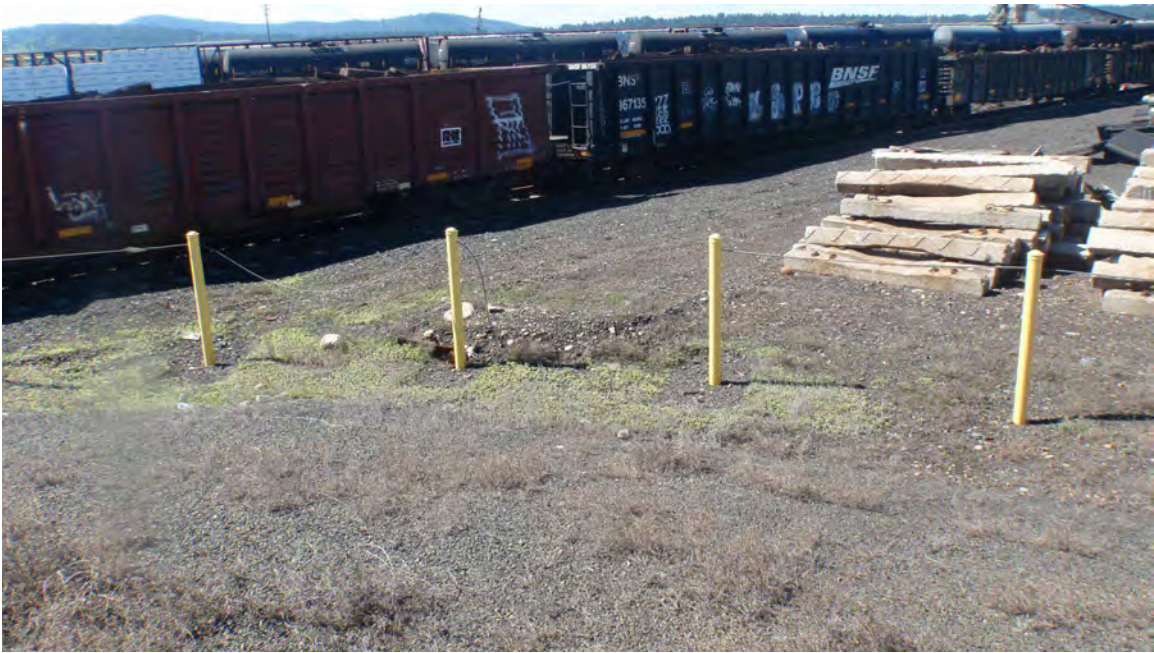
- The perimeter fencing was observed to be in good condition apart from damage to the cable on the southwestern corner of the fence. Cap integrity in the southwestern corner has not been affected by the fence cable damage.
- A small storage shed was observed in the center of the cap.
- For the Former Koch Asphalt Area:
 - No indications of settlement or erosion of the cap were observed.
 - No indications of vandalism of the cap were observed.
 - No puddles or other depressions were observed on the cap.
 - No vegetation was noted on the cap.
 - BNSF is utilizing the area to store equipment/trailers as intended.

Photo #3: Damage to southwestern fence corner.

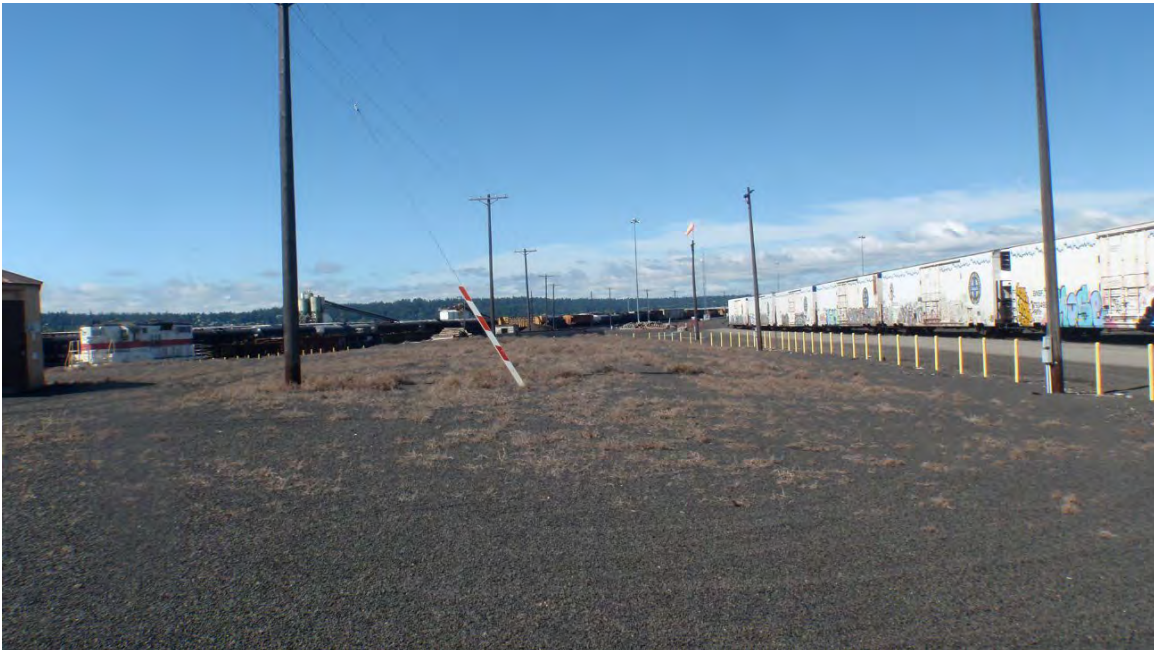
Photo #4: Looking to the southwest.

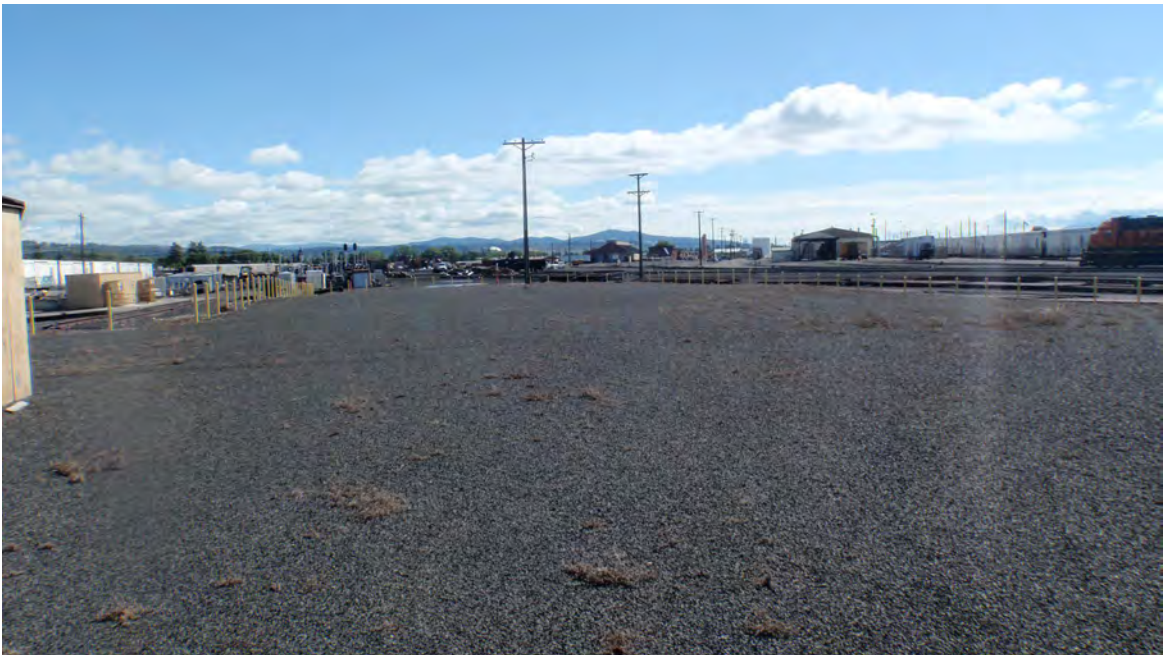
Photo #5: Looking to the northeast.

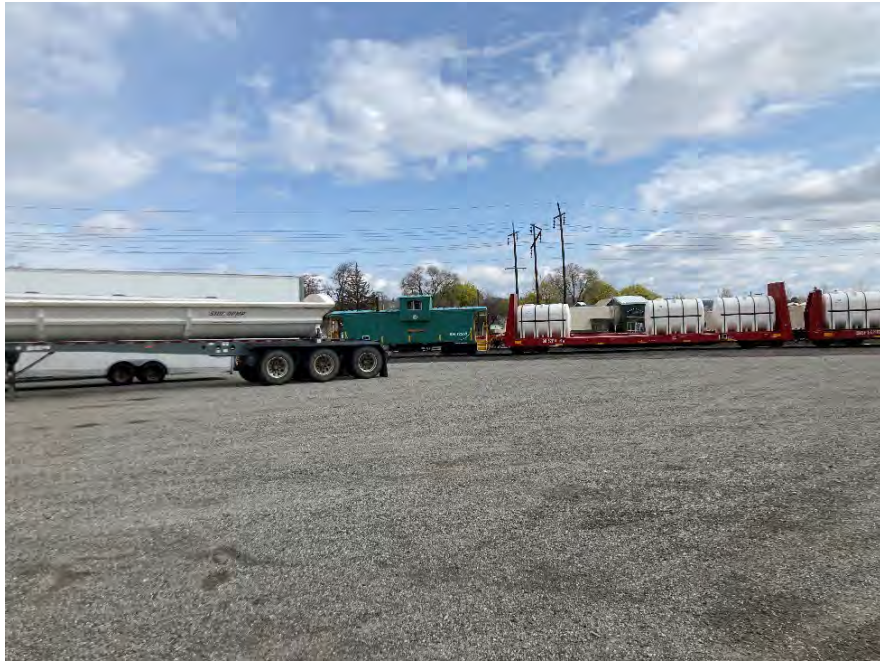
Photo #1: Looking to the north.

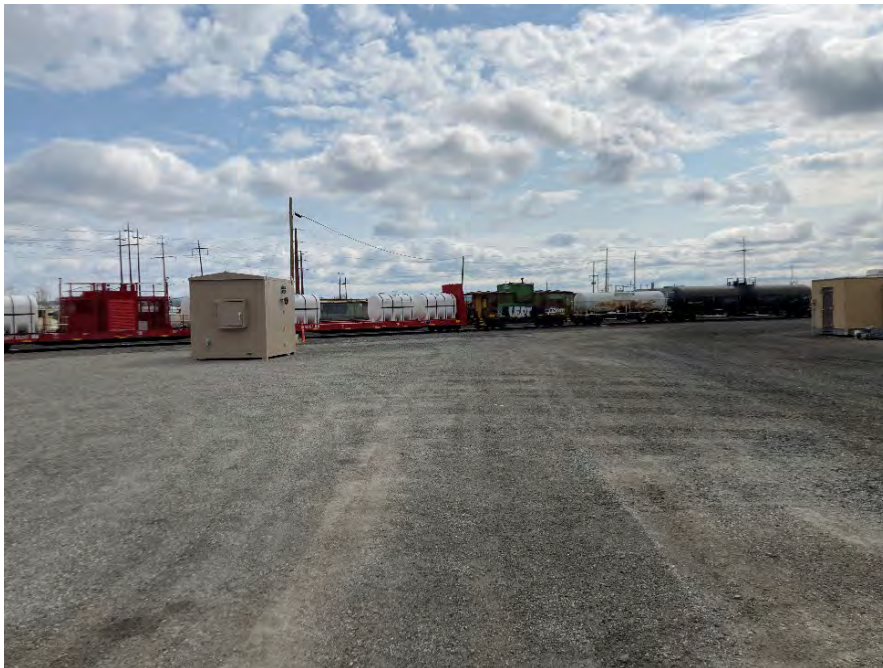
Photo #2: Looking to the northwest.

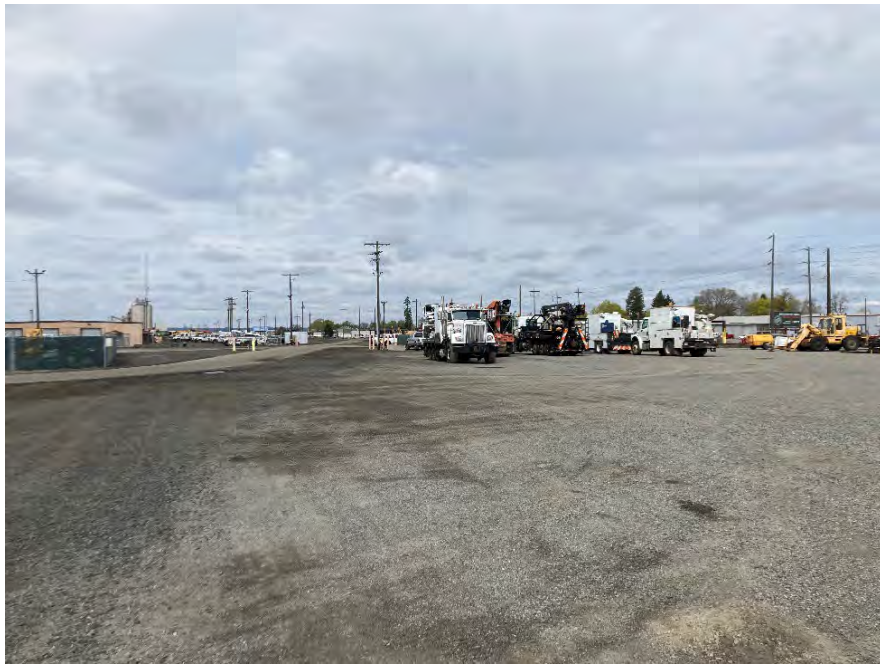
Photo #3: Looking to the west.

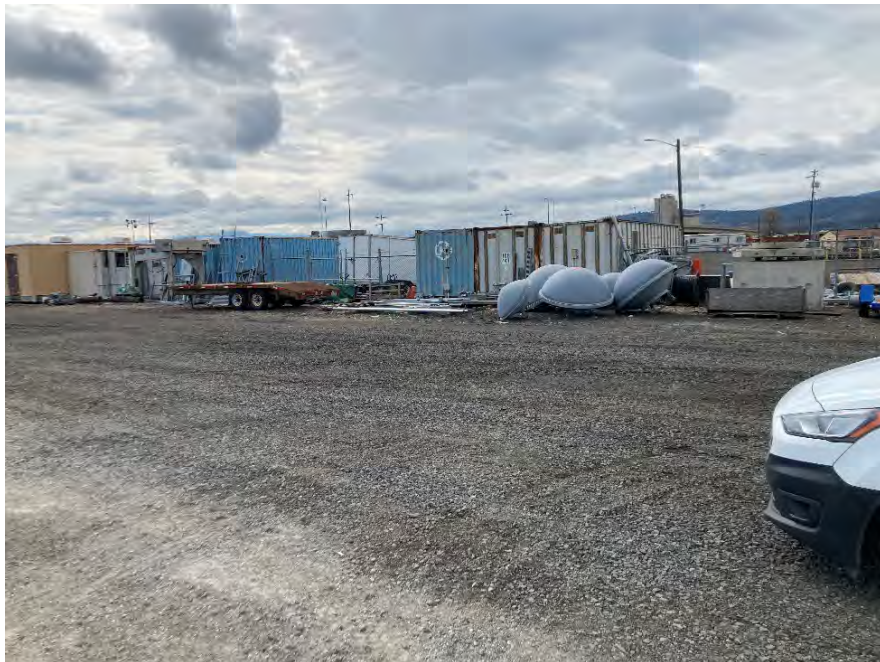
Photo #4: Looking to the south.
