**PHASE I ENVIRONMENTAL SITE ASSESSMENT  
1900/1916 BOREN DEVELOPMENT  
1900 AND 1916 BOREN AVENUE  
SEATTLE, WASHINGTON**

**JULY 8, 2021**

**1350.020.01\_Rev1**

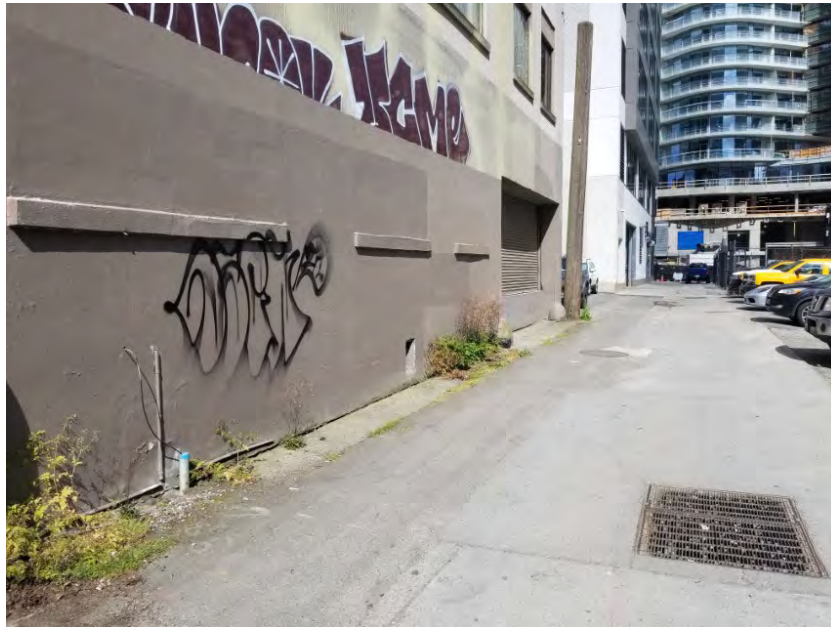
**Photo 11.** View Direction: Northwest  
Viewing the northeast side of the 1916 Boren Avenue building from the adjacent alleyway. The potential fuel fill port is in the small alcove to the left of the warehouse loading dock roll up door.

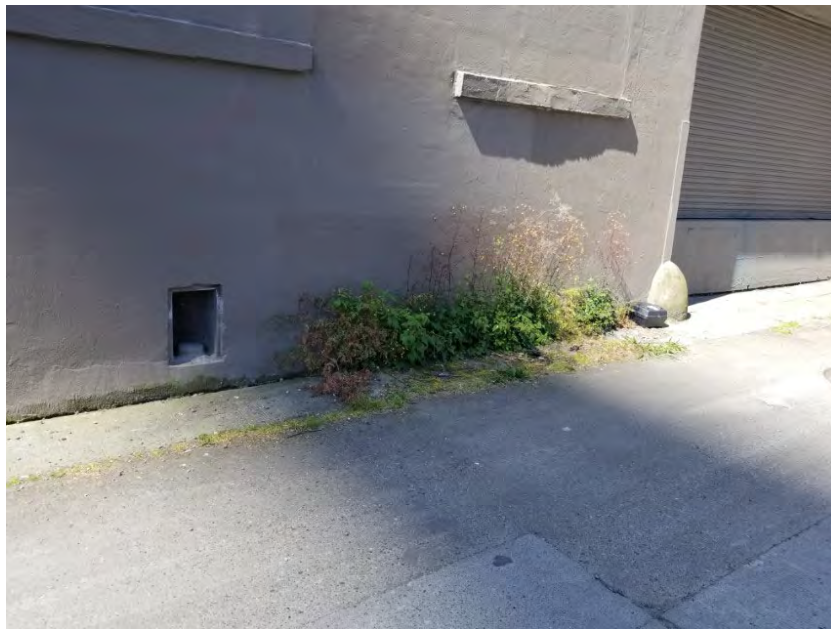
**Photo 12.** View Direction: Northwest  
Viewing the northeast side of the 1916 Boren Avenue building from the adjacent alleyway. The potential fuel fill port is in the small alcove to the right.

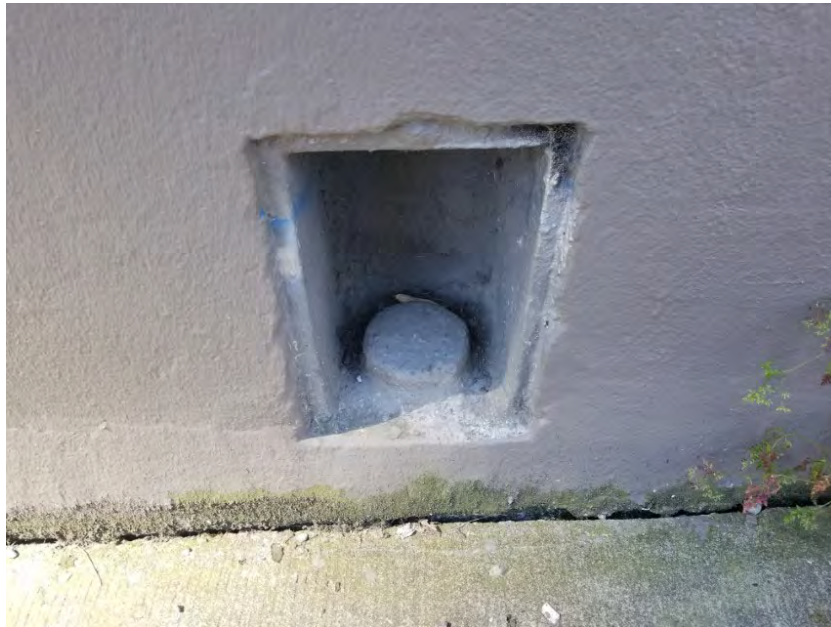
**Photo 13.** View Direction: Northwest  
Viewing the northeast side of the 1916 Boren Avenue building from the adjacent alley way. The potential fuel fill port cap in the small alcove to the left of the loading dock roll up door.

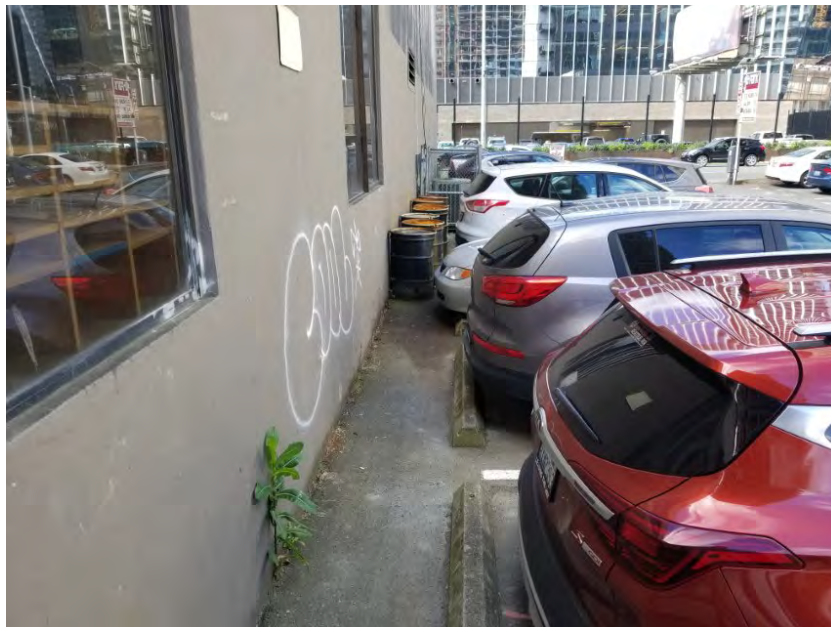
**Photo 14.** View Direction: Southwest  
Viewing drums (center) and parking lot (right) at the northwest side of the 1916 Boren Avenue building.

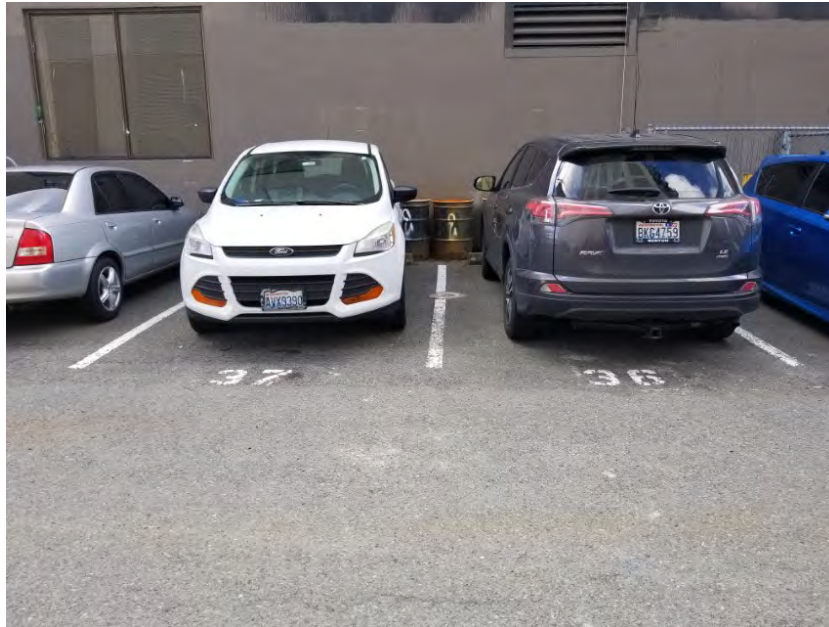
**Photo 15.** View Direction: Southeast  
Viewing drums (background center) from the parking lot at the northwest side of the 1916 Boren Avenue building. A groundwater monitoring well (GEI-1-18) is in-between the two cars on the painted parking space line.

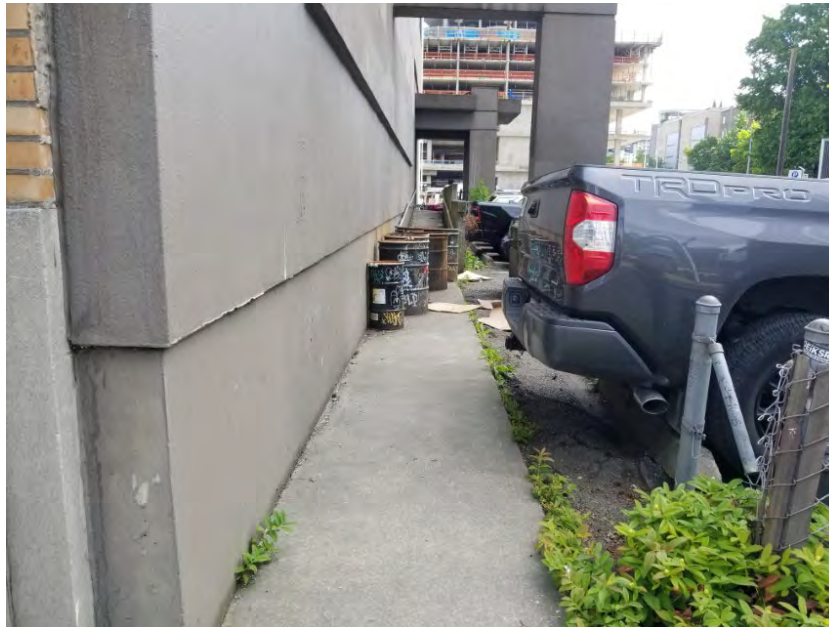
**Photo 16.** View Direction: Northeast  
Viewing drums (center) and parking lot (right) from Boren Avenue at the southeast side of the 1916 Boren Avenue building.

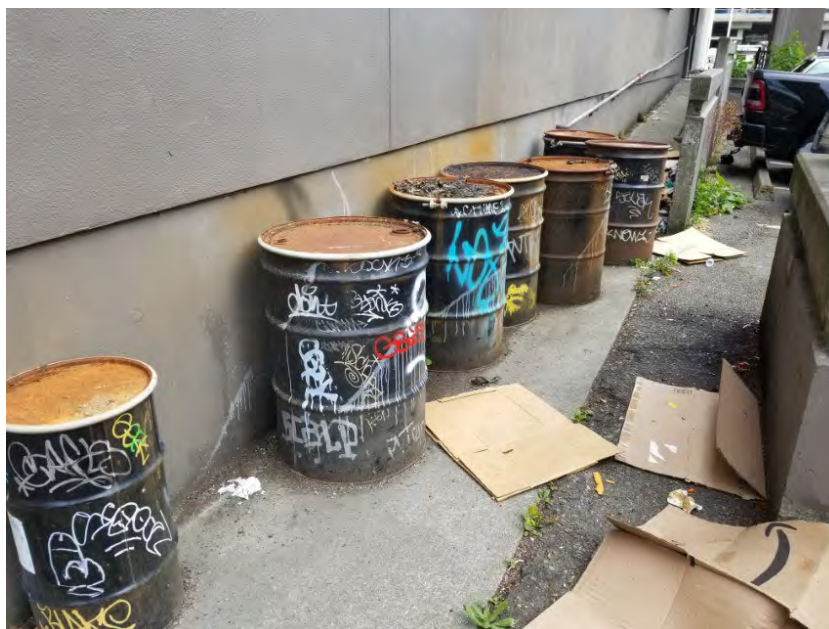
**Photo 17.** View Direction: Northeast  
Viewing drums from the parking lot (right) at the southeast side of the 1916 Boren Avenue building.

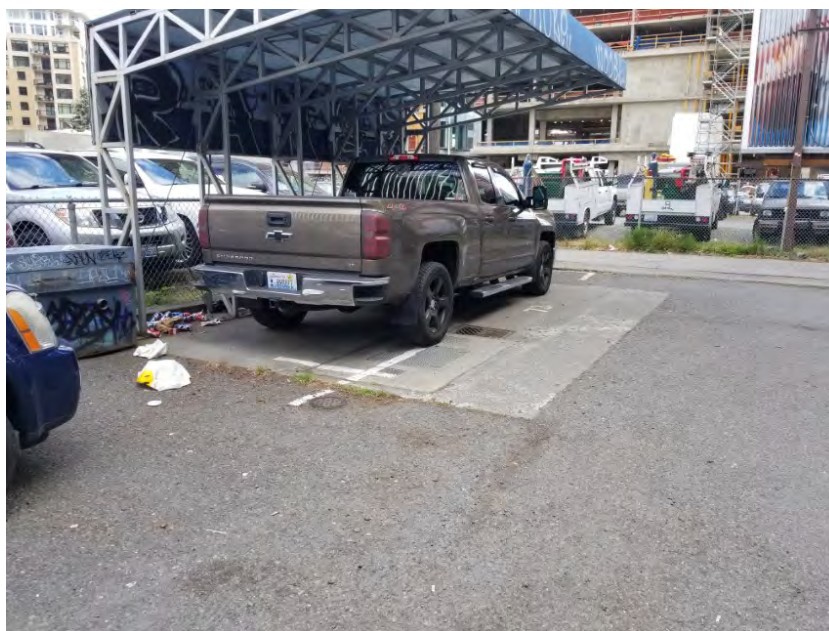
**Photo 18.** View Direction: Northeast  
Viewing wash rack and oil-water separator at the southeast corner of the subject property.

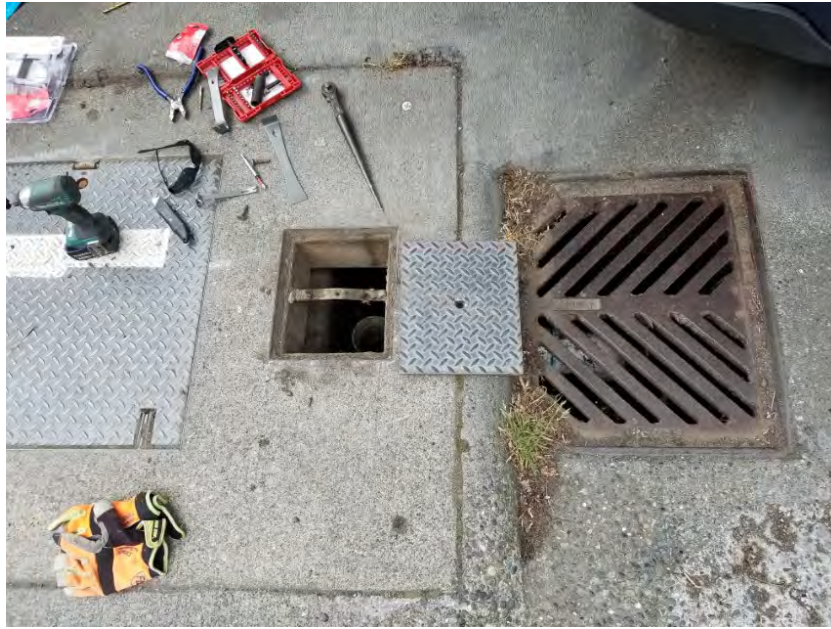
**Photo 19.** View Direction: Northwest  
Viewing the oil-water separator and connected catch basin at the southeast corner of the subject property.

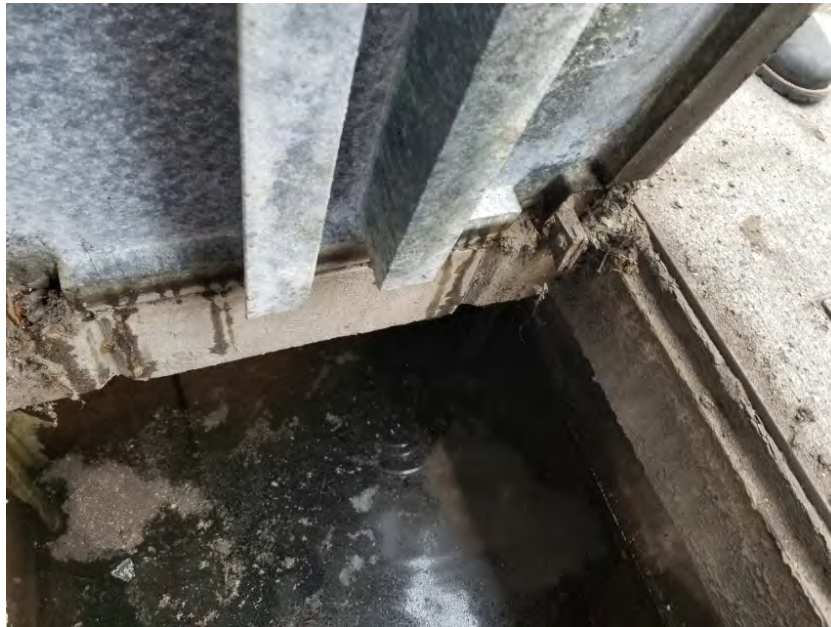
**Photo 20.** View Direction: South  
Viewing the clear water of the oil-water separator at the southeast corner of the subject property. Non-oily dirt is floating on the surface of the water.

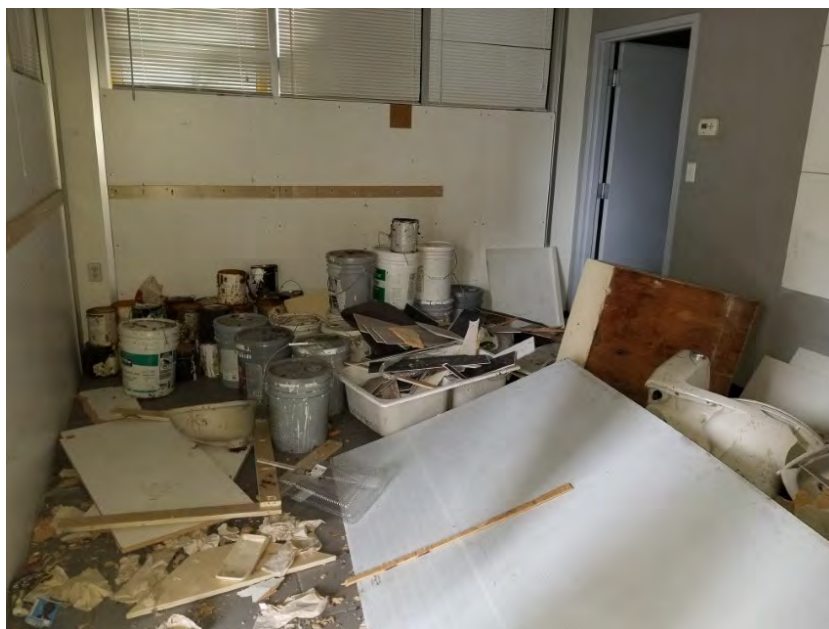
**Photo 21.** View Direction: South  
Viewing paint containers in the lobby of the 1900 Boren Avenue building. The building's office is through the door on the right.

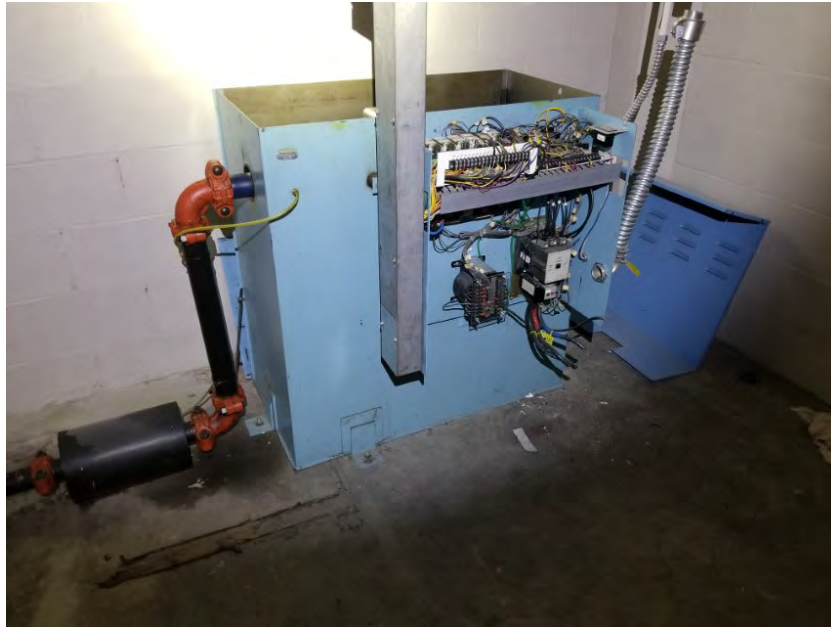
**Photo 25.** View Direction: Northeast  
Viewing the hydraulic tank and equipment in the elevator equipment room on the first floor of the 1916 Boren Avenue building. Minor staining on the concrete floor beneath the equipment motor on the left. The lid to the hydraulic tank is to the right.

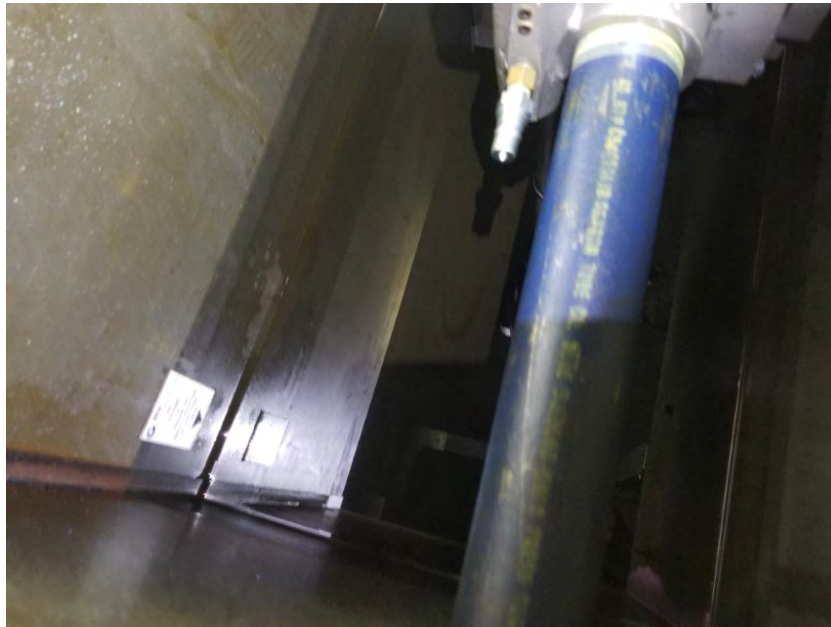
**Photo 26.** View Direction: North  
Viewing the inside of the elevator hydraulic oil tank. The is approximately half-full of hydraulic oil.

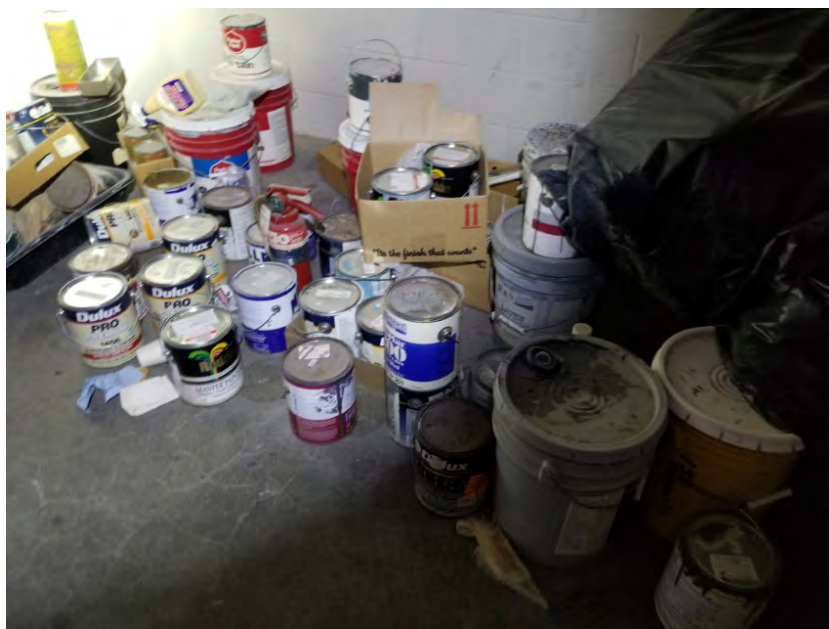
**Photo 27.** View Direction: East  
Viewing paint containers outside the elevator equipment room at the southeast end of the 1916 Boren Avenue building.

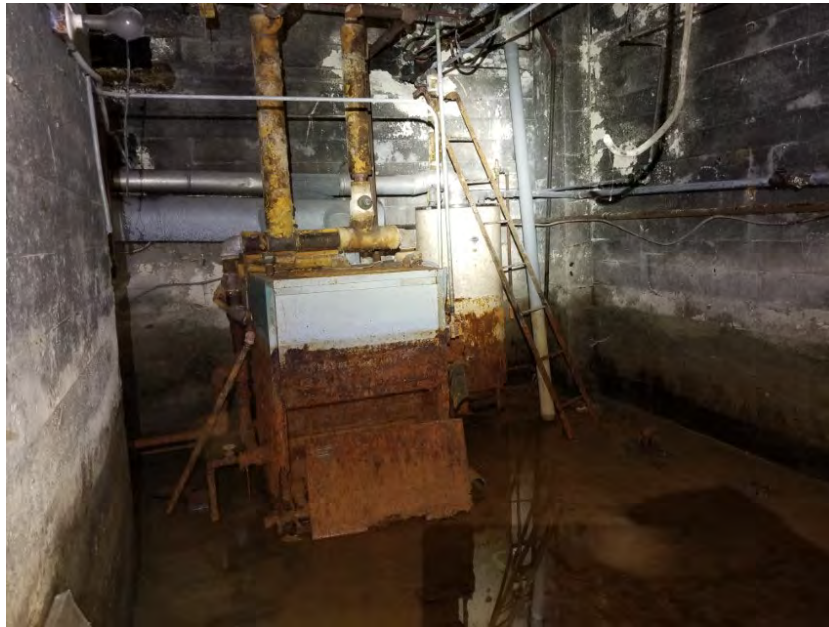
**Photo 34.** View Direction: Southeast  
Viewing the dilapidated boiler in the basement at the southeast corner of the 1916 Boren Avenue building.

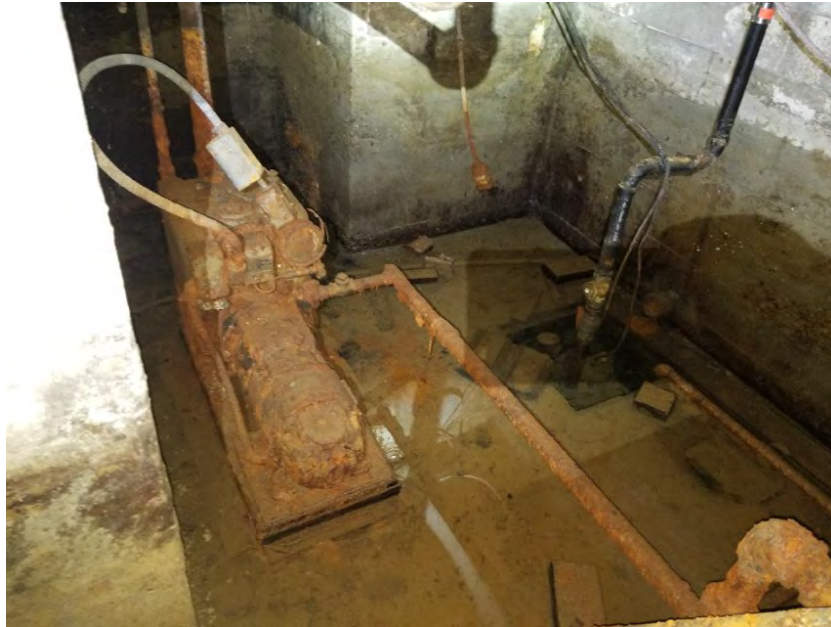
**Photo 35.** View Direction: East  
Viewing boiler water pump (left) and below-grade basement sump pump (right) in the basement boiler room at the southeast corner of the 1916 Boren Avenue building.

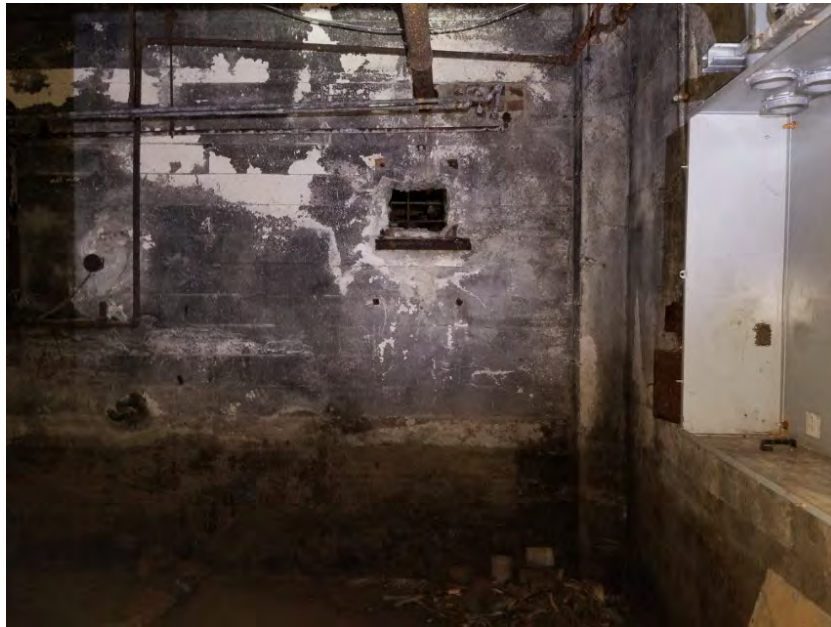
**Photo 36.** View Direction: Northwest  
Viewing a hole in the northwest wall of the basement boiler room in the 1916 Boren Avenue building. Beyond the hole is a crawlspace containing piping.  
Viewing

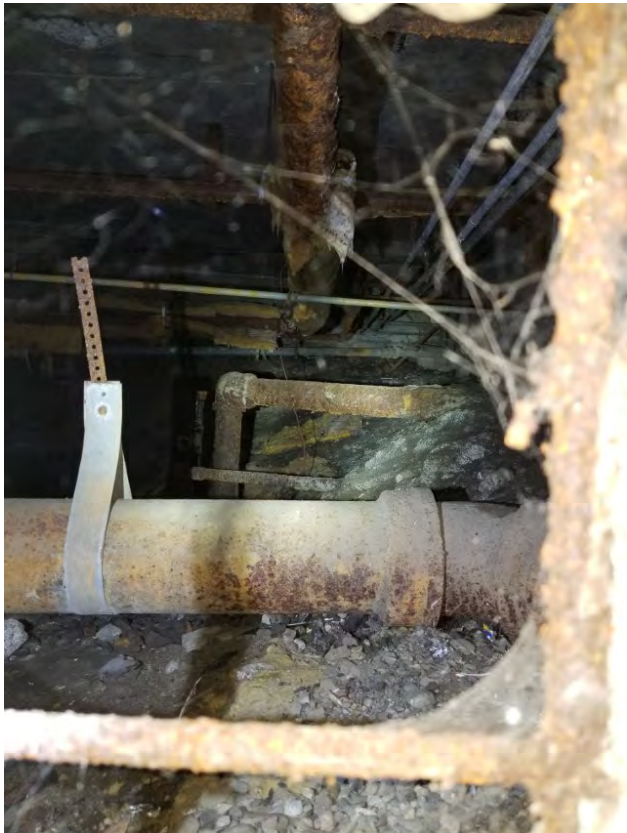
**Photo 37.** View Direction: Northwest  
Viewing of the piping through the hole in the boiler room basement wall.
