## **Third Periodic Review Weyerhaeuser Everett West**

**101 East Marine View Drive, Everett, Washington  
Facility Site ID: 10, Cleanup Site ID: 2902**

**Toxics Cleanup Program, Northwest Region**

June 2025

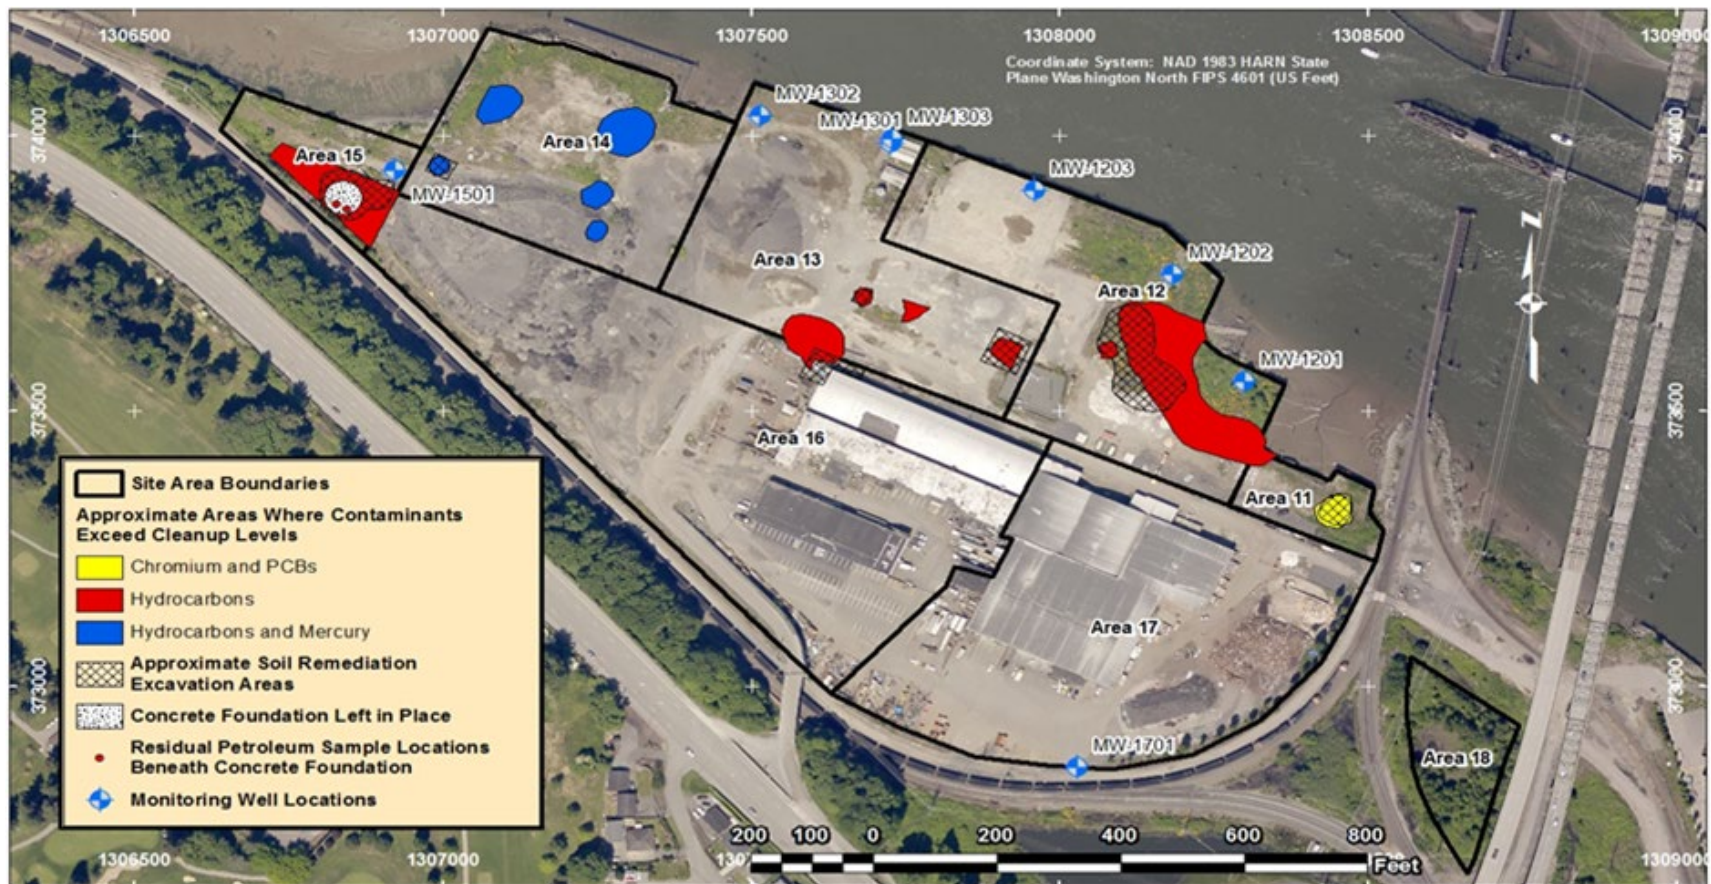
Soil remediation excavation areas and areas where contaminants exceed cleanup levels. Contamination limits from Exhibit B, Figure 2, of the 1994 Prospective Purchaser Consent Decree. Approximate excavation areas from EMCON, 1995, Figure 2-1.

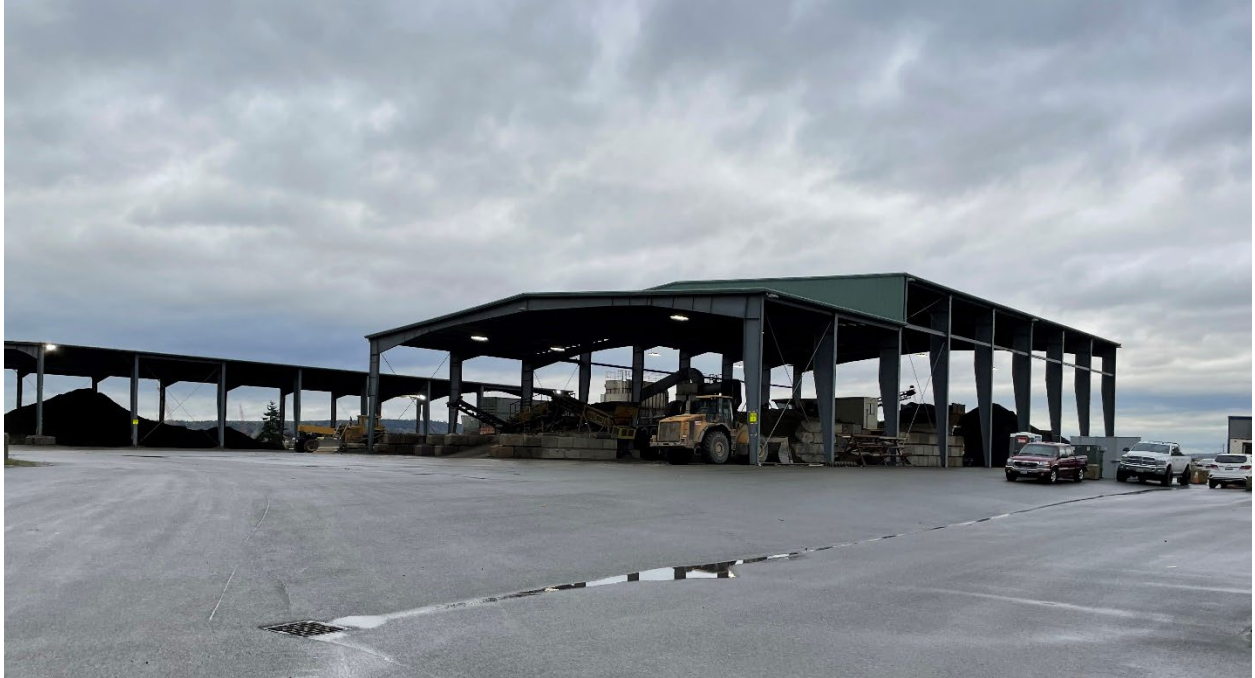
**Photo 1:** Soil Thermal Desorption Facility operated by Cadman.

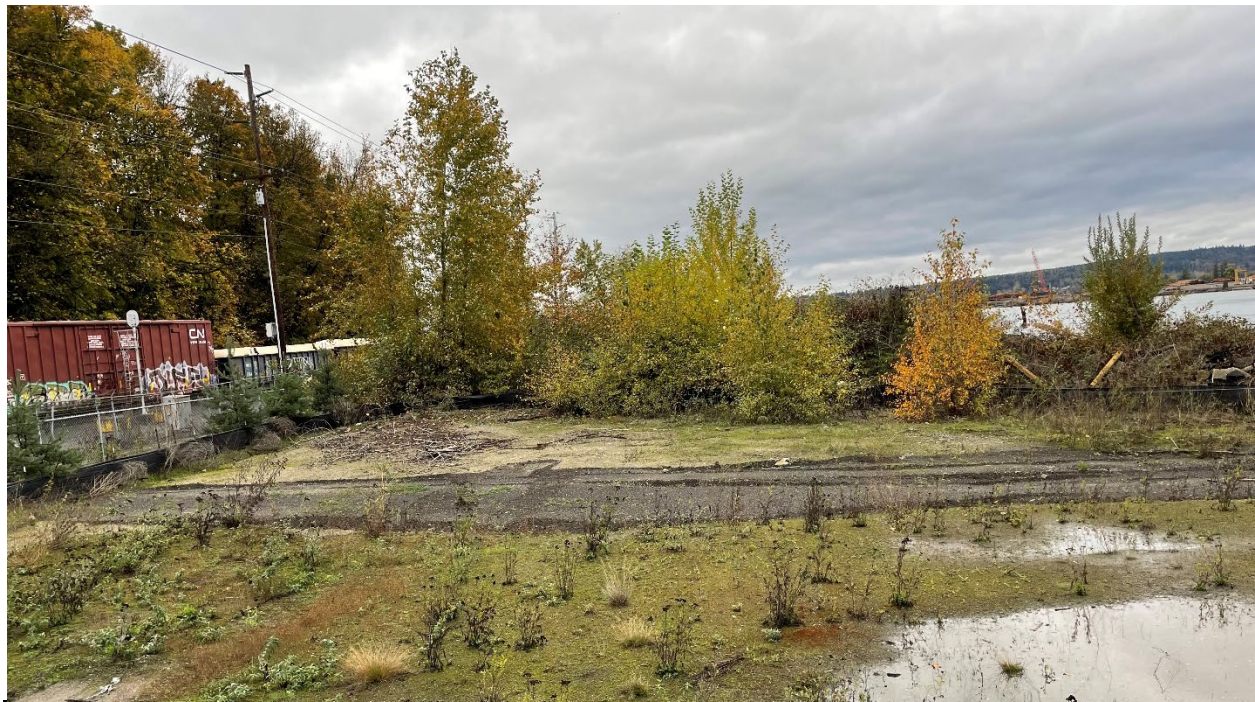
**Photo 2:** Northwest corner of the property (Cleanup Area 15 located in the forested area beyond gravel road).

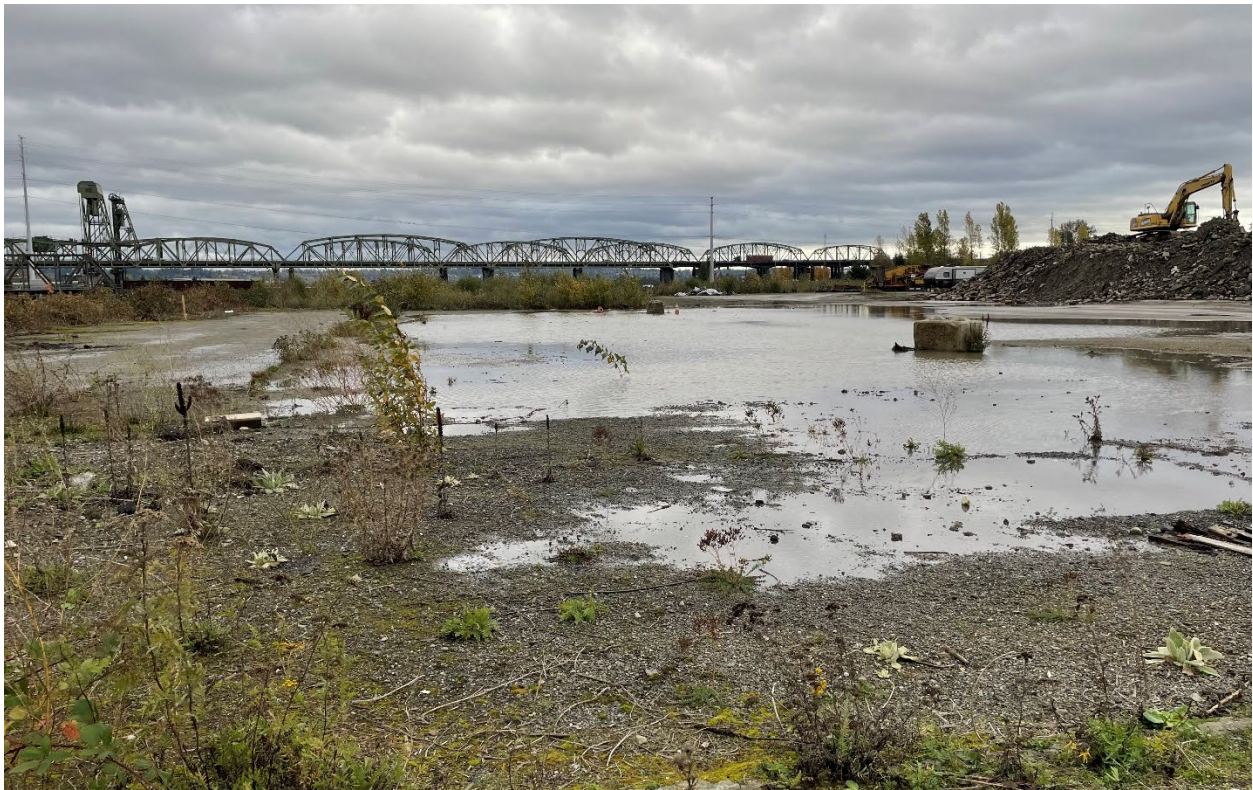
Protection of stormwater discharge to surface water bodies was not specifically discussed in the consent decree or environmental covenant. However, large areas of standing stormwater were observed in the northern paved portion of the property (particularly in cleanup area 12, see photograph 3).

**Photo 3:** Flooded ground surface, looking east toward former Mill C (Cleanup Area 12).

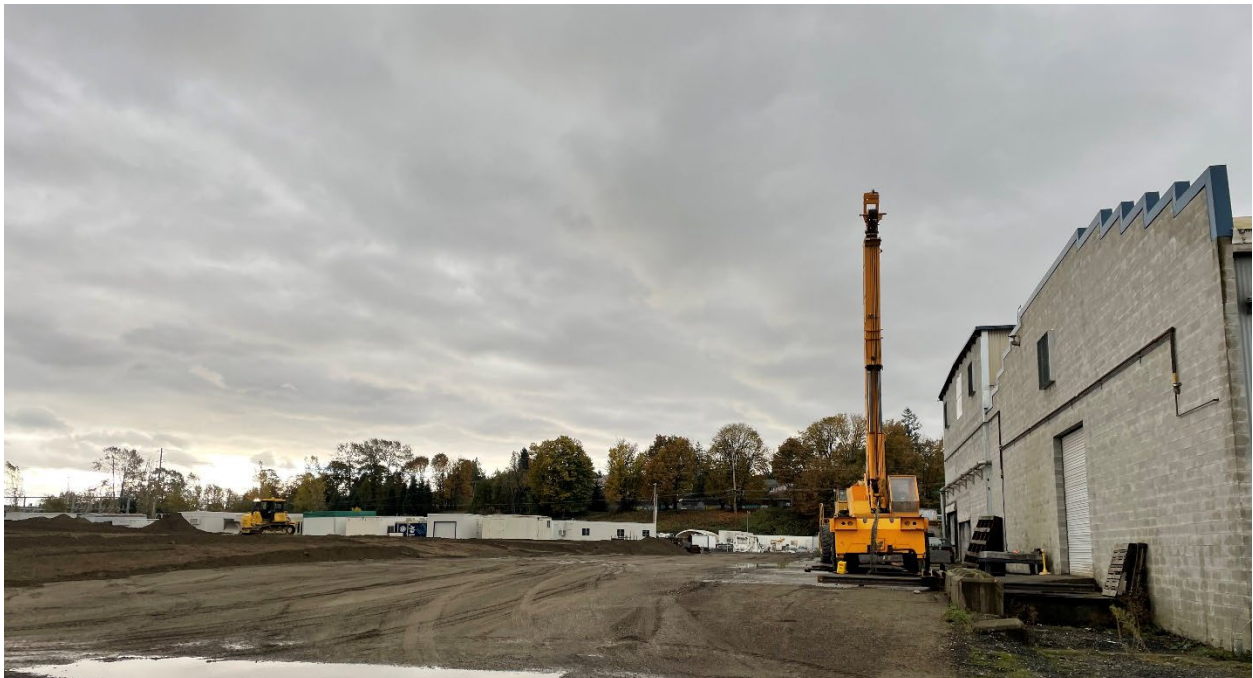
In addition, Ecology observed a portion of the Site being graded during the Site visit (in Area 17, where there was a structure fire in 2016). Ecology was not contacted regarding this work. However, this area does not appear to contain contaminated soils left in place as part of the cleanup action. Additionally, the grading may have been fill that was brought to the Site, based on the elevation of the ground surface (several feet above the surrounding surface), material characteristics (Type 17 fill), and satellite imagery of what appeared to be stockpiles of imported material in that area.

**Photo 4:** Looking south, footprint of former building, demolished following a 2016 structure fire. Area was being graded during Site visit.

- Ecology observed grading activities during the Site visit. Ground disturbing activities could result in the release or exposure of contaminants contained as part of the cleanup action, which is restricted by the Covenant. Ecology's approval should be obtained in advance of ground disturbing activities in the future.

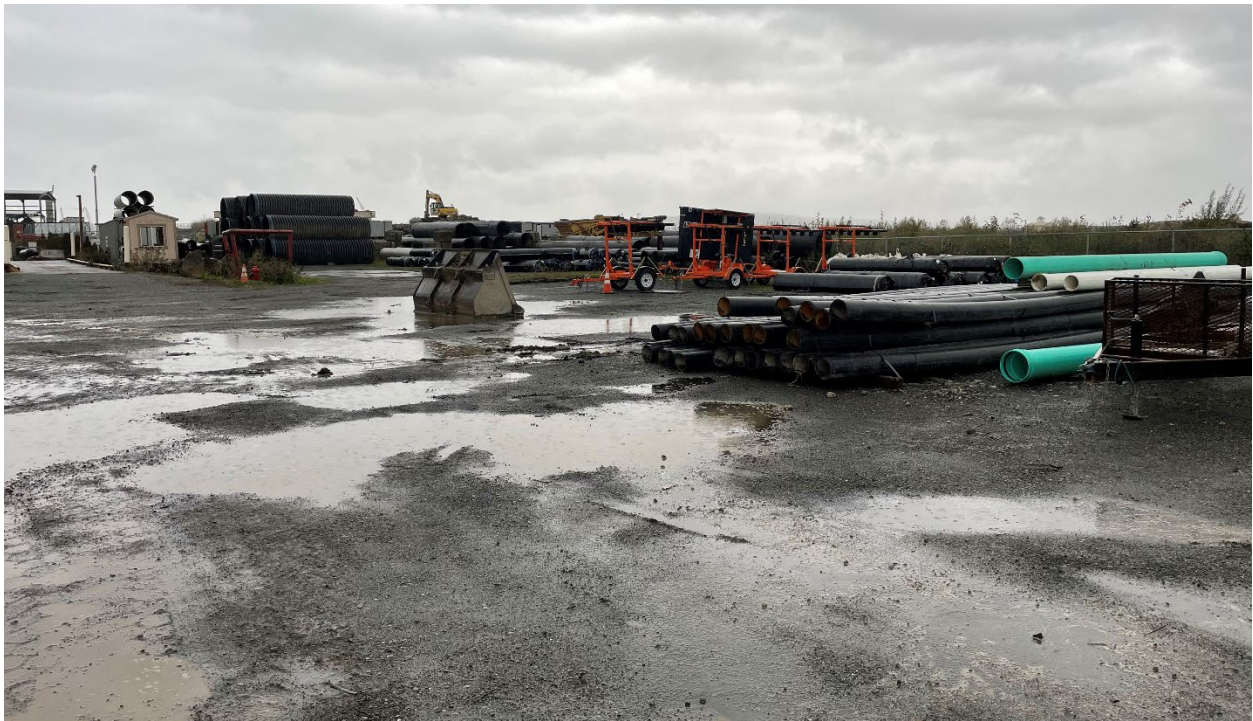
**Photo 5:** Graveled material/equipment storage area, looking northwest, toward Cleanup Area 12 (vegetated area in background).

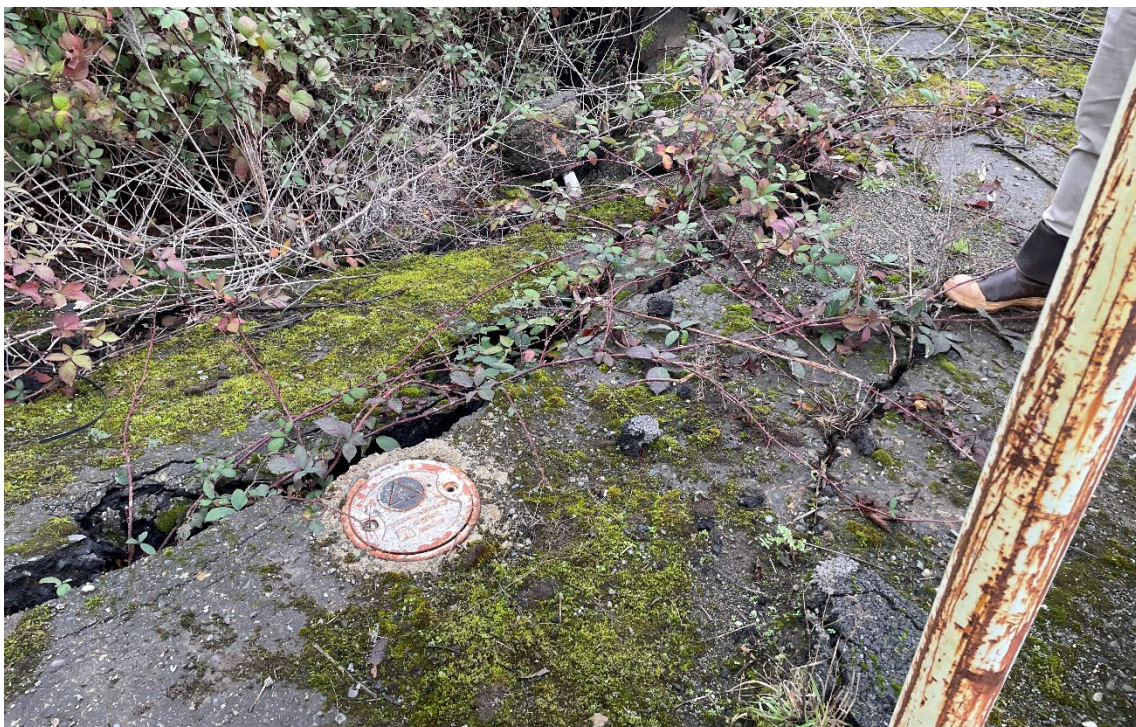
Well MW-1203R was identified during Ecology's October 2023 site visit. The well is located at the north end of the property, at the top of the Snohomish riverbank. Cracks were observed in the ground surface surrounding the well, and the slope appeared to be actively caving toward the river (see photograph 6 in Appendix C).

**Photo 6:** Well MW-1203R looking northwest, toward the Snohomish River. Slope failure can be seen adjacent to the well.

- Monitoring well MW-1203R is located at the north end of the Site, at the top of the Snohomish riverbank. Cracks were observed in the ground surface surrounding the well, and the slope appeared to be actively caving toward the river. This well should be repaired or replaced. Alternatively, if this well and the other 3 monitoring wells for the Site (MW-1202R, MW-1301R, and MW-1501R) are no longer being used for monitoring, they should be properly decommissioned.
