US-12 MP 138 USDOT ROW

SHARP Report — Part 1 of 2

17295 US-12 MP 138 USDOT ROW 20250729

SHARP rating — Medium

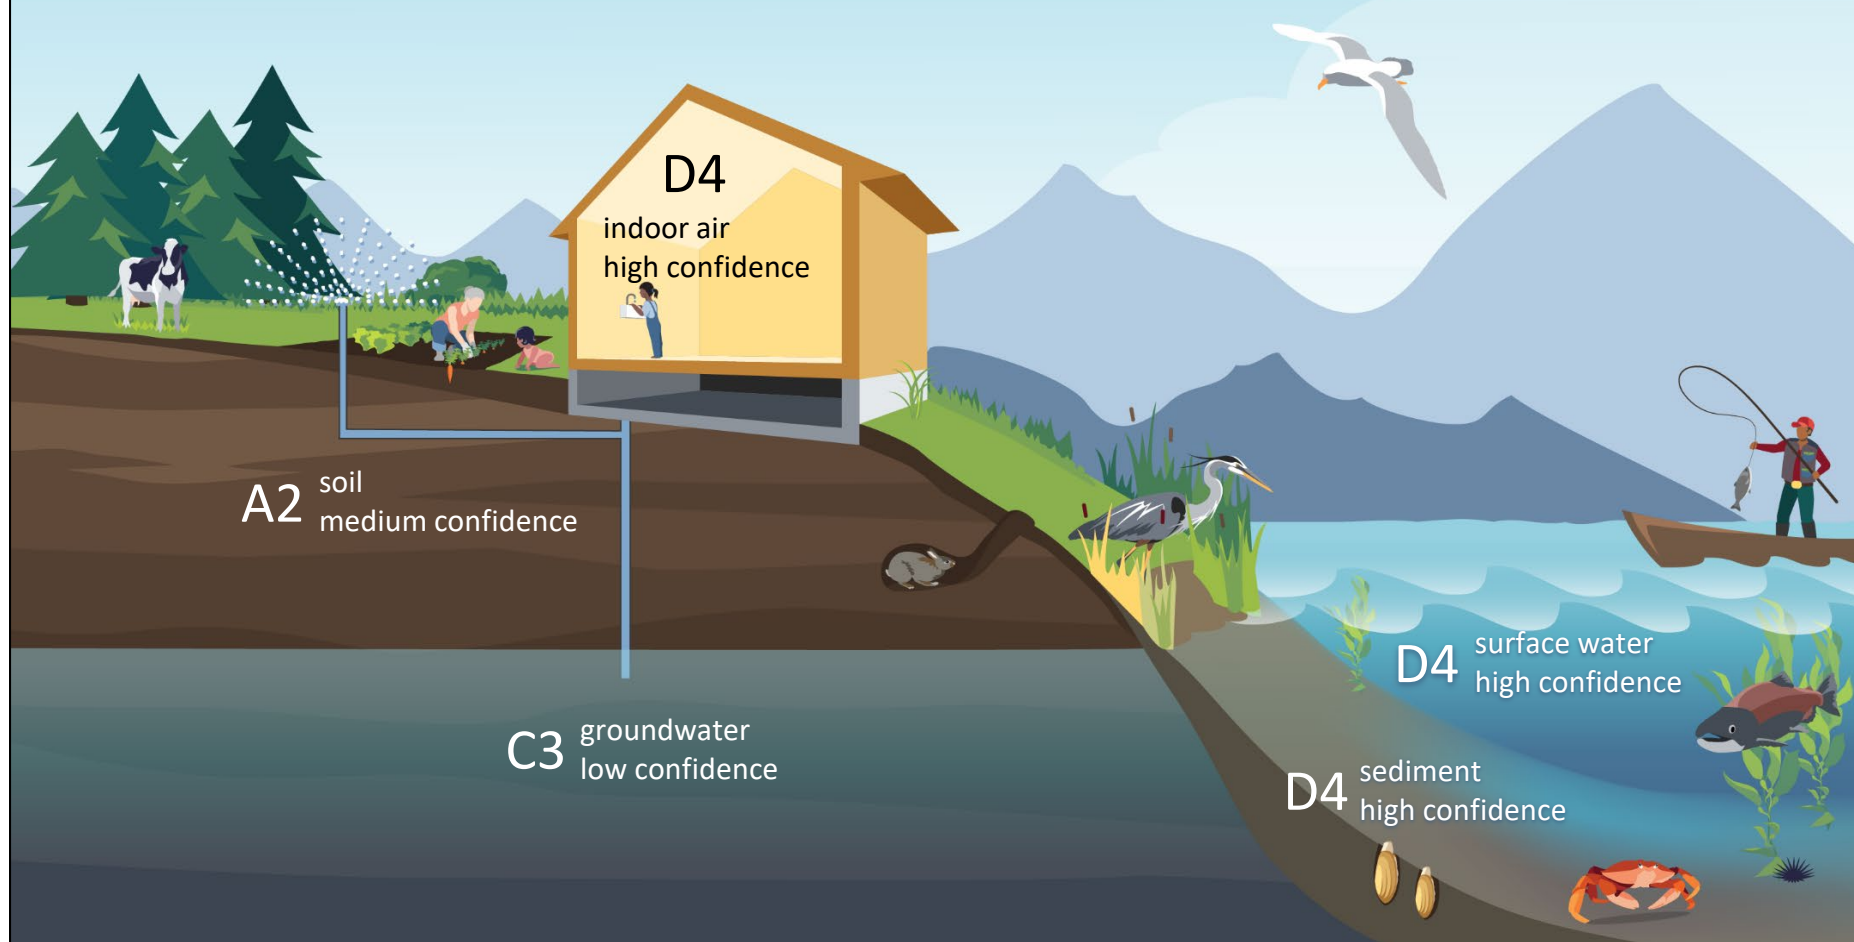
Conceptual site model

A Semi-truck accident resulted in saddle tanks ruptured, diesel released to ground smelled and observed by WSDOT staff as well as photographic evidence of release during tow extraction from the steep embankment.

Photographic evidence and field observations confirm fuel release to soil.

The site is not near any wells or in any wellhead protection zones. Depth to groundwater information in the area is not readily available. Soil to groundwater pathway is possible but unconfirmed.
