## M E M O R A N D U M

**SUBJECT:** Annual Inspection of Protective Cap at 255 South King Street

King Street Property  
255 South King Street  
Seattle, Washington

Project No.: 2000-027-02\_11404  
Date: August 22, 2025  
Drawn By: DL  
Chk By: FNL

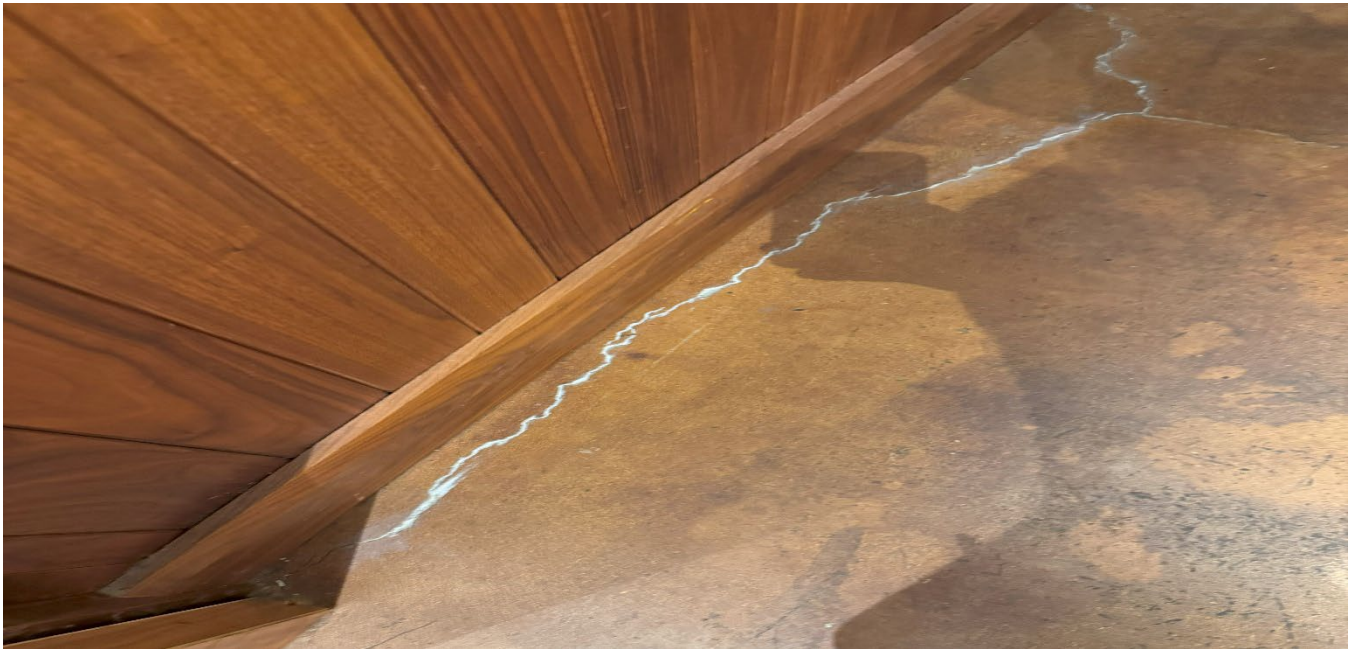
Photograph 1. The previously identified crack sealed with compatible epoxy/caulking in good shape at the 13 Coins Restaurant on the King Street property.

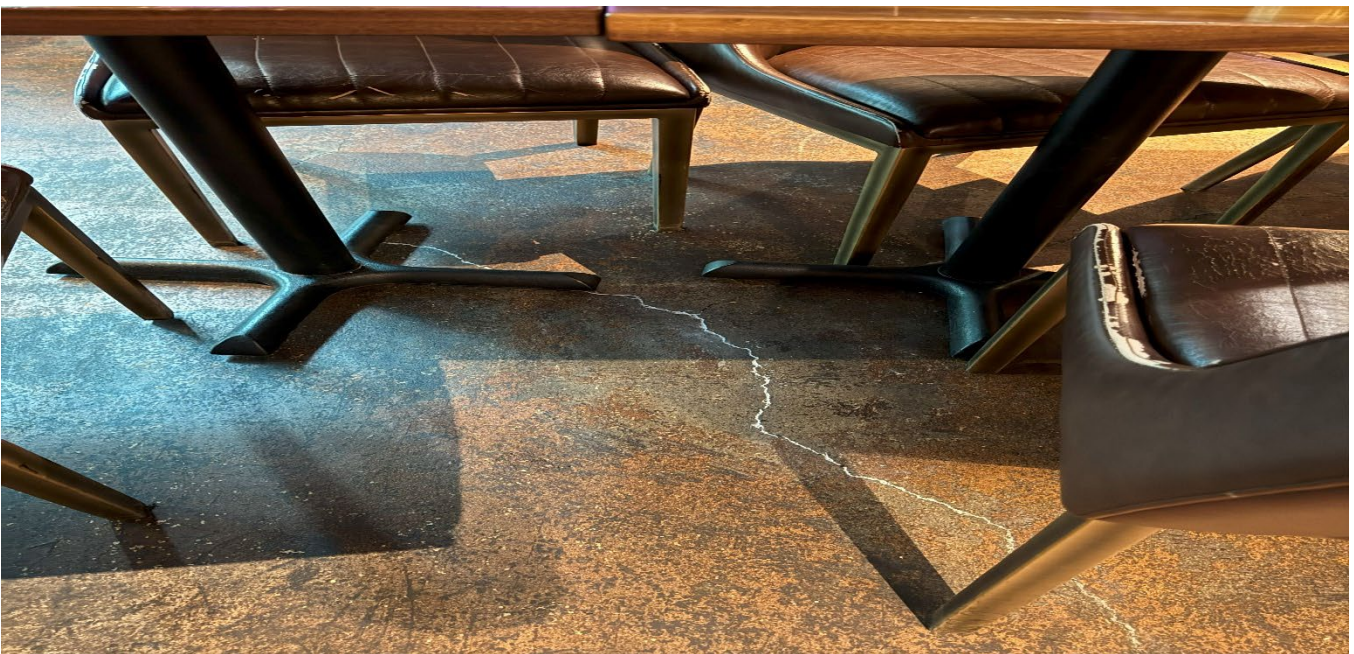
Photograph 2. The previously identified crack sealed with compatible epoxy/caulking in good shape at the 13 Coins Restaurant on the King Street property.

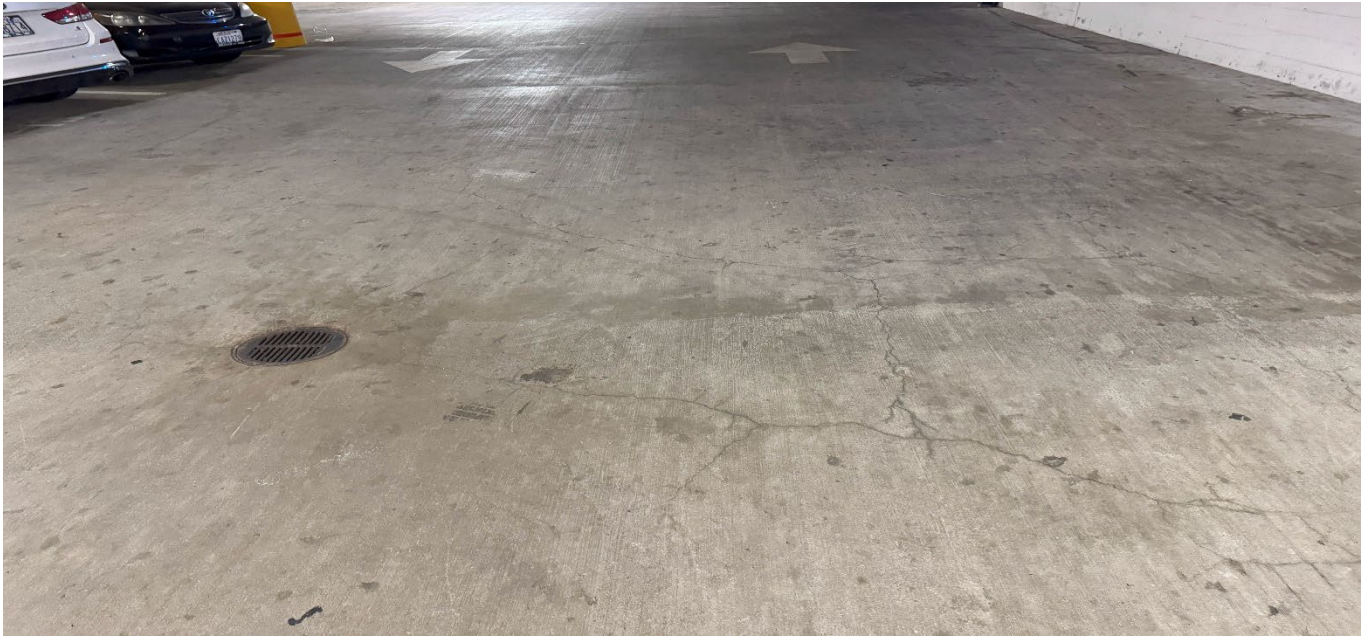
Photograph 3. Non-structural hairline cracking in the underground parking garage. The amount of cracking does not appear to have increased since the 2024 inspection. Repairs are not needed at this time.

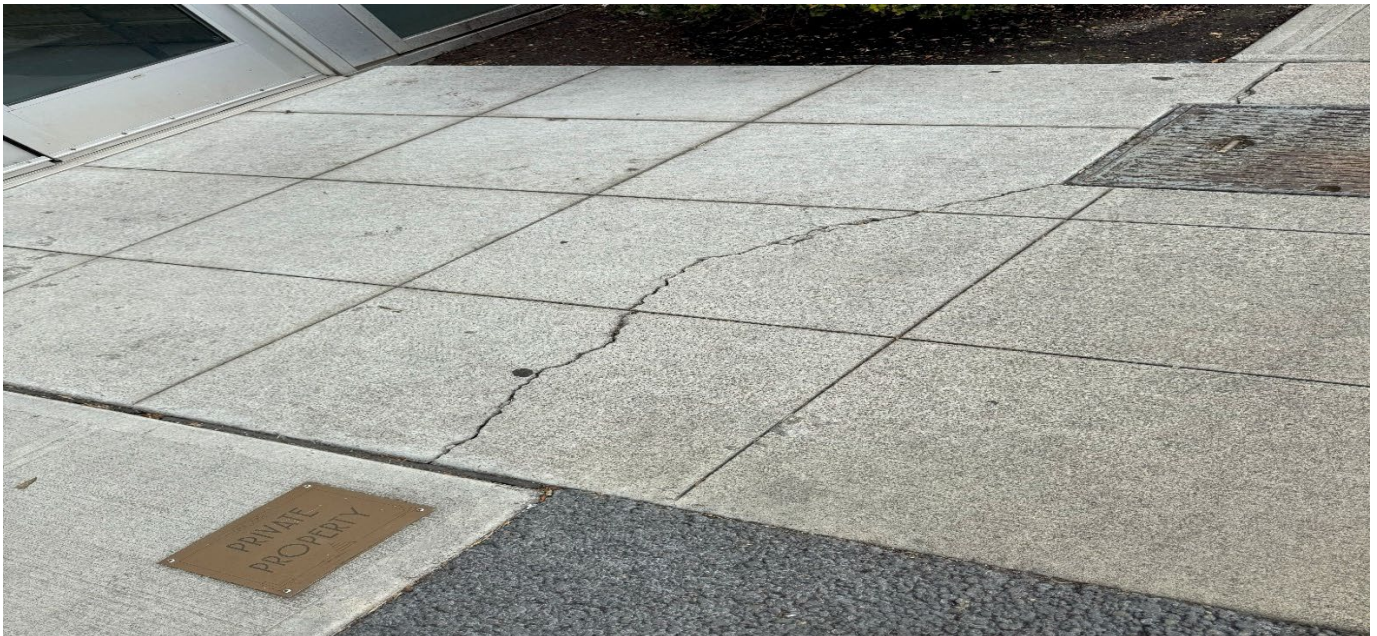
Photograph 4. Previously identified cracking on the southern exterior walkway of the building, immediately adjacent to the southeast corner of the building and at the edge of the property. Repairs are recommended at this time.

Previously identified cracking was also observed in the southern exterior walkway of the building, immediately adjacent to its southeast corner, as well as in the landscaped area east of the building. Identified cracking does not appear to have been addressed; the observed cracking should be repaired by sealing with a compatible epoxy/caulking compound and monitored. No significant cracks, buckling, or other damage were observed on the on-steel sheet pile wall. Photographs of the cap taken on July 22, 2025, are included as Attachment A.

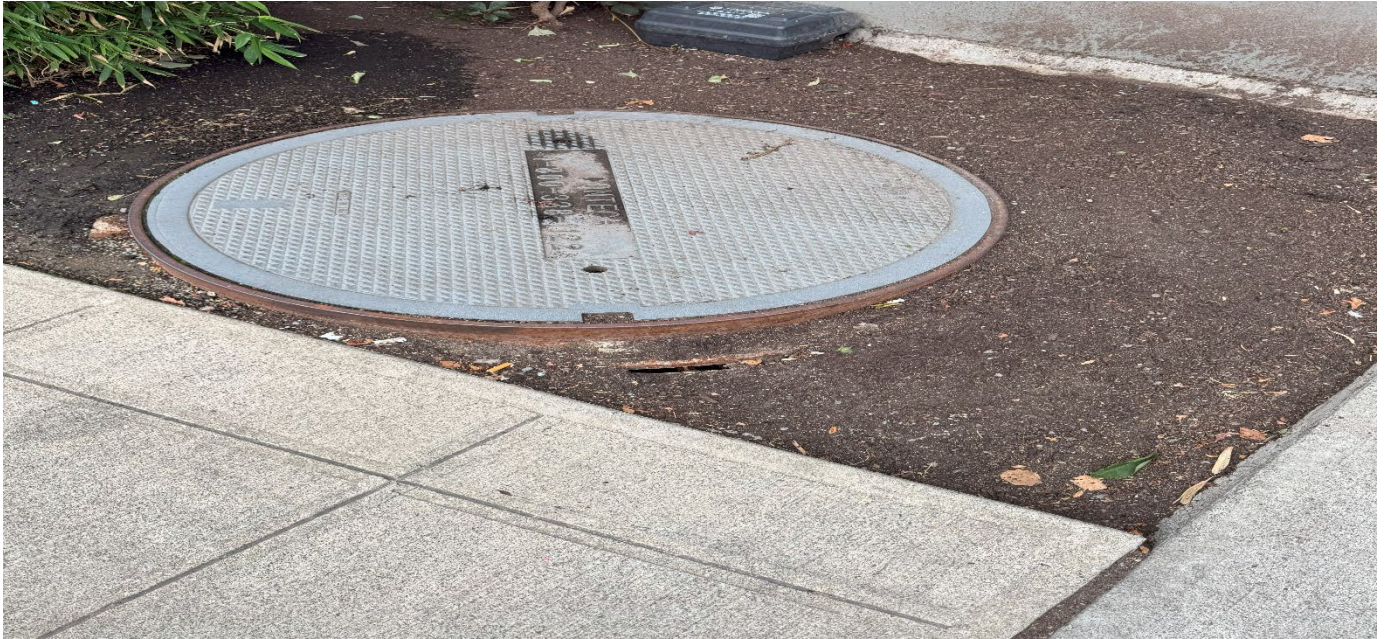
Photograph 5. Previously identified cracking in the landscaped area east of the building. Repairs are recommended at this time.

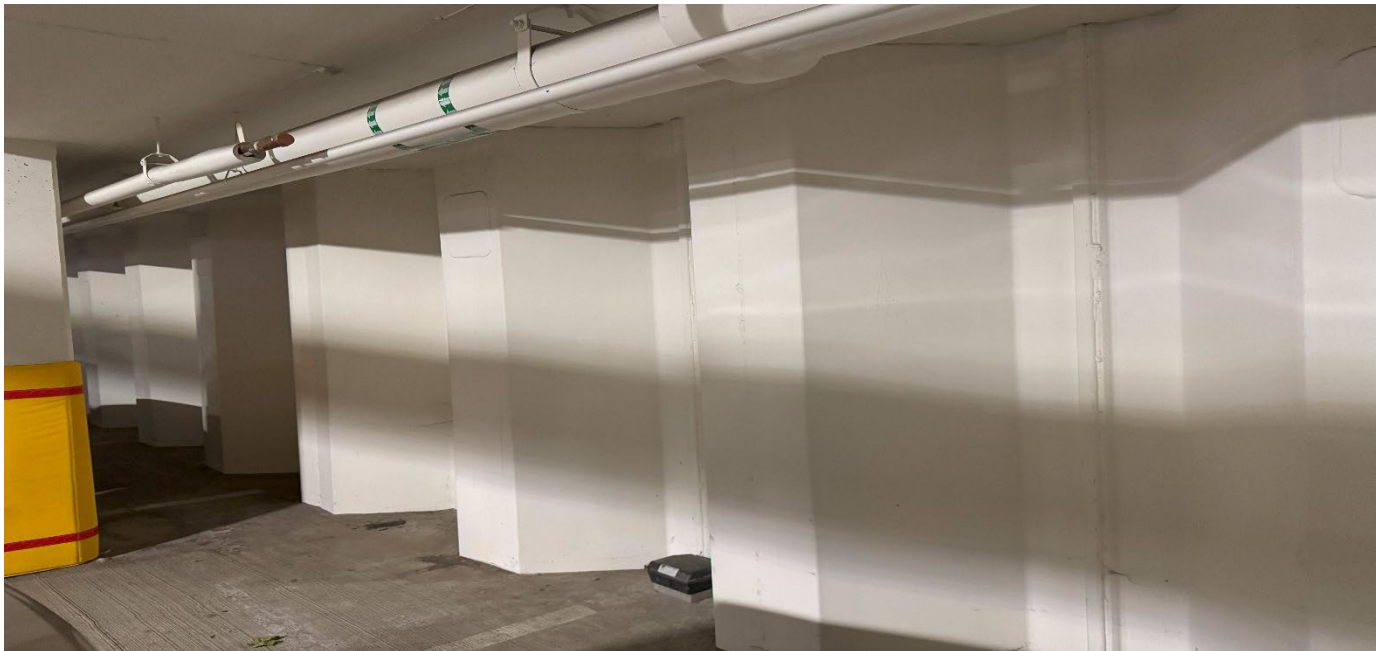
Photograph 6. No significant cracking, buckling, or other damage observed on the steel sheet pile wall during inspection.
