## **Third Periodic Review Northpoint Apartments**

**1001 East Marine View Drive, Everett, Snohomish County  
Facility Site ID: 43112633, Cleanup Site ID: 432**

August 2025

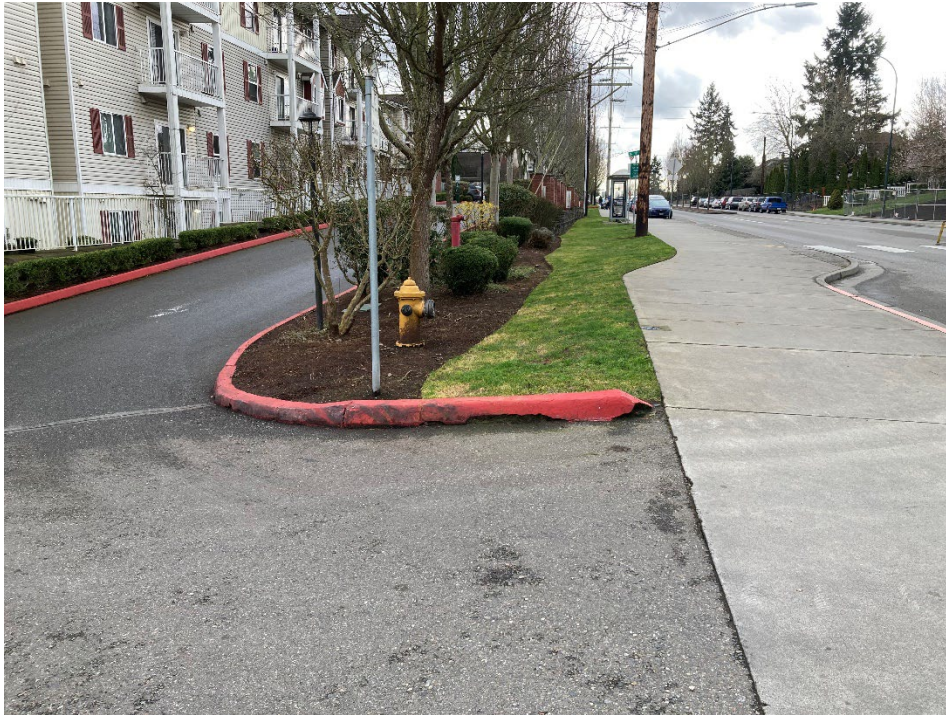
**Photo 1:** Landscaped area from north entrance of the Property

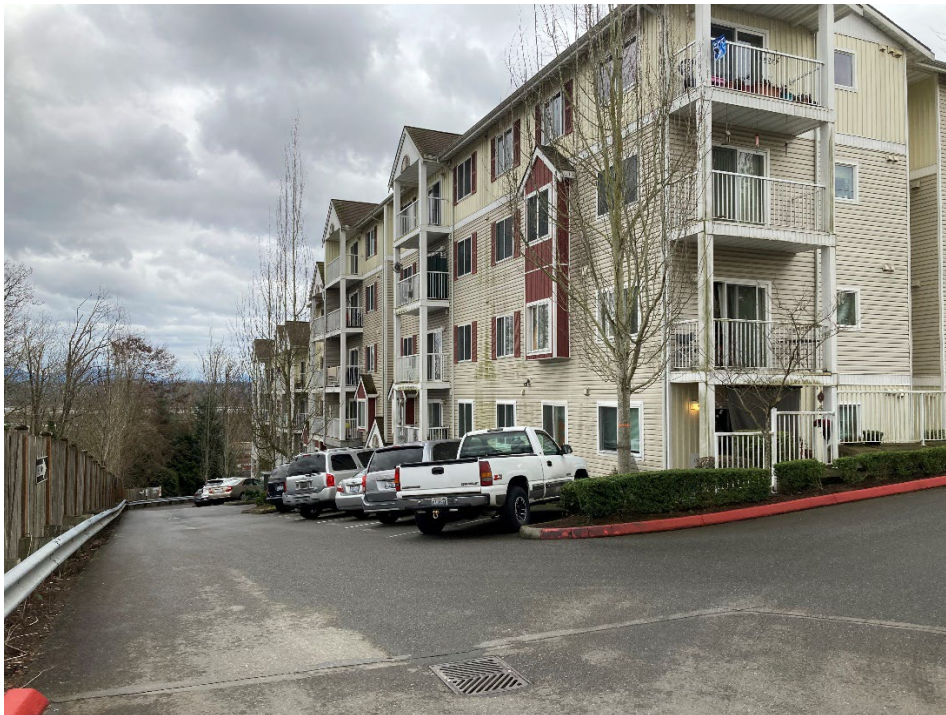
**Photo 2:** Driveway along north end of Property from north entrance

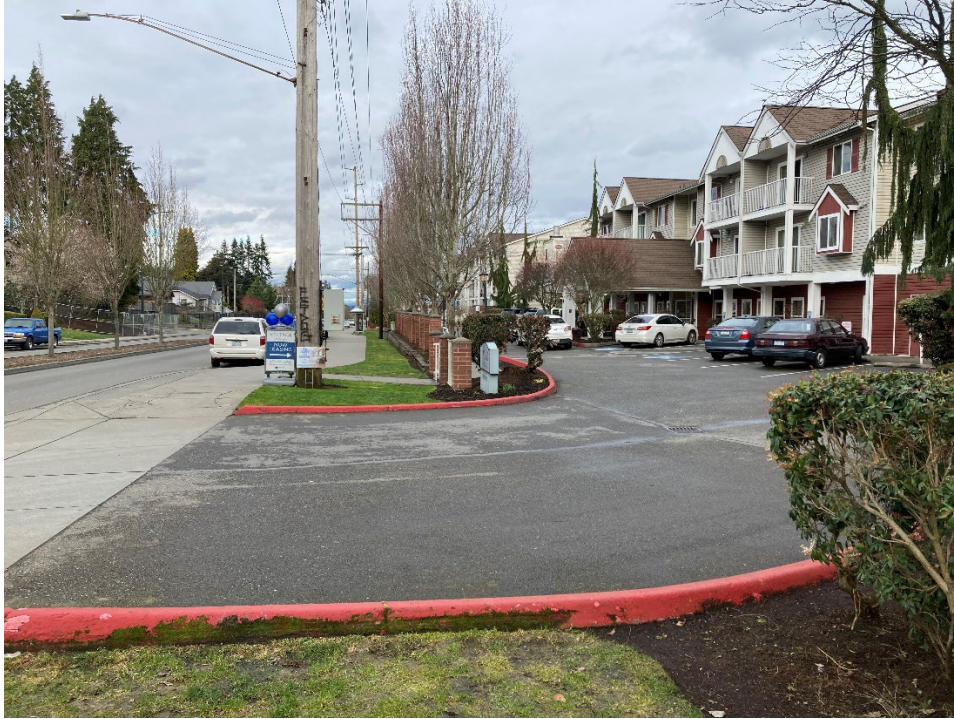
**Photo 3:** Landscaped area and south entrance from E Marine View Dr

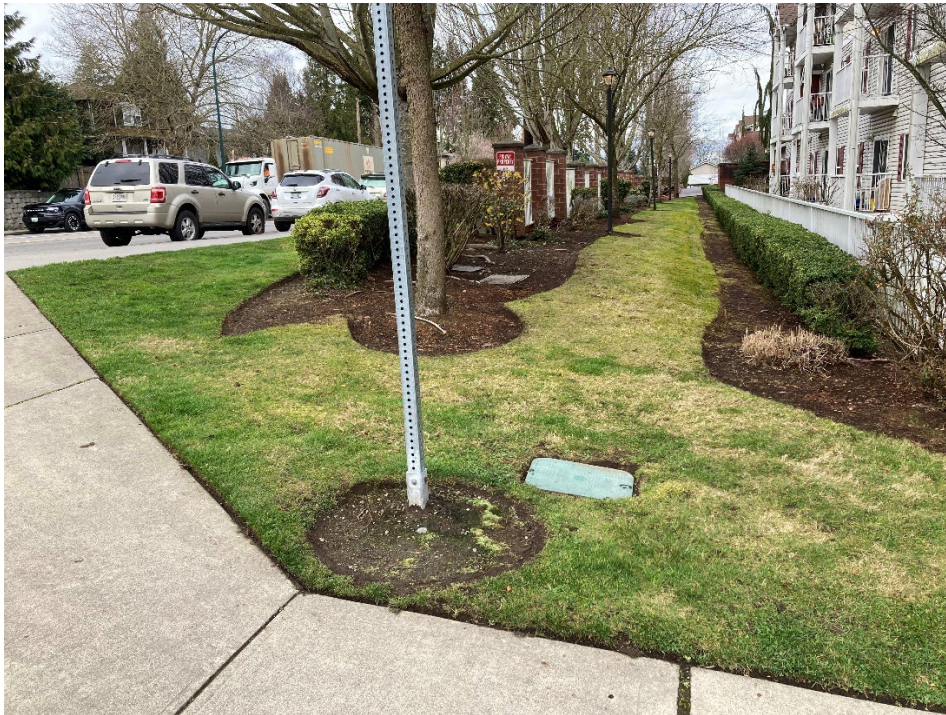
**Photo 4:** Landscaped area from the southwest corner of Property

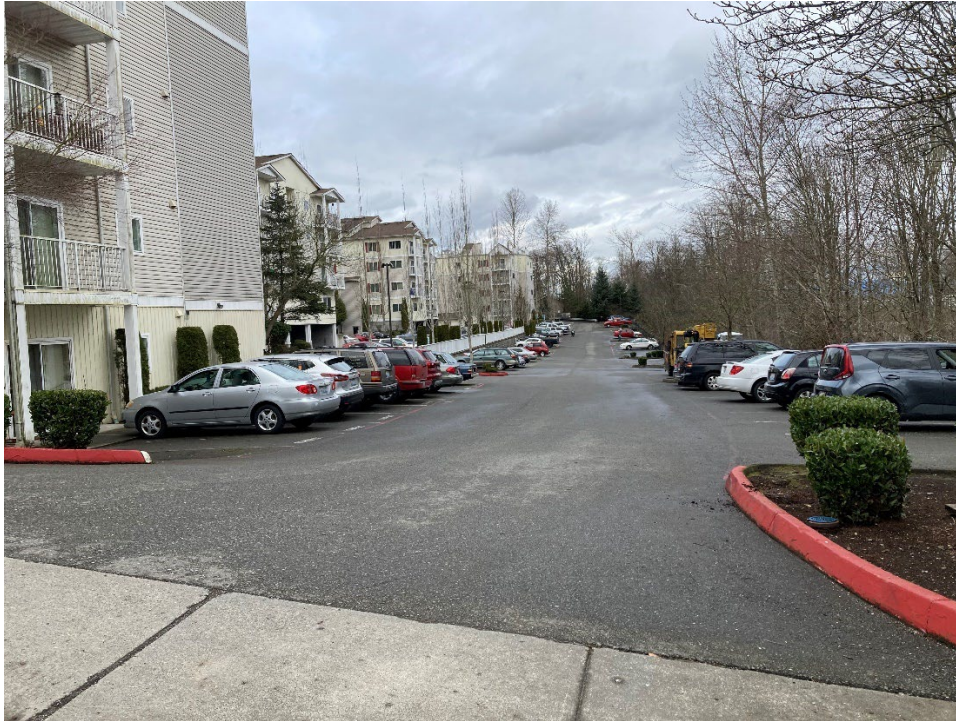
**Photo 5:** Driveway along the eastern portion of the Property from the southeast entrance on 11<sup>th</sup> Street
