Subject: Cap Integrity Monitoring  
BNSF Railway Company, Hillyard Dross Cap  
Spokane, Washington  
KJ 2596114\*00

## Hillyard Dross Cap Inspection

### PROJECT IMAGE DOCUMENTATION

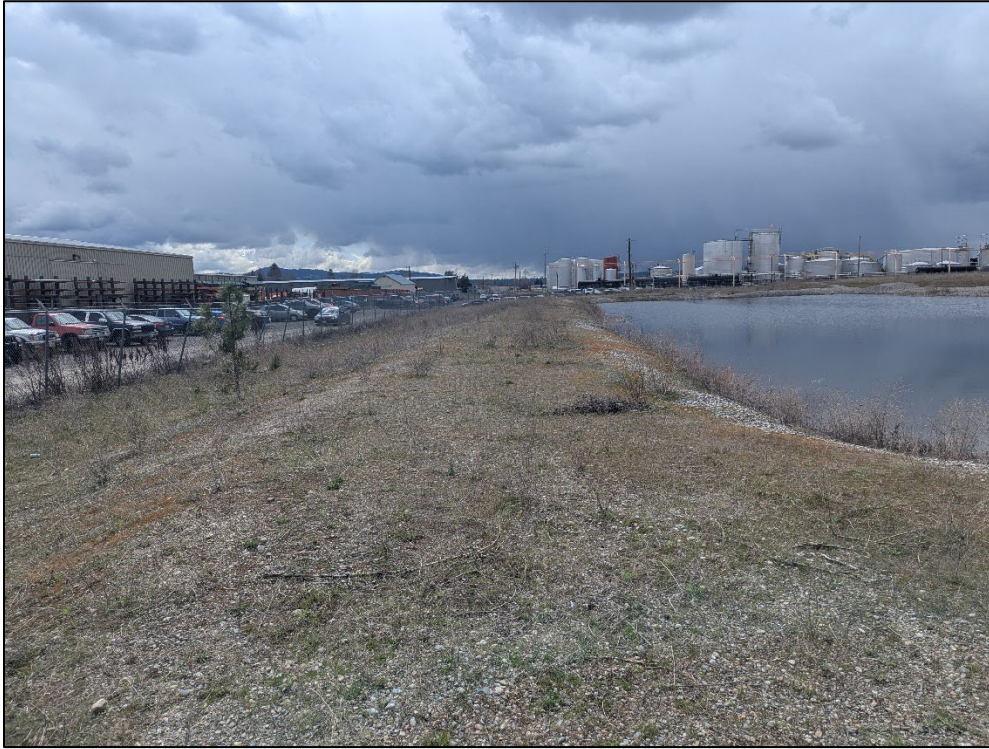
East edge of Cap pond where trees were previously removed

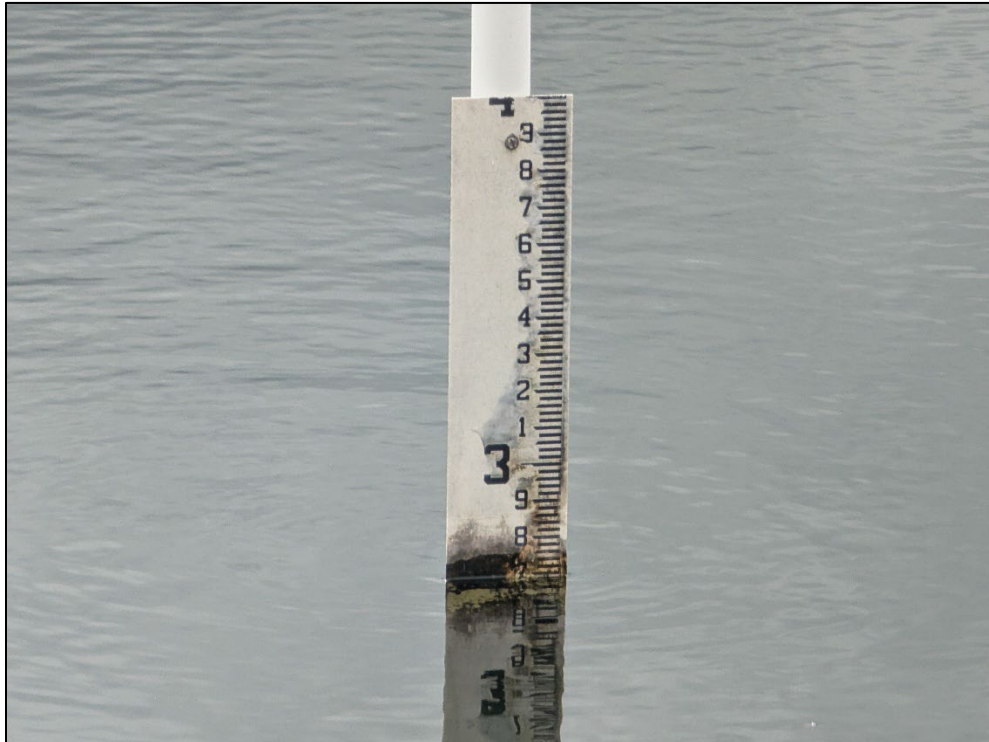
The evaporation pond that collects Site stormwater is located directly northeast of the dross encapsulation cell. Water level elevations measured in the pond are referenced to the North American Vertical Datum of 1988. Post-construction evaporation pond water level elevations are presented in Attachment A. The evaporation pond was not observed to be discharging to the overflow sump and drywell on 3 April 2025.

Pond water level

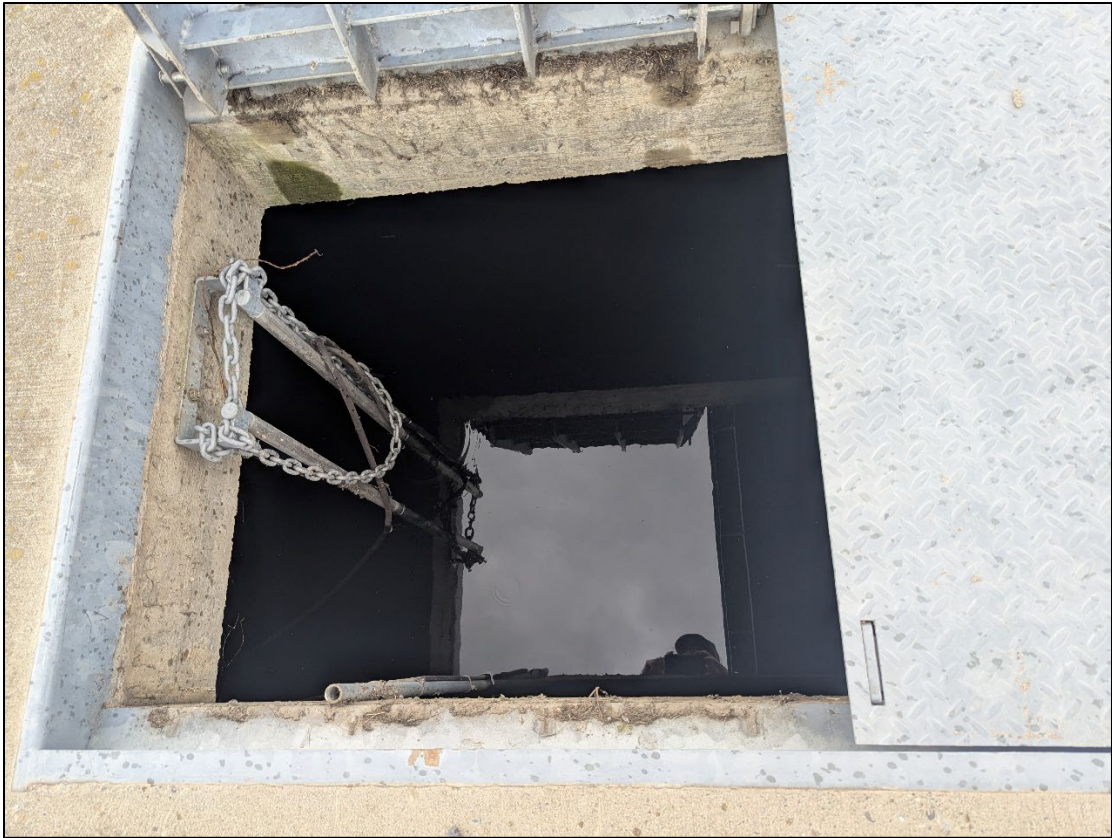
During inspection of the stormwater conveyance, evaporation, and disposal system components, the water level in the West Sump was observed to be higher than normal, indicating the need to inspect the pump. Results of the inspection identified the need to replace the pump, slide rail and receiving plate. The replacement work was completed on 29 August 2025.

Water filling in West Pump Vault indicating need for repairs

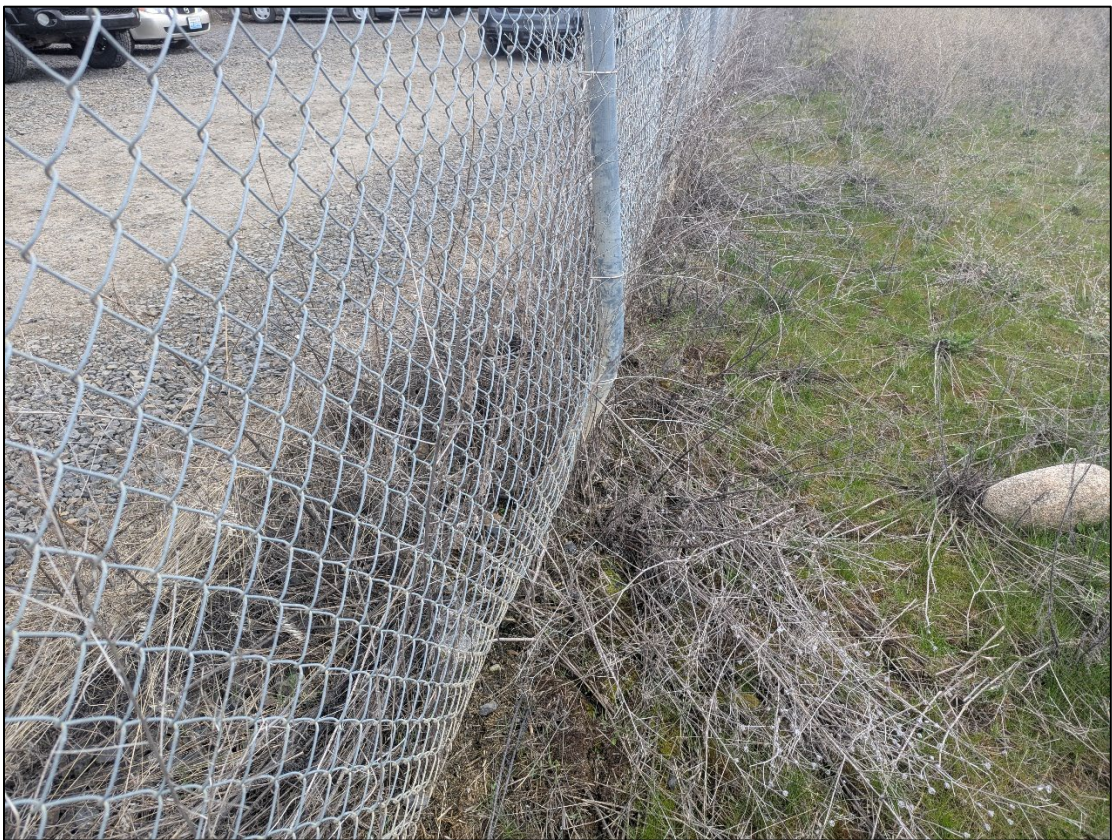
- Fence posts in the northeastern corner of the fence surrounding the dross cap were leaning, but the fence panels were stable and not in need of repair.

Bent fence post on eastern border of Cap

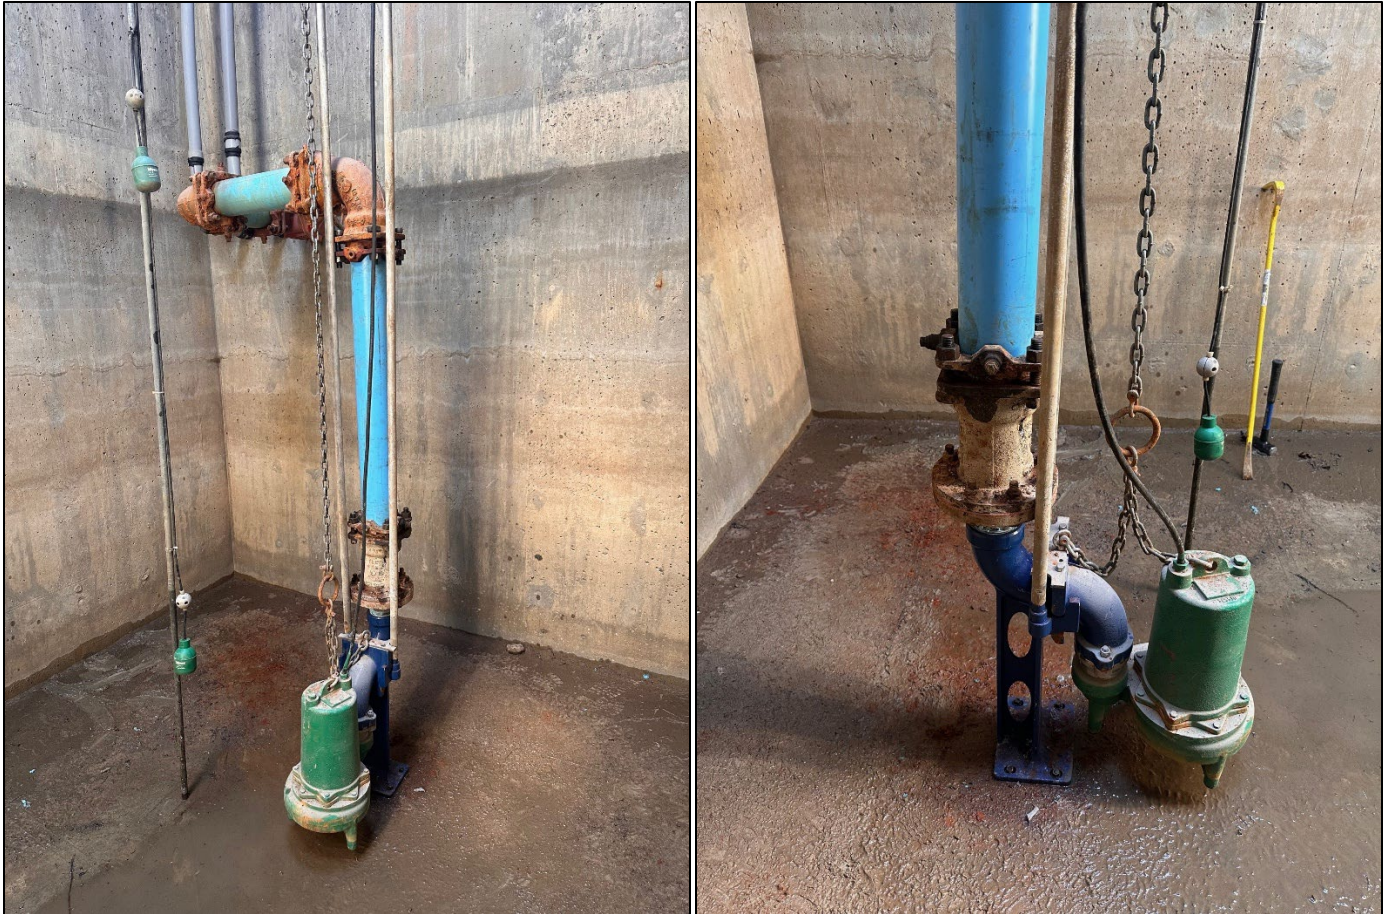
New West Vault Sump Pump Installation
