# Environmental Cap and Drainage System Inspection Report

Former Louisiana Pacific/Pony Lumber Facility  
(Ecology Facility ID #1209)

December 4, 2024

Project No. M0615.24.002

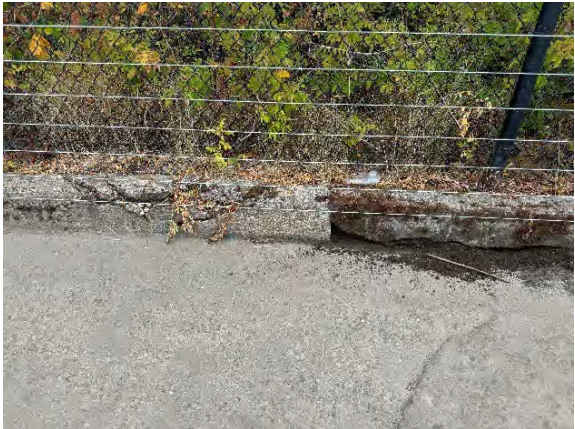
| ID <sup>1</sup> | Type of Structure | Observation | Recommended Actions | Photograph |
|---|---|---|---|---|
| C2 | Curb | Curb damage extending approximately 4 lf; damage to top 2 inches of curb; damage to bottom 2 inches of curb; approximately 2 inches deep in places | Repair curb | |

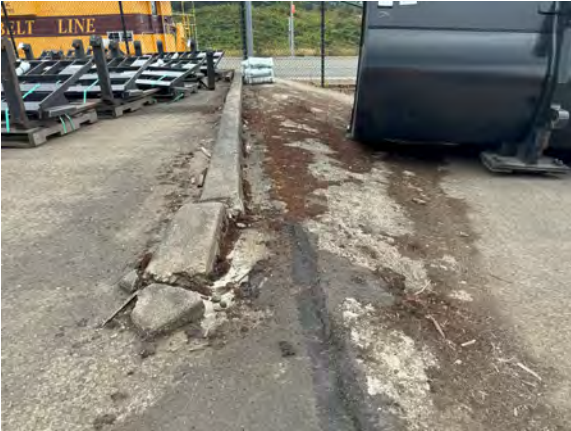
| ID <sup>1</sup> | Type of Structure | Observation | Recommended Actions | Photograph |
|---|---|---|---|---|
| C4 | Curb | Piece of curb approximately 2 lf broken from end of curb; does not appear to be impacting drainage | Remove loose debris; monitor and reevaluate during next inspection cycle | |

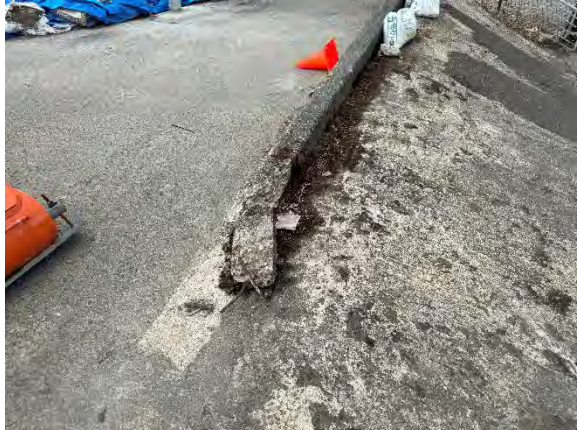
| ID <sup>1</sup> | Type of Structure | Observation | Recommended Actions | Photograph |
|---|---|---|---|---|
| C5 | Curb | Curb damage approximately 3 lf at end of curb; rebar exposed and chunks of curb missing; does not appear to be impacting drainage | Remove loose debris; monitor and reevaluate next inspection cycle | |

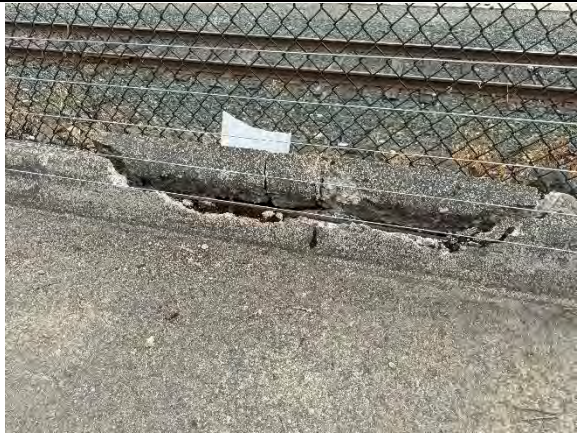
| ID <sup>1</sup> | Type of Structure | Observation | Recommended Actions | Photograph |
|---|---|---|---|---|
| C6 | Curb | Curb damage approximately 4 to 5 lf; exposed rebar and cracks; does not appear to be impacting drainage | Monitor and reevaluate during next inspection | |

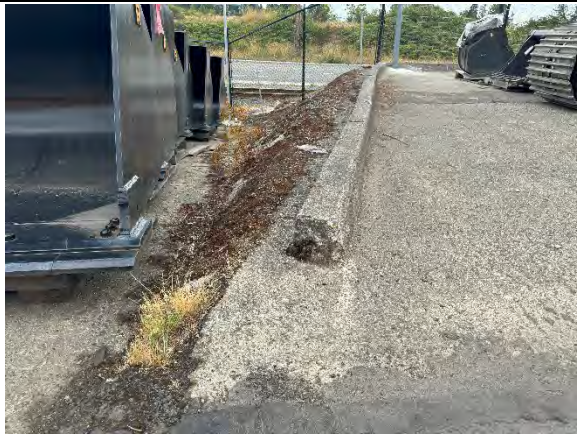
| ID <sup>1</sup> | Type of Structure | Observation | Recommended Actions | Photograph |
|---|---|---|---|---|
| C7 | Curb | Piece of curb approximately 2 lf broken off from end of curb; does not appear to be impacting drainage | None | |

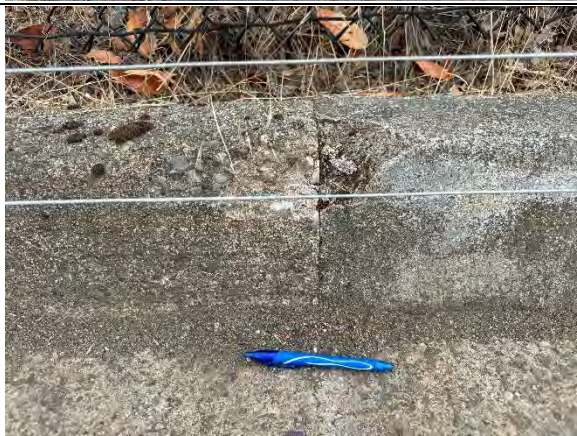
| ID <sup>1</sup> | Type of Structure | Observation | Recommended Actions | Photograph |
|---|---|---|---|---|
| C8 | Curb | Piece of curb with chunk of concrete missing from top 2 inches of curb; does not appear to be impacting drainage | Monitor and reevaluate during next inspection cycle | |

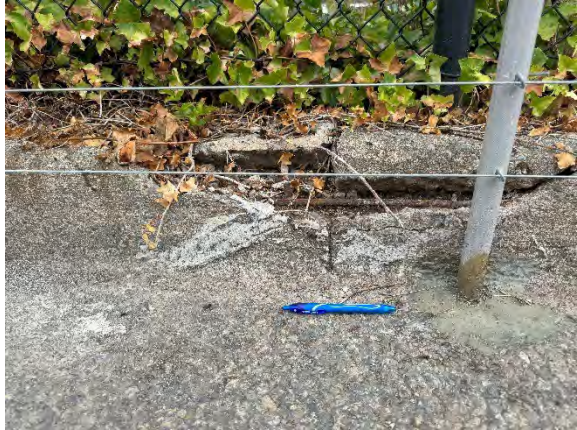
| ID <sup>1</sup> | Type of Structure | Observation | Recommended Actions | Photograph |
|---|---|---|---|---|
| C9 | Curb | Curb damage approximately 3 lf; damage limited to top 2 to 3 inches; chunks of concrete breaking; exposed rebar; does not appear to be impacting drainage | Monitor and reevaluate during next inspection cycle | |

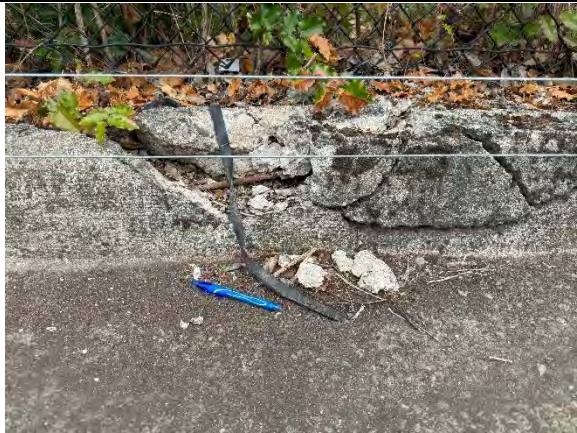
| ID <sup>1</sup> | Type of Structure | Observation | Recommended Actions | Photograph |
|---|---|---|---|---|
| C10 | Curb | Curb damage approximately 2 lf; damage limited to top 4 to 5 inches; chunks of concrete breaking off and cracked; does not appear to be impacting drainage | Monitor and reevaluate during next inspection cycle | |

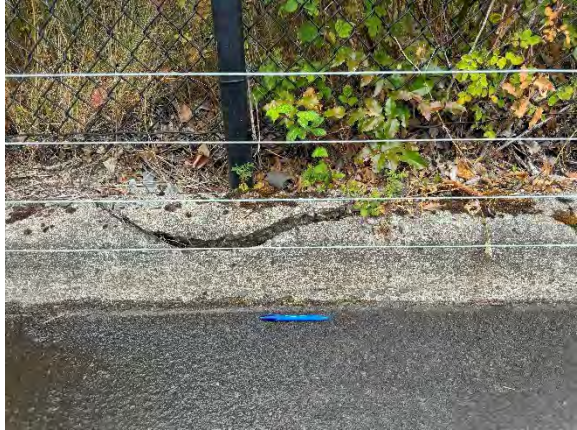
| ID <sup>1</sup> | Type of Structure | Observation | Recommended Actions | Photograph |
|---|---|---|---|---|
| C11 | Curb | Curb damage approximately 2 lf; damage limited to top 2 to 3 inches; does not appear to be impacting drainage | Monitor and reevaluate during next inspection cycle | |

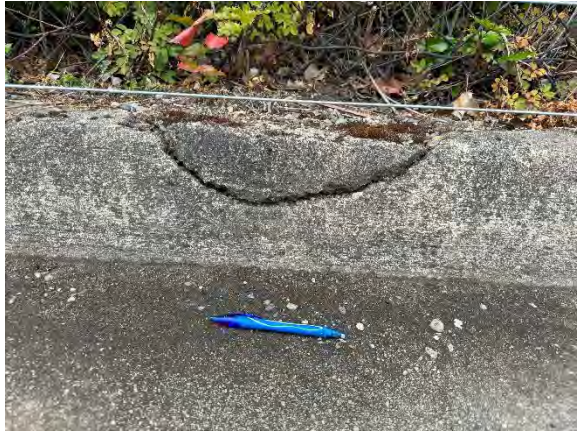
| ID <sup>1</sup> | Type of Structure | Observation | Recommended Actions | Photograph |
|---|---|---|---|---|
| C12 | Curb | Curb damage approximately 1 lf; damage limited to top 2 to 3 inches; does not appear to be impacting drainage | Monitor and reevaluate during next inspection cycle | |

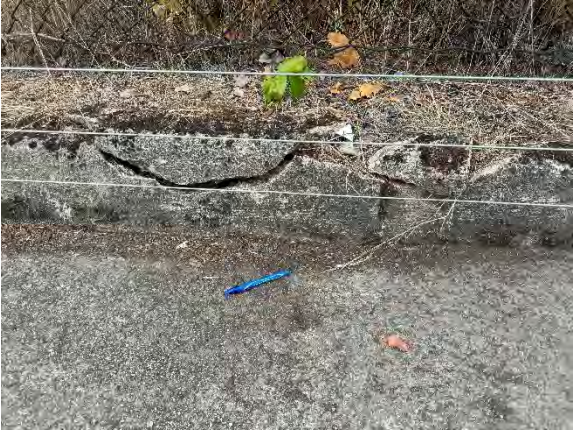
| ID <sup>1</sup> | Type of Structure | Observation | Recommended Actions | Photograph |
|---|---|---|---|---|
| C13 | Curb | Curb damage approximately 3lf; damage limited to top 2 to 3 inches; chunks of concrete breaking off; does not appear to be impacting drainage | Monitor and reevaluate during next inspection cycle | |

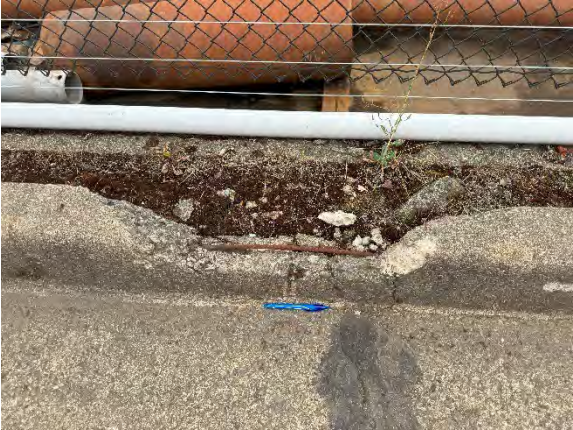
| ID <sup>1</sup> | Type of Structure | Observation | Recommended Actions | Photograph |
|---|---|---|---|---|
| C15 | Curb | Curb damage approximately 3 lf; damage limited to top 2 to 3 inches; exposed rebar; does not appear to be impacting drainage | Monitor and reevaluate during next inspection cycle | A photograph showing a concrete curb with a significant vertical crack and exposed rebar. A blue object is placed on the ground next to the crack for scale. In the background, there is a chain-link fence and some orange pipes. |

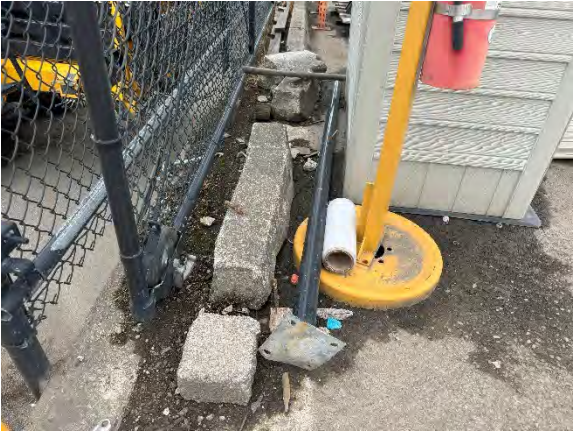
| ID <sup>1</sup> | Type of Structure | Observation | Recommended Actions | Photograph |
|---|---|---|---|---|
| C16 | Curb | Curb damage approximately 5 lf; multiple breaks through vertical profile | Repair curb | A photograph showing a concrete curb with multiple breaks and missing sections. A yellow wheelbarrow is parked next to the damaged curb. In the background, there is a chain-link fence and some equipment. |

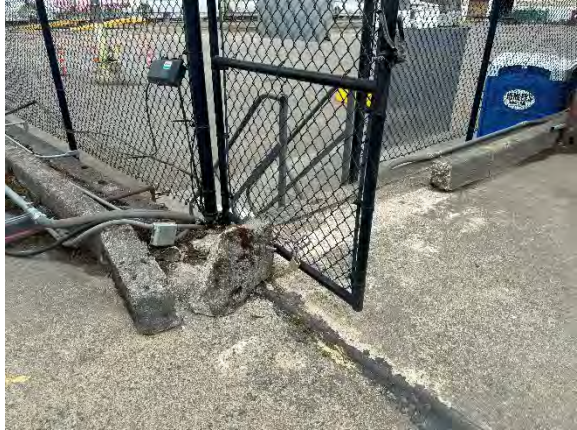
| ID <sup>1</sup> | Type of Structure | Observation | Recommended Actions | Photograph |
|---|---|---|---|---|
| C17 | Curb | Approximately 5 lf section of curb removed for installation of stairs and gate; damage through vertical profile adjacent to missing section | Extend curb or add a structural control to prevent stormwater runoff from sheet flowing off-site | |

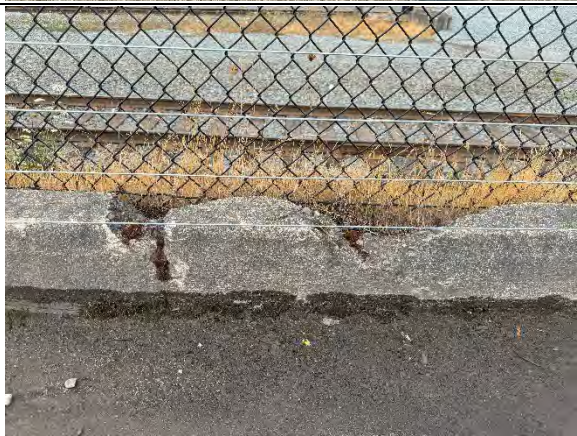
| ID <sup>1</sup> | Type of Structure | Observation | Recommended Actions | Photograph |
|---|---|---|---|---|
| C18 | Curb | Curb damage approximately 2 lf; damage limited to top 2 to 3 inches; does not appear to be impacting drainage | Monitor and reevaluate during next inspection cycle | |

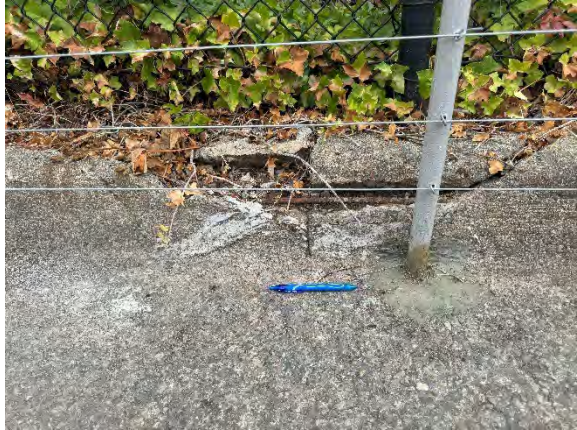
| ID <sup>1</sup> | Type of Structure | Observation | Recommended Actions | Photograph |
|---|---|---|---|---|
| C19 | Curb | Curb damage approximately 3 lf; chunks of concrete breaking; exposed rebar; damage through full extent of vertical profile | Repair curb | |

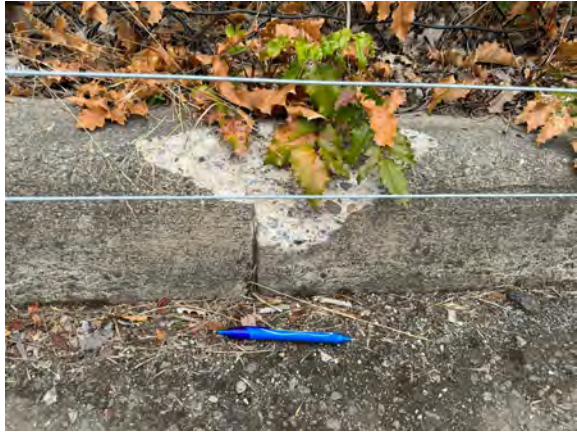
| ID <sup>1</sup> | Type of Structure | Observation | Recommended Actions | Photograph |
|---|---|---|---|---|
| C20 | Curb | Curb damage approximately 1 lf; damage limited to top 2 to 3 inches; does not appear to be impacting drainage | Monitor and reevaluate during next inspection cycle | |

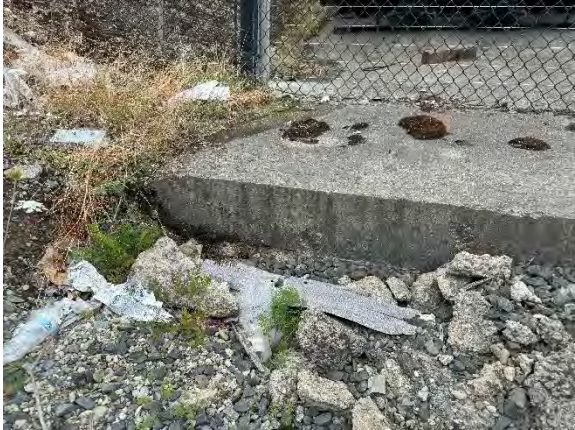
Two areas of erosion were observed near the cap edge (Table 2-1). The first erosion area, located along the fence line near MH12, shows boards and sandbags covering up subgrade undercut concrete. There does not appear to be cracking or damage to the cap at this time, but if erosion continues to undercut the cap, the cap may fail due to stress. The second area of erosion, located outside of the fence near catch basin CB1, included some gravel and concrete chunks observed outside of the fence near catch basin CB1.

| ID <sup>1</sup> | Type of Structure | Observation | Recommended Actions | Photograph |
|---|---|---|---|---|
| E2 | Edge | Potential erosion near cap boundary; concrete chunks and gravel debris observed near cap edge | Monitor and reevaluate during next inspection cycle | |

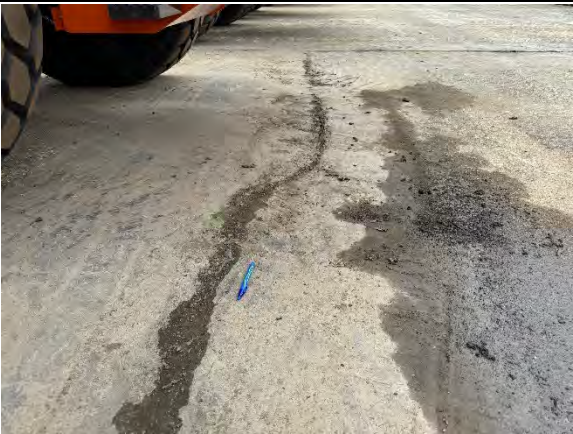
| ID <sup>1</sup> | Type of Structure | Observation | Recommended Actions | Photograph |
|---|---|---|---|---|
| P1 | Pavement | Cracks wider than 1/8 inch;<br>approximately 12 lf; sealant missing<br>in some places | Reseal crack | |

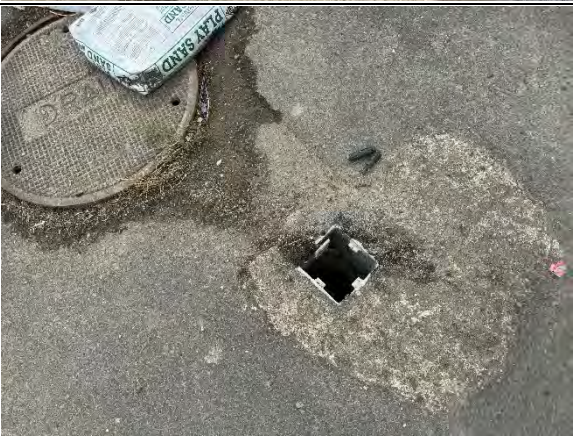
| ID <sup>1</sup> | Type of Structure | Observation | Recommended Actions | Photograph |
|---|---|---|---|---|
| P2 | Pavement | Void from former footing; appears to<br>no longer be in use | Seal void | |

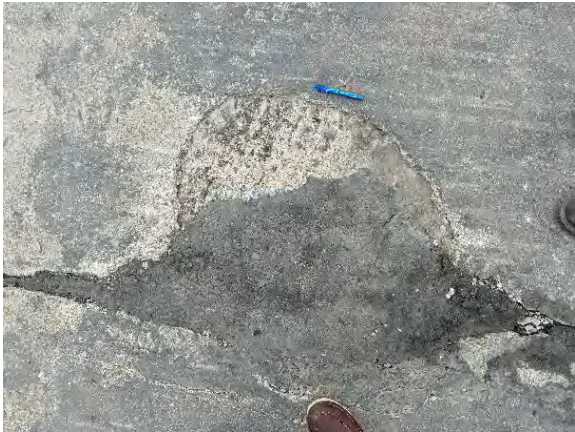
| ID <sup>1</sup> | Type of Structure | Observation | Recommended Actions | Photograph |
|---|---|---|---|---|
| P4 | Pavement | Asphalt patch with signs of degradation; crack as deep as 1 inch | Reseal crack | |

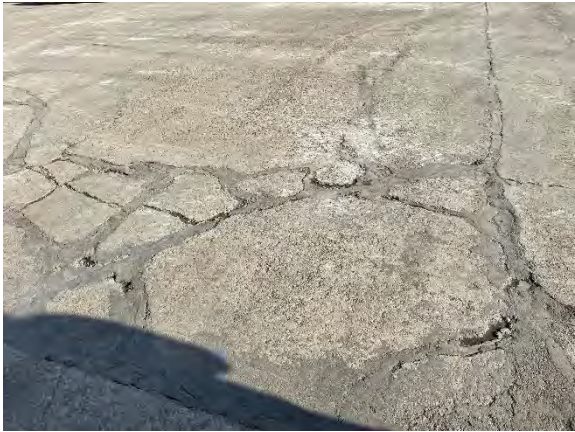
| ID <sup>1</sup> | Type of Structure | Observation | Recommended Actions | Photograph |
|---|---|---|---|---|
| P5 | Pavement | Sealing wear in crack network; approximately 100 square feet across; sealant missing in portions of cracks | Reseal cracks | |

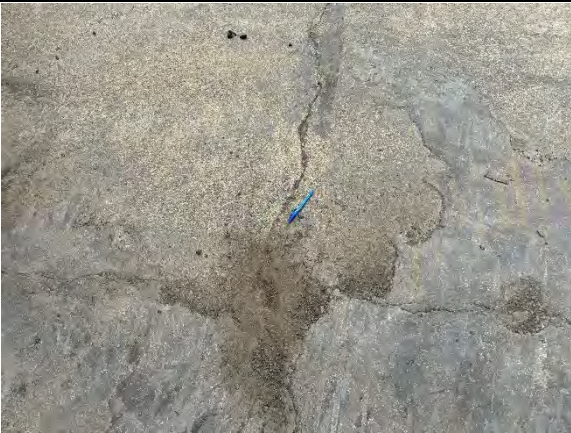
| ID <sup>1</sup> | Type of Structure | Observation | Recommended Actions | Photograph |
|---|---|---|---|---|
| P9 | Pavement | Slurry seal wear; chipping and cracking | Monitor and reevaluate for repair during next inspection cycle | |

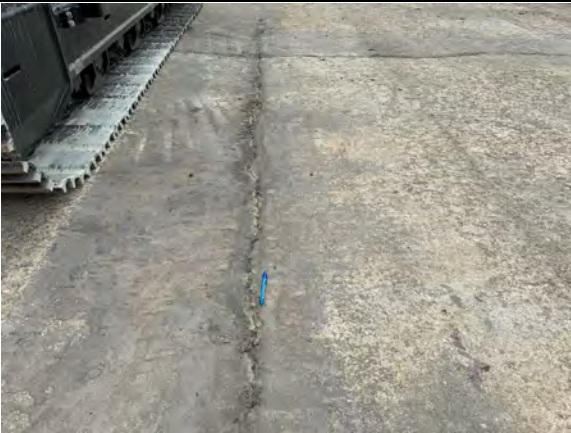
| ID <sup>1</sup> | Type of Structure | Observation | Recommended Actions | Photograph |
|---|---|---|---|---|
| P11 | | Partially sealed crack with deteriorated sealant in places; wider than 1/8 inch; approximately 20 lf | Seal crack | |

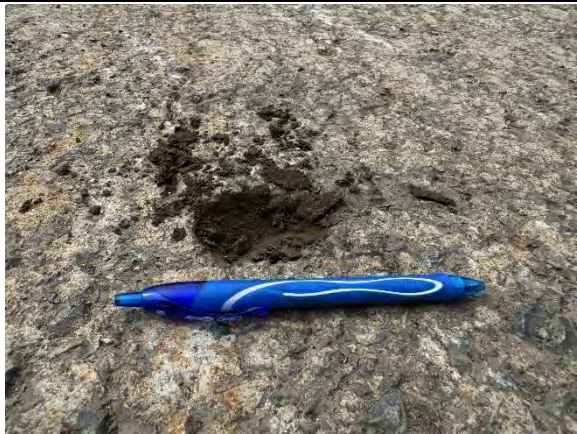
| ID <sup>1</sup> | Type of Structure | Observation | Recommended Actions | Photograph |
|---|---|---|---|---|
| P12 | Pavement | Pock mark in pavement;<br>approximately 1 inch deep | Monitor and reevaluate for repair during<br>next inspection cycle | |

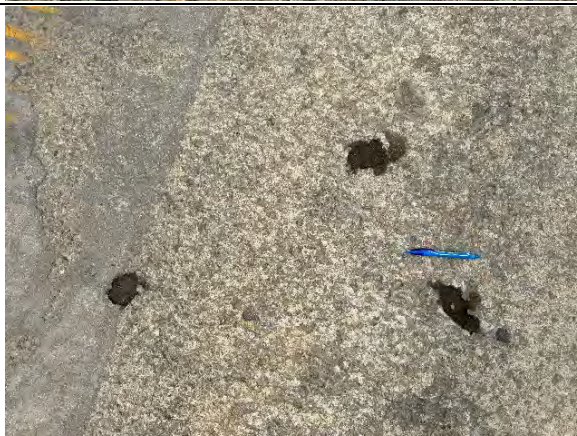
| ID <sup>1</sup> | Type of Structure | Observation | Recommended Actions | Photograph |
|---|---|---|---|---|
| P13 | Pavement | Pock marks in pavement;<br>approximately 1 inch deep | Monitor and reevaluate for repair during<br>next inspection cycle | |

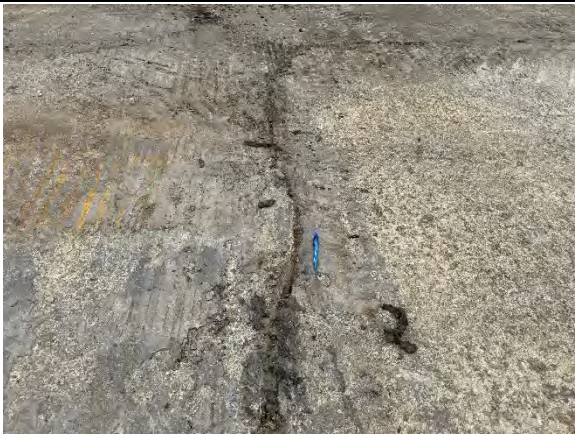
| ID <sup>1</sup> | Type of Structure | Observation | Recommended Actions | Photograph |
|---|---|---|---|---|
| P16 | Pavement | Previously sealed crack with sealant missing in places; wider than 1/8 inch; approximately 20 lf; | Reseal crack | |

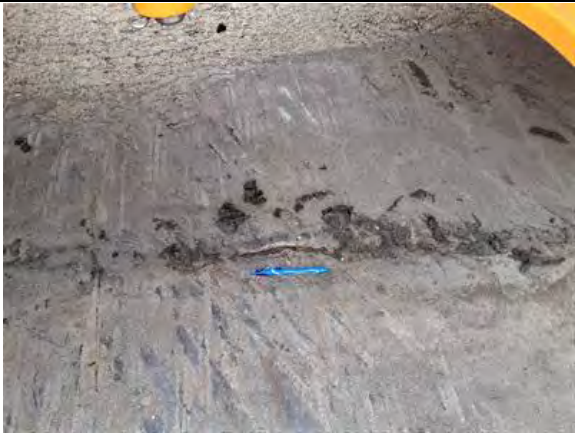
| ID <sup>1</sup> | Type of Structure | Observation | Recommended Actions | Photograph |
|---|---|---|---|---|
| P20 | Pavement | Previously sealed crack with sealant missing in areas | Reseal crack | |

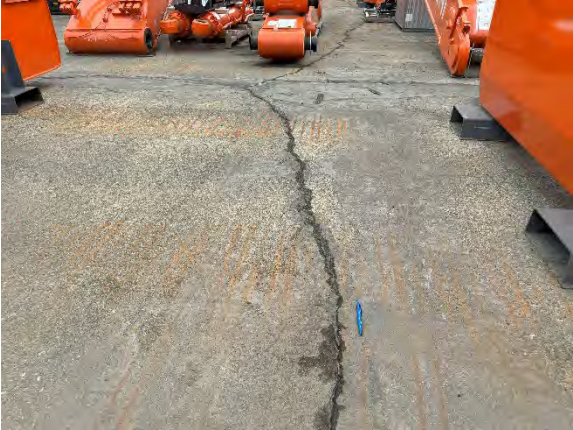
| ID <sup>1</sup> | Type of Structure | Observation | Recommended Actions | Photograph |
|---|---|---|---|---|
| P21 | Pavement | Previously sealed crack with sealant missing in places; approximately 50 lf | Reseal crack | |

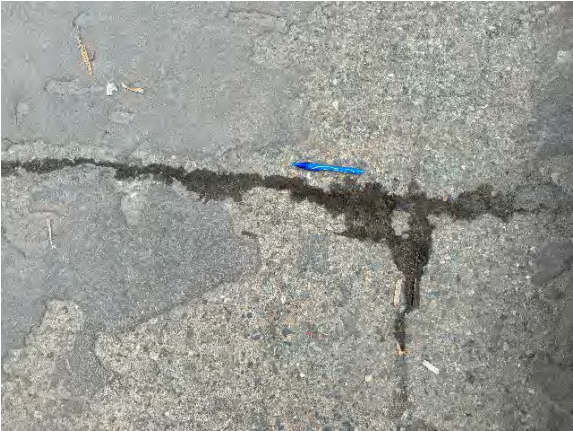
| ID <sup>1</sup> | Type of Structure | Observation | Recommended Actions | Photograph |
|---|---|---|---|---|
| P22 | Pavement | Previously sealed crack with sealant missing in places; approximately 8 lf | Reseal crack | |

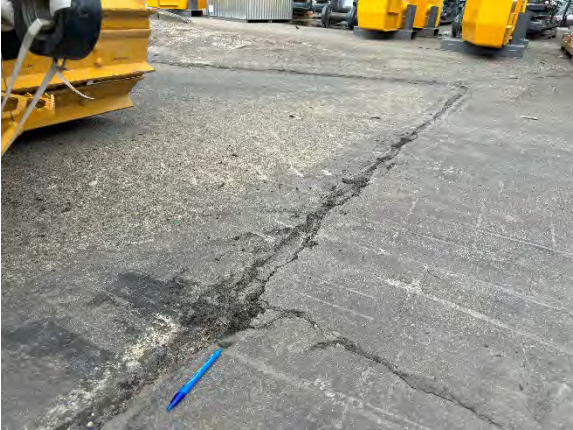
| ID <sup>1</sup> | Type of Structure | Observation | Recommended Actions | Photograph |
|---|---|---|---|---|
| P26 | Pavement | Degraded sealant near site entrance ramp; approximately 30-foot-by-20-foot area | Reseal cracks | |

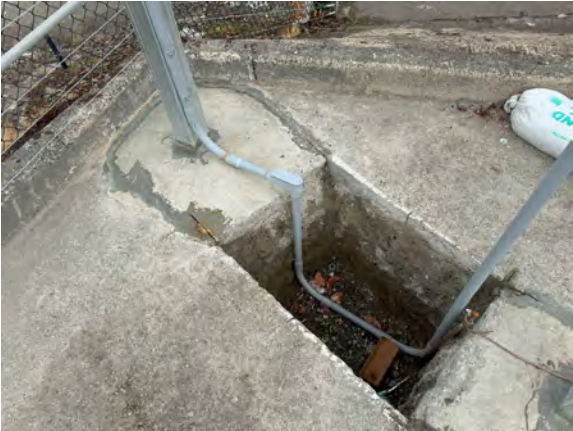
| ID <sup>1</sup> | Type of Structure | Observation | Recommended Actions | Photograph |
|---|---|---|---|---|
| P27 | Pavement | Concrete cut for electric fence construction; approximately 4-foot-by-3-foot-by-3-foot | Repair concrete | |

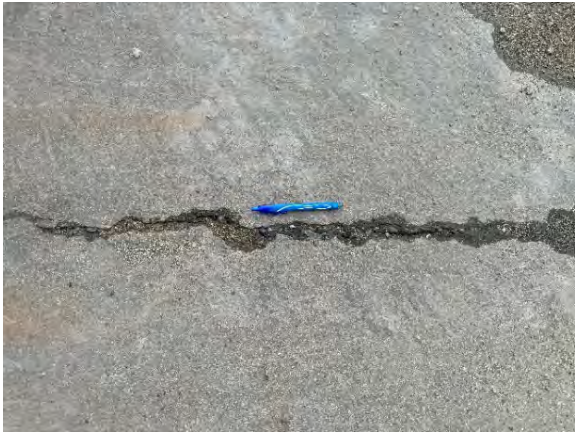
| ID <sup>1</sup> | Type of Structure | Observation | Recommended Actions | Photograph |
|---|---|---|---|---|
| P28 | Pavement | Previously sealed crack with sealant missing in places; wider than 0.5 inch; approximately 5 lf | Seal crack | |

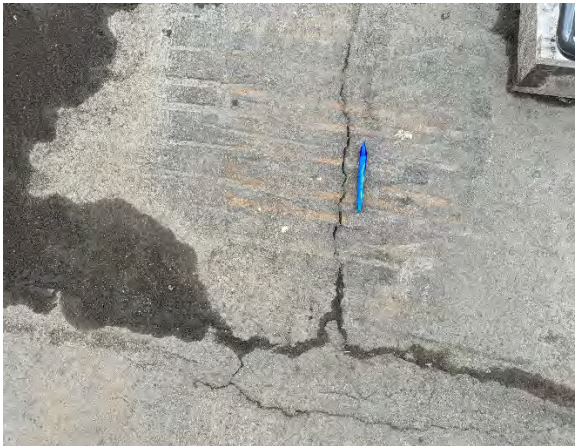
| ID <sup>1</sup> | Type of Structure | Observation | Recommended Actions | Photograph |
|---|---|---|---|---|
| P29 | Pavement | Previously sealed crack with sealant missing in places; approximately 2 lf | Reseal cracks | |

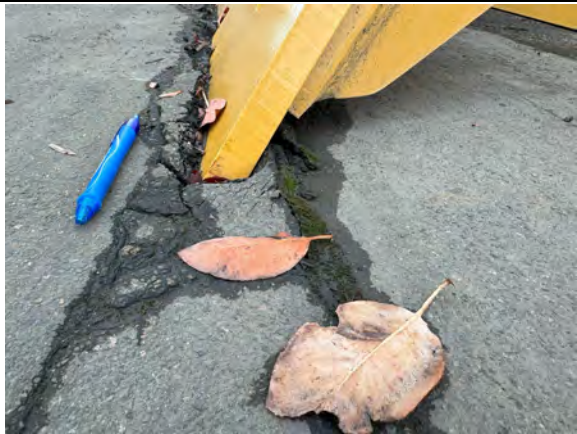
| ID <sup>1</sup> | Type of Structure | Observation | Recommended Actions | Photograph |
|---|---|---|---|---|
| P30 | Pavement | Depression and cracks in cap from equipment blade; approximately 0.5 inch deep and 8 lf | Repair depression and seal cracks | |

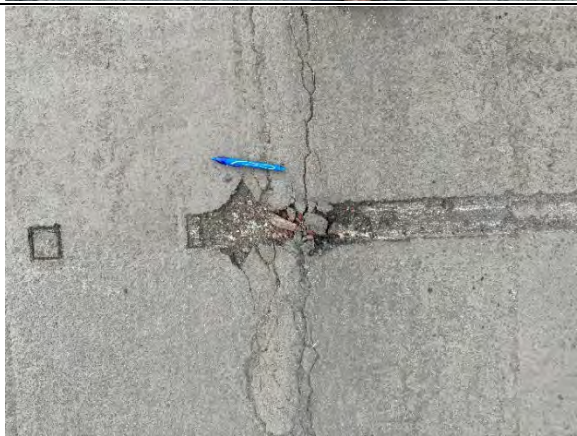
| ID <sup>1</sup> | Type of Structure | Observation | Recommended Actions | Photograph |
|---|---|---|---|---|
| P31 | Pavement | Multiple gouges in concrete from equipment racks; approximately 0.25 inch deep | Monitor and reevaluate during next inspection cycle | |

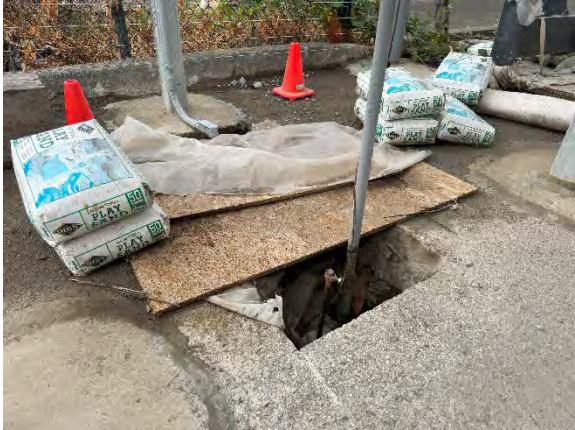
| ID <sup>1</sup> | Type of Structure | Observation | Recommended Actions | Photograph |
|---|---|---|---|---|
| P32 | Pavement | Concrete cut for electric fence construction; approximately 4-foot-by-2-foot-by-3-foot | Repair concrete | |

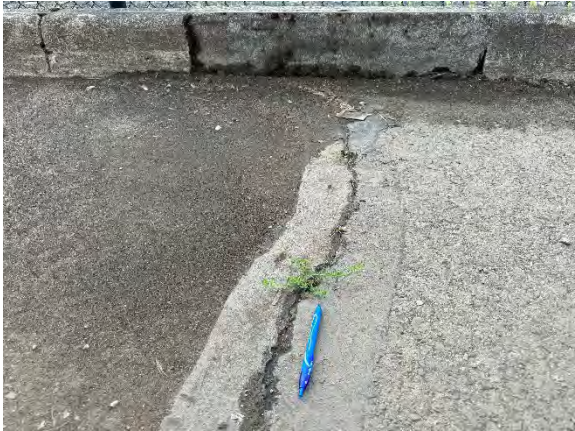
| ID <sup>1</sup> | Type of Structure | Observation | Recommended Actions | Photograph |
|---|---|---|---|---|
| P33 | Pavement | Vegetation growth in portions of crack wider than 1/8 inch wide; approximately 6 lf | Remove vegetation and reseal crack | |

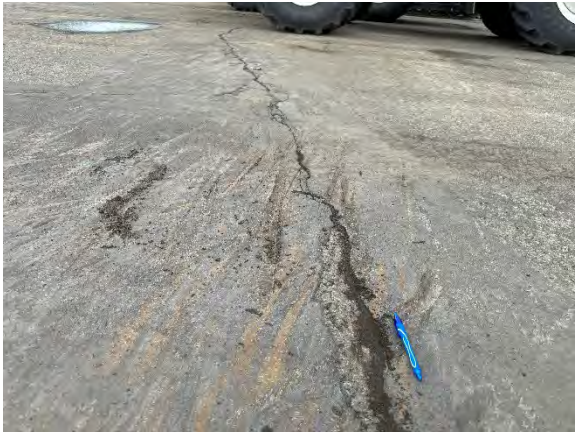
| ID <sup>1</sup> | Type of Structure | Observation | Recommended Actions | Photograph |
|---|---|---|---|---|
| P34 | Pavement | Surface gouges up to 0.25 inch deep; unsealed crack wider than 1/8 inch; approximately 30 lf | Seal cracks | |

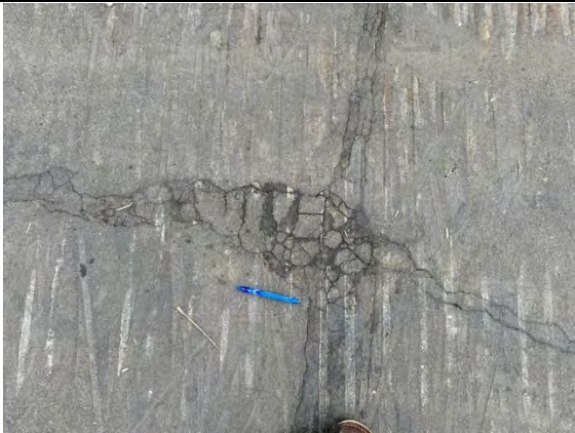
| ID <sup>1</sup> | Type of Structure | Observation | Recommended Actions | Photograph |
|---|---|---|---|---|
| P35 | Pavement | Alligator cracking; extending 7 lf at intersection of four linear cracks | Seal cracks | |

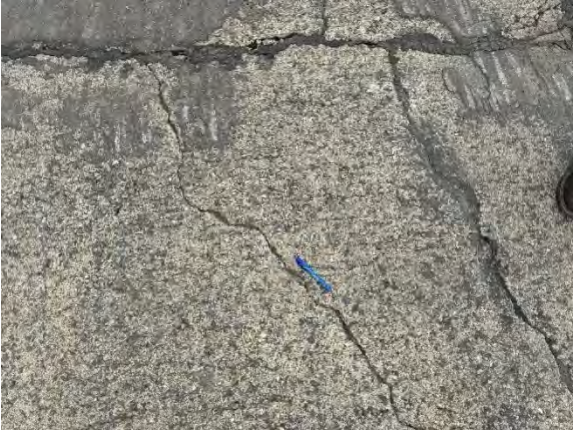
| ID <sup>1</sup> | Type of Structure | Observation | Recommended Actions | Photograph |
|---|---|---|---|---|
| P36 | Pavement | Previously sealed crack with sealant missing in places; wider than 1/8 inch; approximately 4 lf | Seal crack | |

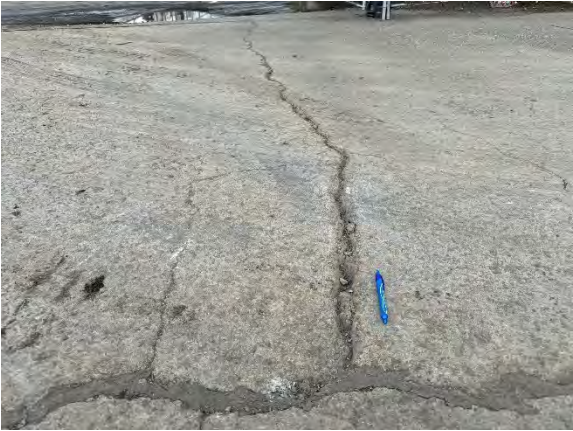
| ID <sup>1</sup> | Type of Structure | Observation | Recommended Actions | Photograph |
|---|---|---|---|---|
| P38 | Pavement | Multiple previously sealed cracks at site entrance; sealant missing in places; as wide as 1 inch and up to 0.5 inch deep | Reseal cracks | |

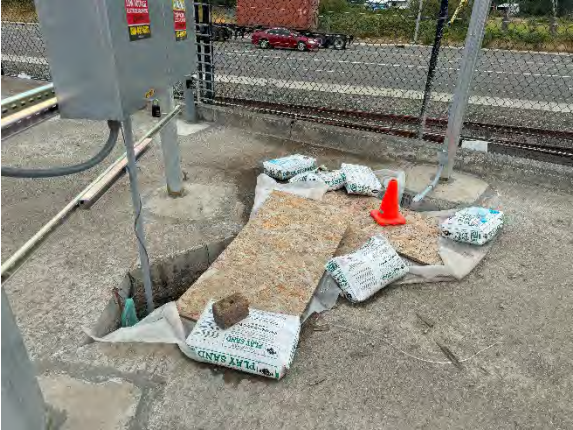
| ID <sup>1</sup> | Type of Structure | Observation | Recommended Actions | Photograph |
|---|---|---|---|---|
| P39 | Pavement | Concrete cut for electric fence construction; approximately 8-foot-by-2-foot-by-3-foot | Repair concrete | |

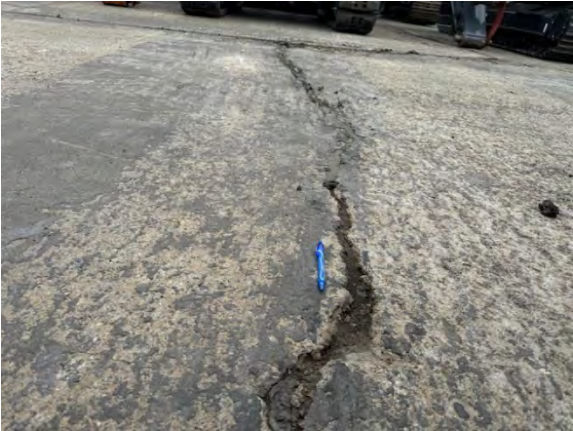
| ID <sup>1</sup> | Type of Structure | Observation | Recommended Actions | Photograph |
|---|---|---|---|---|
| P40 | Pavement | Previously sealed crack with sealant missing in places; up to 1 inch deep; approximately 15 lf | Reseal crack | |

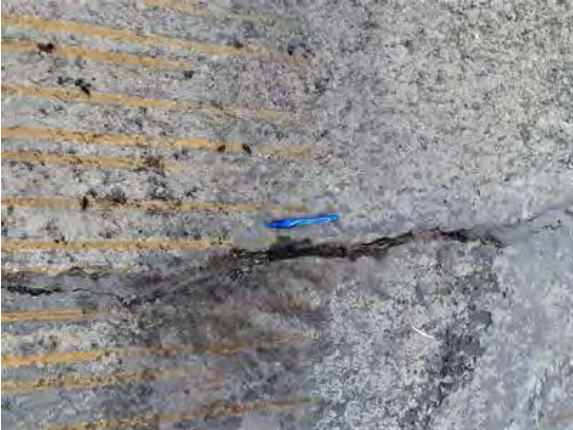
| ID <sup>1</sup> | Type of Structure | Observation | Recommended Actions | Photograph |
|---|---|---|---|---|
| P41 | Pavement | Previously sealed crack with sealant missing; up to 1 inch deep; approximately 10 lf | Reseal crack | |

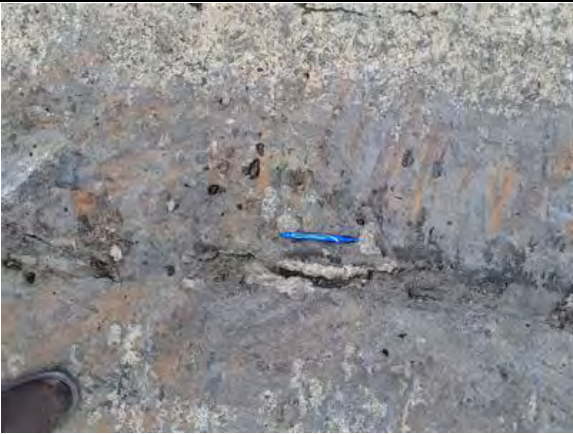
| ID <sup>1</sup> | Type of Structure | Observation | Recommended Actions | Photograph |
|---|---|---|---|---|
| P42 | Pavement | Previously sealed crack with sealant missing; up to 0.5 inch deep; approximately 2 lf | Reseal crack | |

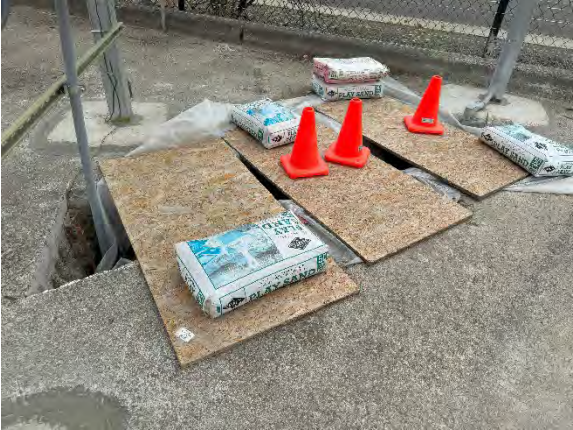
| ID <sup>1</sup> | Type of Structure | Observation | Recommended Actions | Photograph |
|---|---|---|---|---|
| P43 | Pavement | Concrete cut for electric fence construction; approximately 8-foot-by-2-foot-by-3-foot | Repair concrete | |

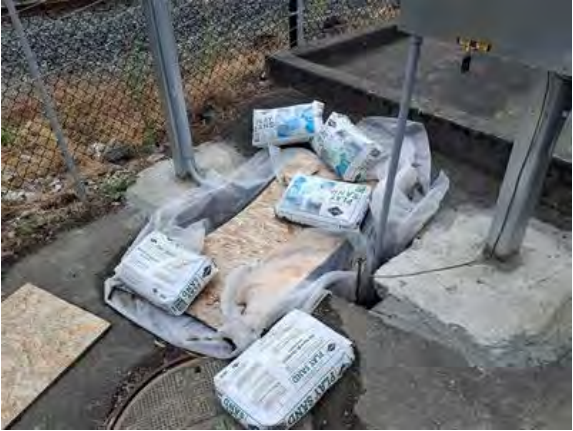
| ID <sup>1</sup> | Type of Structure | Observation | Recommended Actions | Photograph |
|---|---|---|---|---|
| P44 | Pavement | Concrete cut for electric fence construction; approximately 4-foot-by-2-foot-by-3-foot | Repair concrete | |

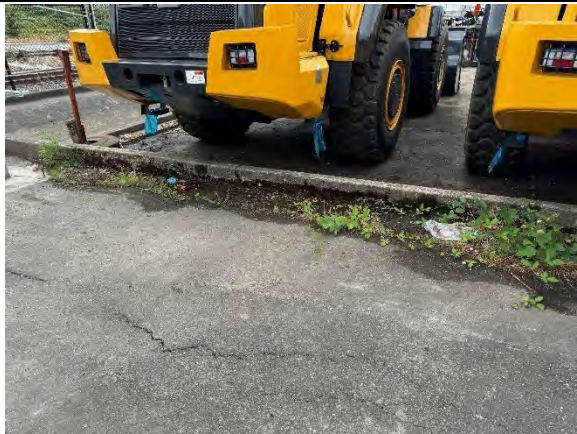
| ID <sup>1</sup> | Type of Structure | Observation | Recommended Actions | Photograph |
|---|---|---|---|---|
| P45 | Pavement | Vegetation growth in cracks adjacent to curb and parallel crack; approximately 20 lf | Remove vegetation and seal cracks; evaluate if northeast corner of cap is subsiding toward Wapato Creek | |

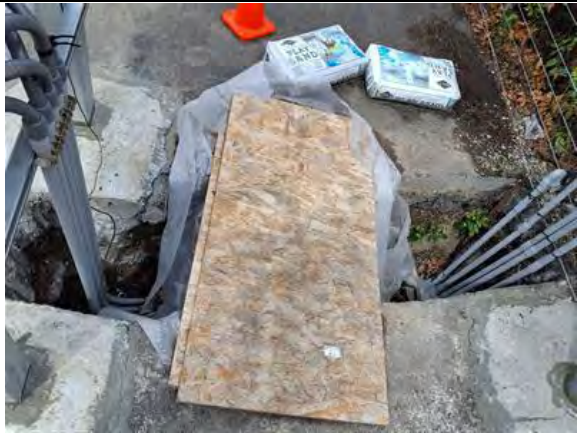
| ID <sup>1</sup> | Type of Structure | Observation | Recommended Actions | Photograph |
|---|---|---|---|---|
| P46 | Pavement | Concrete cut for electric fence construction; approximately 4-foot-by-2-foot-by-3-foot | Repair concrete | |

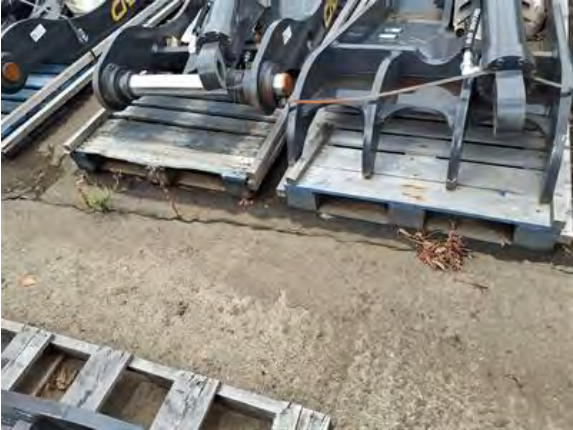
| ID <sup>1</sup> | Type of Structure | Observation | Recommended Actions | Photograph |
|---|---|---|---|---|
| P47 | Pavement | Vegetation growth in portions of crack; wider than 1/8 inch; approximately 60 lf | Remove vegetation and seal crack | |

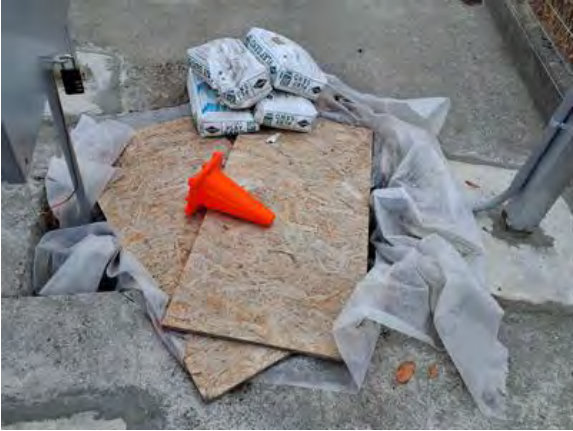
| ID <sup>1</sup> | Type of Structure | Observation | Recommended Actions | Photograph |
|---|---|---|---|---|
| P48 | Pavement | Concrete cut for electric fence construction; approximately 4-foot-by-2-foot-by-3-foot | Repair concrete | |

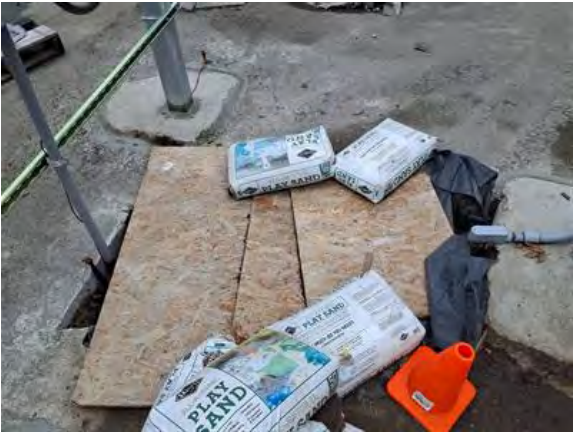
| ID <sup>1</sup> | Type of Structure | Observation | Recommended Actions | Photograph |
|---|---|---|---|---|
| P49 | Pavement | Concrete cut for electric fence construction; approximately 8-foot-by-2-foot-by-3-foot | Repair concrete | |

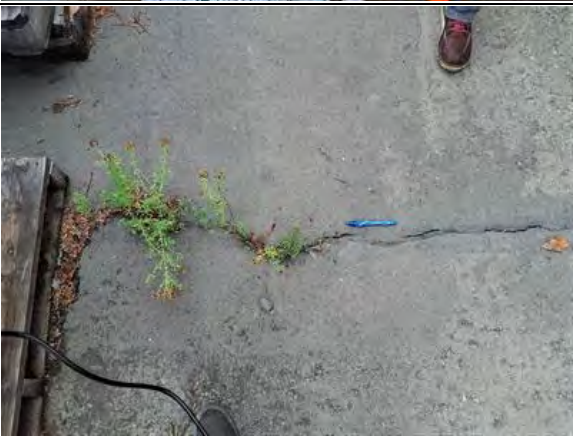
| ID <sup>1</sup> | Type of Structure | Observation | Recommended Actions | Photograph |
|---|---|---|---|---|
| P50 | Pavement | Vegetation growth in portion of crack; wider than 1/8 inch; approximately 8 lf | Remove vegetation and seal crack | |

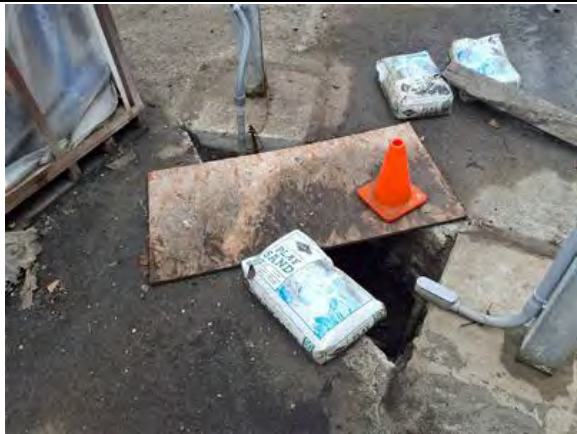
| ID <sup>1</sup> | Type of Structure | Observation | Recommended Actions | Photograph |
|---|---|---|---|---|
| P51 | Pavement | Concrete cut for electric fence construction; approximately 3-foot-by-2-foot-by-3-foot | Repair concrete | |

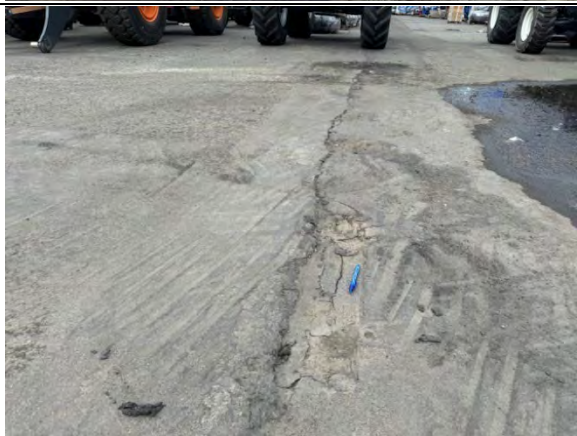
| ID <sup>1</sup> | Type of Structure | Observation | Recommended Actions | Photograph |
|---|---|---|---|---|
| P52 | Pavement | Previously sealed crack with sealant missing in places; approximately 20 lf | Reseal crack | |

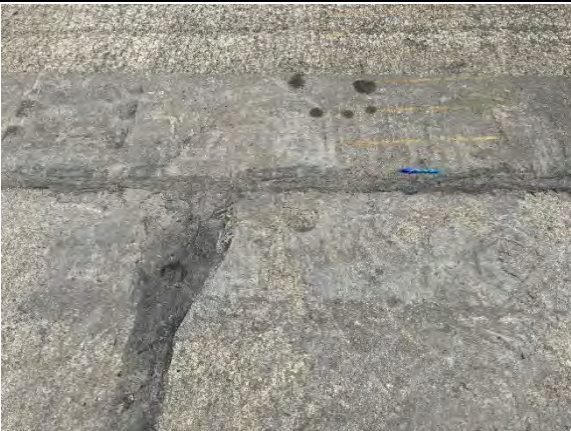
| ID <sup>1</sup> | Type of Structure | Observation | Recommended Actions | Photograph |
|---|---|---|---|---|
| P8 | Pavement | Vegetation removed and crack sealed; approximately 50 lf; | None | |

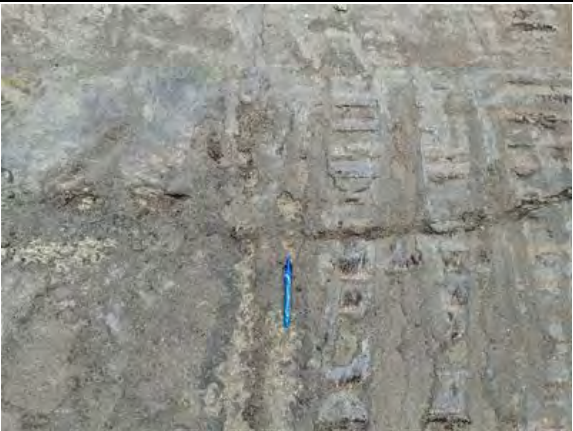
| ID <sup>1</sup> | Type of Structure | Observation | Recommended Actions | Photograph |
|---|---|---|---|---|
| P15 | Pavement | Sealed crack; approximately 15 lf | None | |

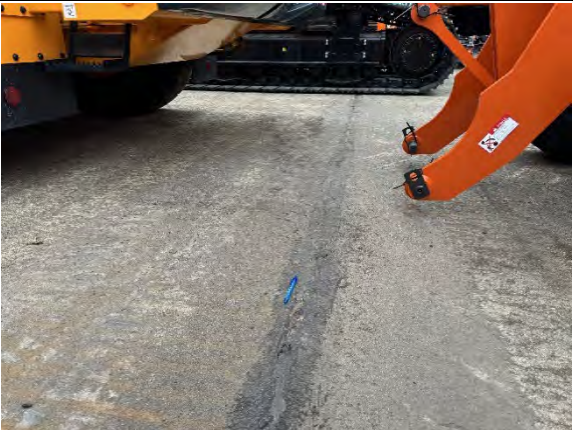
| ID <sup>1</sup> | Type of Structure | Observation | Recommended Actions | Photograph |
|---|---|---|---|---|
| P17 | Pavement | Sealed crack; approximately 40 lf | None | |

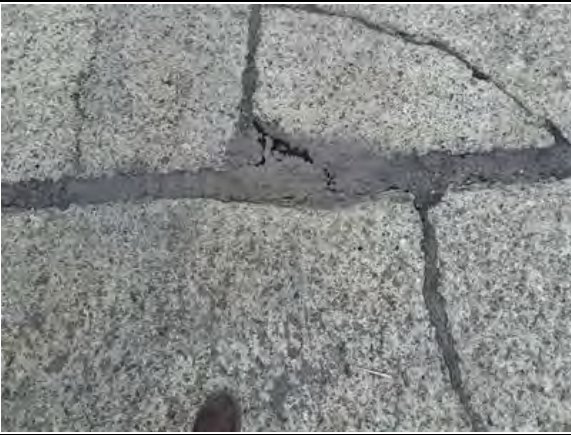
| ID <sup>1</sup> | Type of Structure | Observation | Recommended Actions | Photograph |
|---|---|---|---|---|
| P18 | Pavement | Sealed cracks; approximately 30 lf | None | |

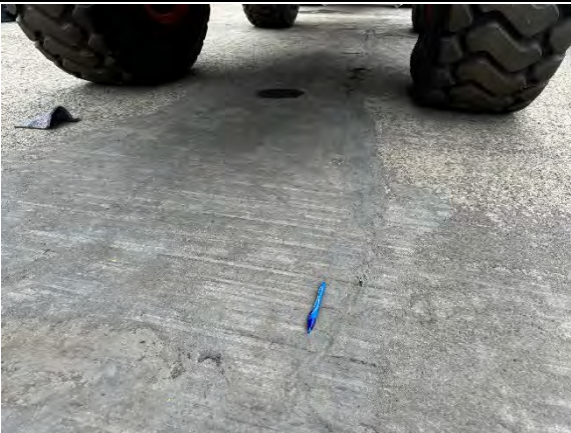
| ID <sup>1</sup> | Type of Structure | Observation | Recommended Actions | Photograph |
|---|---|---|---|---|
| P19 | Pavement | Vegetation removed and crack sealed; approximately 30 lf | None | |

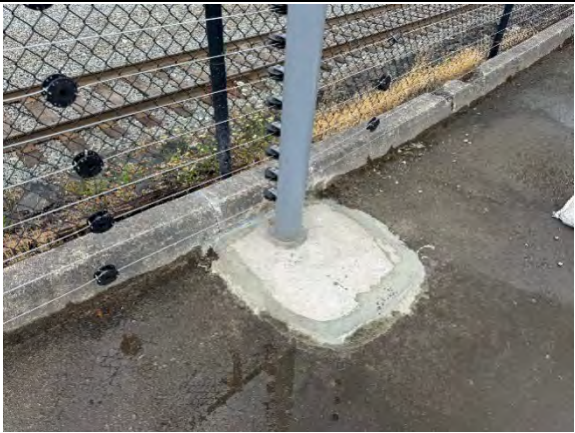
| ID <sup>1</sup> | Type of Structure | Observation | Recommended Actions | Photograph |
|---|---|---|---|---|
| P25 | Pavement | Electric fence component posts and supports installed around edge of property; epoxy sealant; typical | None | |

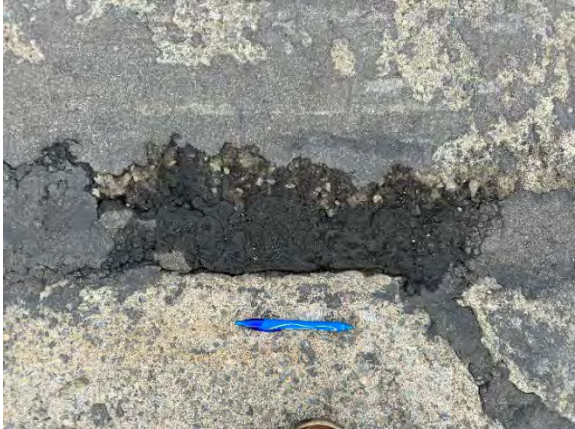
| ID <sup>1</sup> | Type of Structure | Observation | Recommended Actions | Photograph |
|---|---|---|---|---|
| P37 | Pavement | Previously sealed pavement gouge with sealant degradation; approximately 1 lf and 0.5 inch deep; | Monitor and reevaluate for repair during next inspection cycle | |

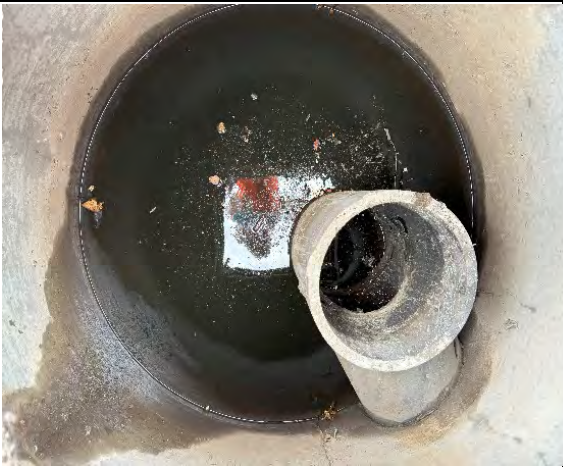
| ID | Type of Structure | Observation | Sediment Accumulation | Additional Observations | Recommended Actions | Photograph |
|---|---|---|---|---|---|---|
| CB3 | Catch basin | Structurally sound; functioning normally | Water present in structure and too deep to measure | Floatables in the riser and surface; debris in filter | Remove floatables in accordance with stormwater maintenance requirements | |

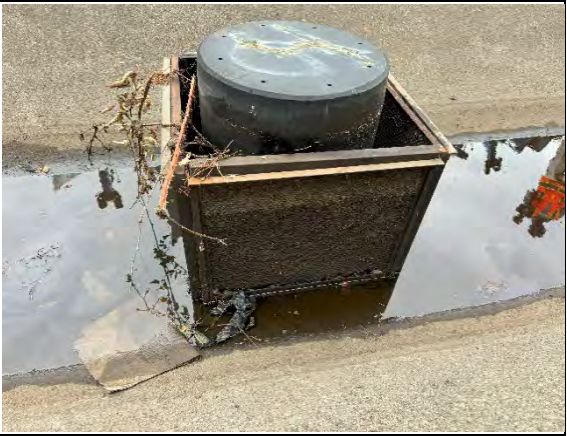
| ID | Type of Structure | Observation | Sediment Accumulation | Additional Observations | Recommended Actions | Photograph |
|---|---|---|---|---|---|---|
| TB6 | Treatment basin | Structurally sound; functioning normally | 0.5 inches of sediment in basin and 1 inch of standing water | Organic and inorganic debris in basin, damaged grate on north end, north facing screen is torn at bottom allowing material to pass | Remove accumulated sediment and debris in accordance with stormwater maintenance requirements; replace damaged screen | |
