# Environmental Cap and Drainage System Inspection Report

Former Louisiana Pacific/Pony Lumber Facility  
(Ecology Facility ID #1209)

December 4, 2024

Project No. M0615.24.002

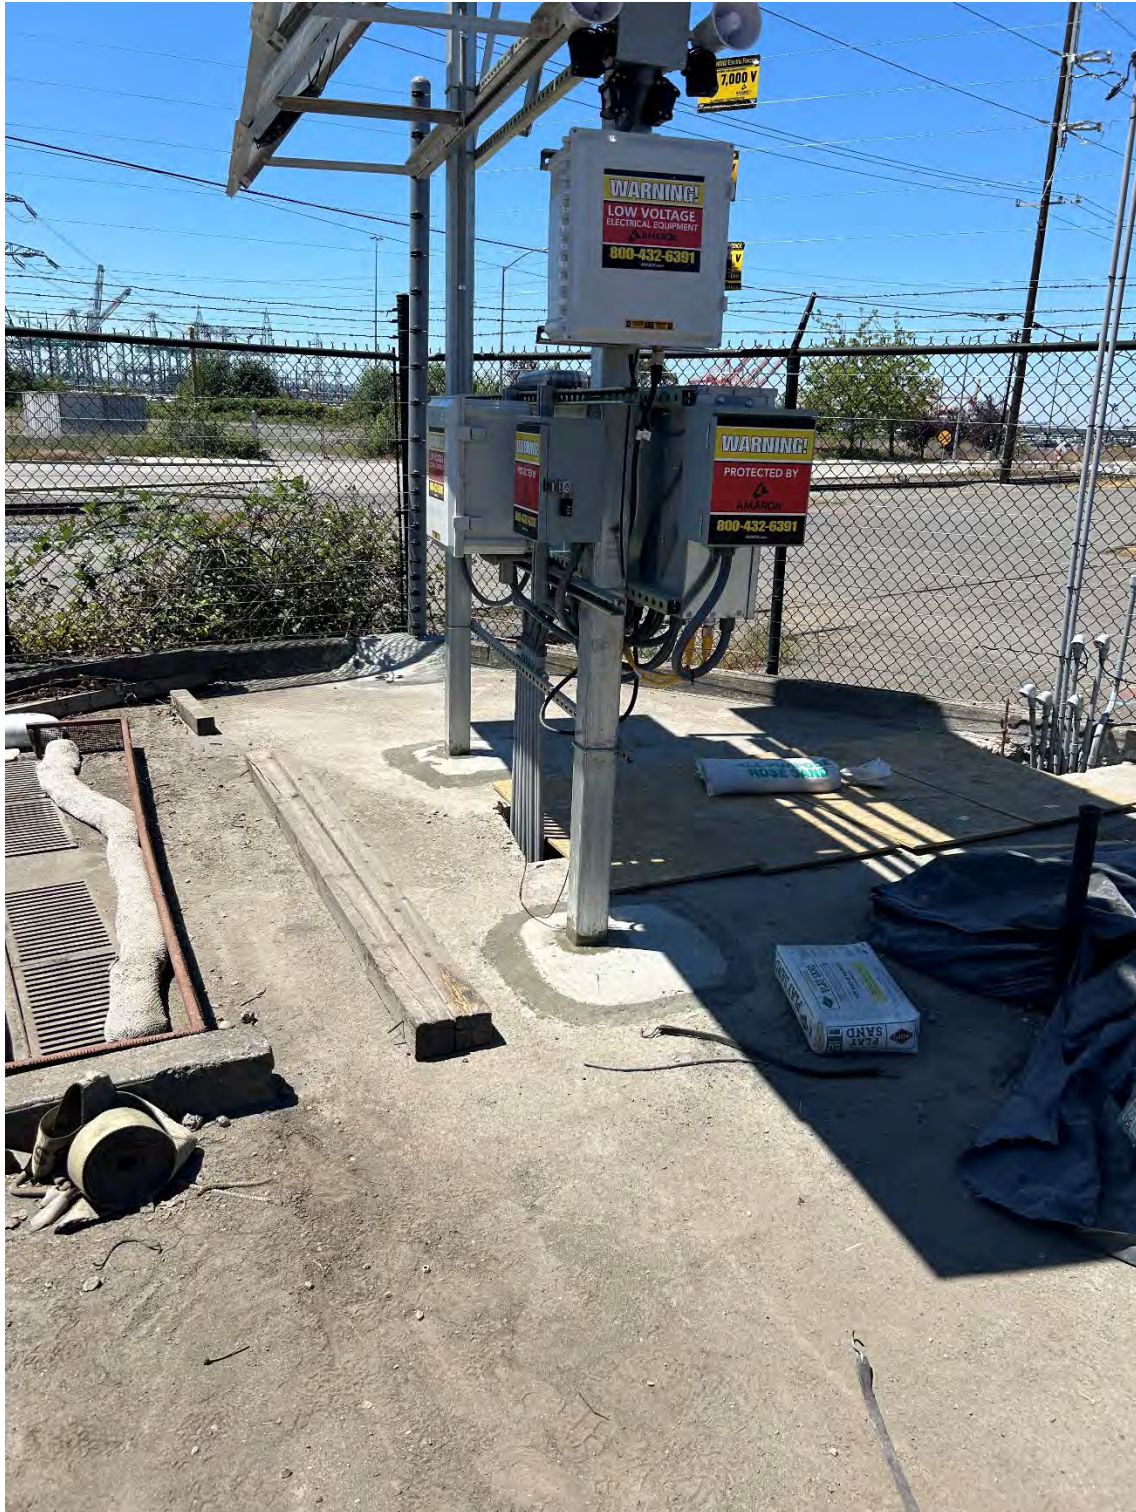
Component support structure, Conduit trenches have not been filled with concrete as they are waiting on final electrical inspection. Trenches will have similar raised concrete as post foundations. Note epoxy sealant at post to foundation and foundation to surrounding concrete.

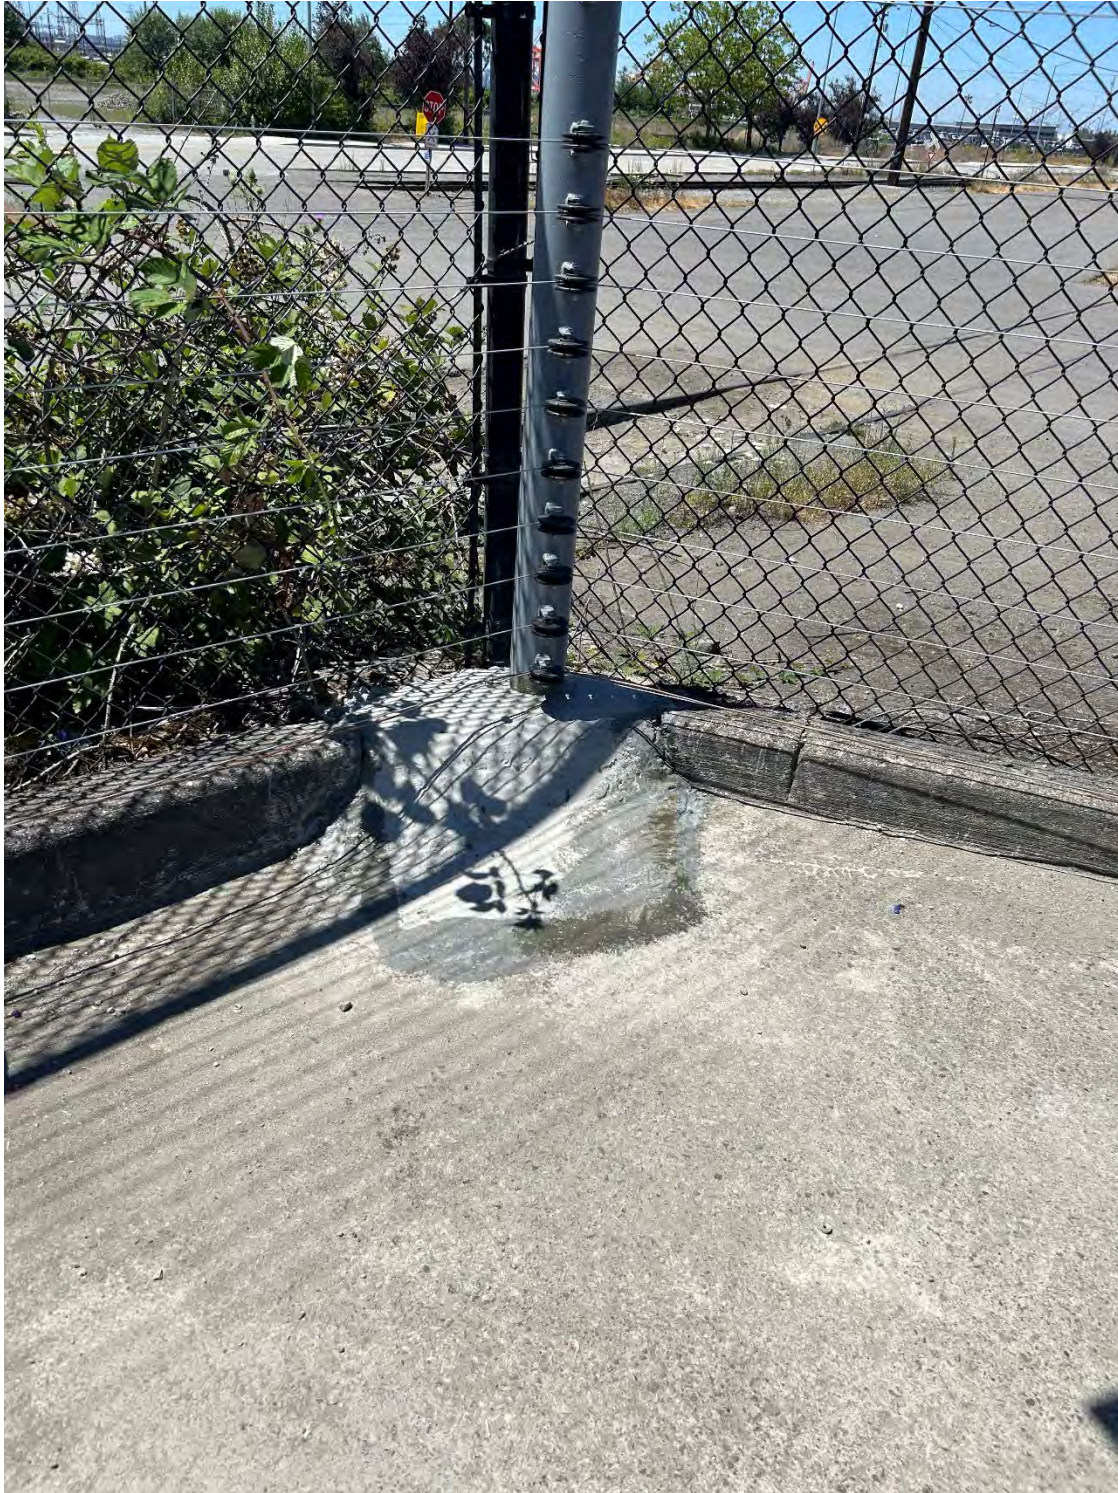
Typical corner post foundation raised to divert water away from post. Post to foundation and foundation to surrounding pavement have been sealed with epoxy to prevent water intrusion at the joint, typical.

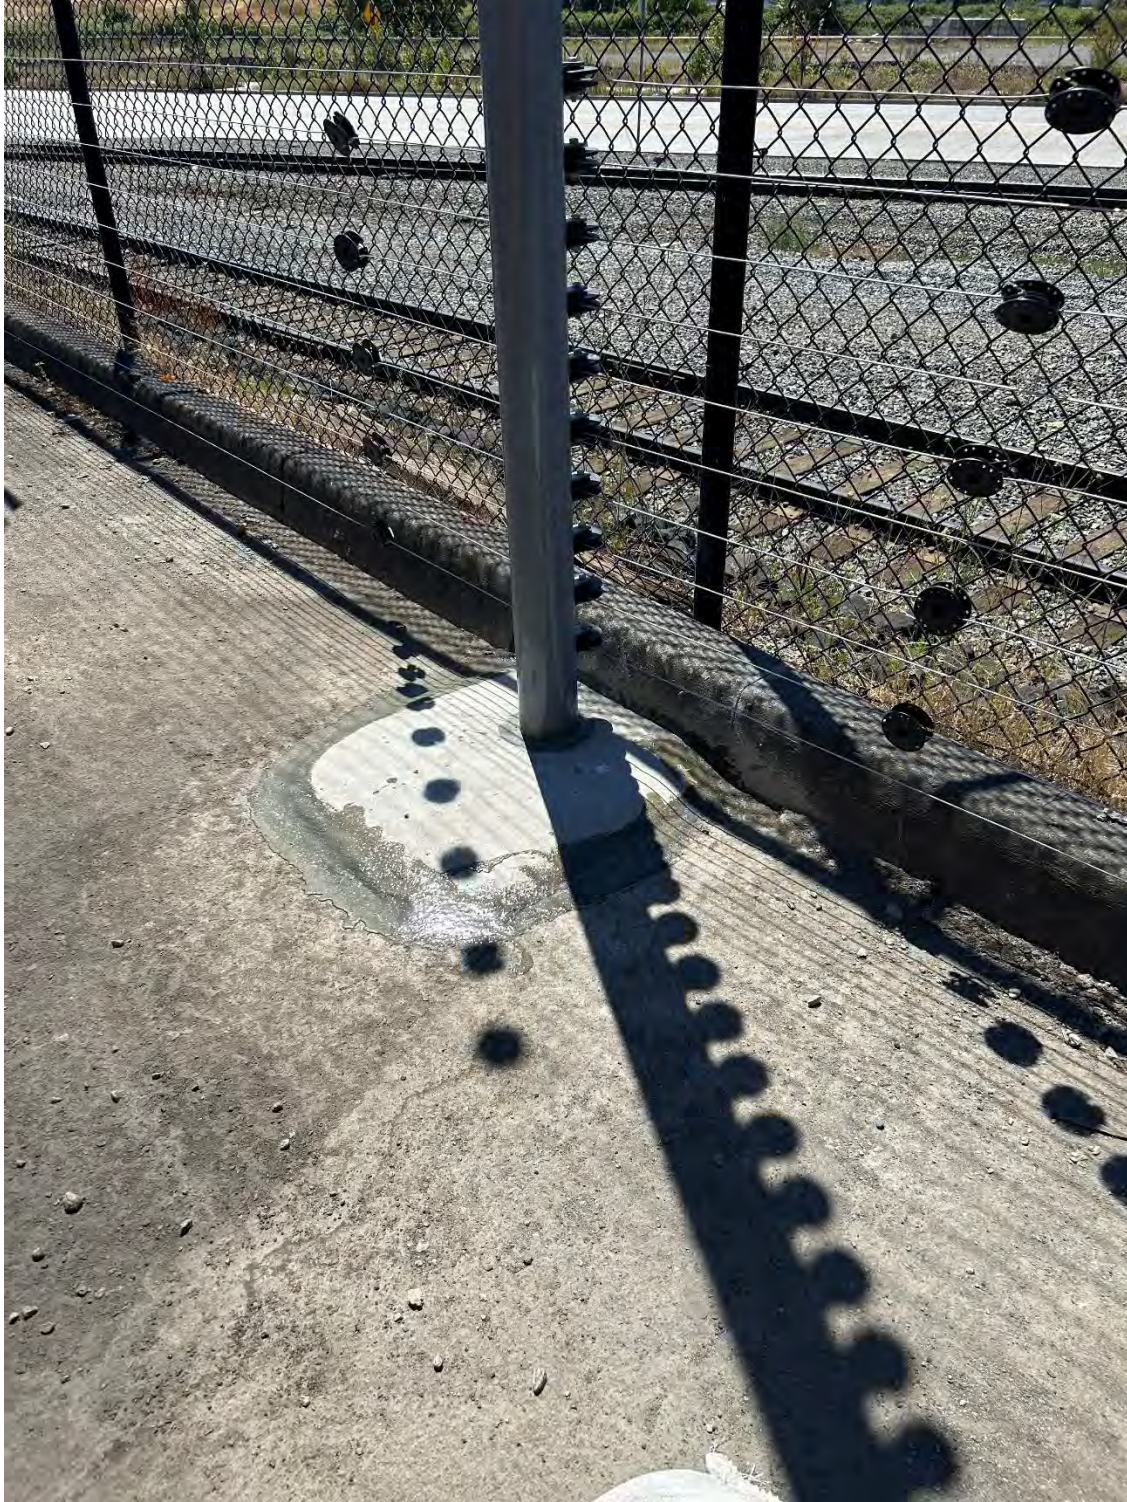
Line post is similar to corner post. Concrete foundation is raised to divert water away from new post. Post to foundation and foundation to adjacent pavement have been sealed with epoxy to prevent water intrusion at the joints.

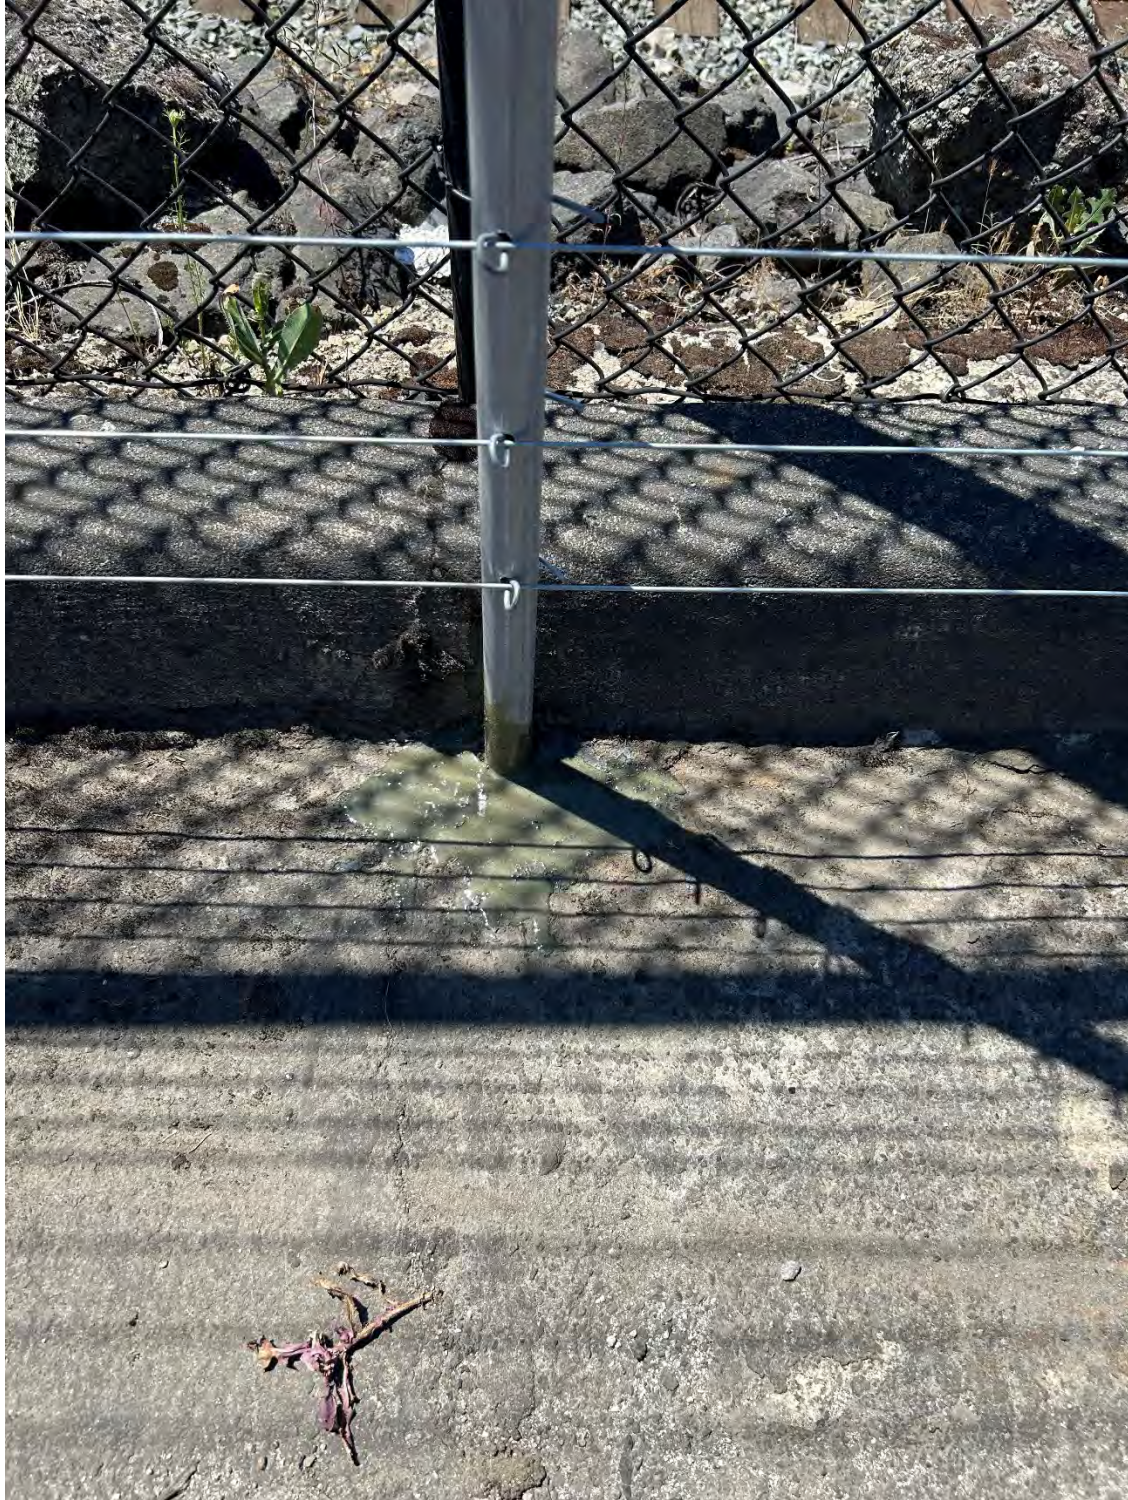
Intermediate posts were core drilled into the concrete cap. Following grouting in place the entire area was flooded with epoxy to prevent water intrusion.
