GEOTECHNICAL ENGINEERING SERVICE  
McCOLLUM PARK  
128TH STREET SOUTHEAST  
SNOHOMISH COUNTY, WASHINGTON

E-4428

November 1, 1989

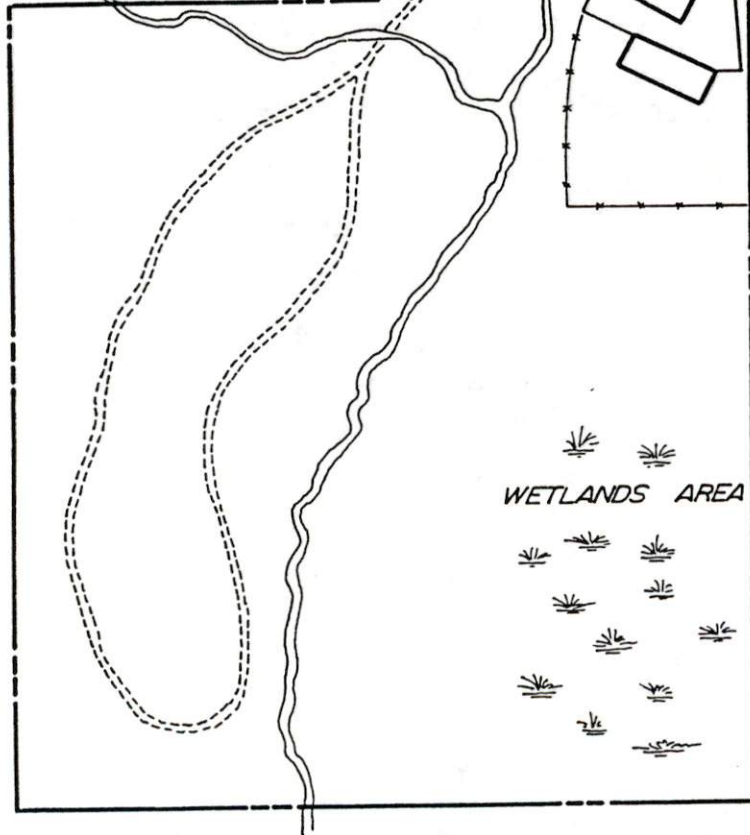
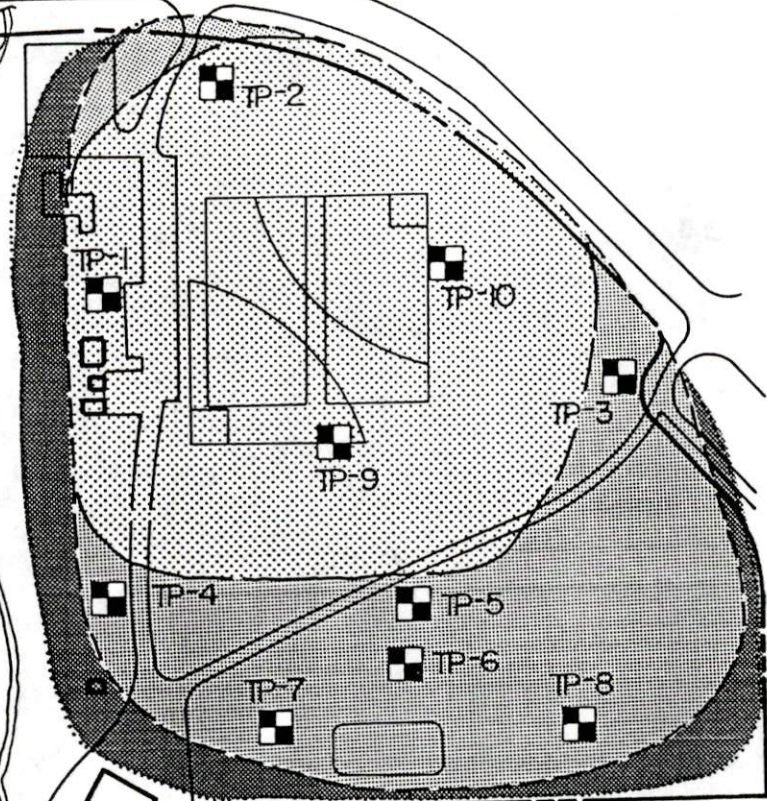
Plate 2 shows our estimation of the approximate extent of the landfill in three cases: the originally estimated extent (as shown on the conceptual master plan); the extent of the landfill based on the results of our subsurface exploration; and the estimated extent beyond the perimeter defined by our study. Plate 4 presents several cross sectional views of the landfill. The approximate cap thickness, depth of landfill and bottom profile are included.

Our exploratory test pit excavations encountered a cap over the landfill which ranged between one foot (Pits 4 and 6) and four feet (Pits 3 and 8) in thickness. At Test Pit 7, we were unable to discern a fill cap beneath approximately four inches of topsoil and sod. At this location the soil matrix appeared to blend immediately into the landfill refuse content. The cap material consisted primarily of a loose silty sand with gravel.

The soil landfill cap is underlain by the raw landfill content, which ranged from three feet (Pit 9) to more than thirteen (13) feet (Pit 2) in thickness. The majority of the exposed landfill material comprised general household and building refuse including glass, plastic, metallic material, lumber pieces and other miscellaneous materials. In Test Pit 7 the refuse was intermixed with wood debris. The approximate thickness of the landfill content is contoured on Plate 3, attached. Test Pits 2, 3, 8 and 10 were all terminated within the refuse layer; they did not penetrate into the underlying soil.

Based on our subsurface exploration, additional cap material (between six to twenty-four inches) will be required in the southwestern portion of the landfill area. The permeability of existing cap can be reduced to the recommended amount by intermixing bentonite powder in the upper twelve inches of the cap material.

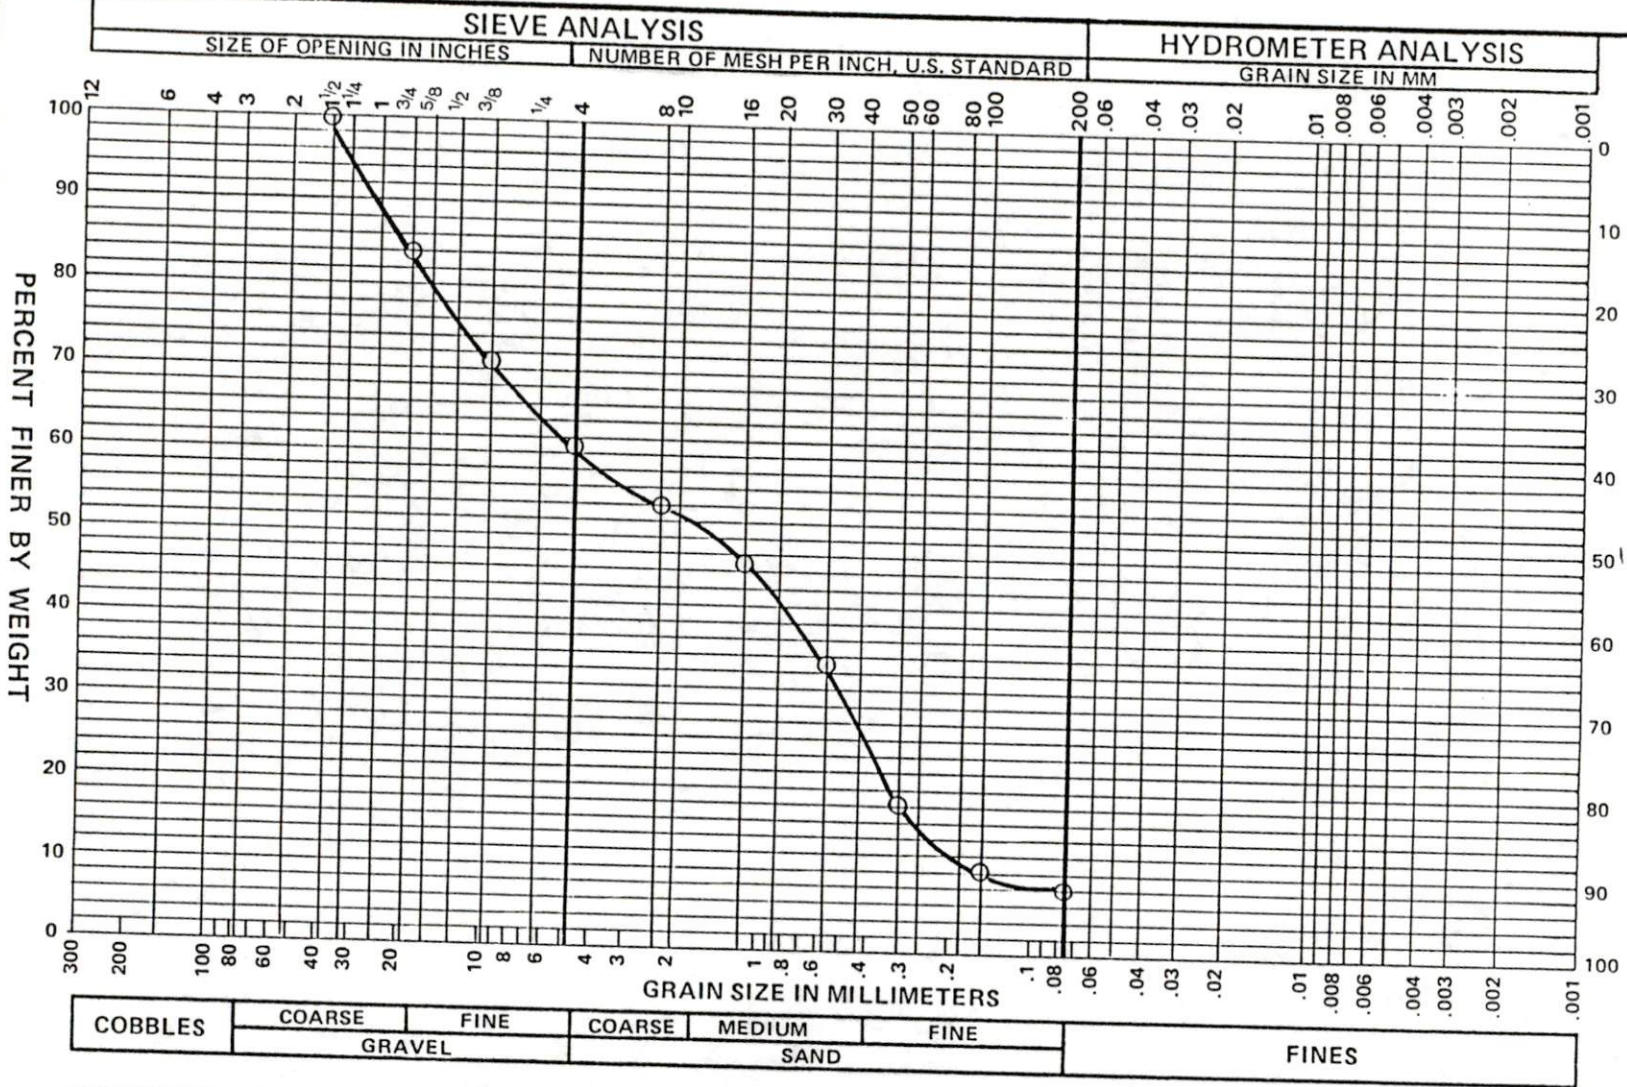
GRAIN SIZE ANALYSES  
MCCOLLUM PARK  
SNOHOMISH COUNTY, WASHINGTON

KEY	Boring or Test Pit No.	DEPTH (ft.)	USCS	DESCRIPTION	Moisture Content (%)	LL	PL
○ —	TP-10	2	SP-SM	Poorly graded SAND with silt	2.5
