DATE: September 10, 2025  
TO: Mark Jusayan, Seattle Public Utilities  
Ashley Piatek, CenterPoint Properties  
FROM: Laura Lee and Alexander Leshner, EIT  
SUBJECT: South Park Landfill 2025 Annual Landfill Cap Inspection  
CC: Ryan Gardiner, Washington State Department of Ecology  
PROJECT NUMBER: 553-1550-067  
PROJECT NAME: South Park Landfill Site Coordinator

This technical memorandum summarizes the findings of the May 2025 annual landfill cap inspection at the South Park Landfill in Seattle, Washington. The inspection fulfills the requirements of the Cleanup Action Plan (CAP), which is a component of the Consent Decree signed on March 26, 2019.

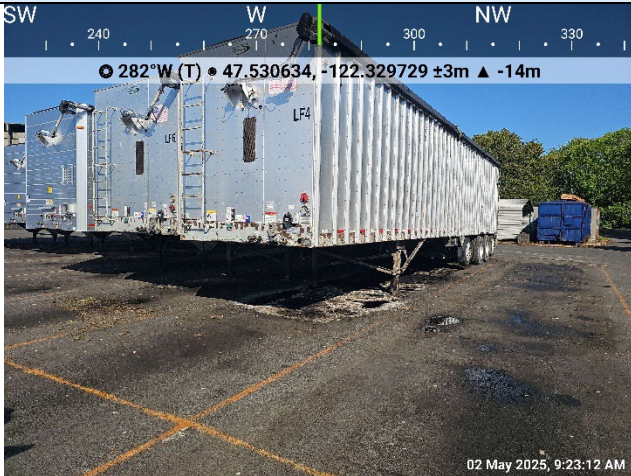
| SRDS | Description | October 2024 Inspection | | May 2025 Inspection | | | | Photographs |
|---|---|---|---|---|---|---|---|---|
| AC-5 | Cracking, divots and ponding | Area has potholes and divots with ponding. | No actions taken | No significant changes observed | The area has potholes and divots with ponding, primarily under the container. The asphalt appears to be corroded, though the original source contributing to this condition is uncertain. Recommendations:<br><div><div>1.</div>Perform maintenance to repair the damaged asphalt area.</div> <div><div>2.</div>Document maintenance using Cap Maintenance Form B.</div> <div><div>3.</div>If the container is identified as the source of corrosion, consider moving the container to prevent further degradation or recurrence.</div> | December 2025 | SRDS | |

Due to the planned redevelopment of the SRDS property, temporary pavement restoration is not recommended at this time, except at locations SRDS AC-5 and AC-22, as described in Table 1.

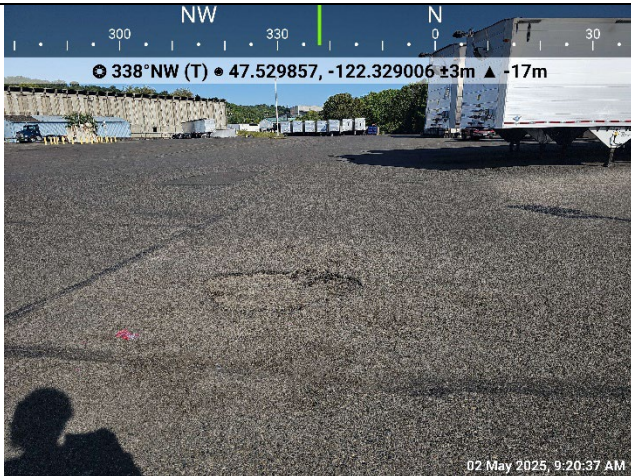
| SRDS | Description | October 2024 Inspection | | May 2025 Inspection | | | | Photographs |
|---|---|---|---|---|---|---|---|---|
| AC-22 | Cracking and rut in asphalt | Cracks and ruts in pavement. Patch rut in asphalt and seal to prevent further degradation. | New location, no action taken | Revised determination | Cracks and ruts do not fully penetrate the asphalt cap surface. It appears that some maintenance may have been performed since the October 2024 reinspection. No further maintenance is needed currently. The Site Coordinator will continue monitoring every 6 months. If maintenance was performed, SRDS needs to submit a completed Cap Maintenance Form B to the Site Coordinator. | N/A | N/A | |

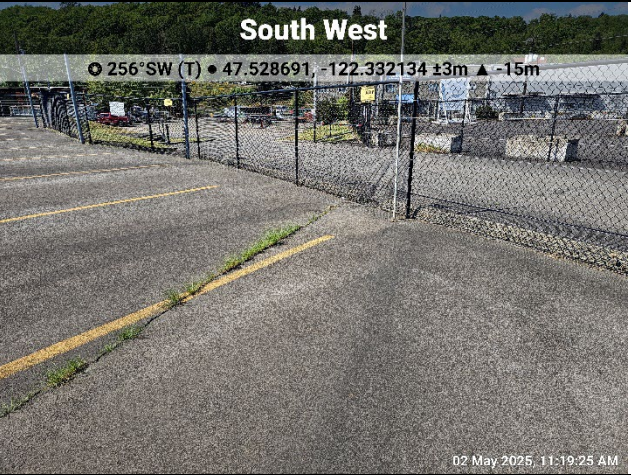
| CPSP Location | Description | October 2024 Inspection | | May 2025 Inspection | | | | Photographs |
|---|---|---|---|---|---|---|---|---|
| AC-20 | Minor cracks | Increased plant growth in the crack.<br><br>Follow-up reinspection | No actions taken or required | Revised determination | Determined not to be a significant issue impacting the cap. | N/A | N/A | |

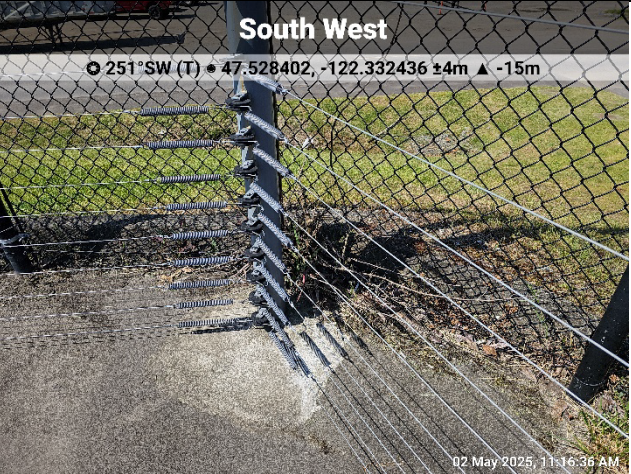
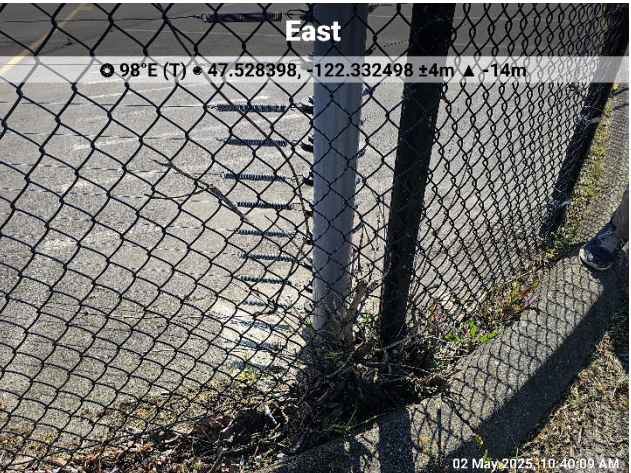
| CPSP Location | Description | October 2024 Inspection | | May 2025 Inspection | | | | Photographs |
|---|---|---|---|---|---|---|---|---|
| AC-21 | Holes near fence allowing growth of plants & ponding presence | Plant has been mostly removed. Seal pavement where the plant was growing. | Plant was cut back. Maintenance form was submitted. | No significant changes observed | Previous recommendations remain. Continue to inspect to see if the plant continues to grow and disrupt the asphalt. | Past Due | CenterPoint | |

| Asphalt Concrete | | | | |
|---|---|---|---|---|
| Open cracks/ruts | <input checked="" type="checkbox"/> | <input type="checkbox"/> | <input checked="" type="checkbox"/> | Location CPSP AC-21 needs repairs |

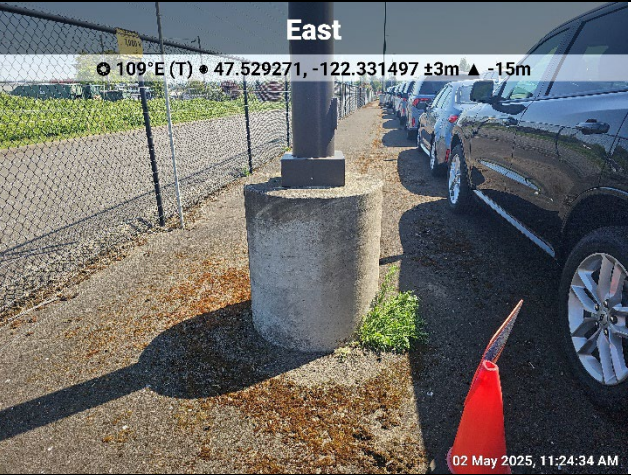
| CPSP Location | Description | October 2024 Inspection | | May 2025 Inspection | | | | Photographs |
|---|---|---|---|---|---|---|---|---|
| AC-22 | Unsealed pavement after plant removal | Part of the plant was removed but has since regrown. Remove the plant and seal the pavement. | No actions taken or maintenance forms received | Revised Assessment | Post is not sealed, but there is no indication that this is potentially impacting the cap. | N/A | N/A | |

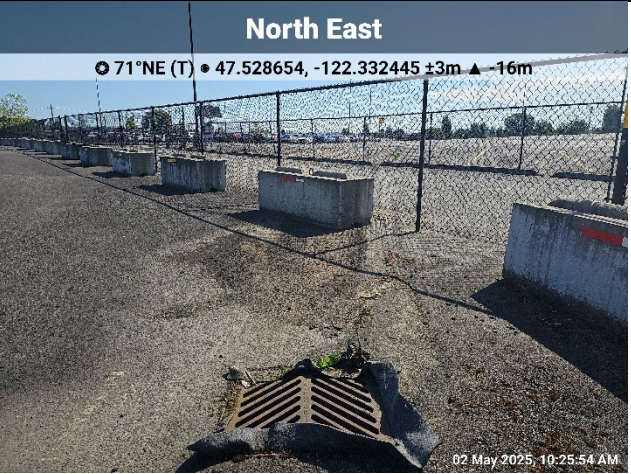
| CPSP Location | Description | October 2024 Inspection | | May 2025 Inspection | | | | Photographs |
|---|---|---|---|---|---|---|---|---|
| AC-23 | Separation of pavement from storm drain | Most of the plant next to the storm drain has been removed but the roots are still there, and the cap penetration was not sealed. Plant roots had pushed up the pavement. Repair and seal pavement. | No actions taken | No significant changes observed | Previous recommendations remain. | Past Due | CenterPoint | |

| Asphalt Concrete | | | | |
|---|---|---|---|---|
| Separation of pavement from curbs, gutters, or catch basins | <input checked="" type="checkbox"/> | <input type="checkbox"/> | <input type="checkbox"/> | CPSP AC-23 needs repair |

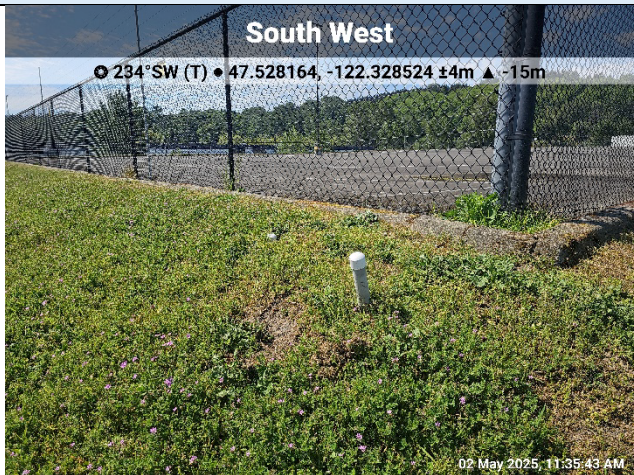
| CPSP Location | Description | October 2024 Inspection | | May 2025 Inspection | | | | |
|---|---|---|---|---|---|---|---|---|
| G-1 | An open pipe present | Need investigation of this open pipe and action should be taken to cap it, if it does not have any purpose. | Action Not Yet Completed | Resolved | Pipe is now capped. | N/A | N/A | |

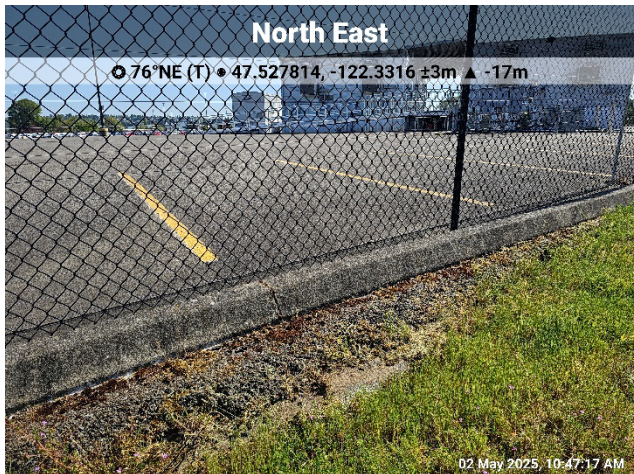
| CPSP Location | Description | October 2024 Inspection | | May 2025 Inspection | | | | |
|---|---|---|---|---|---|---|---|---|
| G-6 | Geomembrane exposed in this area | Geomembrane is still exposed.<br><br>Locations with exposed geomembrane are of the highest concern due to the potential compromise of the landfill cap. The configuration of the geomembrane and cover at the interface of the parking area does not appear to be in accordance with Figure 5 of the Interim Action Work Plan (IAWP). The geomembrane appears to be directly below the asphalt with no drainage layer or surfacing layer in between. Along with Site Coordinator, prepare a plan to reestablish cover over the geomembrane. Most likely, the area should be exposed, and the geomembrane tested for damage before repairs are made. The crest of slope should then be provided cover to the maximum extent possible considering the existing asphalt and curb configuration.<br><br>Geomembrane still exposed. Previous recommendations remain. | Action Not Yet Completed. | No significant changes observed | Geomembrane remains exposed. Previous recommendations remain. | Past Due | CenterPoint | |

| Low-Permeability Geomembrane | | | | |
|---|---|---|---|---|
| Exposed geomembrane | <input checked="" type="checkbox"/> | <input type="checkbox"/> | <input checked="" type="checkbox"/> | Locations CPSP G-6, G-7, G-8, and G-16 need repair |

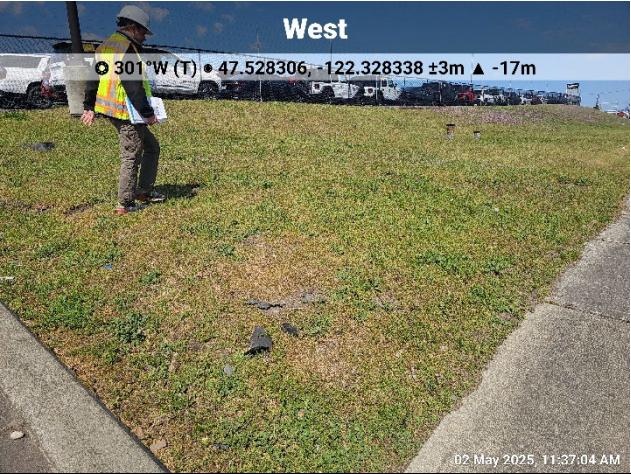
| CPSP Location | Description | October 2024 Inspection | | May 2025 Inspection | | | | |
|---|---|---|---|---|---|---|---|---|
| G-8 | Exposed geomembrane around utility access hole | Work with Site Coordinator to prepare a plan to re-establish cover over the geomembrane. The geomembrane should be carefully exposed so as to not damage the geomembrane and inspected to determine if it is excess material or part of the cover. Make repairs as necessary and install adequate cover soil in accordance with the IAWP. | No documentation of actions taken. | No significant changes observed | Geomembrane is still exposed. Previous recommendations remain. | Past Due | CenterPoint | |

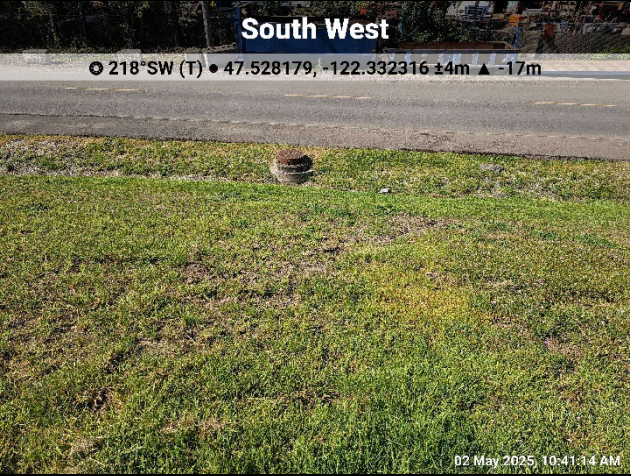
| CPSP Location | Description | October 2024 Inspection | | May 2025 Inspection | | | | |
|---|---|---|---|---|---|---|---|---|
| G-15 | Erosion and rilling on the bank. | N/A | N/A | New Point | Geomembrane is not exposed, but clear evidence of erosion and rilling on the bank at the southwest corner of the CPSP property. Further erosion could lead to exposure and damage to the membrane. Recommend reestablishing the dirt and grass on the hillside. | December 2025 | CenterPoint | |

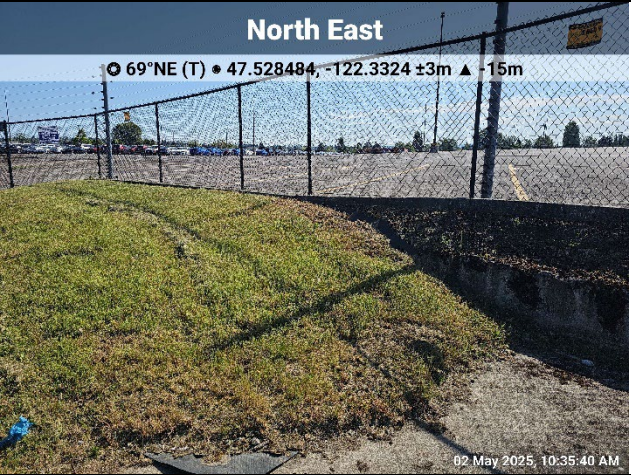
| CPSP Location | Description | October 2024 Inspection | | May 2025 Inspection | | | | Photographs |
|---|---|---|---|---|---|---|---|---|
| G-16 | Geomembrane exposed in this area | N/A | N/A | New Point | The geomembrane is exposed at the edges of the hillside. Recommend reestablishing the dirt and grass on the hillside. | 12/1/2025 | CenterPoint | |

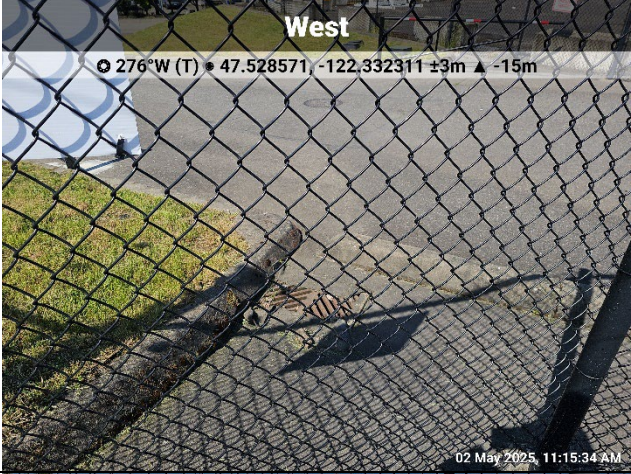
| CPSP Location | Description | October 2024 Inspection | | May 2025 Inspection | | | | Photographs |
|---|---|---|---|---|---|---|---|---|
| SW-3 | Catch basin clogged | The catch basin inlet was partially obstructed. Remove the obstruction. | Some debris was removed. No maintenance form was submitted. | No significant changes observed | Previous recommendations remain, and sediment is observed, but there is no pooling due to dry conditions. Recommend replacing the fabric filter.<br><br>This will likely be an area of continuous maintenance. | Ongoing | CenterPoint | |

The two stormwater catch basins (SW-3 and SW-4) appear to require clearing of accumulated debris and replacement of the felt inserts. The efficiency of drainage could not be assessed due to dry weather during the inspection. These locations require continual maintenance.

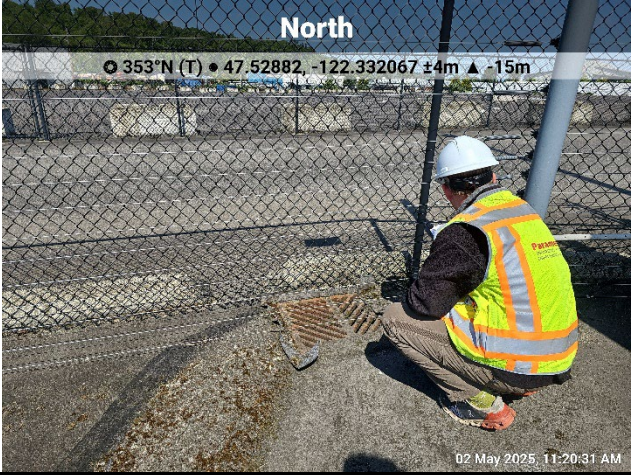
| CPSP Location | Description | October 2024 Inspection | | May 2025 Inspection | | | | Photographs |
|---|---|---|---|---|---|---|---|---|
| SW-4 | Catch basin clogged | The catch basin inlet was obstructed with sediment buildup and plant growth. Remove the obstruction and vegetation. | Action not yet completed. | No significant changes observed | Previous recommendations remain, and sediment is observed, but no pooling due to dry conditions. Recommend replacing the fabric filter. | Ongoing | CenterPoint | |

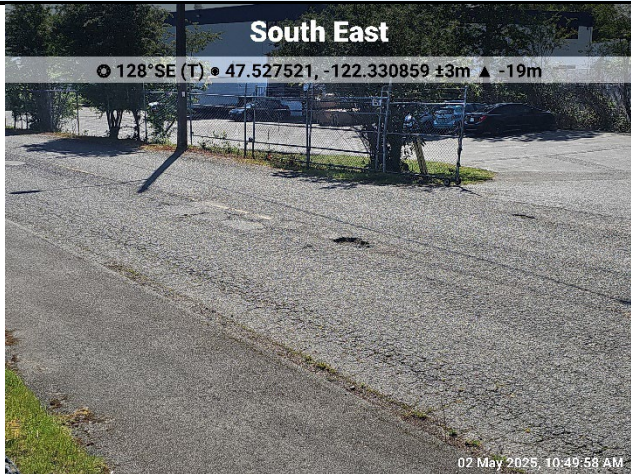
| ROW Location | Description | October 2024 Inspection | | May 2025 Inspection | | | | |
|---|---|---|---|---|---|---|---|---|
| AC-1 | Asphalt cracks and ruts | Part of the pothole was repaired but there is still a significant size hole in the asphalt and cracking. | Partial Asphalt Patching. | Same | Partial asphalt patching observed, but deep holes remain.<br><br>Repair/repatching should be coordinated with SDOT. Reported on the SDOT Find It, Fix It app. | December 2025 | SDOT | |

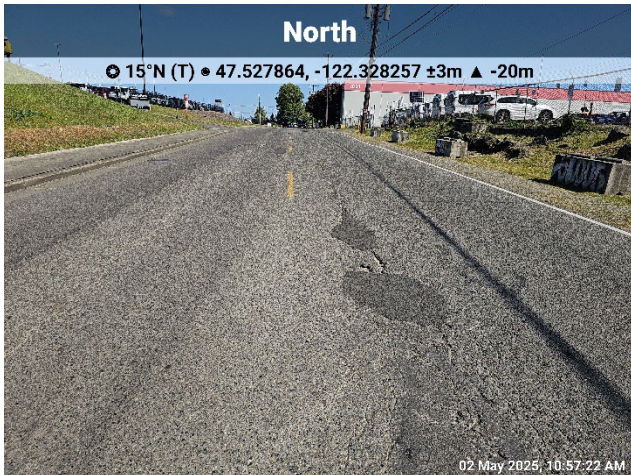
| ROW Location | Description | October 2024 Inspection | | May 2025 Inspection | | | | |
|---|---|---|---|---|---|---|---|---|
| AC-2 | Asphalt open cracking | Cracks got extended and holes are deeper. Some of the holes are close to penetrating the cap.<br><br>Repatching should be coordinated with SDOT. | No action taken | Improved | Previous pothole and some deep cracks were patched; however, several cracks are deeper and need repair.<br><br>Repair/repatching should be coordinated with SDOT. Reported on the SDOT Find It, Fix It app. | December 2025 | SDOT | |

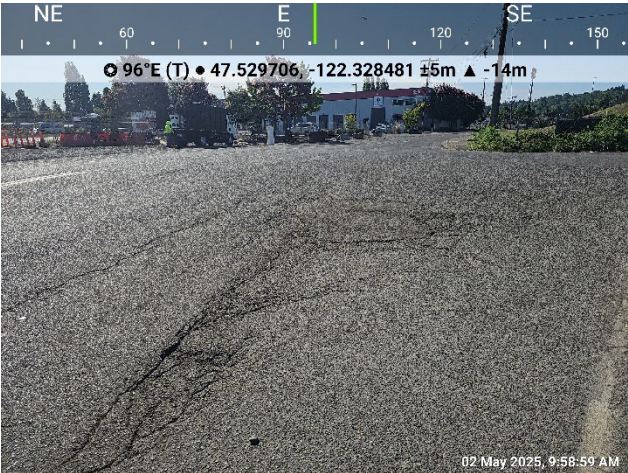
| ROW Location | Description | October 2024 Inspection | | May 2025 Inspection | | | | Photographs |
|---|---|---|---|---|---|---|---|---|
| AC-3 | Potholes alongside of street in the gravel | Pothole appears to be getting worse and should be patched to prevent further erosion. | Site Coordinator reported on SDOT Find It, Fix It; repairs were not made | Improved | Major pothole is addressed. | N/A | N/A | |

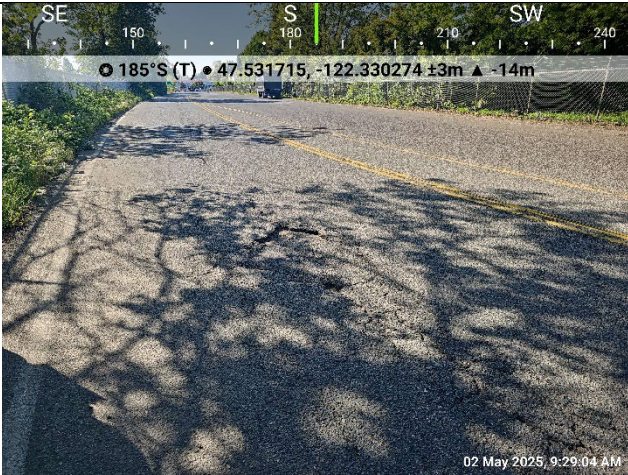
| ROW Location | Description | October 2024 Inspection | | May 2025 Inspection | | | | Photographs |
|---|---|---|---|---|---|---|---|---|
| AC-4 | Asphalt cracks, pothole, and ruts in the middle of roadway. | Previous pothole patched. | Repaired | Worse | Pothole present, several asphalt cracks and ruts have worsened, and require repair.<br><br>Repair/repatching should be coordinated with SDOT. Reported on the SDOT Find It, Fix It app. | December 2025 | SDOT | |

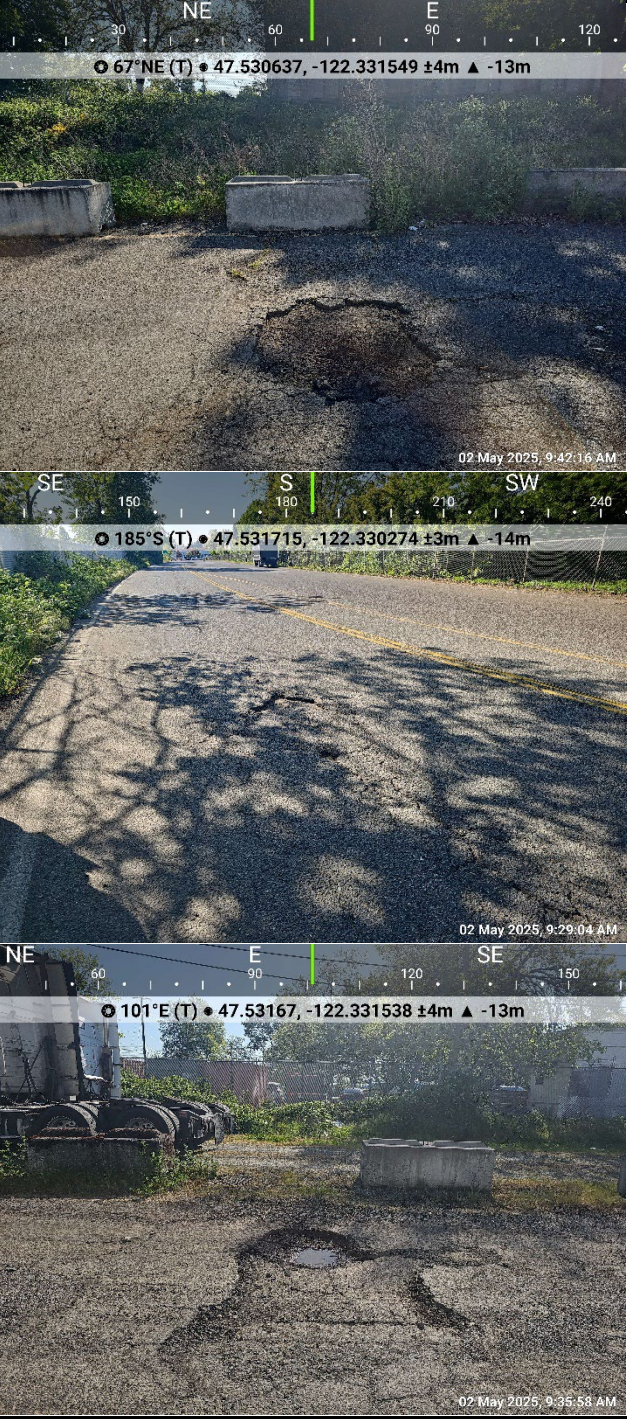
| ROW Location | Description | October 2024 Inspection | | May 2025 Inspection | | | | Photographs |
|---|---|---|---|---|---|---|---|---|
| AC-5 | Deep potholes, depressions, puddles. | Not applicable | Not Applicable | New Point | Multiple potholes present for the length of the alley.<br><br>Repair/repatching should be coordinated with SDOT. Reported on the SDOT Find It, Fix It app. | December 2025 | SDOT | |

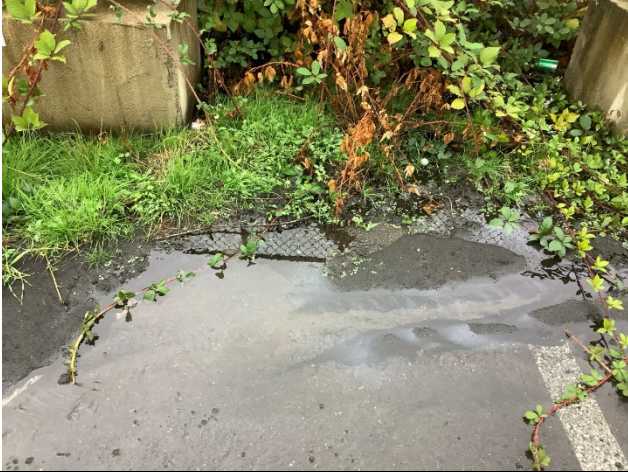
AC-13: Sediment buildup with oil sheen was observed. Blackberries have grown back. Regular maintenance is recommended.

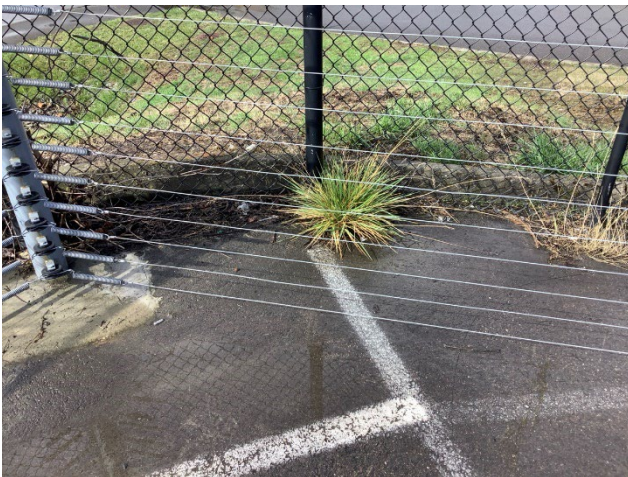
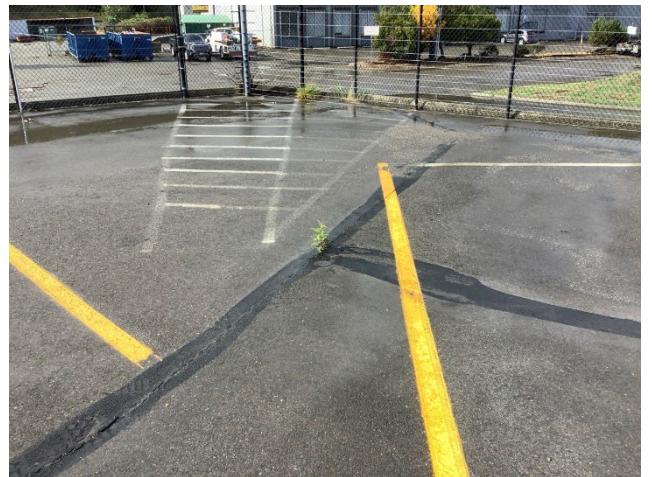
AC-21: Seal pavement where the plants have grown back.

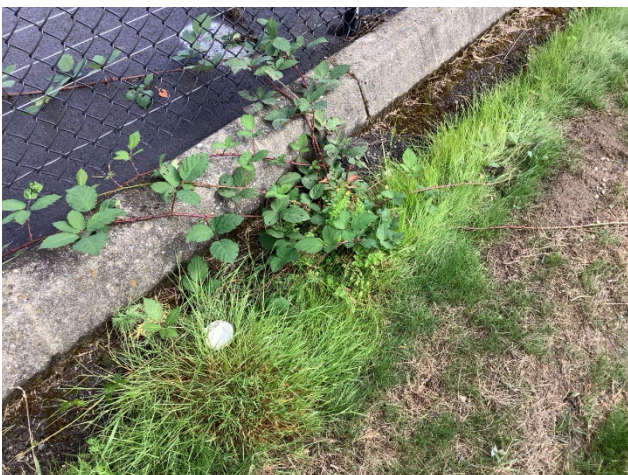
G-4: Blackberries have grown back. Regular maintenance is recommended.
