**SIXTH FIVE-YEAR REVIEW REPORT FOR  
HARBOR ISLAND SUPERFUND SITE  
KING COUNTY, WASHINGTON**

**U.S. Environmental Protection Agency**

**Region 10**

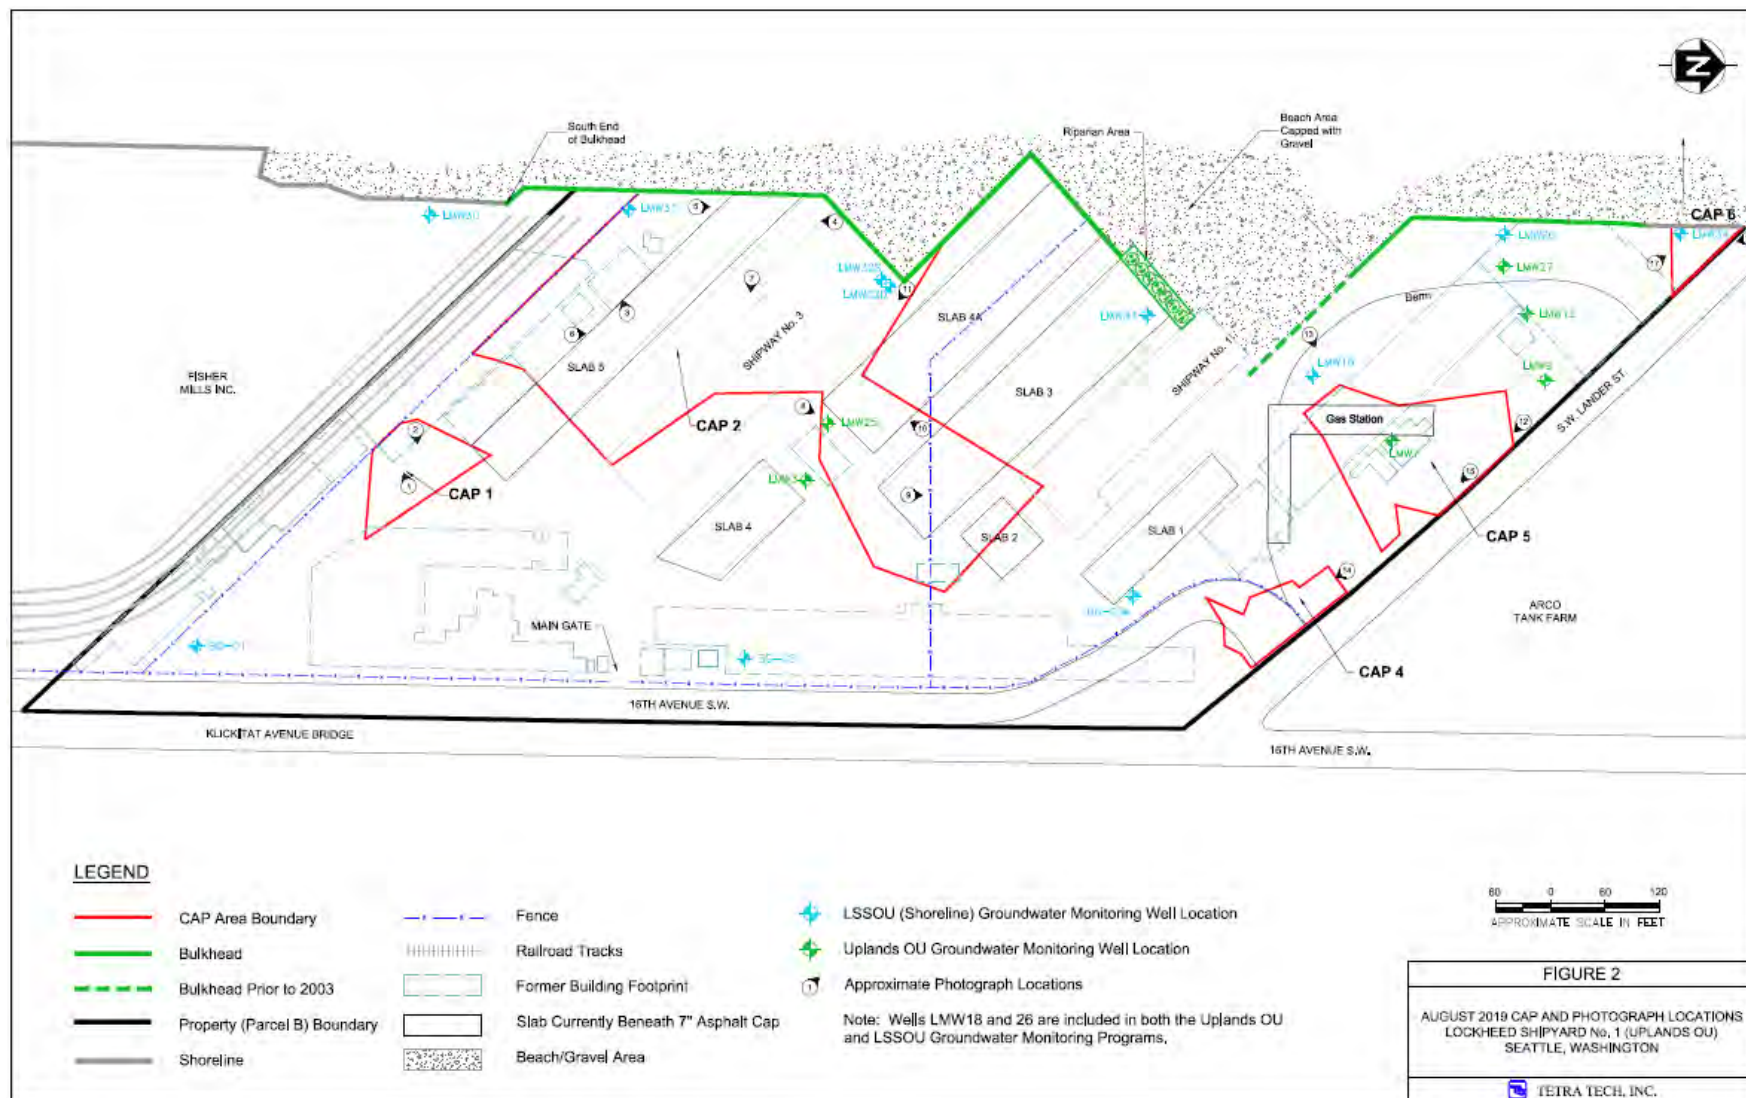
**Figure 6. Locations of Asphalt Cap, LU-OU3.**

As part of the institutional controls, annual cap inspections and cap maintenance are required to ensure protection of on-site workers from dermal contact and reduce infiltration from rainwater. There are five capped areas at LU-OU3 that require annual inspections for cracks, breaches, and the presence of vegetation (Figure 6).

| Year | Cap Area 1 | Cap Area 2 | Cap Area 4 | Cap Area 5 | Cap Area 6 |
|---|---|---|---|---|---|
| 2023 | Good Condition. | Good Condition. Small divots on the asphalt surface and minor cracks were observed. | Good Condition. Minor weeds and minor cracks were observed. The total cap thickness in this area is over 3 feet, weeds unlikely to penetrate cap. | Satisfactory Condition. Weeds observed along borders. Minor cracks observed. | Satisfactory Condition. Weeds observed. |
| 2024 | Very Good Condition. Small divots in asphalt but thickness remains over 7 inches. | Good Condition. Small divots on the asphalt surface and minor cracks were observed. | Good Condition. Minor weeds observed. The total cap thickness in this area is over 3 feet. | Good Condition. | Good Condition. |

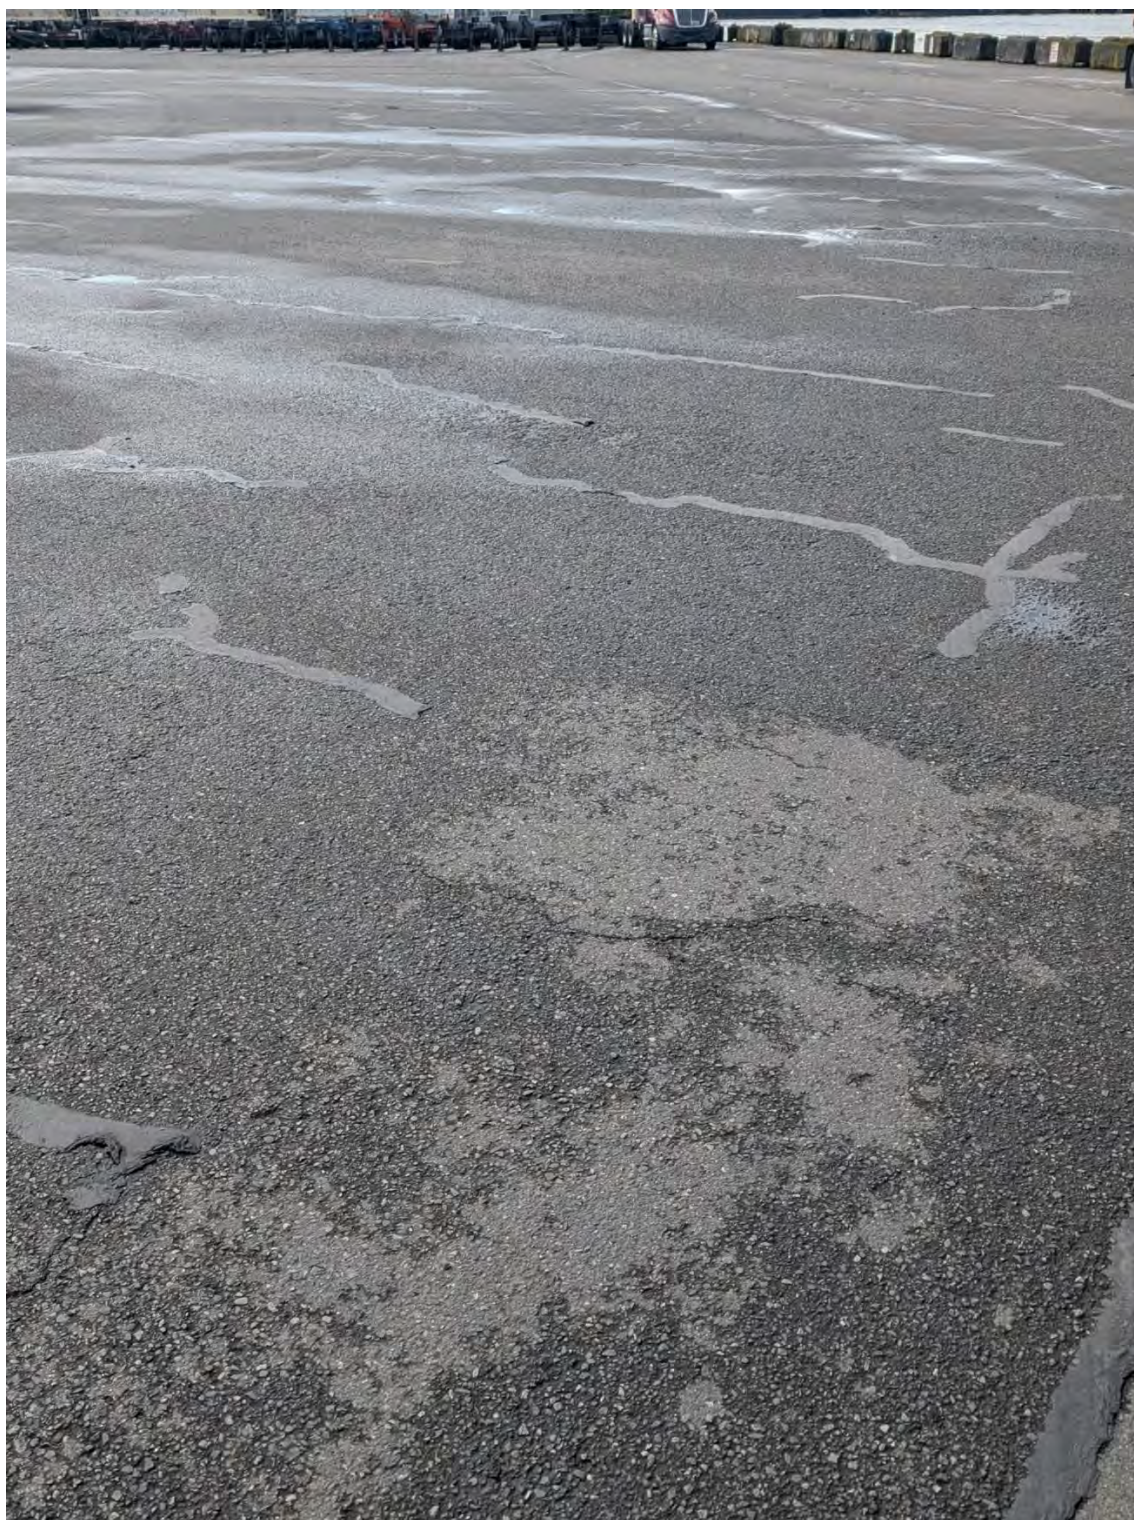
Photo 1. Lockheed Upland Cap with Repaired Cracks

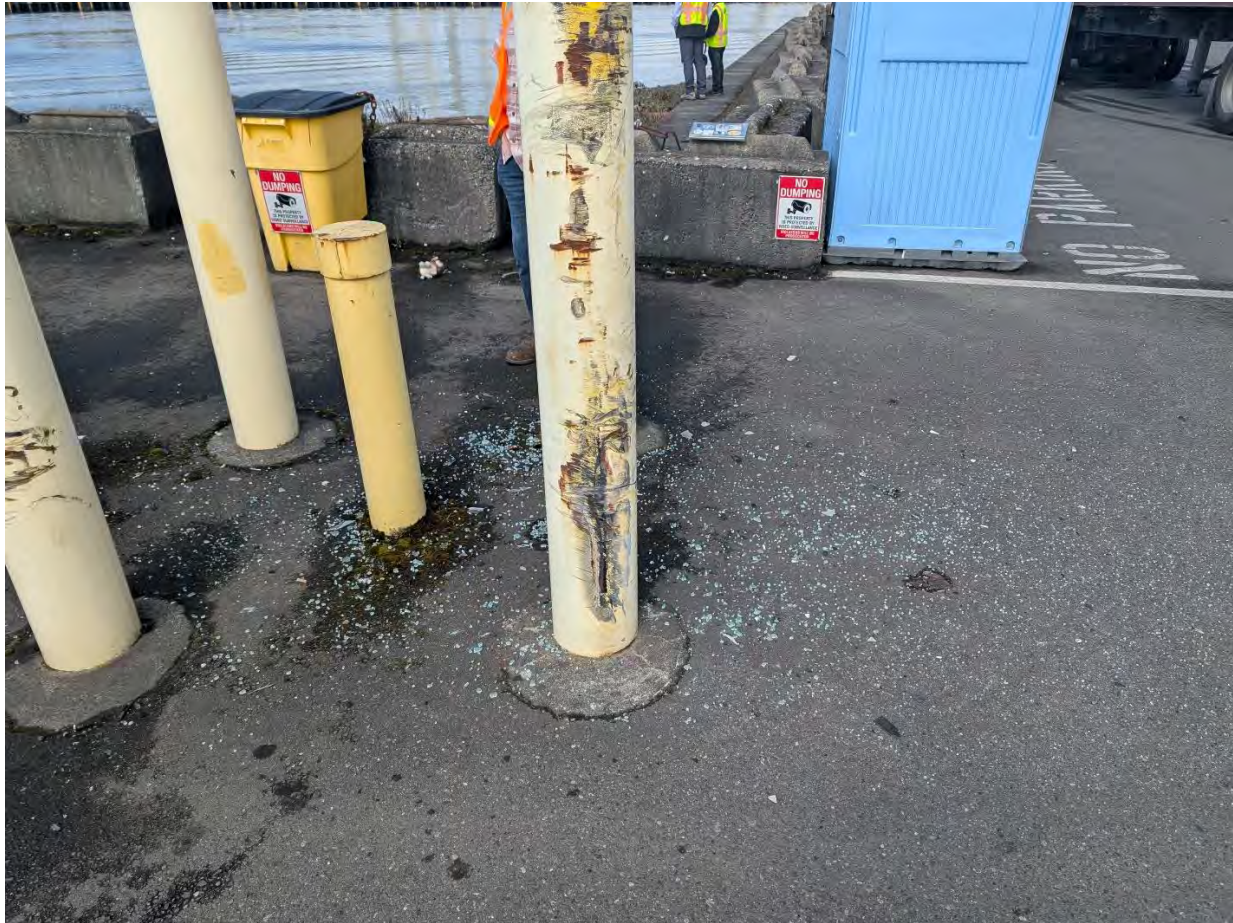
Photo 2. Lockheed Upland Monitoring Well LMW-32D with Damaged Bollard

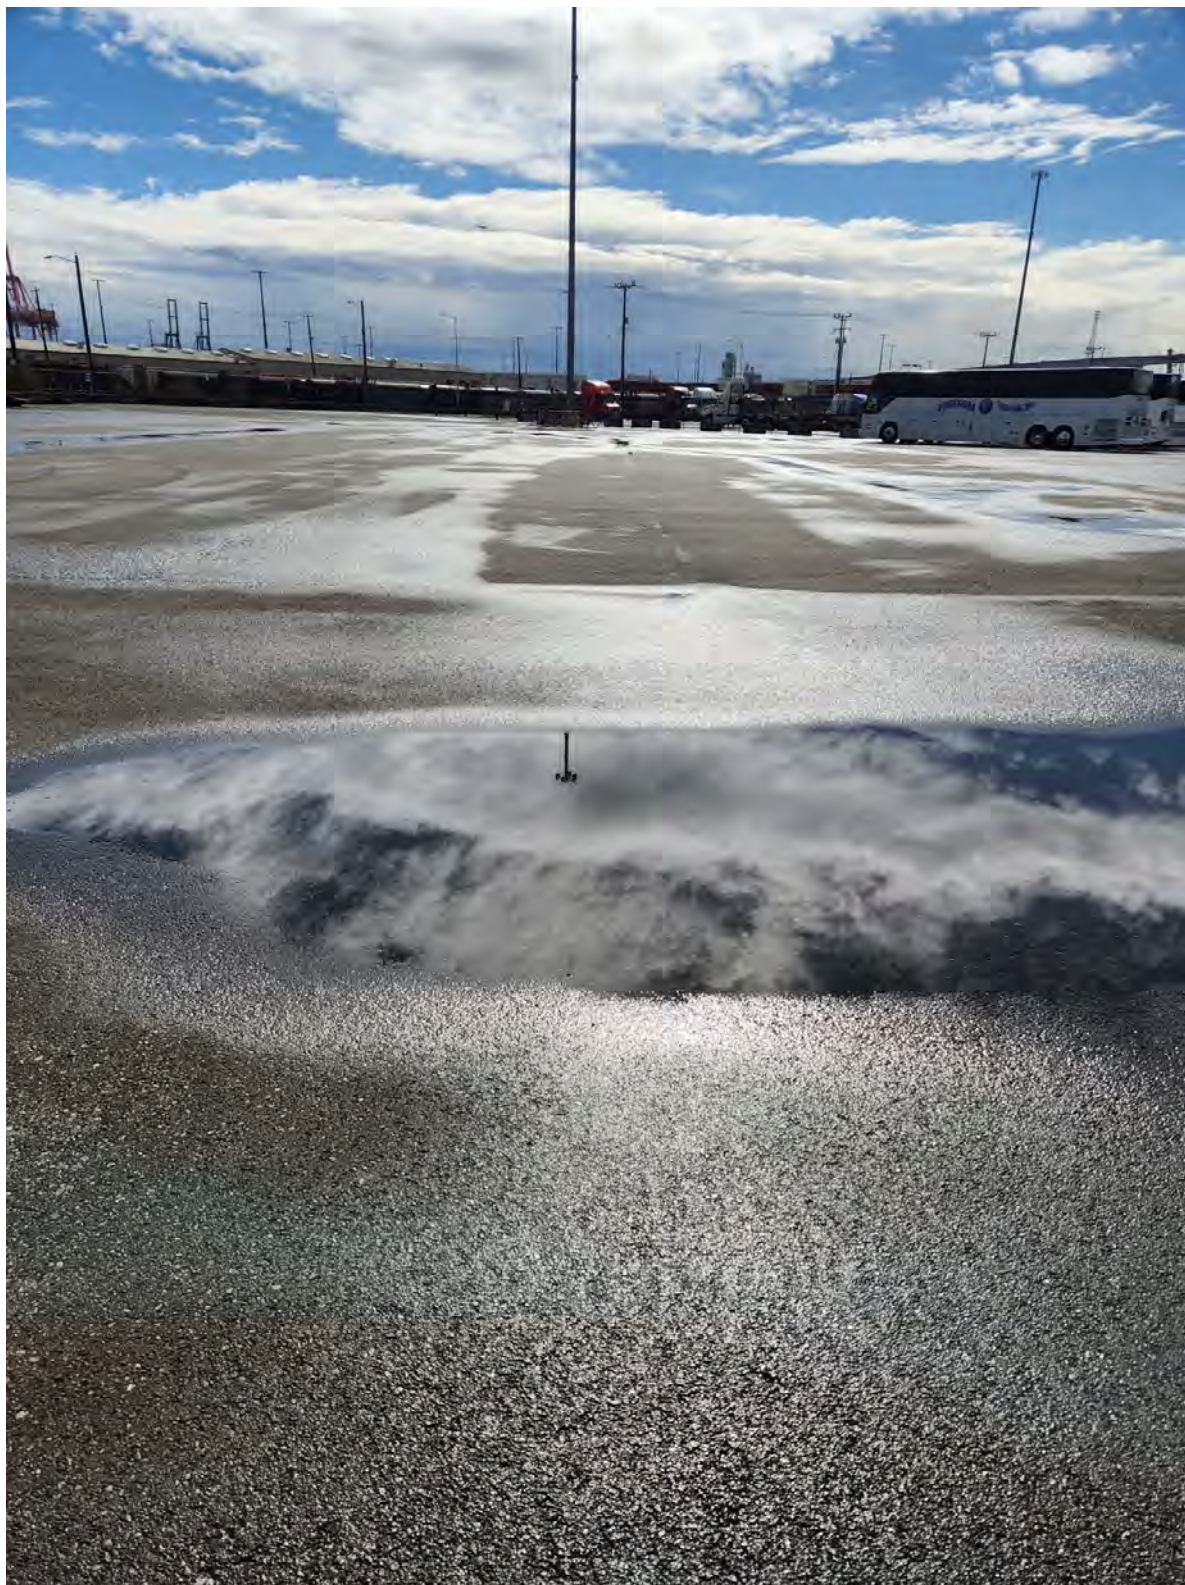
Photo 3. Lockheed Upland Ponding

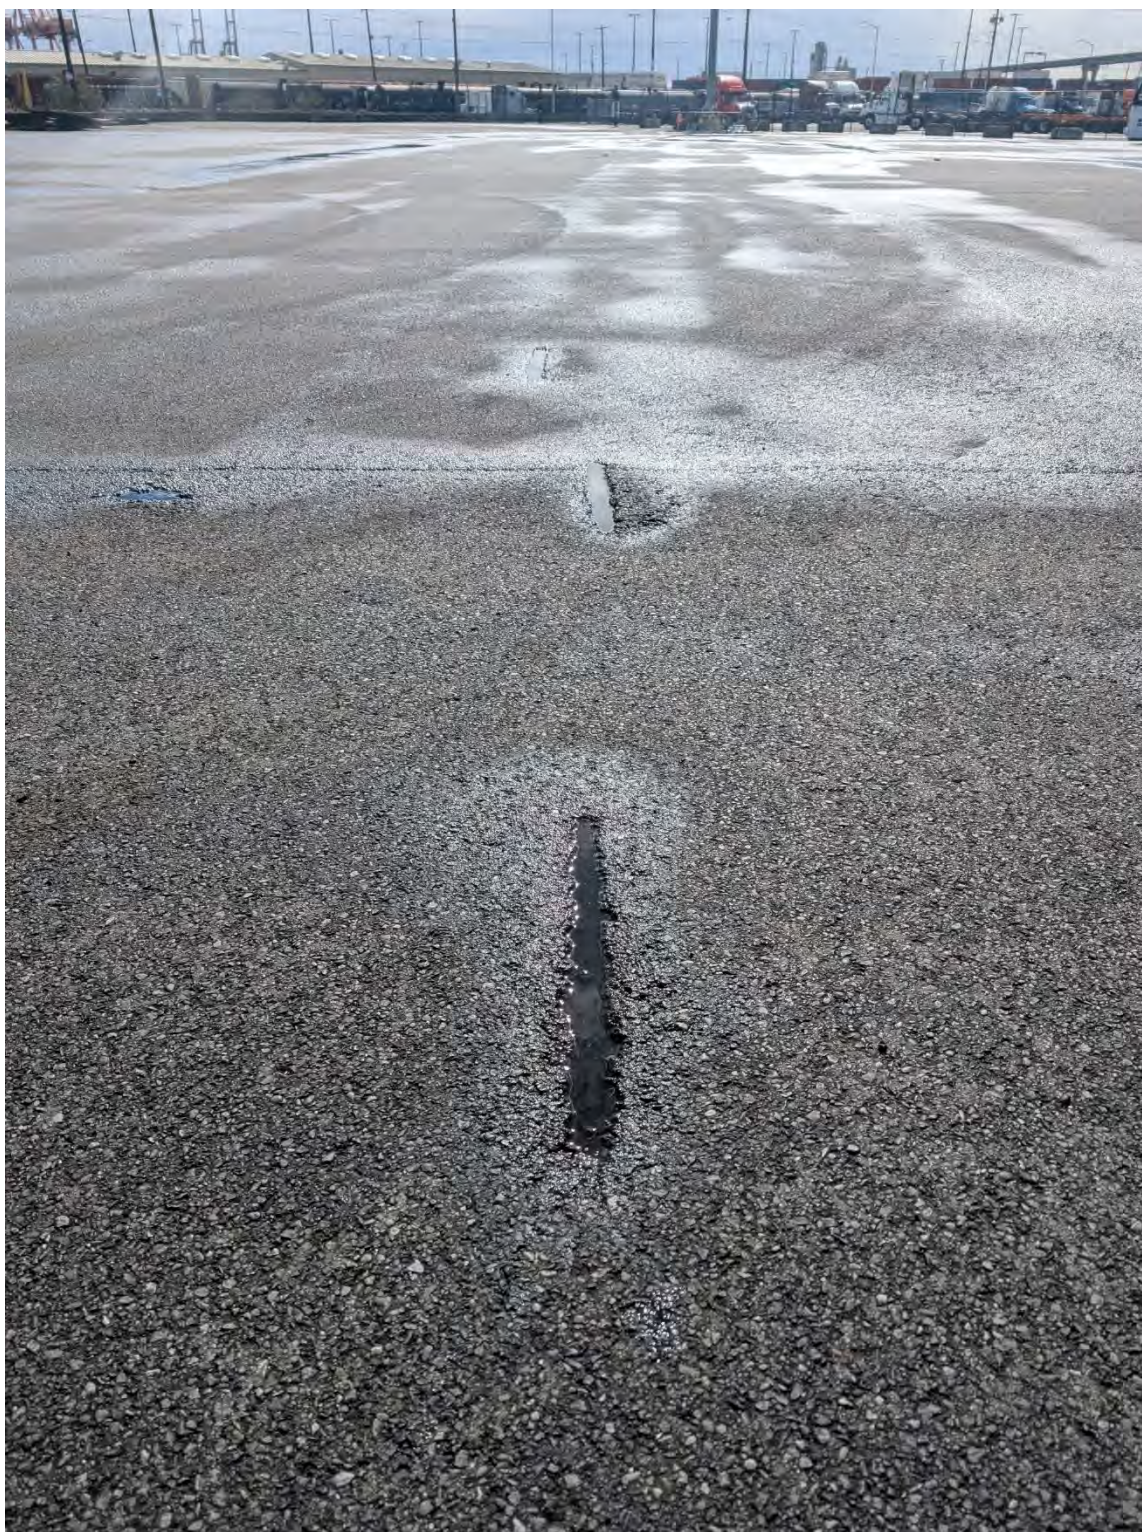
Photo 4. Lockheed Upland Gouges on Cap

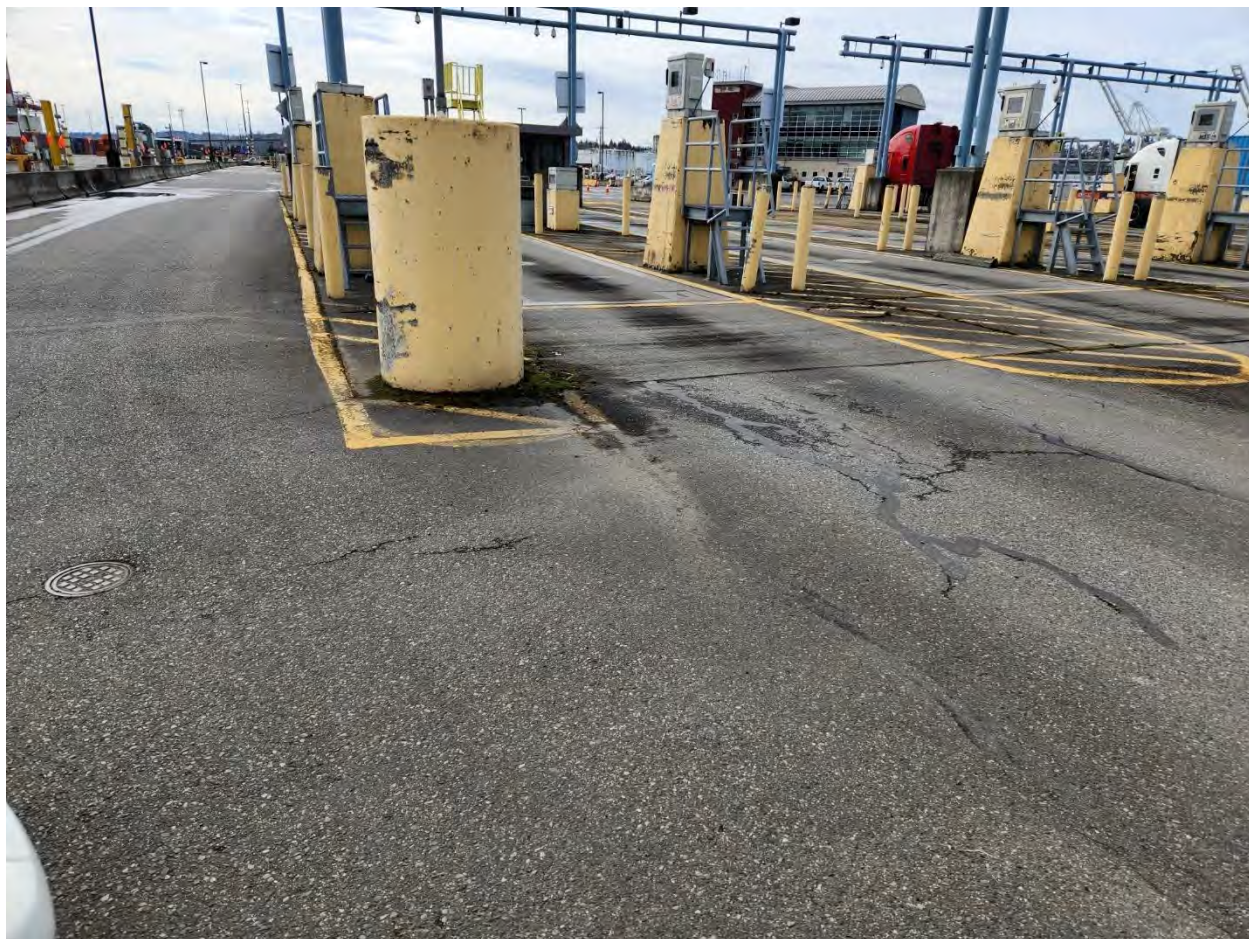
Photo 6. Terminal 18 Northern Area Pavement Cracks with Repairs

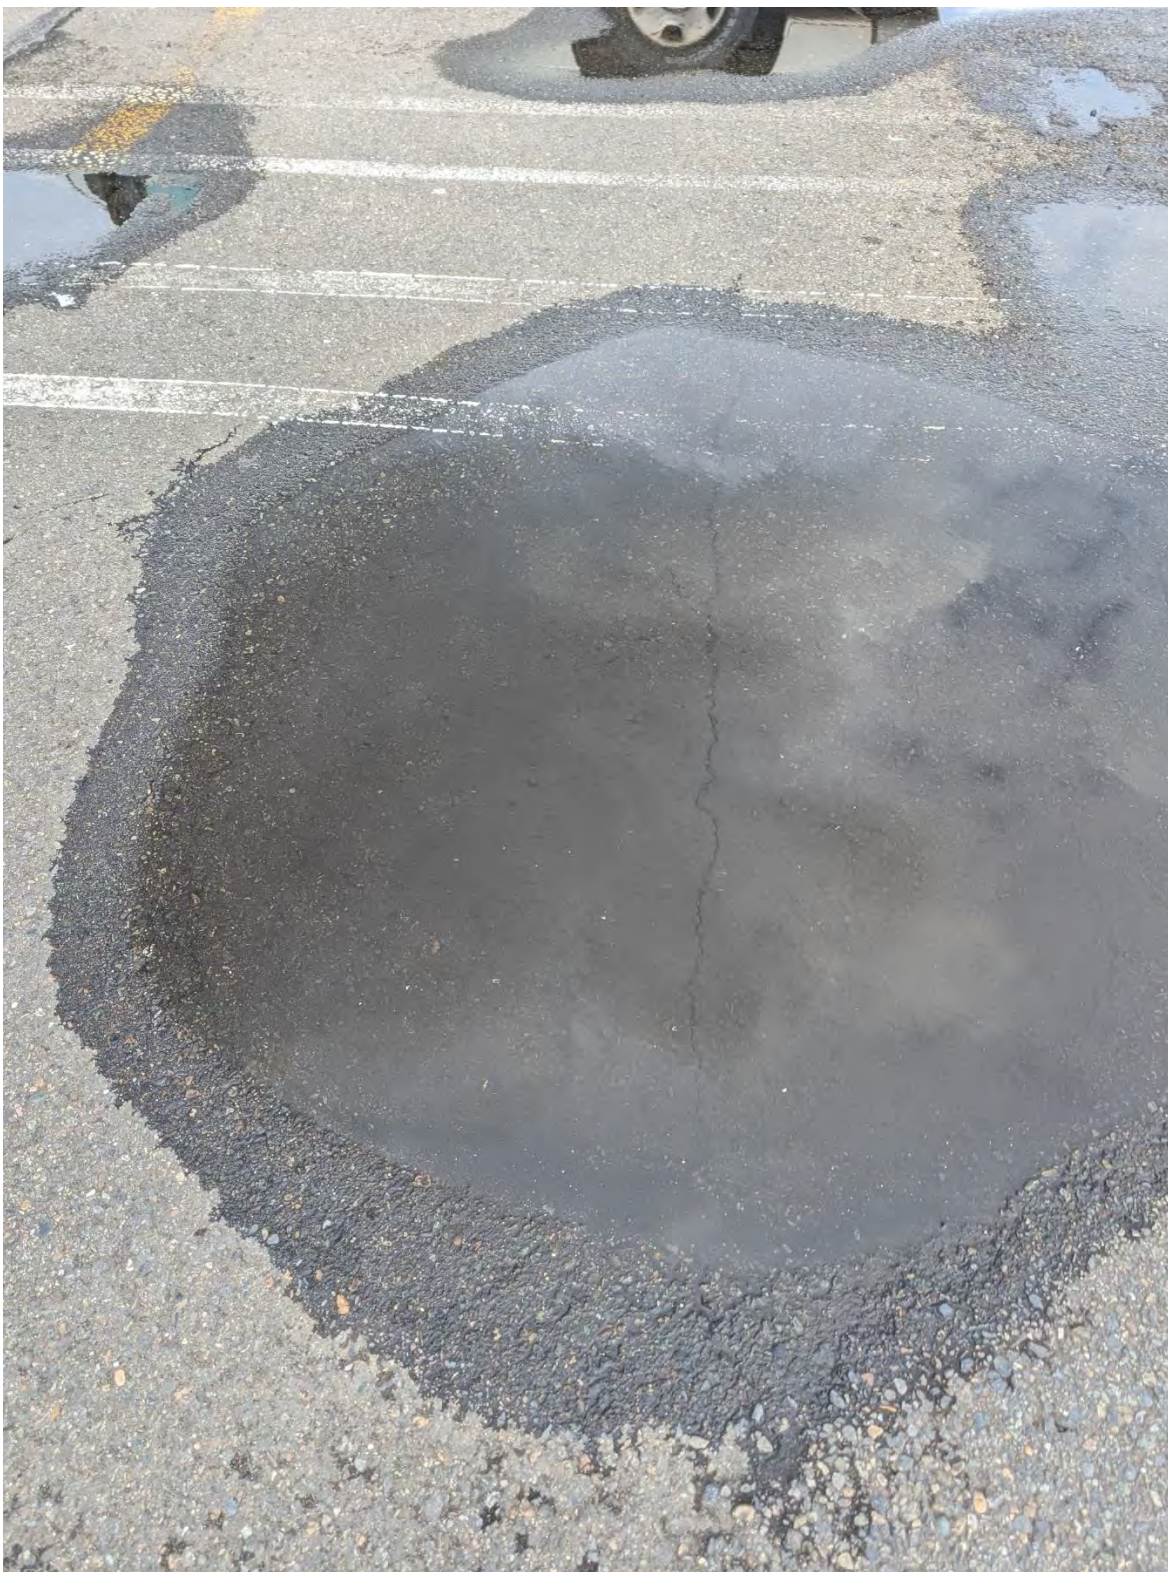
Photo 7. Terminal 18 Central Area Ponding with Cracking

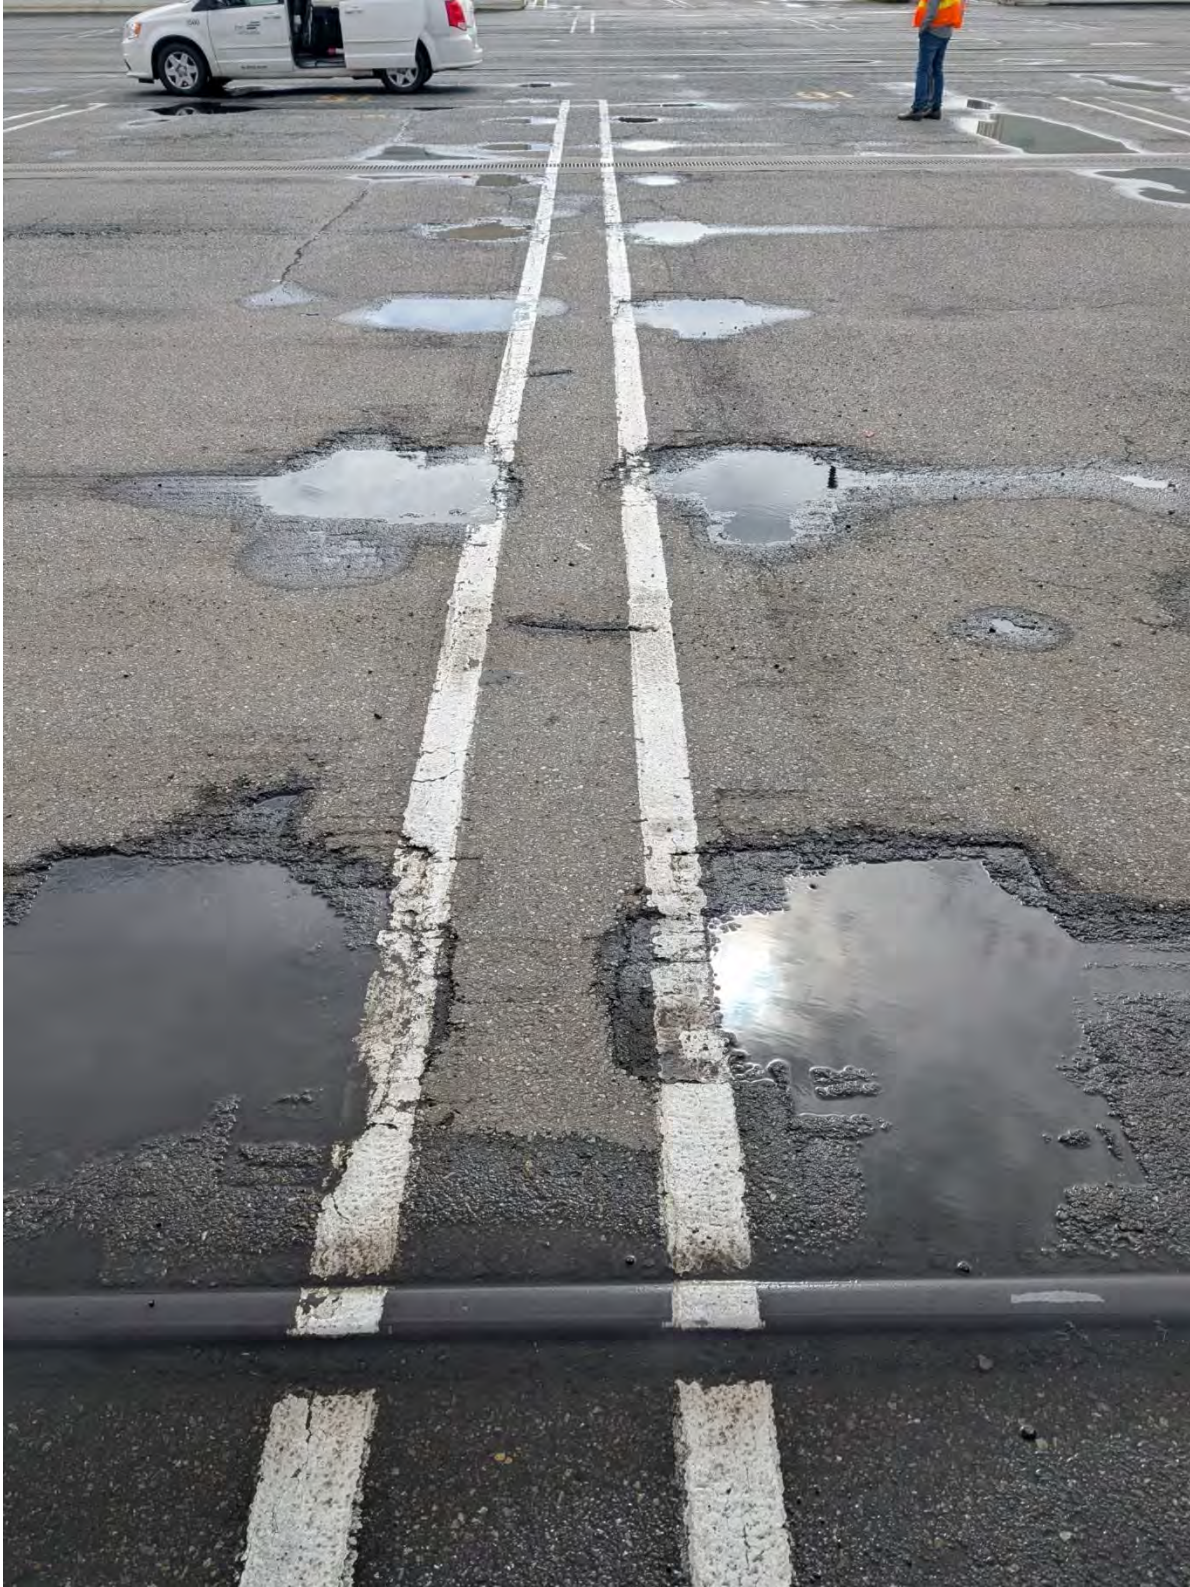
Mr. Brick Spangler of the Port of Seattle commented that the remedy is functioning as intended. While the cap is showing some signs of wear in portions of T-18, it remains protective. The Port continues to conduct O&M inspections and maintenance.

Photo 8. Terminal 18 Central Area Cap Damage from Containers

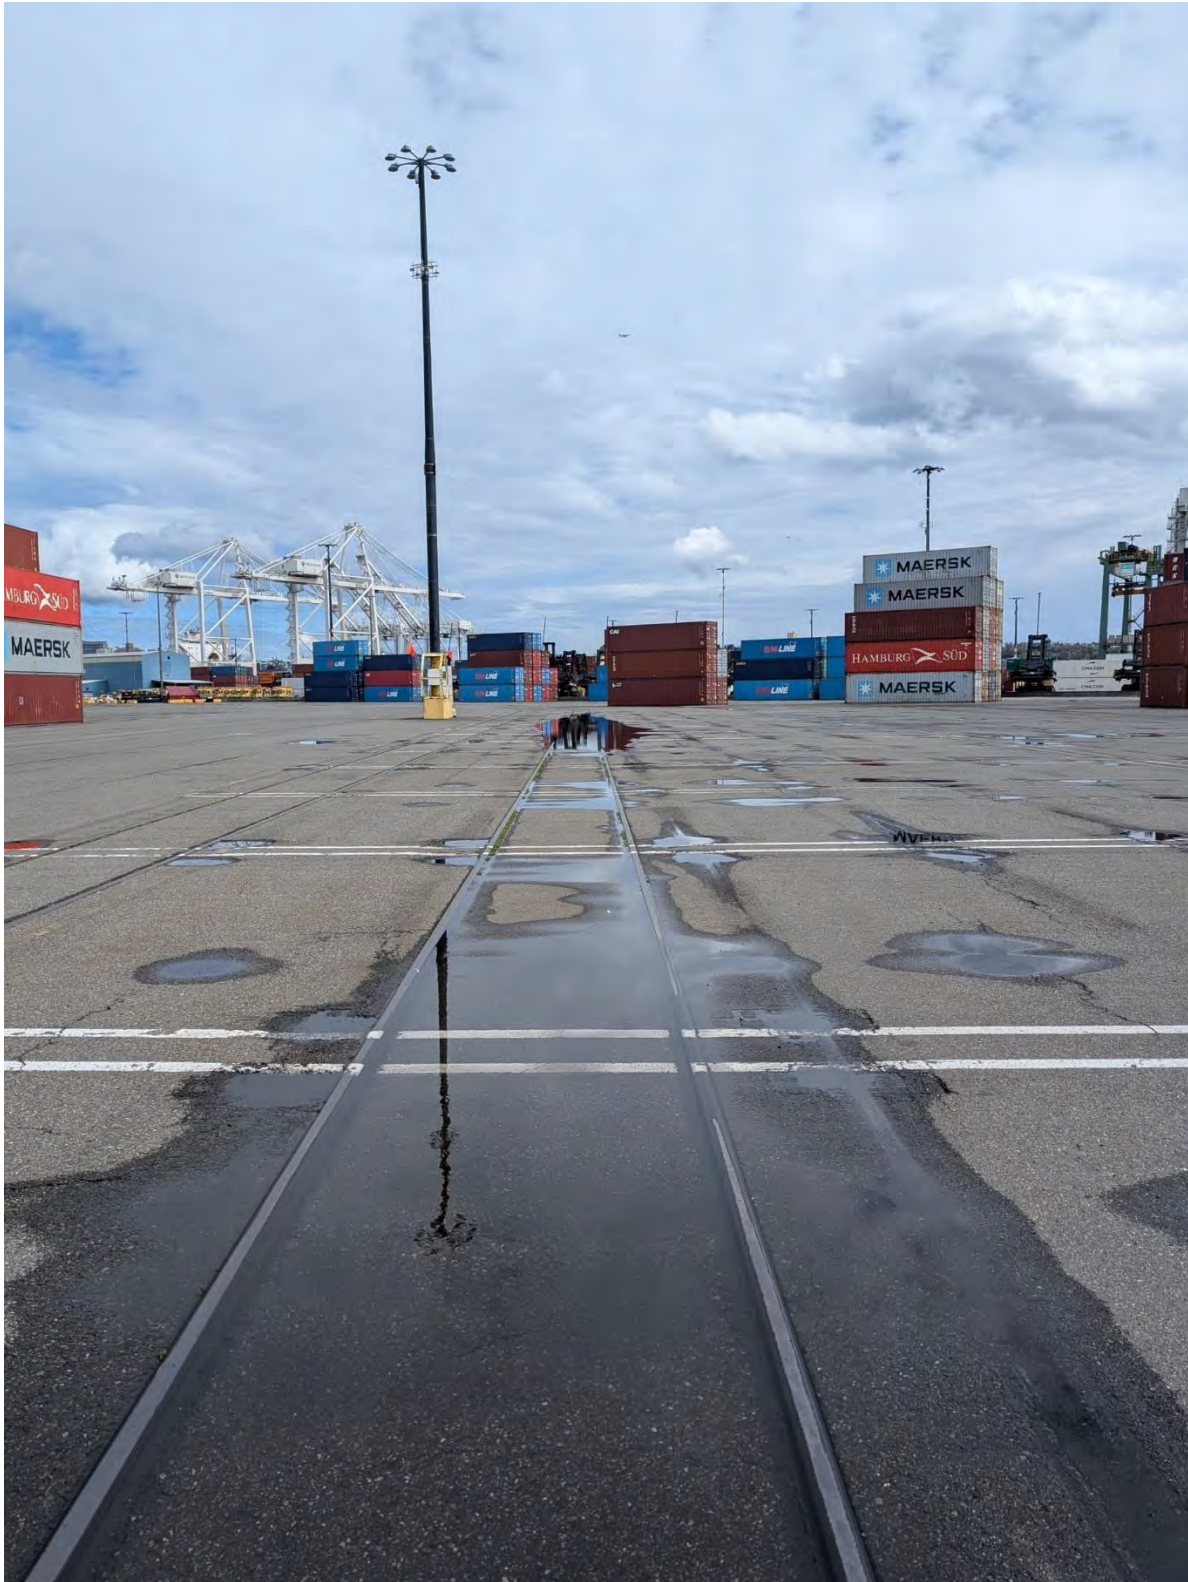
Photo 9. Terminal 18 Southern Area Ponding Along Rail Lines

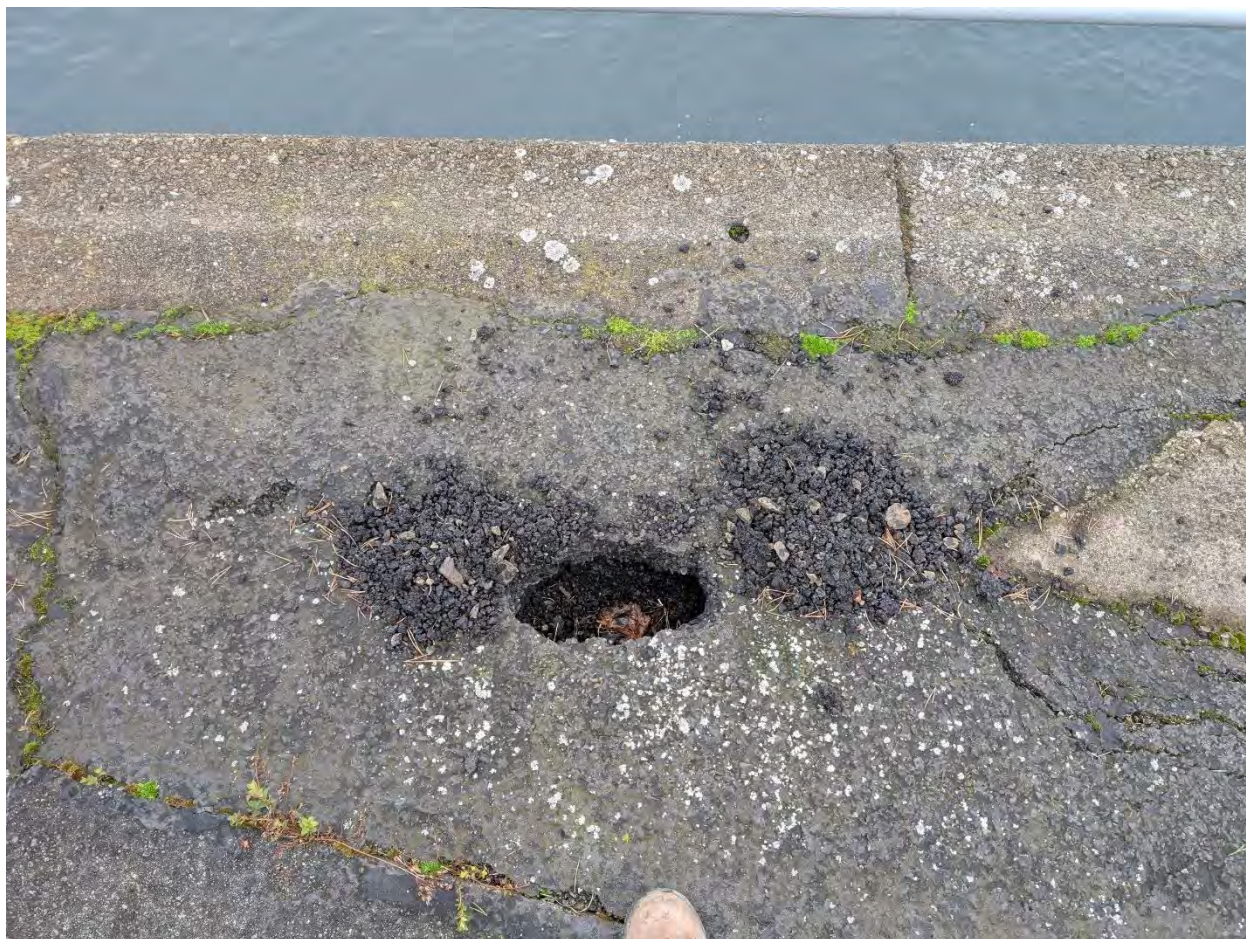
Photo 15. UPRR Parcel A Hole on Eastern End

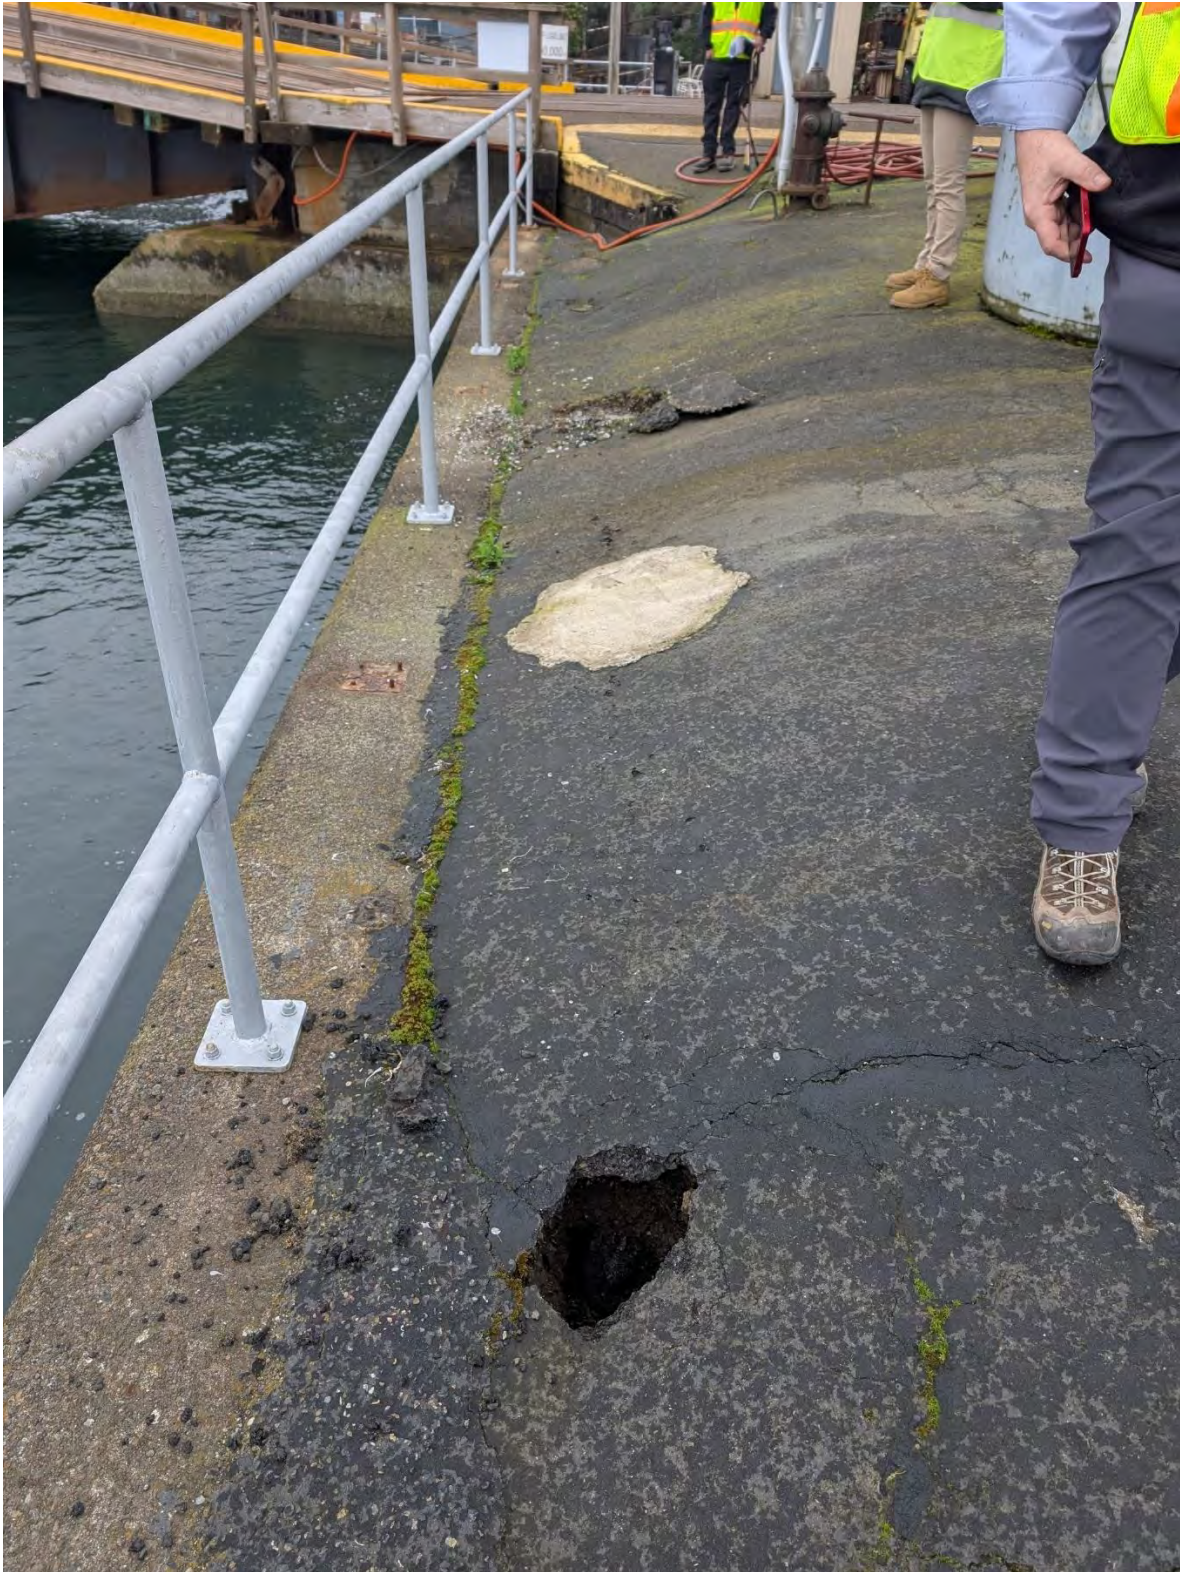
Photo 16. UPRR Parcel A Holes on Western End
