## **Fourth Periodic Review Sparks & Buttercup Subdivision**

**12<sup>th</sup> Avenue and Eastern Street, Spokane  
Facility Site ID: 695, Cleanup Site ID: 1140**

November 2025, Publication 25-09-028

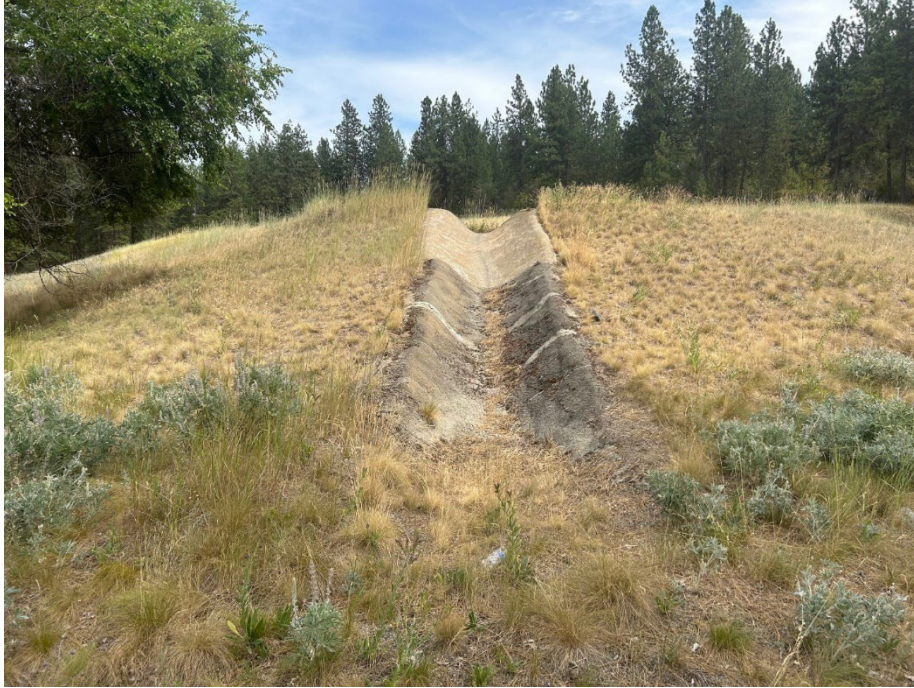
During the Site visit Ecology conducted on July 22, 2025, the soil cap appeared to be in satisfactory condition and continues to provide a barrier to residual contamination, which prevents direct human or animal contact. The Site remains undeveloped. There is evidence of human foot traffic and wildlife use on the cap and surrounding slope. This traffic does not appear to be adversely impacting the cap or posing a risk of exposing contaminated soils contained at the Site. Wood fencing, signage, and concrete and metal drainage controls appear to be in satisfactory condition, though signs of potential animal burrowing and/or erosion of soils were observed near the northwestern drainage trench. A photo log is in Appendix C.

**Photo 1: Northwest drainage trench — from the northwest**

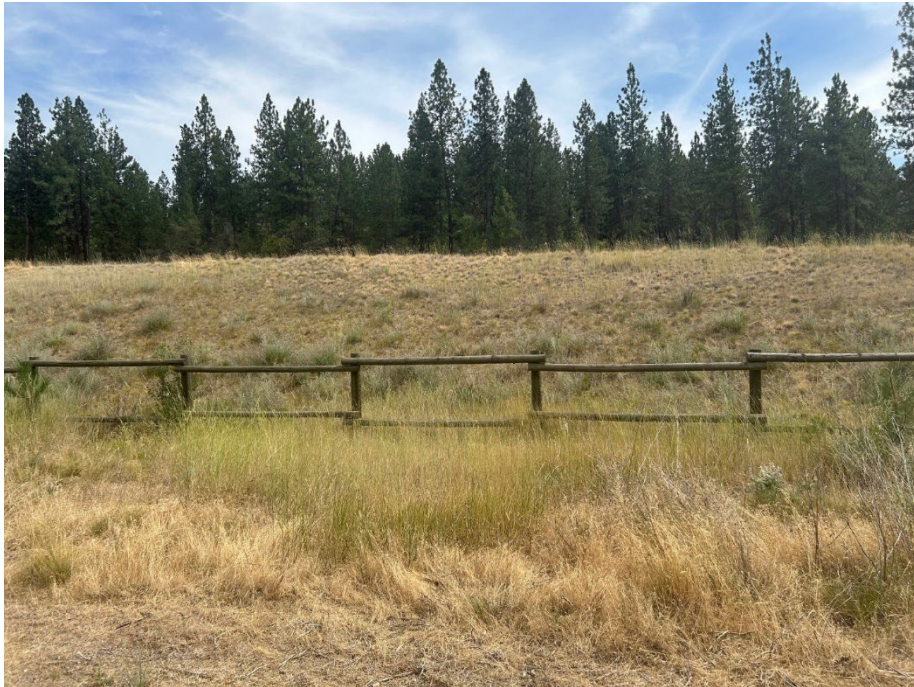
**Photo 2: Northern landfill slope and fence — from the north**

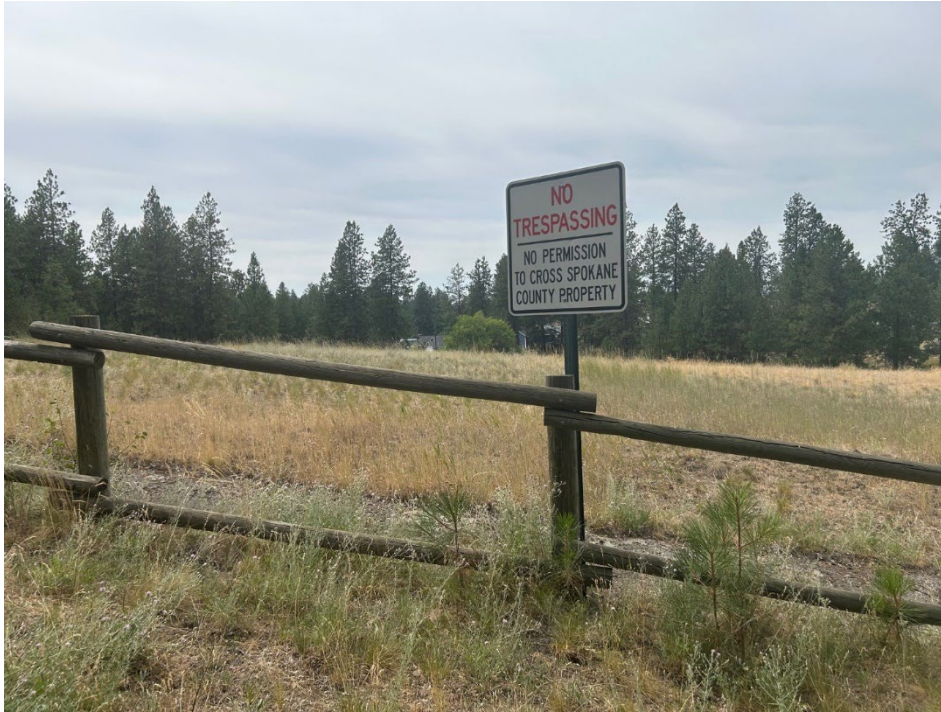
**Photo 3: Eastern landfill boundary, fence, and sign — from the east**

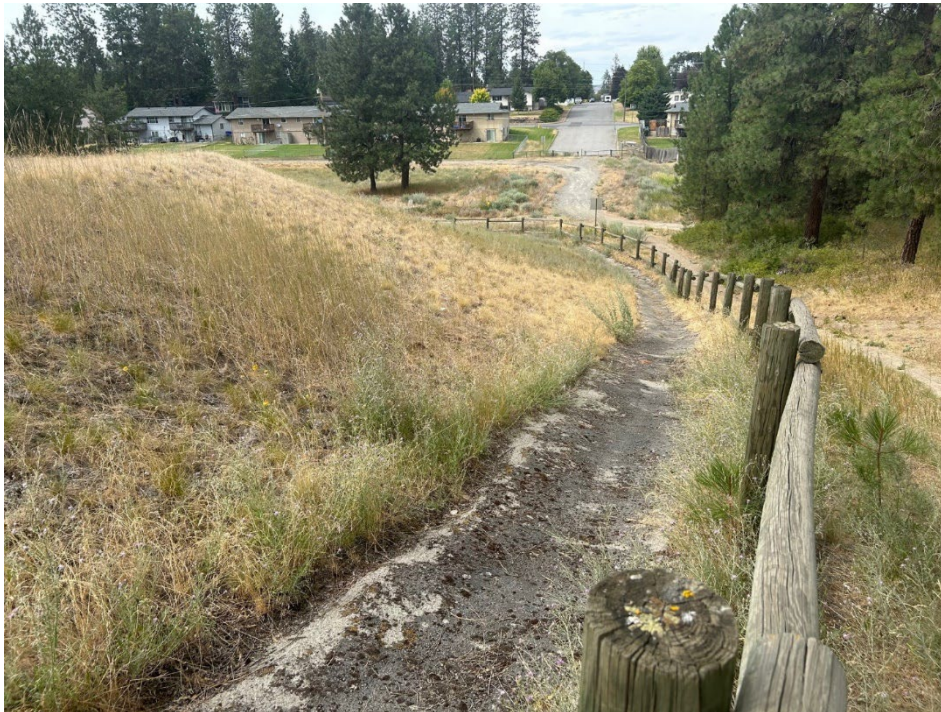
**Photo 4: Eastern drainage trench and fence— from the south**

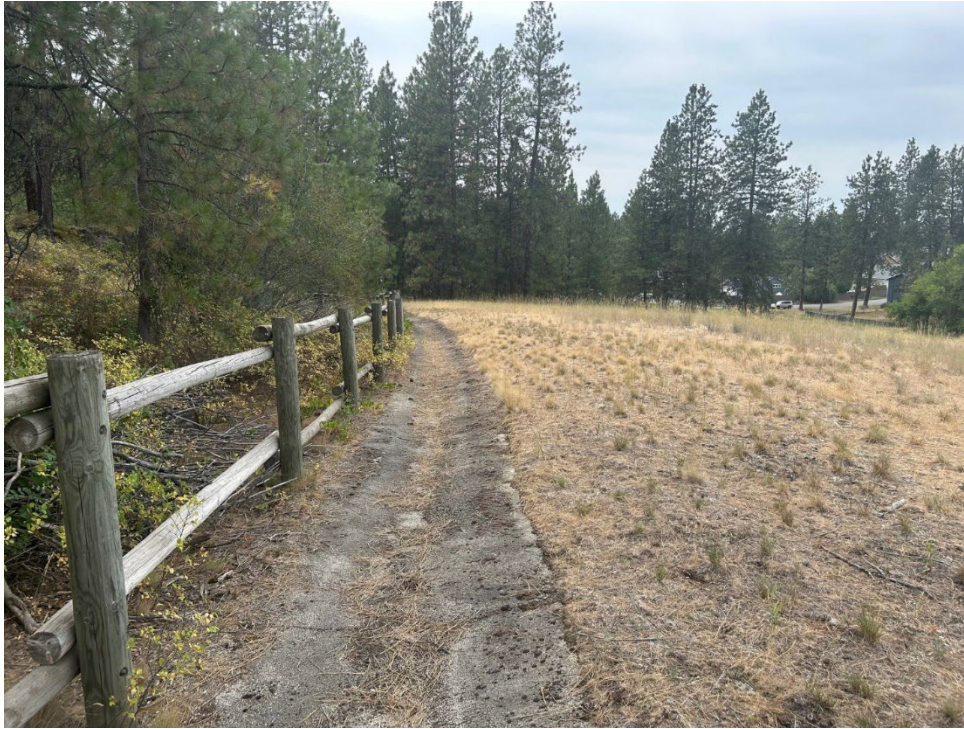
**Photo 5: Southern drainage trench and fence— from the east**

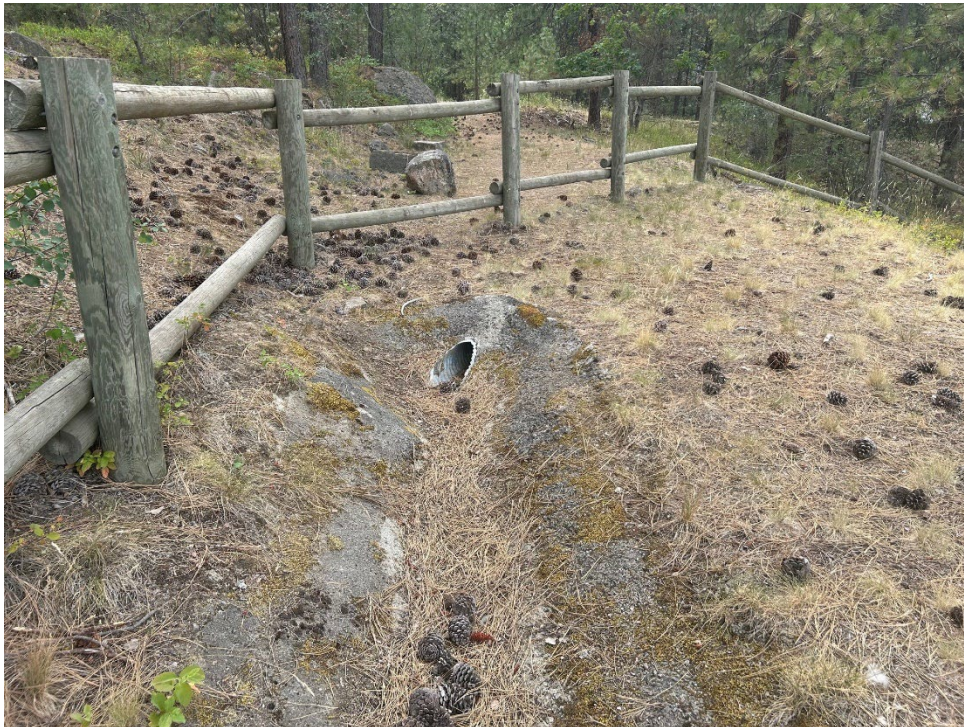
**Photo 6: Southern drainage trench, culvert, and fence — from the east**
