TECHNICAL MEMORANDUM

RE: **Former Mill E / Koppers Facility
2024 Annual Performance and Compliance Monitoring Report**

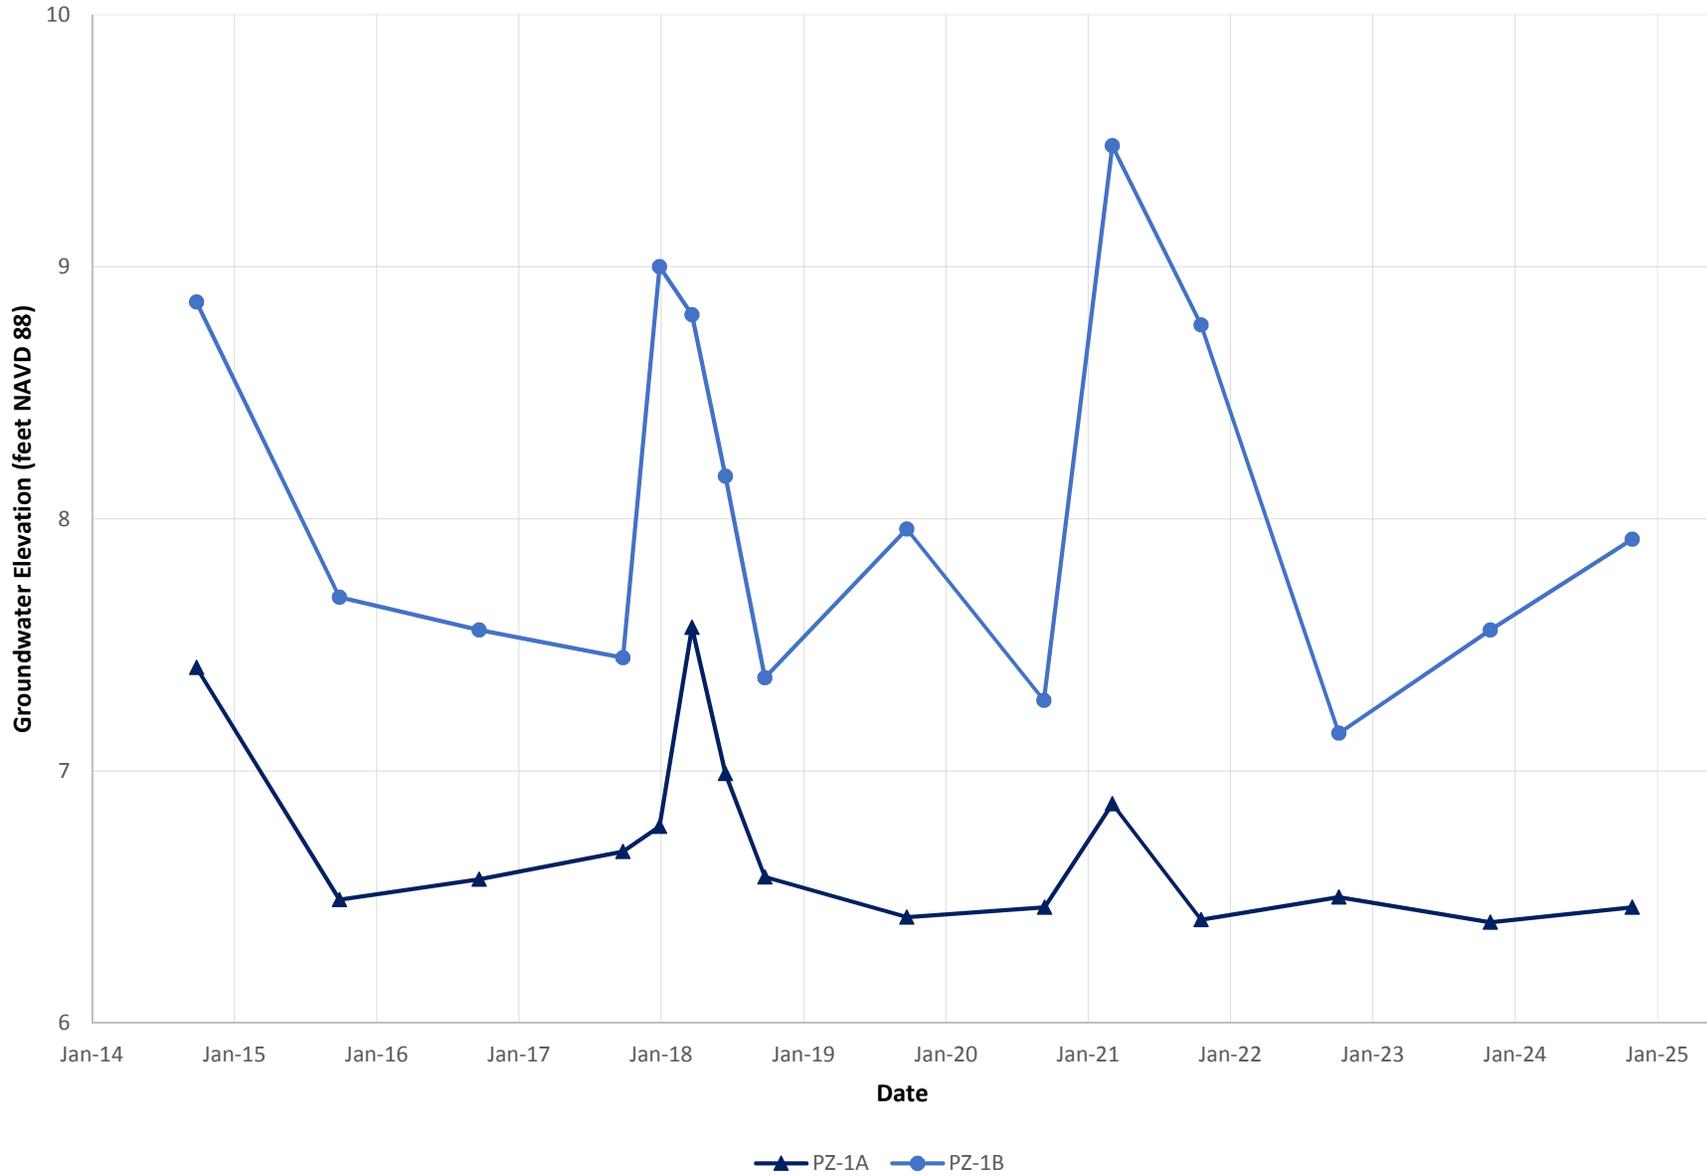
Figure 3
Groundwater Elevation Trends
PZ-1A and PZ-1B
Former Mill E / Koppers Facility
Everett, Washington

Groundwater elevation trends for each piezometer pair are presented on Figures 3 through 5 and show a comparison of historical groundwater elevation data from 2014 to 2024. Review of the data indicates the groundwater elevations outside of the barrier wall are higher than inside the barrier wall with the exception for piezometer PZ-3B in September 2015 and in October and November 2022. As part of the data review, MEC discovered the groundwater elevation for piezometer PZ-3B in 2015 was reported by others one-foot higher than the corrected value; therefore, a lower groundwater elevation outside was observed. The reason for the lower water level observed in piezometer PZ-3B in 2015 is unknown; however, it may be due to dry season conditions observed similar in 2022. The slightly lower than expected groundwater elevations in piezometer PZ-3B in October and November 2022 may be the result from the atypical dry summer months in 2022 (AESI, 2022).

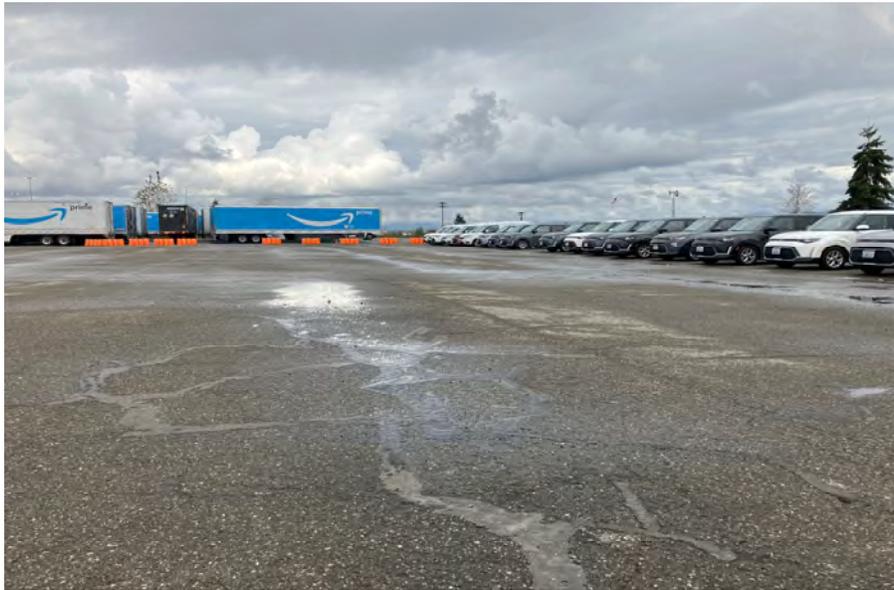
The property is occupied by Amazon service small delivery vehicles and truck and trailers, many of which were parked at the time of the site visit. There was white paint marked parking spaces observed throughout the site (Photographs 1 and 2).

Photograph 1 - Looking north-northeast at the southern portion of the asphalt cap. Multiple cracks are observed to be repaired with a crack joint sealant.

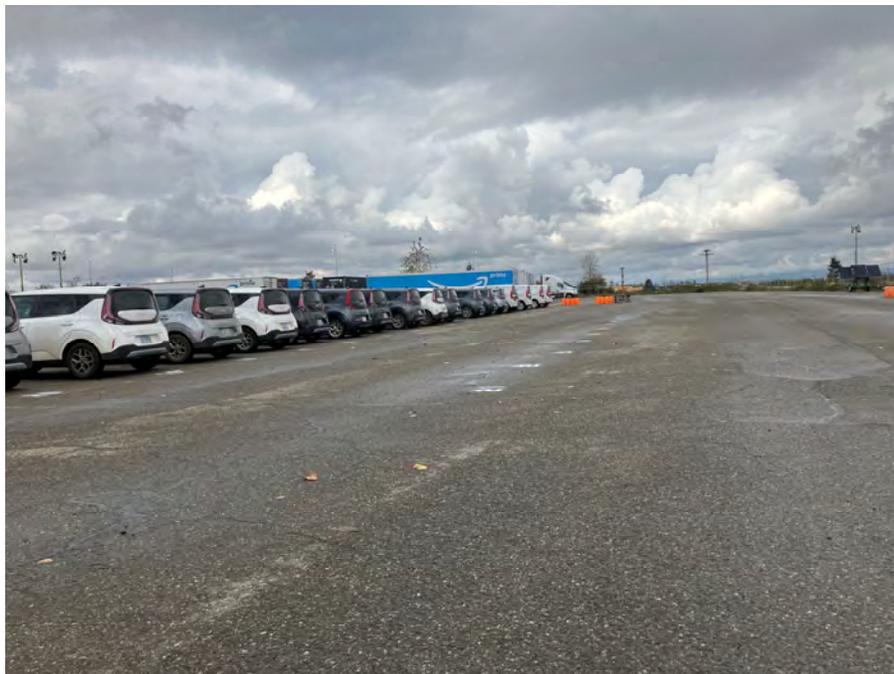
Photograph 2 - Looking north-northwest at the southeastern portion of the asphalt cap with thin cracks on surface observed to be repaired.

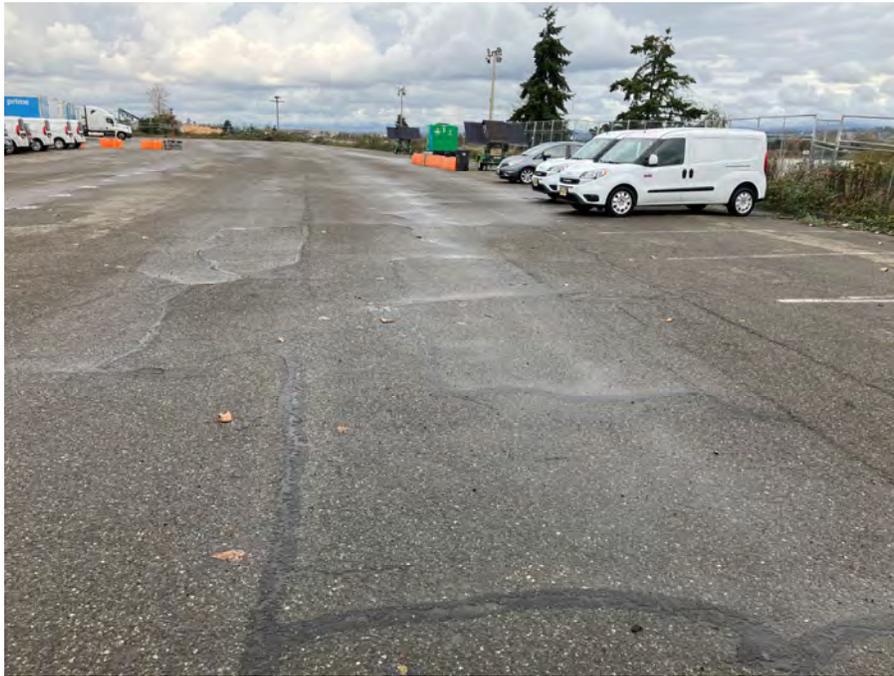
Most of the asphalt cap, about 85 to 95 percent, was visible at the time of the site visit. The asphalt cap was observed to be in serviceable condition. The minor cracks in the asphalt cap from the previous year were observed to have been repaired with asphalt crack filler/sealer (Photograph 3).

Photograph 3 - Looking west at the northeastern portion of the asphalt cap. Photograph of typical asphalt crack repaired with a joint sealant.

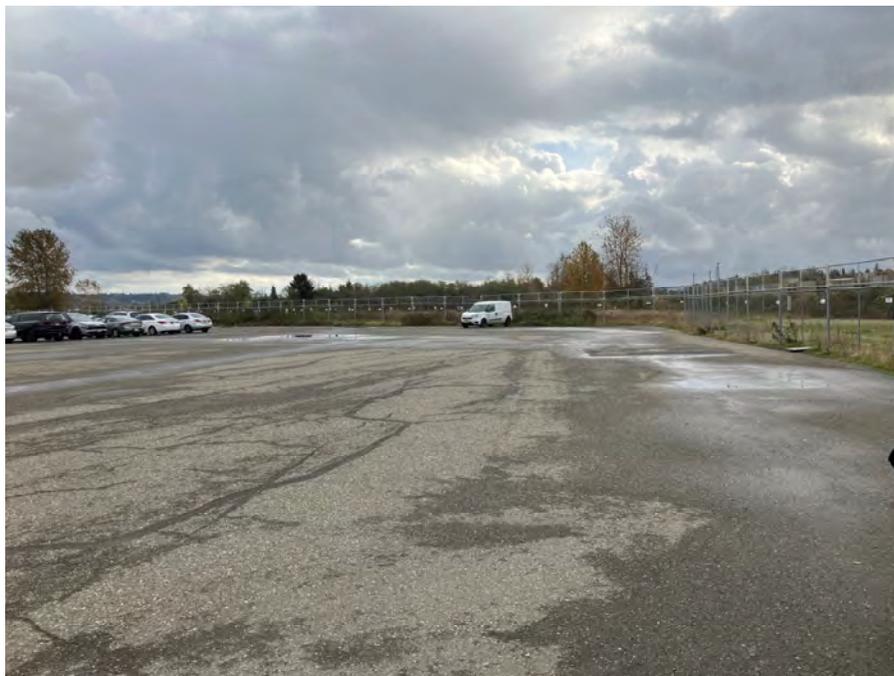
No obvious signs of major cracking, fissures, or surface pumping were observed. There are areas where shallow depressions were observed, which were less than 2-inches in depth from recent rainfall. These shallow depressions were less than 10 feet in diameter, like the previous year. Minor ponding on asphalt surface was observed in areas with shallow depressions (Photograph 4).

Photograph 4 - Looking south-southwest at the western portion of the asphalt cap with repaired cracks on surface and minor ponding.

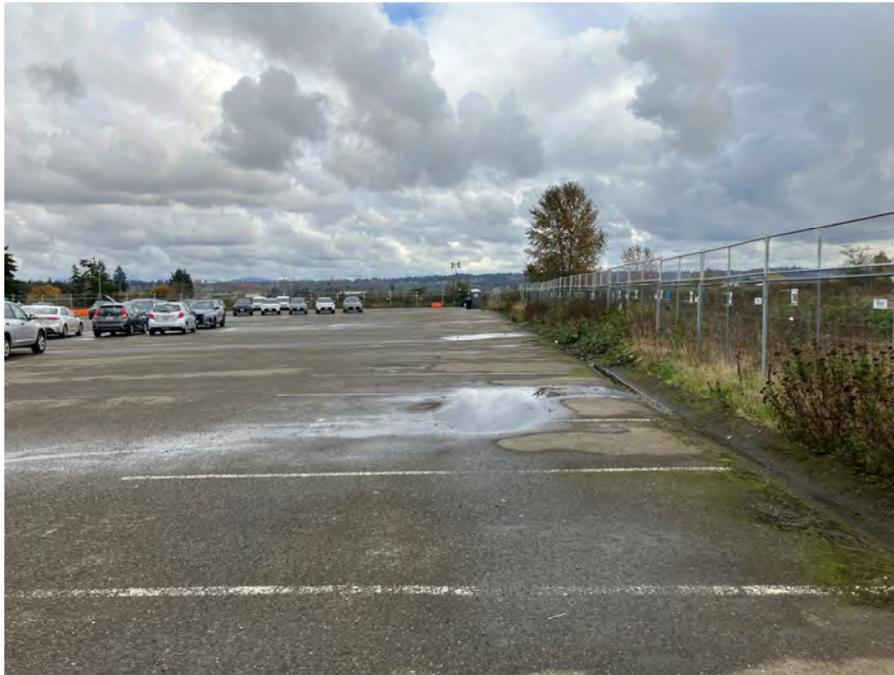
Drainage ditches had nominal amounts of accumulated sediment than previous year, and where present, the accumulated sediment amounts appeared to be less than 1/2-inch. Minor cracks with vegetation growing through were observed along the southern drainage ditch. In addition, vegetation was growing from the adjoining soil cap area into the southern drainage ditch (Photograph 5).

Photograph 5 - Looking east at southeastern portion of the asphalt cap. Photograph shows vegetation in the south drainage ditch. Vegetation was observed to be growing through minor cracks and adjoining soil cap area.

Madrona Environmental Consulting, LLC recommends maintaining the drainage ditches by removing visible vegetation from the minor cracks and sediment in the drainage ditches, and overlying vegetation in ditches from soil cap areas inside the fenced area. In addition, it is recommended that maintenance of the asphalt cap continue, if cracks are observed, to maintain the asphalt cap integrity in a serviceable condition and meet the performance objectives to prevent potential direct contact with contaminated soil and surface water infiltration at the site.

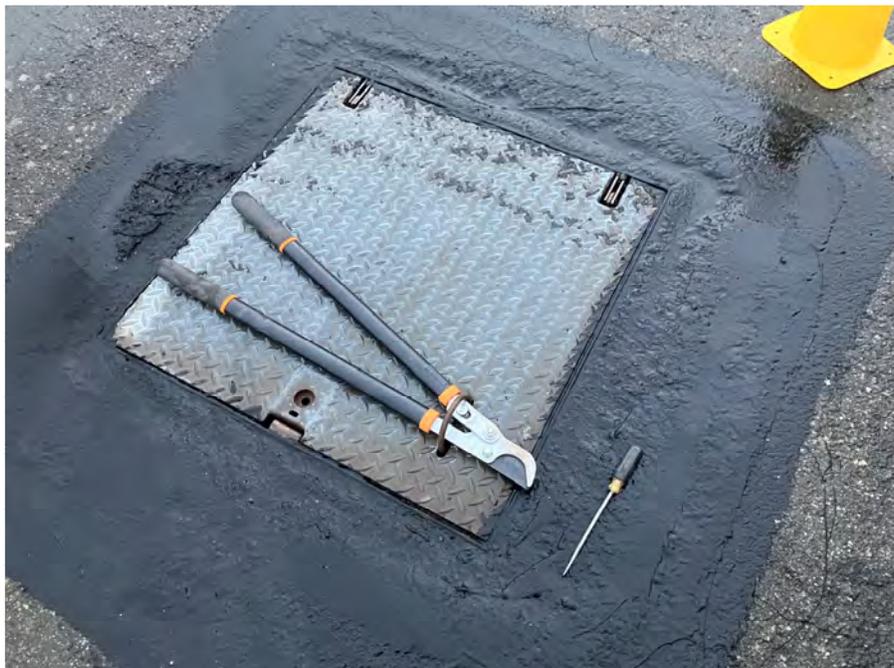
The vault lid for well PZ-3A was partially sealed with asphalt sealant from asphalt cap repairs performed at the site (Photograph 6). MEC was able to remove the sealant to access the well.

Photograph 6 - Photograph of well PZ-3A vault lid with asphalt sealant.

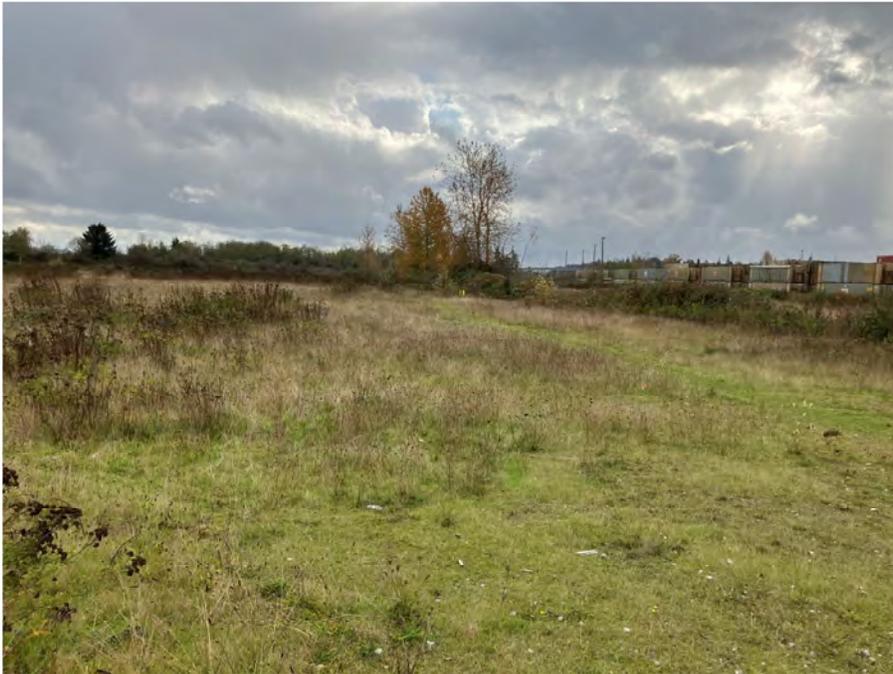
The soil cap to the south of the asphalt cap appeared intact and is performing as intended (Photographs 7 and 8). No major ponding or erosion was observed. Photographs of general observations are provided below.

Photograph 7 - Looking south at western portion of the soil cap.

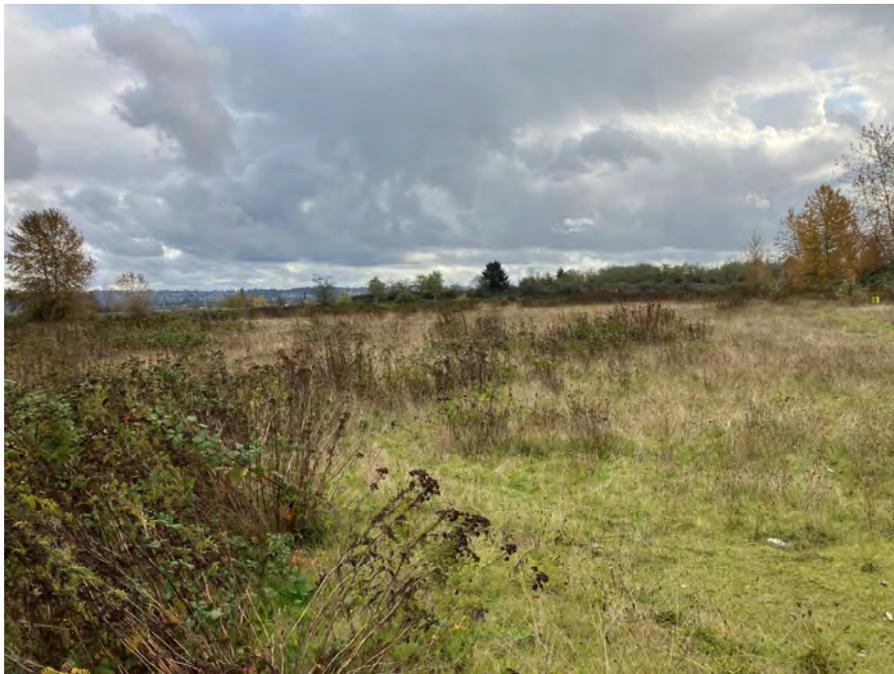
Photograph 8 - Looking south at eastern portion of the soil cap.
