## **Periodic Review BNSF Hillyard Lead Soil Site**

**5201 North Ferrall Street, Spokane  
Facility Site ID: 960924, Cleanup Site ID: 1371**

November 2025, Publication 25-09-030

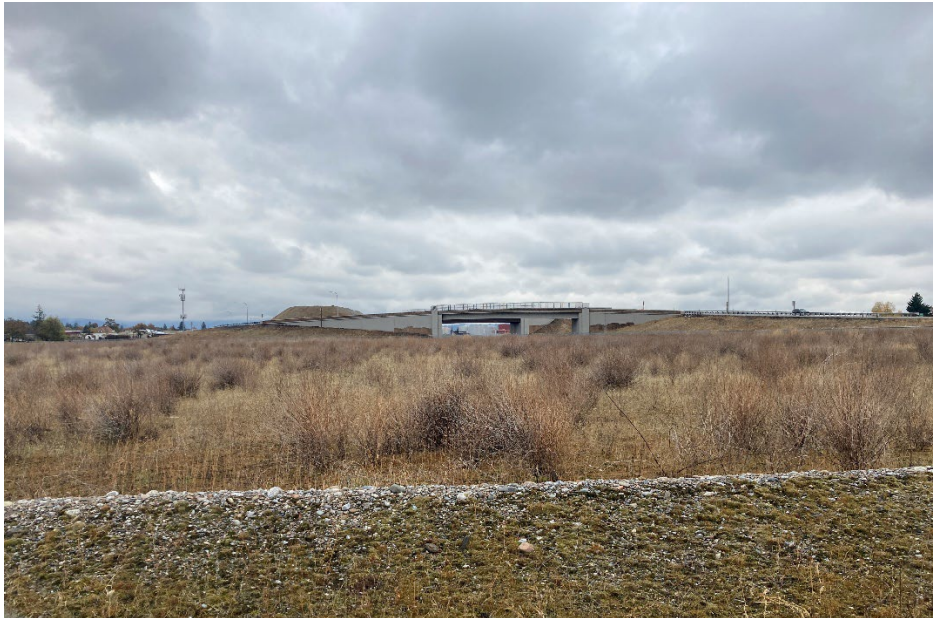
During the Site visit Ecology conducted on November 4, 2025, the soil cap appeared to be in satisfactory condition and continues to provide a barrier to residual contamination, which prevents direct human or animal contact. The Site remains undeveloped with the exception of the 6-ft chain-link fence installed around the perimeter of the containment area.

**Photo 1: Capped containment area with sloped perimeter — from the north**

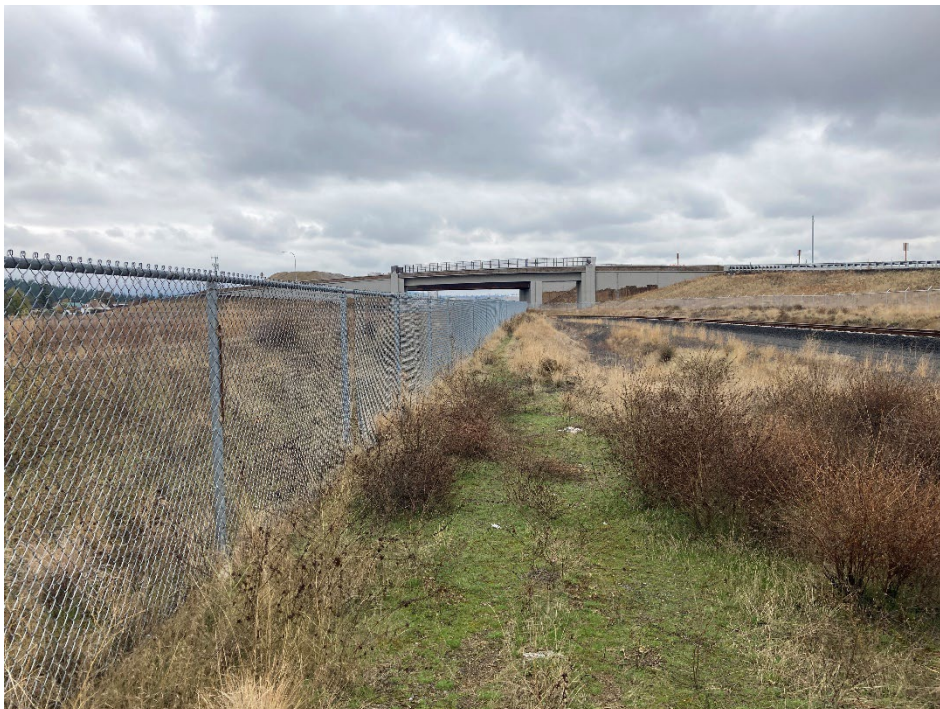
**Photo 2: Western perimeter fence and BNSF railway — from the north**

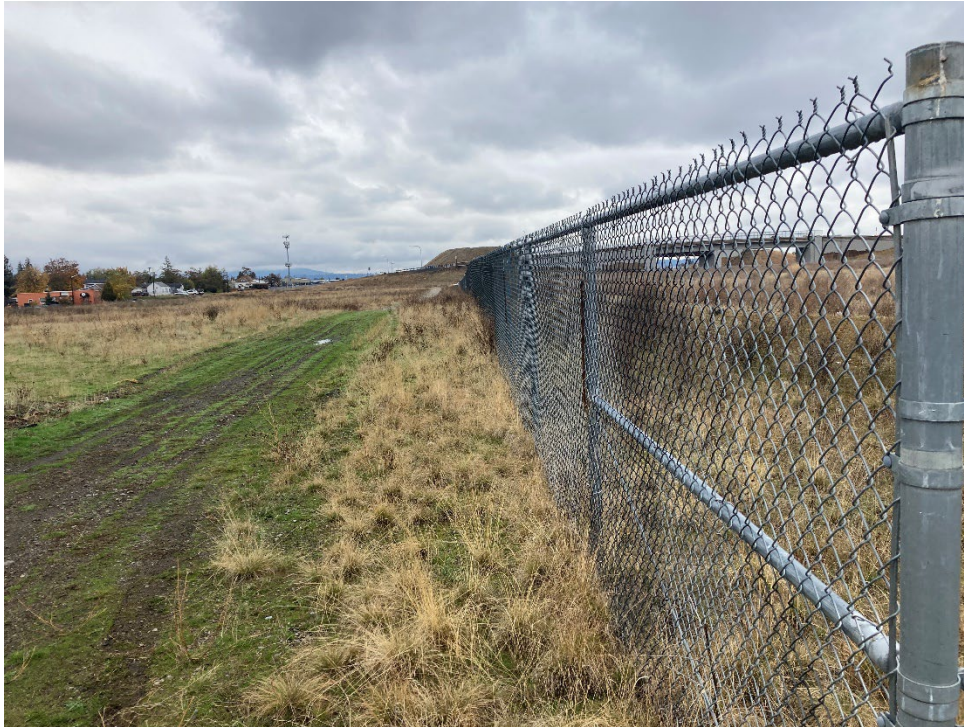
There is evidence of human foot traffic around and within the containment area, as observed in garbage piles inside and outside the fence. This traffic does not appear to be adversely impacting the cap or posing a risk of exposing contaminated soils contained at the Site. Ecology also observed where fencing has undergone repair due to vandalism and/or theft. These incidents have been reported to Ecology by BNSF since 2022. These damaged areas have been reinforced through additional welding. A photo log is in Appendix C.

**Photo 3: Eastern perimeter fence with welded reinforcement — from the north**

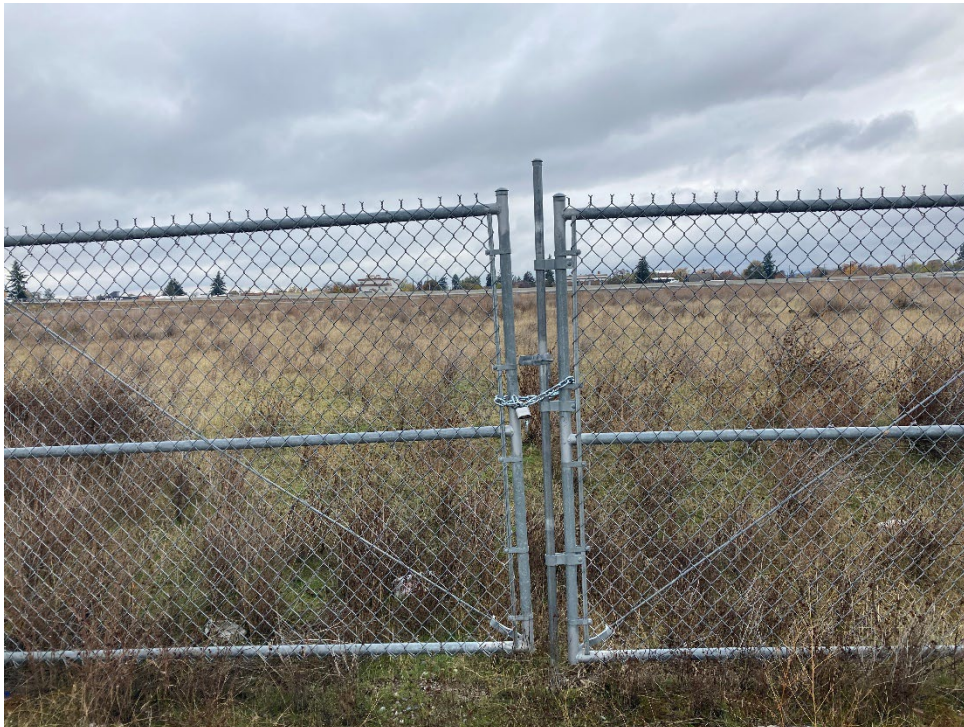
**Photo 4: Containment area access gate — from the east**

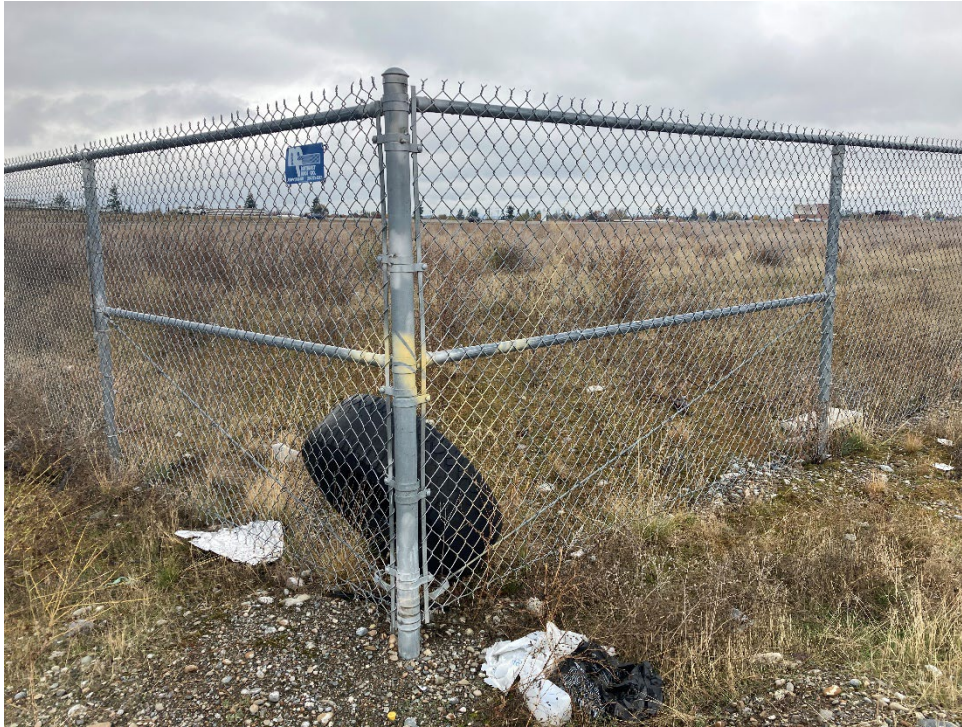
**Photo 5: Southeast corner of perimeter fence with debris — from the southeast**

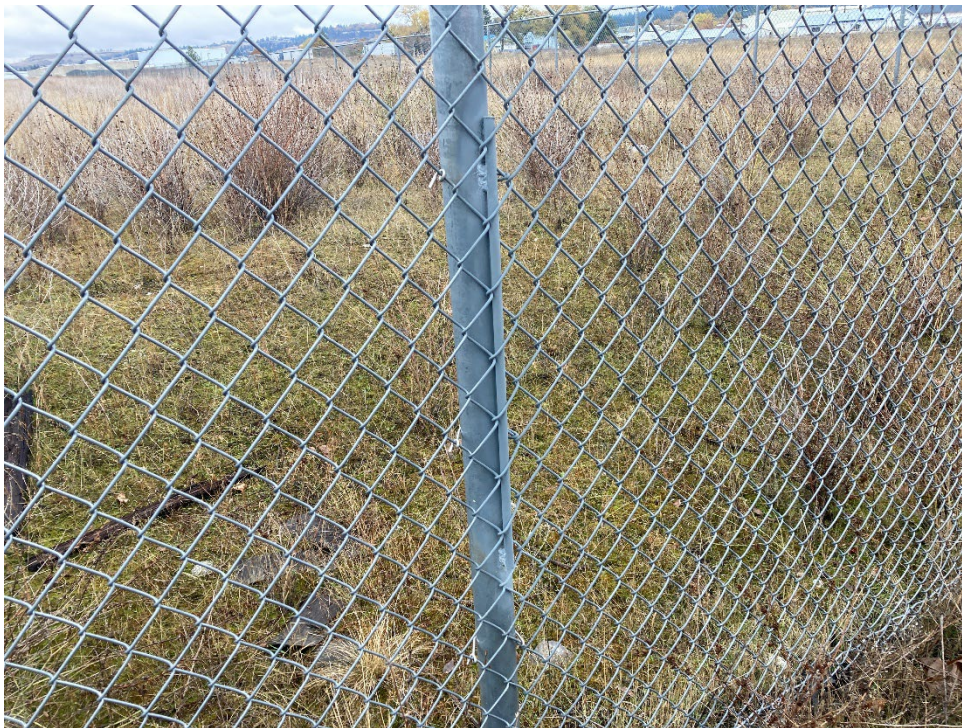
**Photo 6: Welded post to reinforce perimeter fence — from the south**
