**RE: 2025 ANNUAL PROGRESS REPORT
BLOCK 38 WEST SITE
500 THROUGH 536 WESTLAKE AVENUE NORTH
SEATTLE, WASHINGTON
CONSENT DECREE NO: 25-2-01367-7 SEA
FARALLON PN: 397-019**

**ATTACHMENT A
DECEMBER 2025 PERIODIC MONITORING FORM**

PERIODIC MONITORING FORM

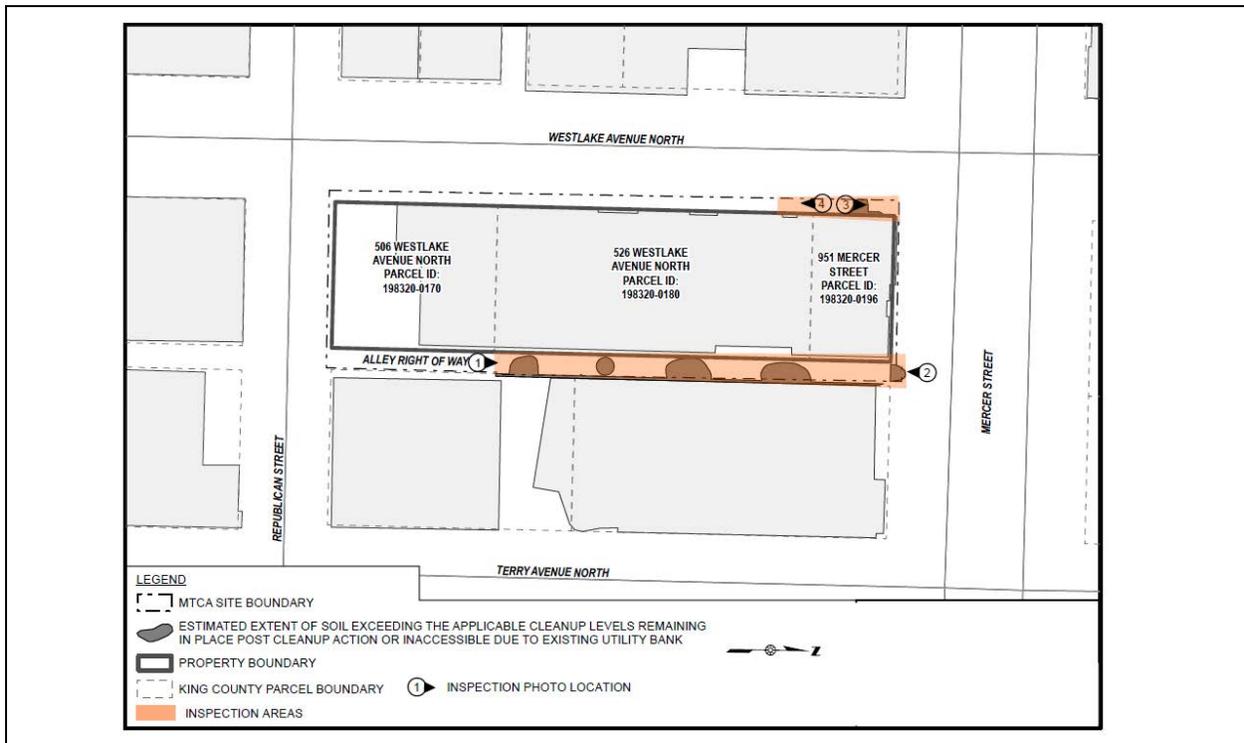
Site Inspection Sketch

On Monday December 1, 2025, Farallon conducted a visual inspection of the concrete capped areas (alleyway and northwestern corner) of the Block 38 West Site where contaminated soil was left in-place following the completion of cleanup action activities. No cracks, differential settlement, spalling, buckling or vegetation in cracks were observed in the capped areas during the visual inspection.

The concrete capped areas at the Block 38 West Site are in good condition and no repairs are warranted at this time. Photographs of the capped areas are provided in the attached photolog.

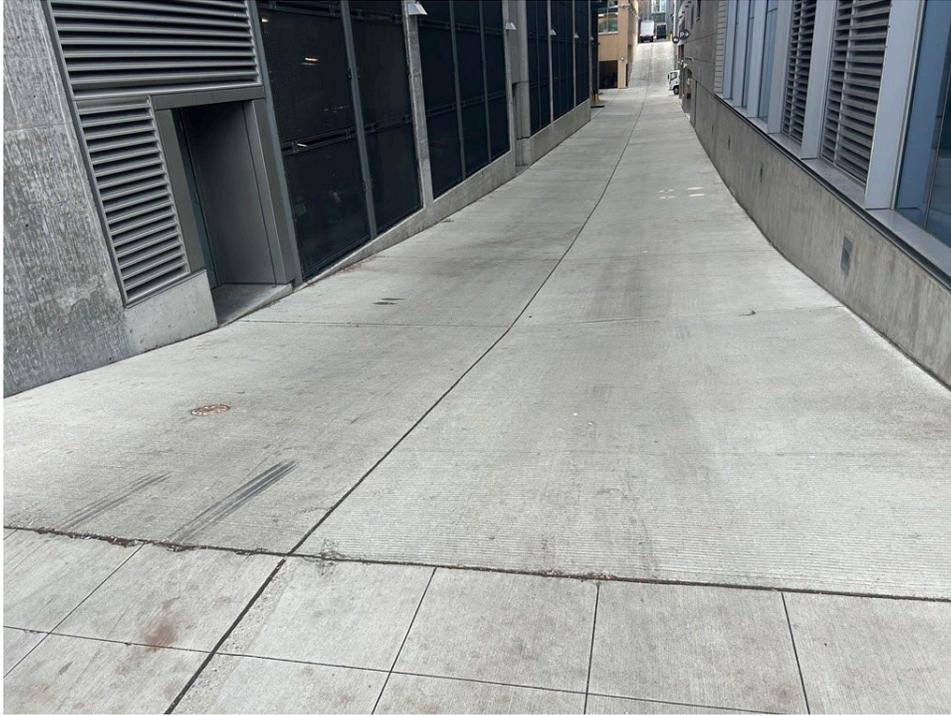
Photograph 1. Block 38 West Site – Alleyway Capped Area Looking West.

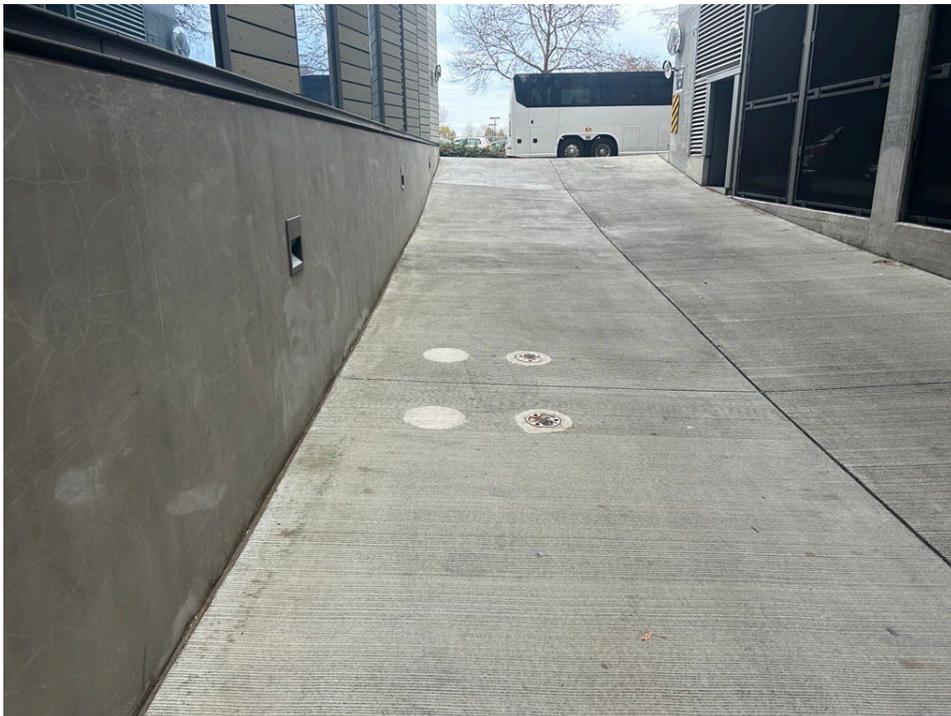
Photograph 2. Block 38 West Site – Alleyway Capped Area Looking North.

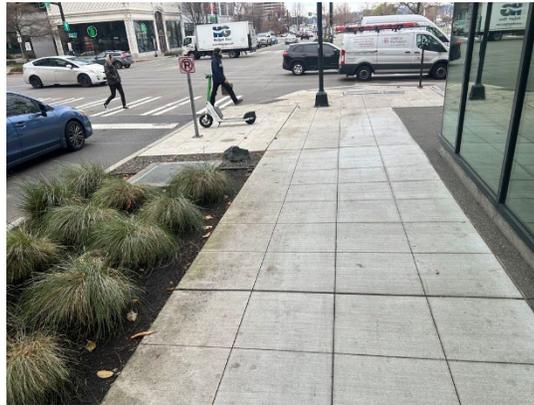
Photograph 3. Block 38 West Site – Northwest Capped Area Looking North.

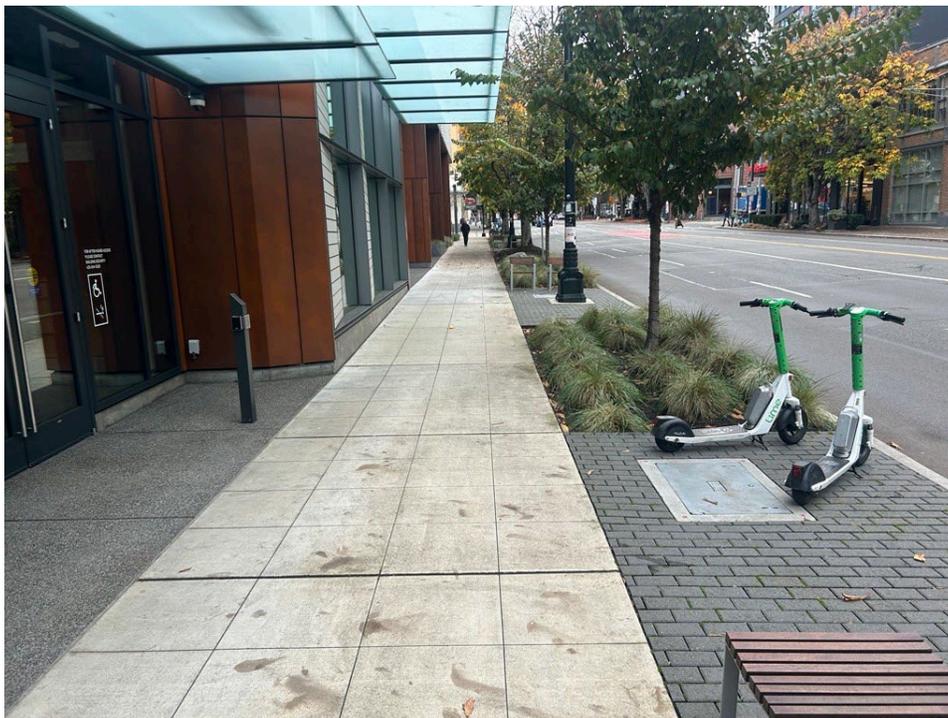
Photograph 4. Block 38 West Site – Northwest Capped Area Looking South.
