**ALUMINUM RECYCLING TRENTWOOD SITE, UNION PACIFIC RAILROAD - 2025 INSPECTION REPORT**

# 2025 Inspection Report

**Site:** Union Pacific Railroad – Aluminum Recycling Trentwood Site

**2025 Inspection Report  
Addendum 1**

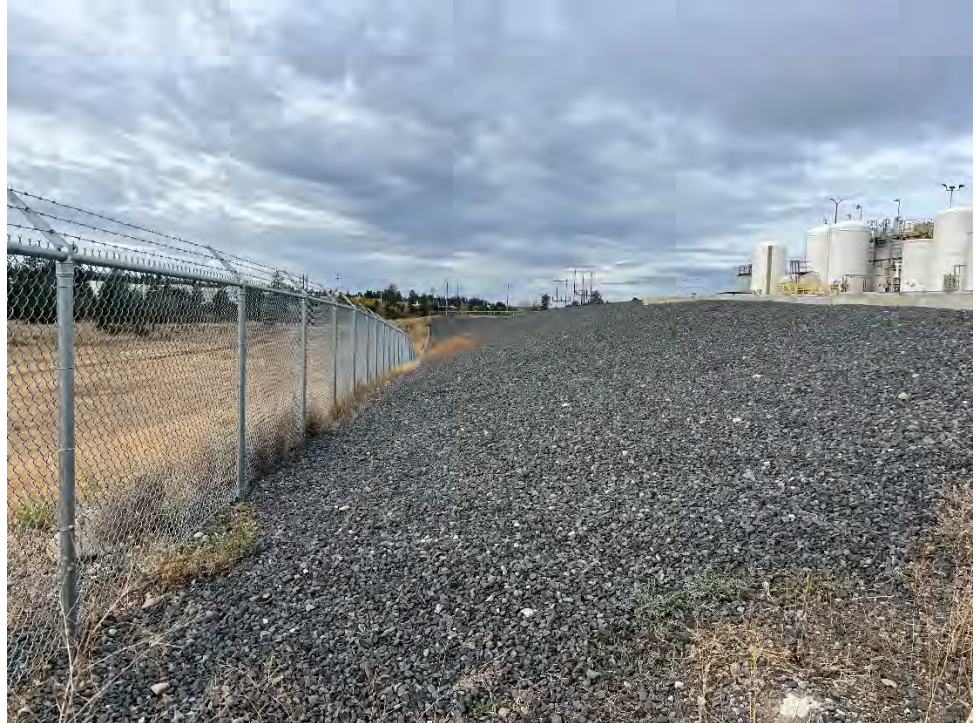
**PHOTOGRAPH 1**

- 3) Evidence of driving (tire tracks) was observed on the ecological cap and railroad ditch. These tracks resemble those shown in the 2024 inspection photos (see Photographs 10B, 11, and 13).
- 4) There has been an increase in vegetation in areas of the ecological cap, most notably along the bottom edge of the south slope and along the north ditch (see Photographs 1, 2, 5, 9A, and 9C).

Ecological cap south slope overview. View looking west-southwest.

- 1) Monitor vegetation growth during the 2026 annual inspection.
- 2) Place 6-inches of ecological cap gravel on the observed geotextile exposures to anchor the geotextile and protect the cap from potential damage and monitor these areas for worsening conditions. Ecological cap gravel shall be angular to subangular, sound, hard, durable natural rock conforming to the requirement so the WSDOT 9-03.9(2) “Permeable Ballast” (i.e. ecological cap gravel previously approved as part of the clean up action).

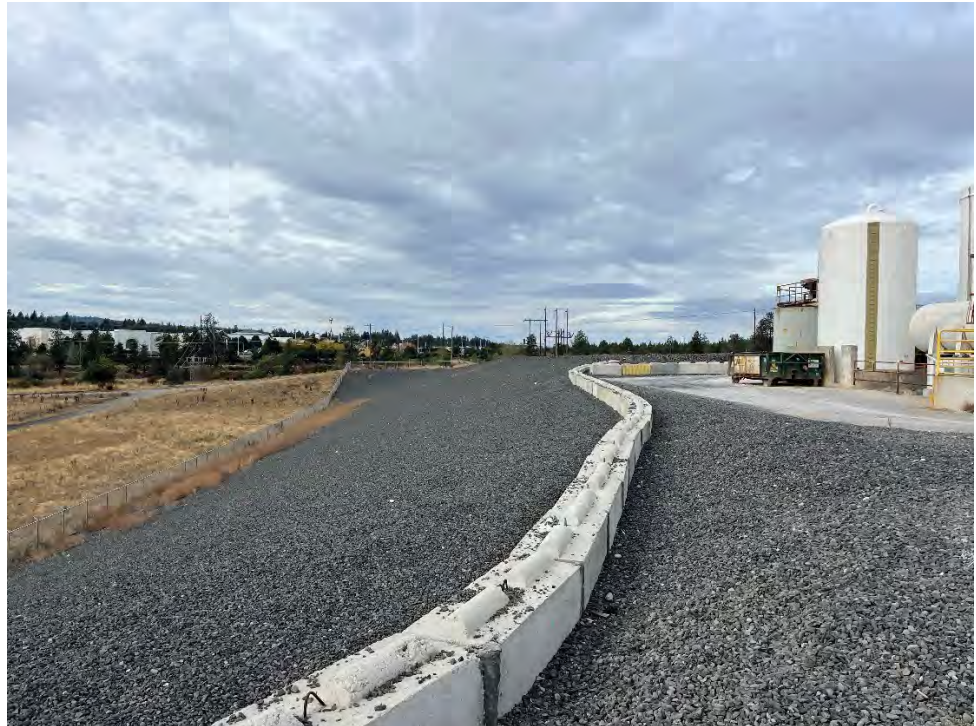
**PHOTOGRAPH 2**

Ecological cap south side slope from Kemira Facility. View looking west-southwest.

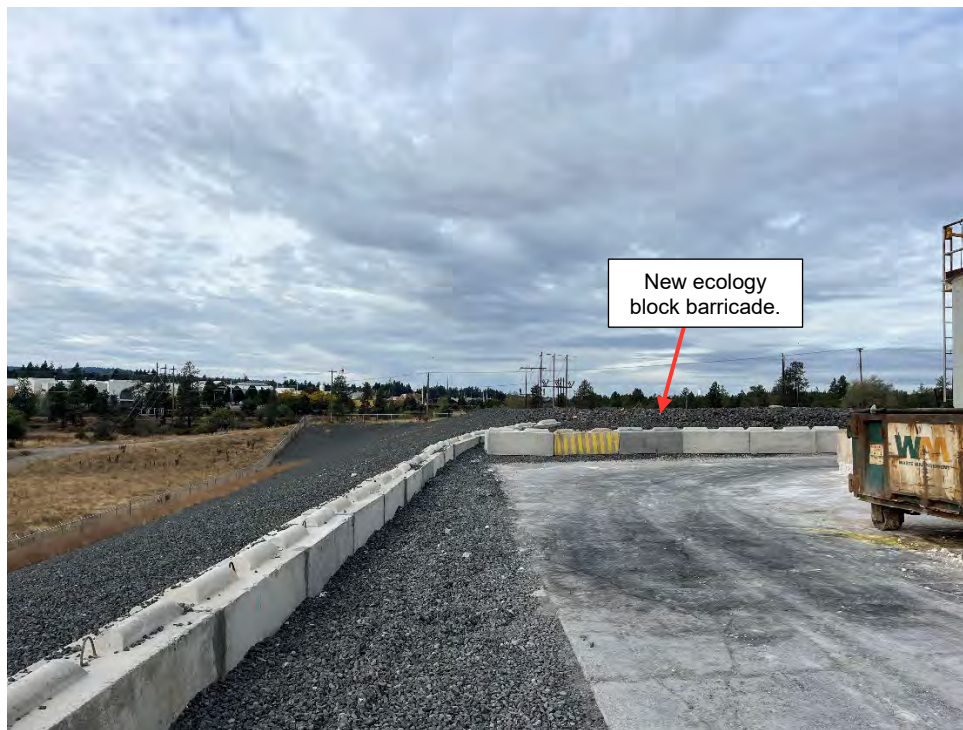
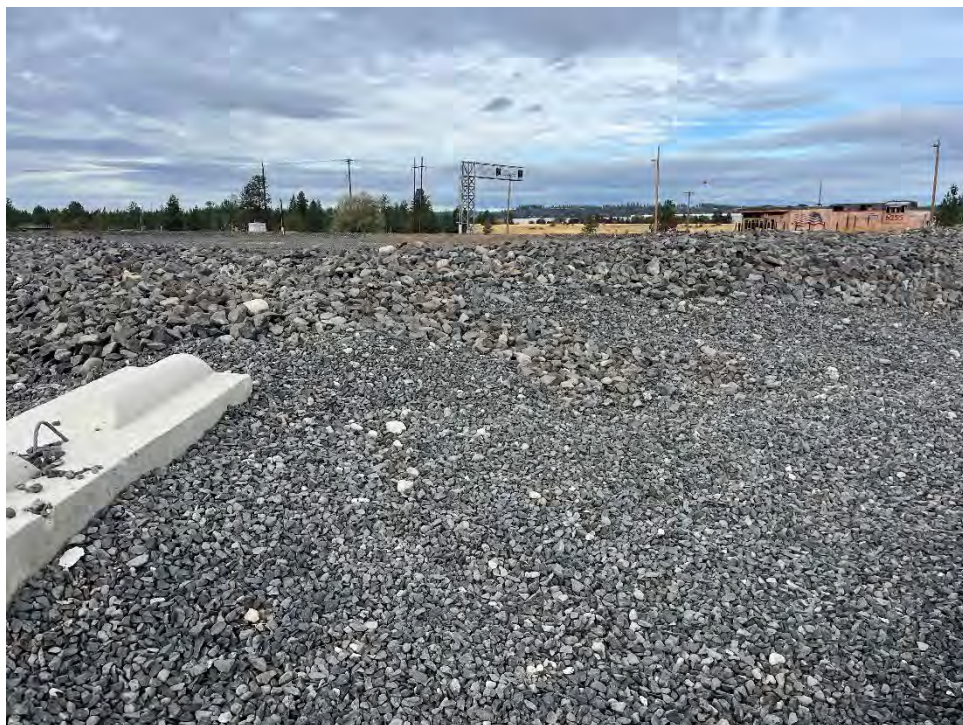
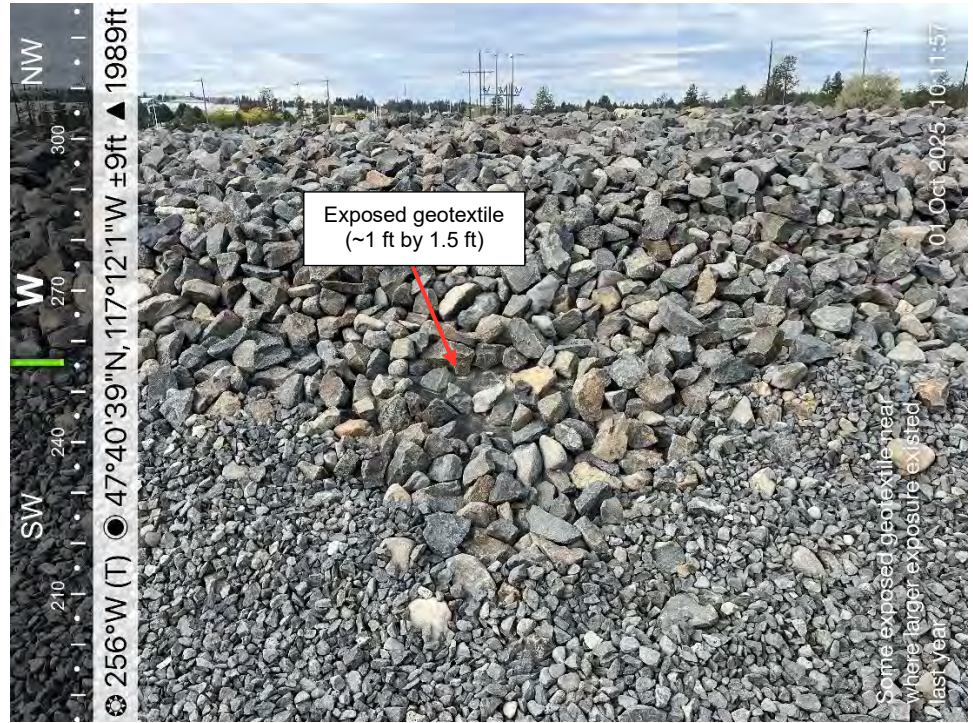
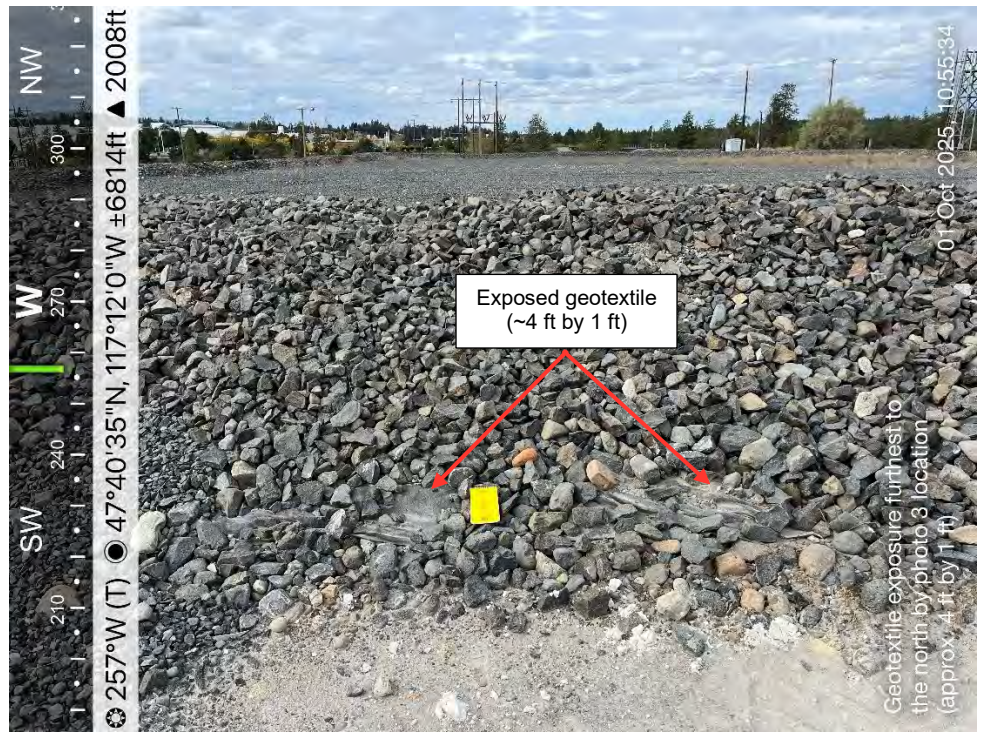
**PHOTOGRAPHS 3A, 3B,  
3C, AND 3D**

Geotextile was visible at a few locations including near the access point, west of the overflow channel, at the northeast corner of the property, and along the north ditch (see Photographs 3C-3D, 7B, 8B, 9B-9F). Underlying soil was not observed at any of these locations indicating the ecological cap is still functioning as intended. The geotextile exposures appear to be a result of thin rock coverage.

- 1) The 2024 inspection recommended a barricade be placed across the access point to limit vehicular traffic. Ecology blocks were observed across the access point in 2025 which meet the barricade recommendation (see Photograph 3A).
- 2) In the 2024 inspection, an area approximately 5-feet by 6-feet of damaged geotextile and exposed underlying material was noted. In 2025 this area was observed to be repaired (see Photograph 3B).

Kemira facility ecological cap overview and view of newly placed ecological blocks placed to barricade the access point (3A) and closeup of cap area that was compromised in 2024 but has since been remediated (3B). View of two geotextile exposures (3C and 3D). Views looking west.

Note, this recommendation has been addressed by the contractor GrayMar Environmental on December 9<sup>th</sup>, 2025 (see the 2025 Inspection Report Addendum 1 attached for documentation of these repairs).

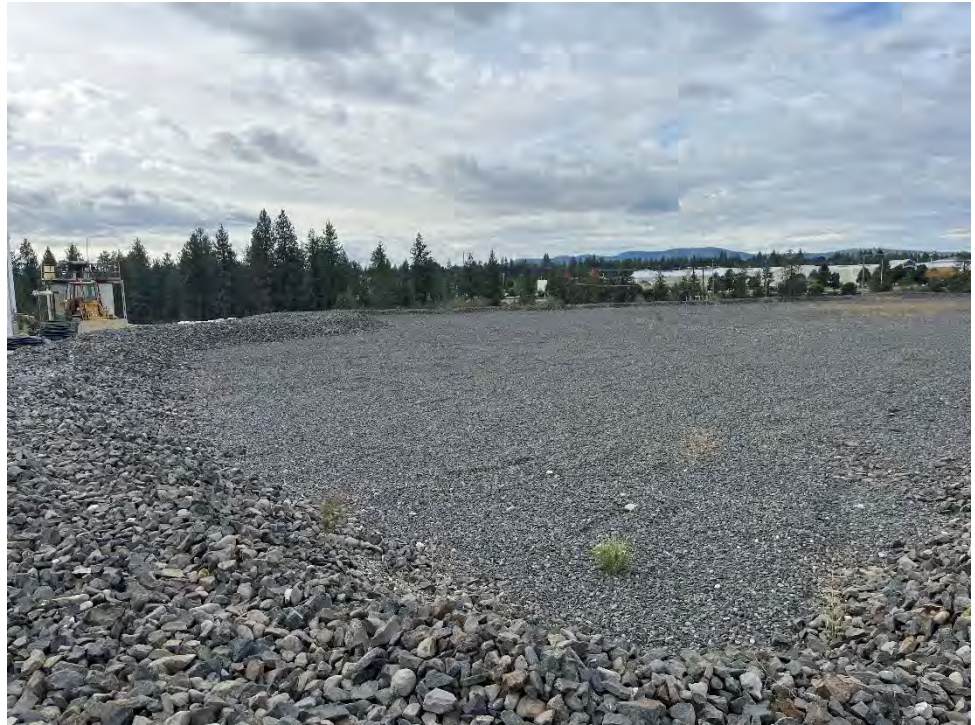
**PHOTOGRAPH 4**

Ecological cap and berm overview. View looking west.

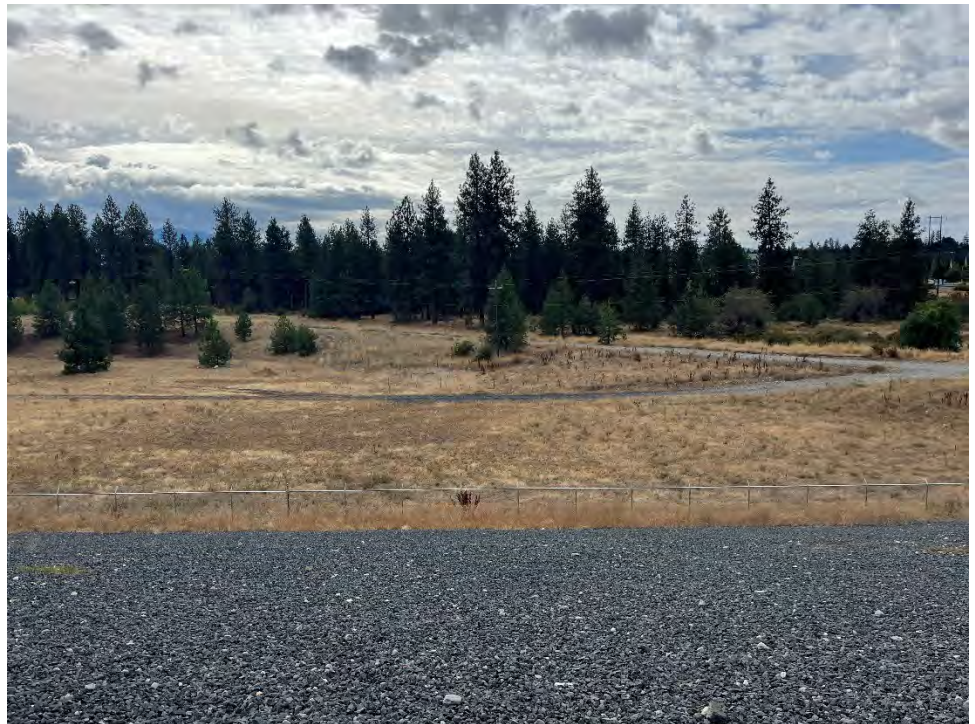
**PHOTOGRAPH 5**

Ecological cap south slope and WSDOT property below. View looking south.

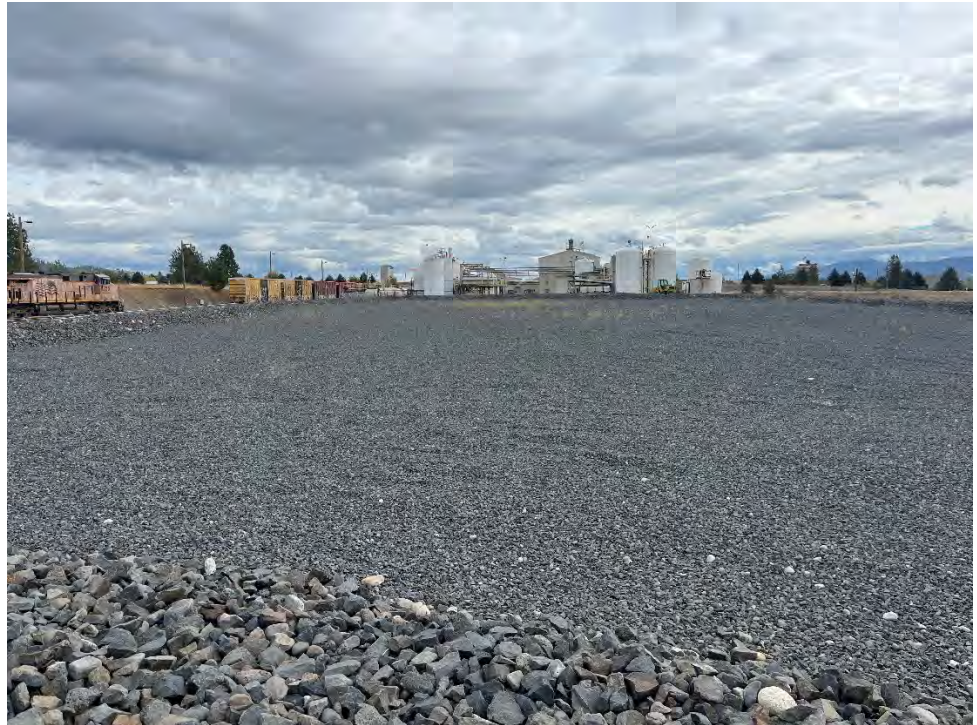
**PHOTOGRAPH 6**

Ecological cap overview.  
Looking east toward Kemira  
facility.

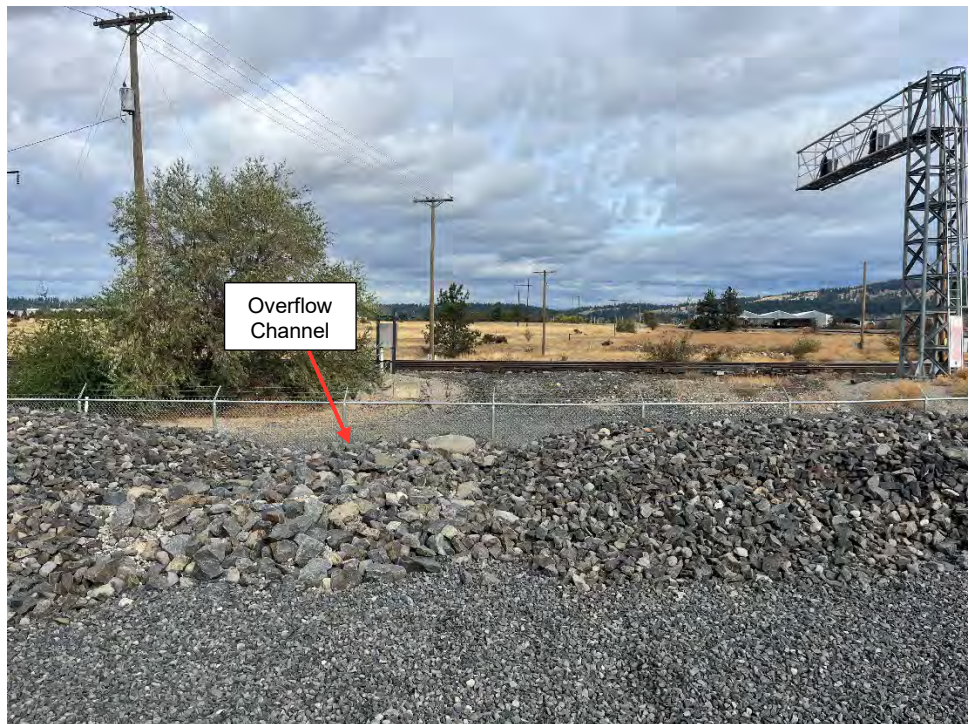
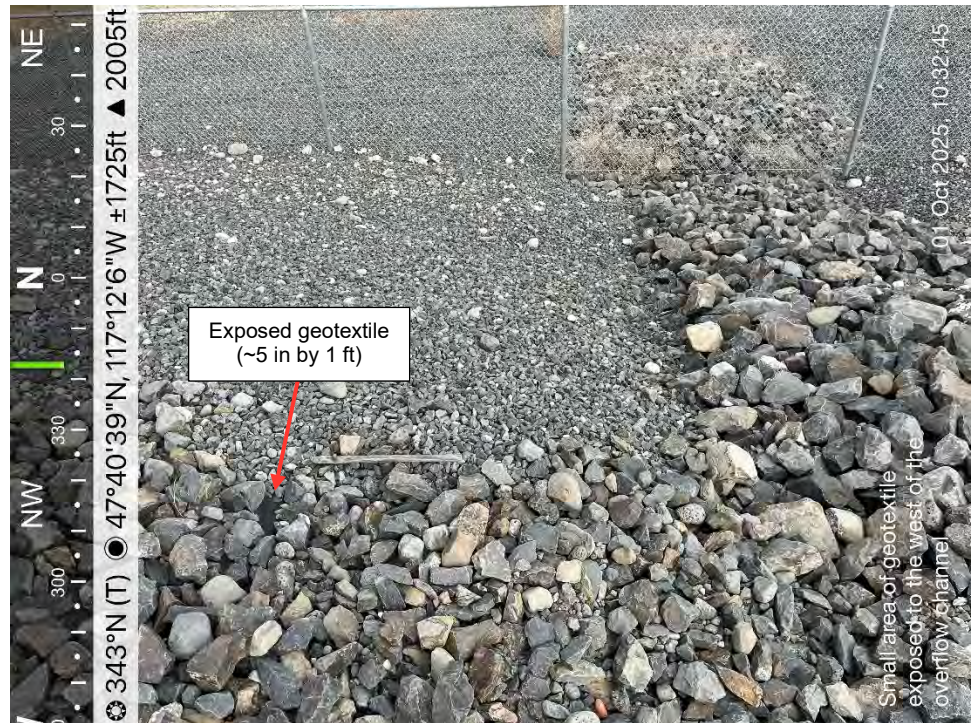
**PHOTOGRAPHS 7A AND  
7B**

Top of Overflow Channel  
(7A). Exposed geotextile (7B).  
Views looking north.

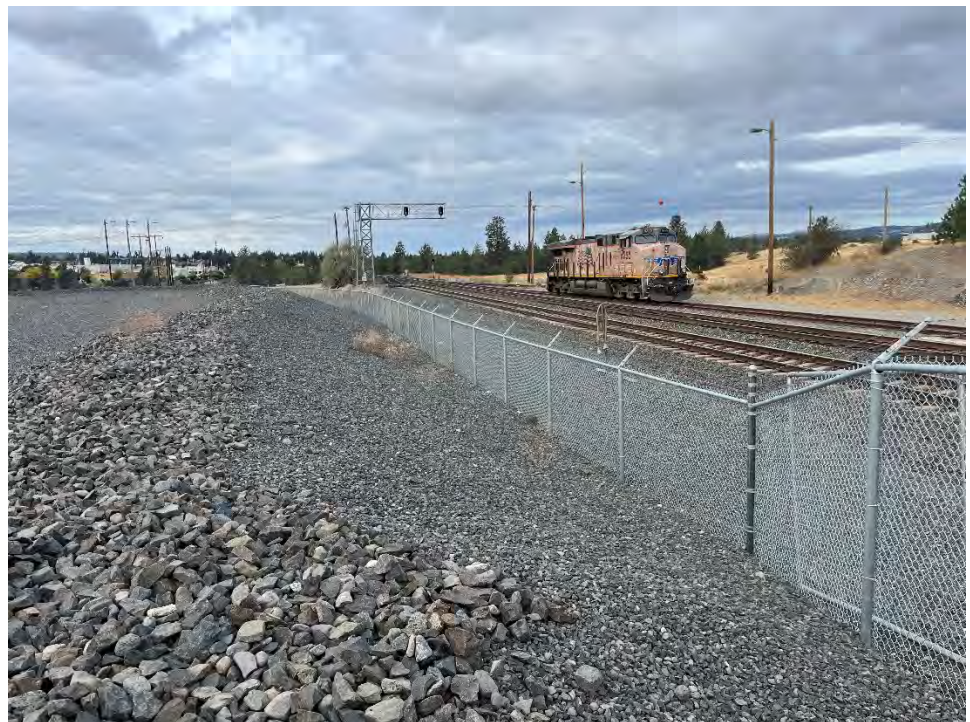
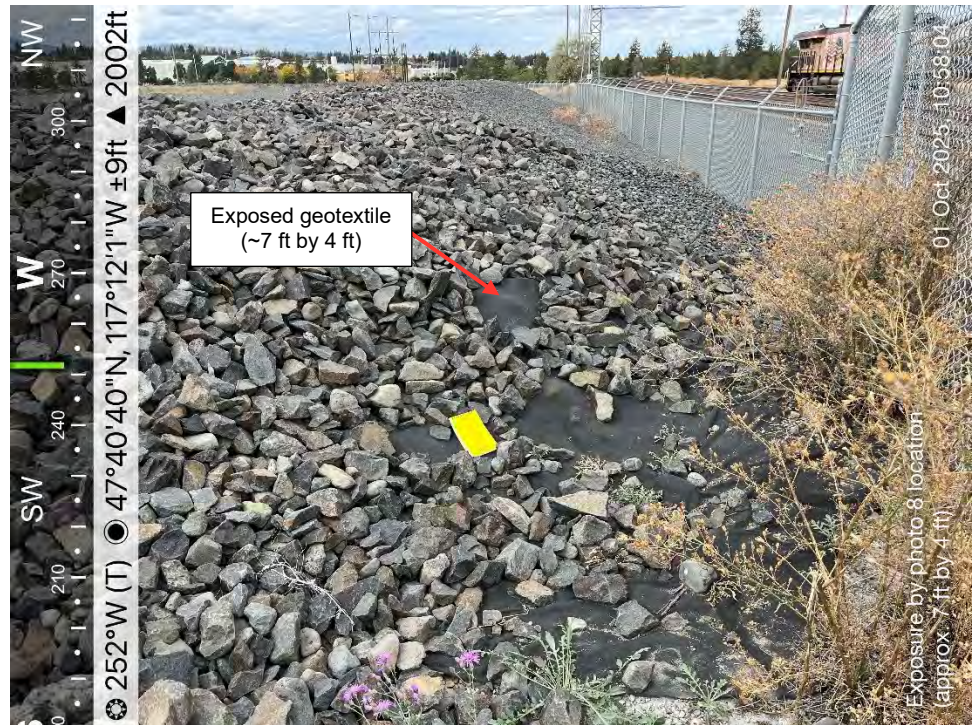
**PHOTOGRAPHS 8A AND 8B**

North berm overview and railroad ditch north side of UPRR property (8A). View of geotextile exposure (8B). View looking west.

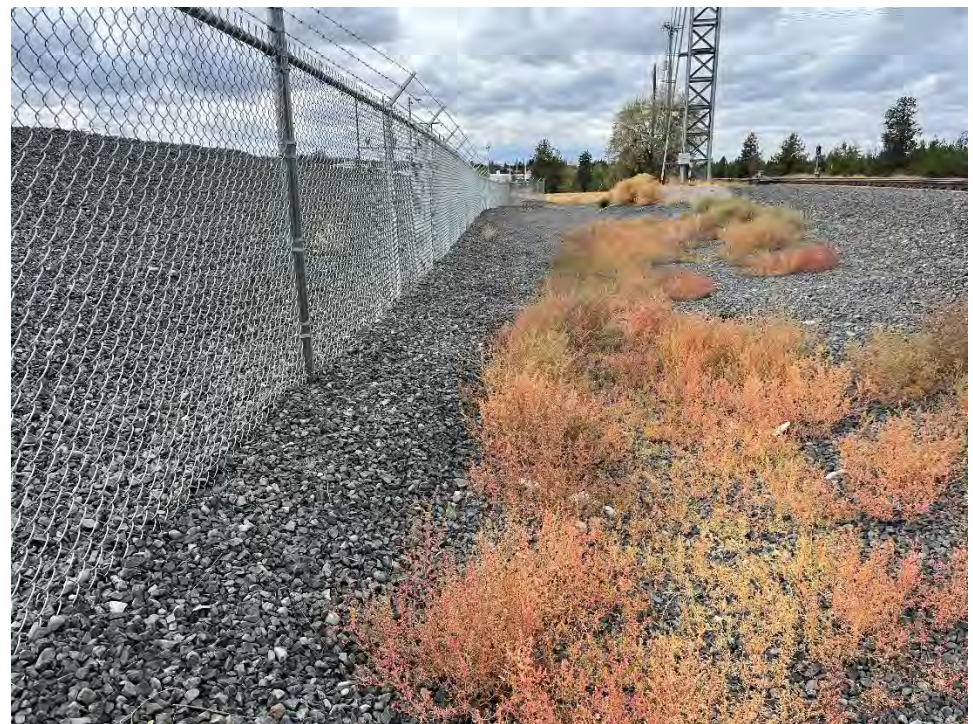
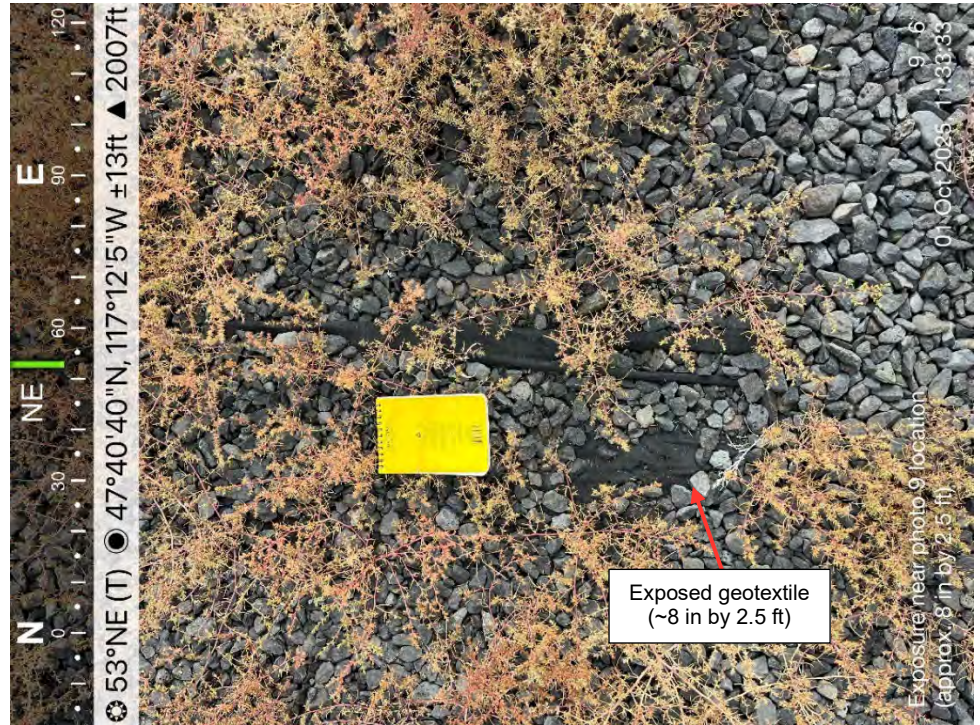
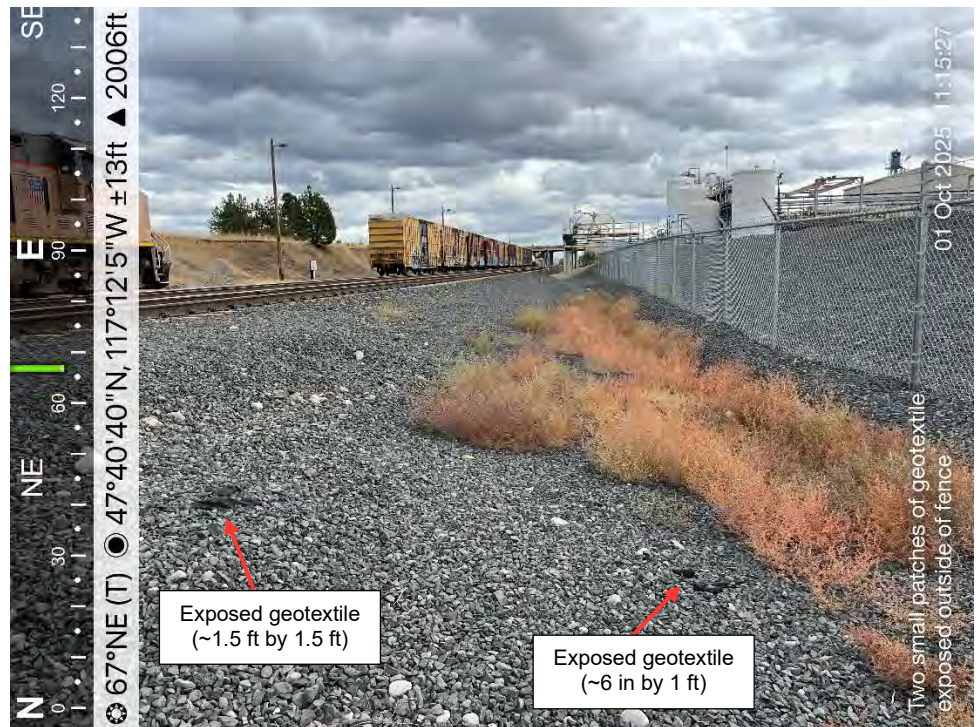
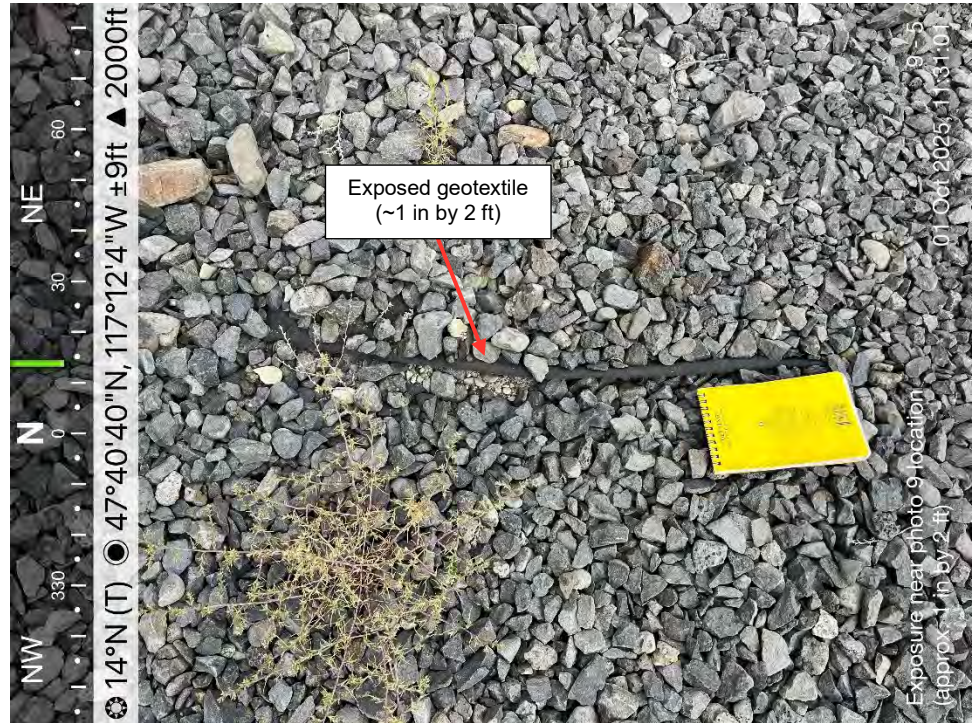
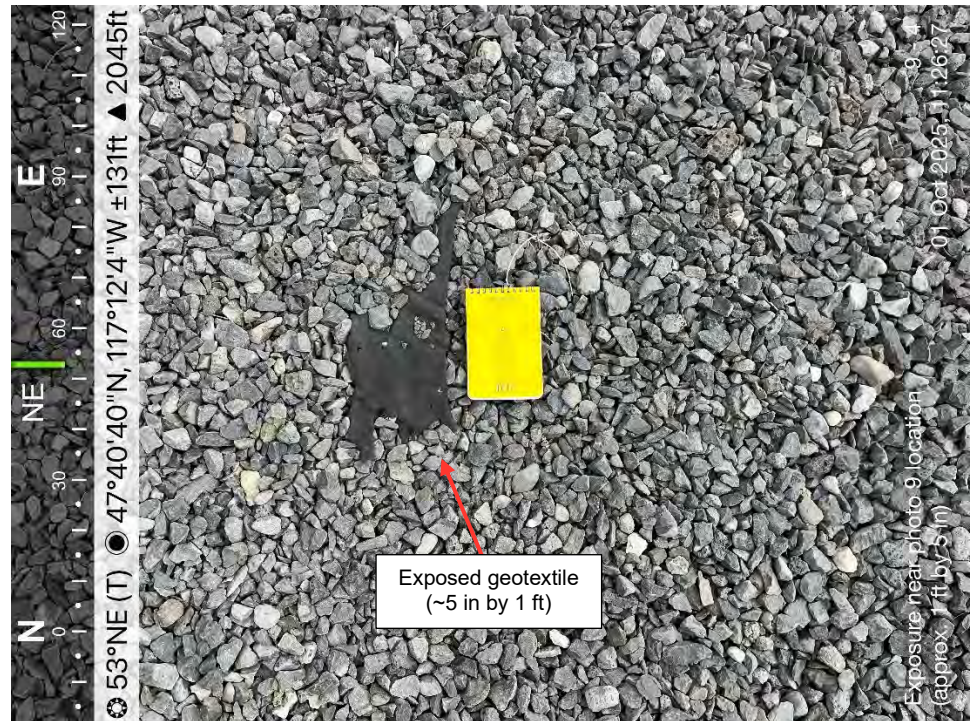
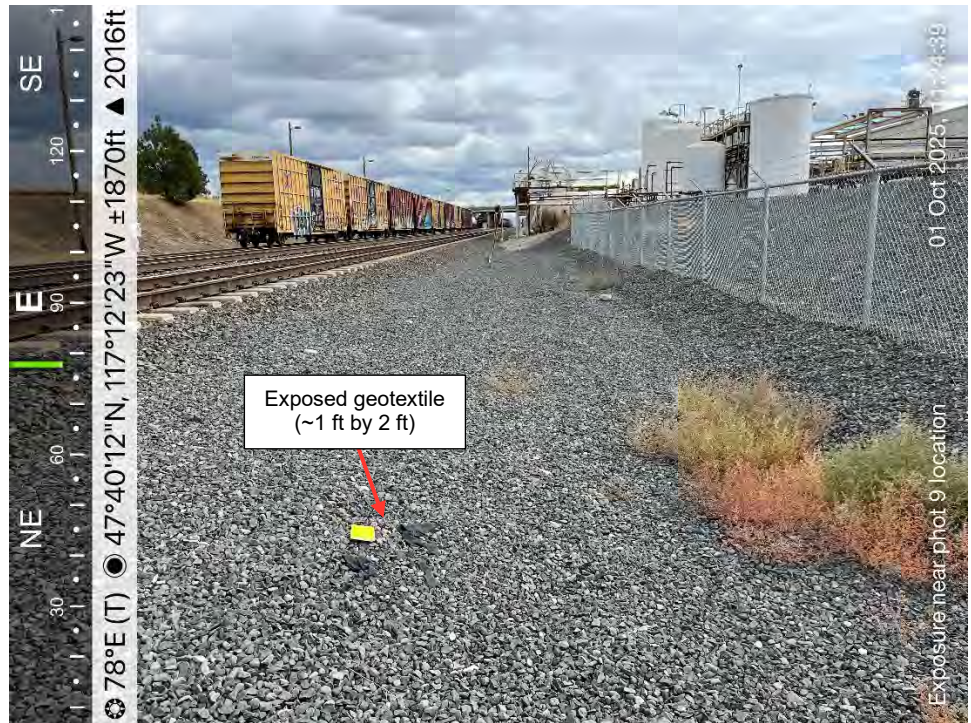
**PHOTOGRAPHS 9A, 9B, 9C, 9D, 9E, AND 9F**

Railroad ditch overview (9A). View looking west. Six geotextile exposures spanned across approximately 50 feet (9B-9F).

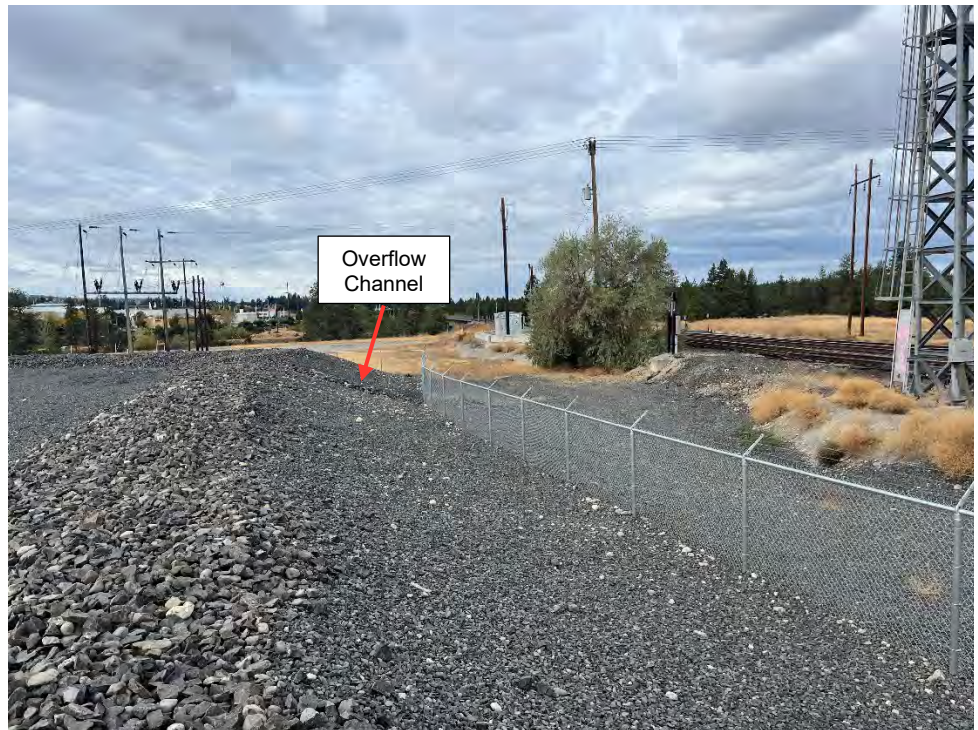
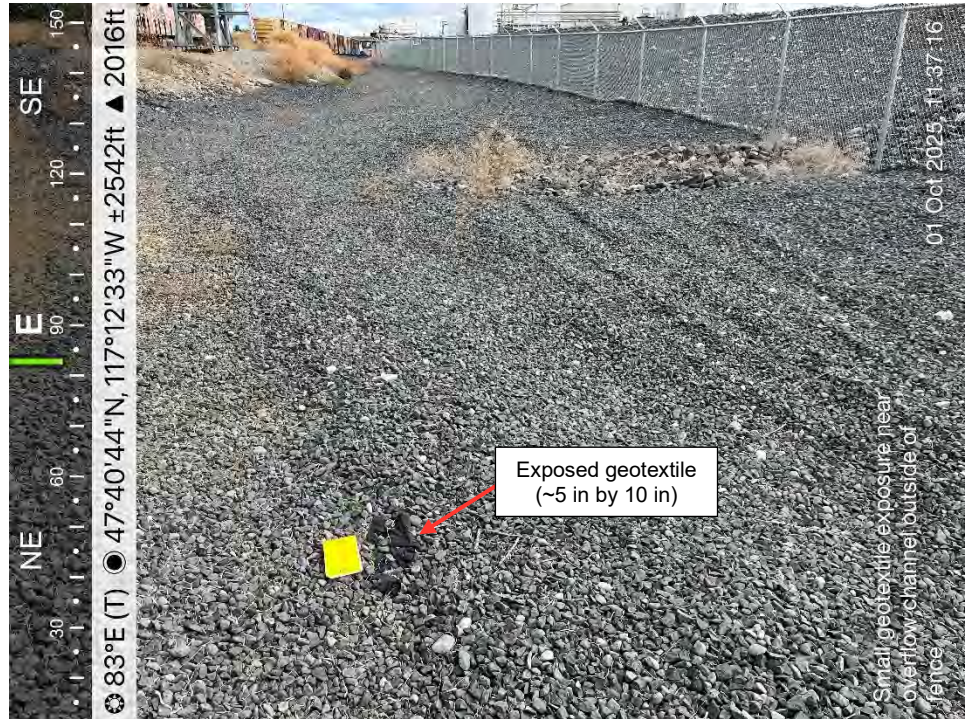
**PHOTOGRAPHS 10A AND 10B**

Overflow channel area leading into railroad ditch (10A). View looking west-southwest. Exposed geotextile to the west of the overflow channel outlet (10B). View looking northeast.

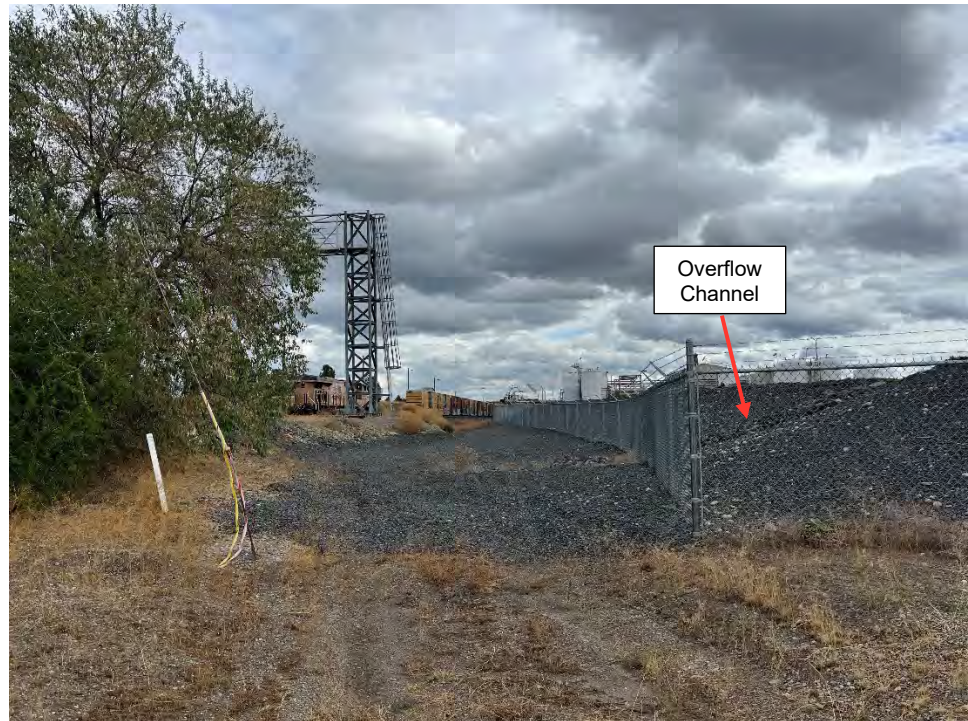
**PHOTOGRAPH 11**

Railroad ditch and overflow channel. View looking east-northeast.

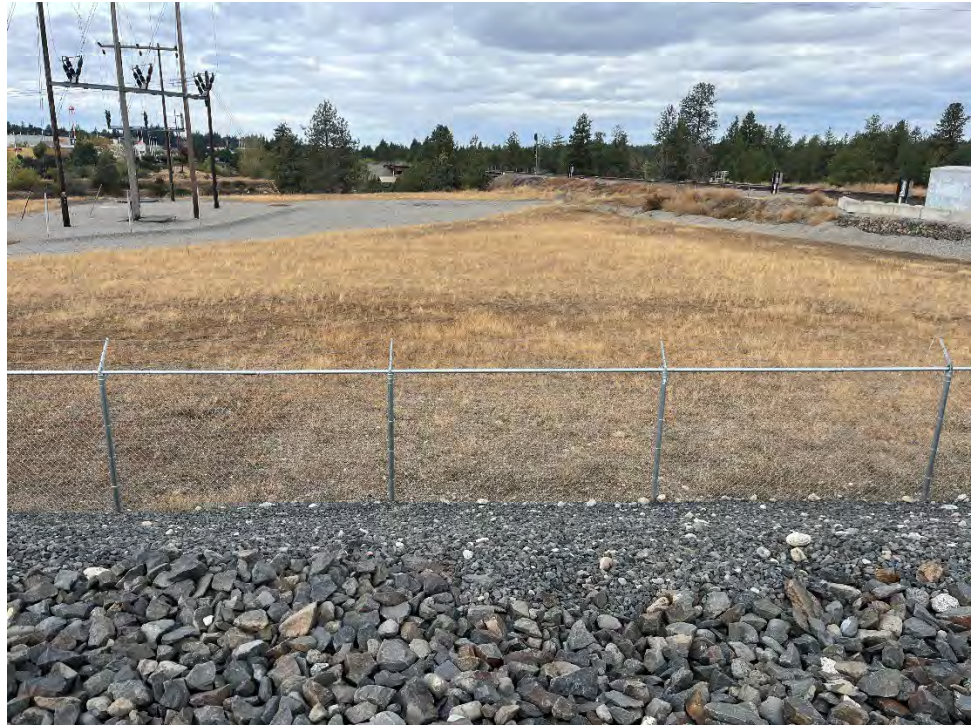
**PHOTOGRAPH 12**

West Berm and Pentzer Property. View looking west.

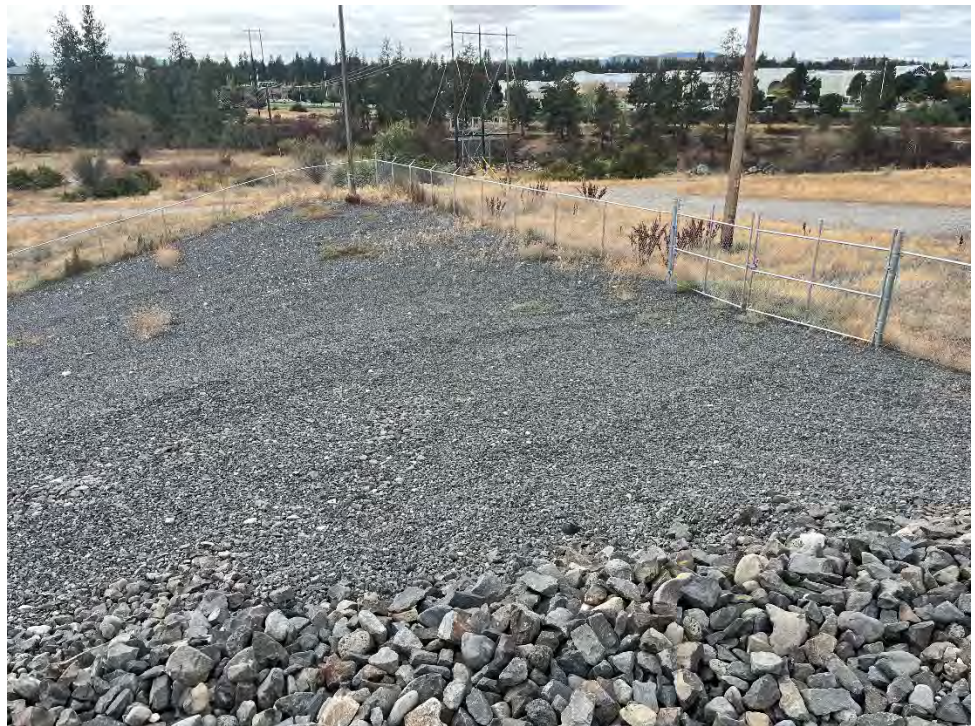
**PHOTOGRAPH 13**

Southwest corner of Ecological Cap and access gate. View looking south-southwest.

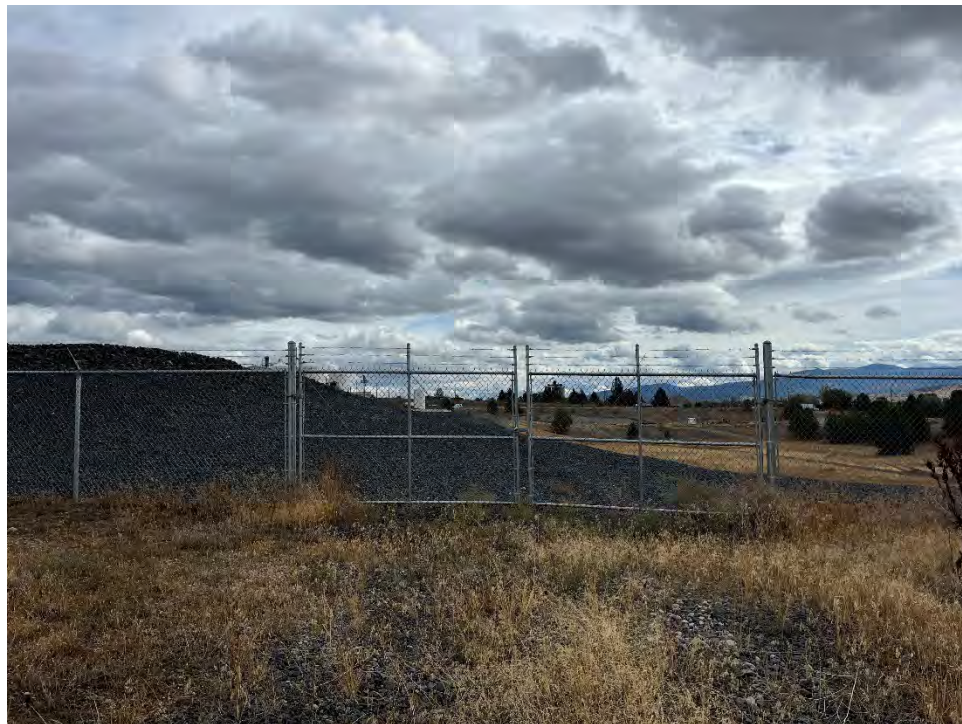
**PHOTOGRAPH 14**

UPRR property access gate.  
View looking east.

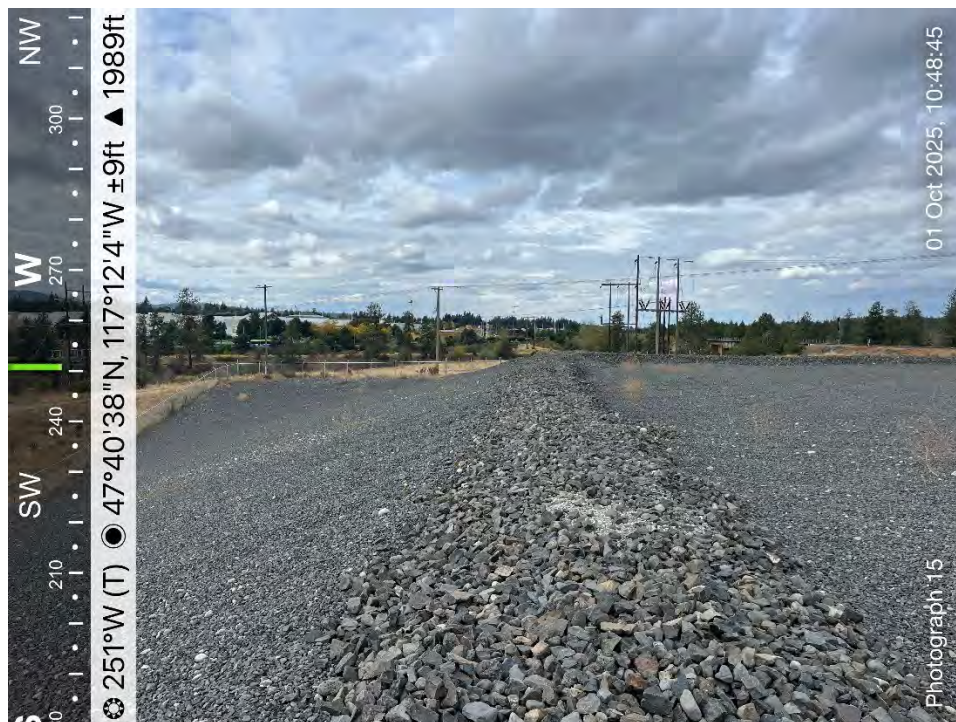
**PHOTOGRAPH 15**

South berm overview. View looking southwest.
