## **Shadow Development LLC**

Re: Shadow Development Response - Notice of Periodic Review Conducted at the following Cleanup Site:

- Name: Weyerhaeuser Everett West
- Address: 101 East Marine View Drive, Everett, WA
- Facility/ Site No.: 10
- Cleanup Site No.: 2902

## **Third Periodic Review Weyerhaeuser Everett West**

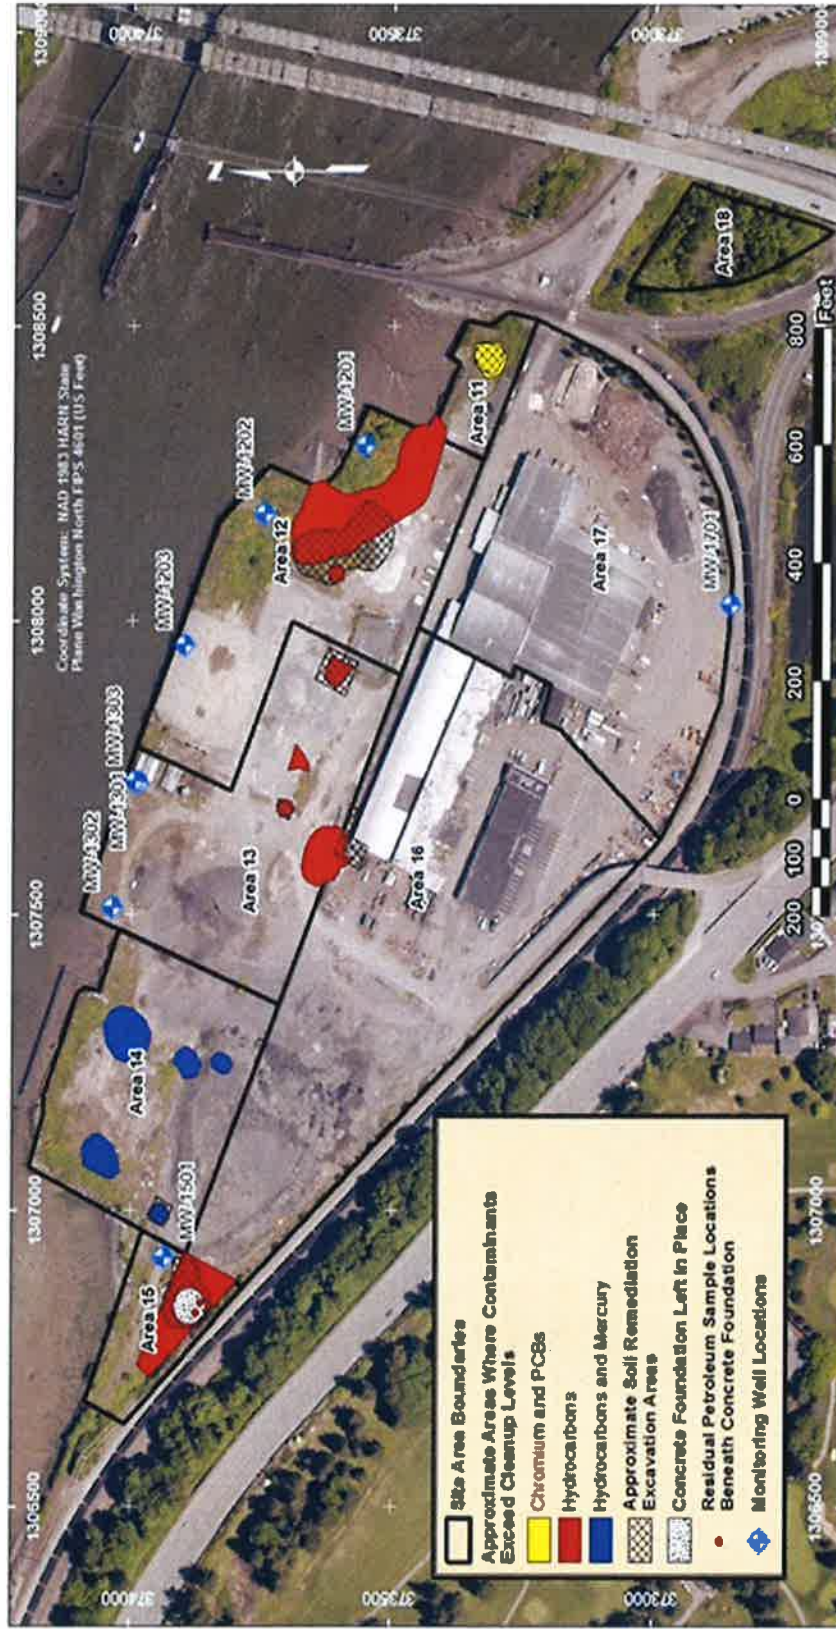
Soil remediation excavation areas and areas where contaminants exceed cleanup levels. Contamination limits from Exhibit B, Figure 2, of the 1994 Prospective Purchaser Consent Decree. Approximate excavation areas from EMCON, 1995, Figure 2-1.

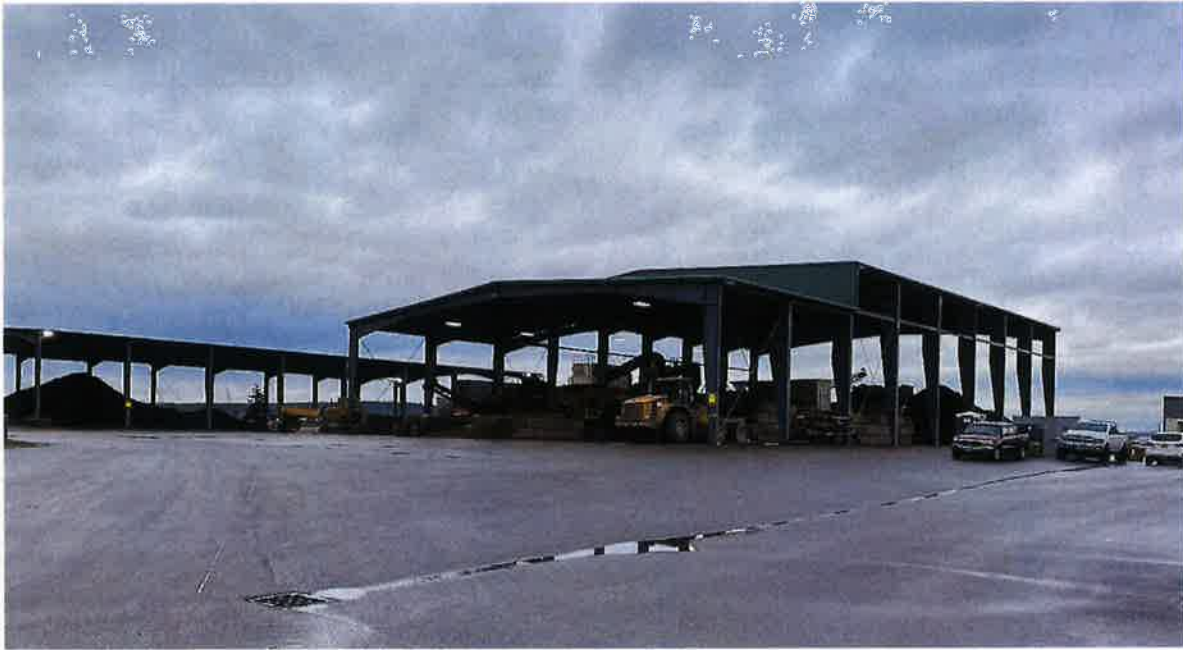
**Photo 1:** Soil Thermal Desorption Facility operated by Cadman.

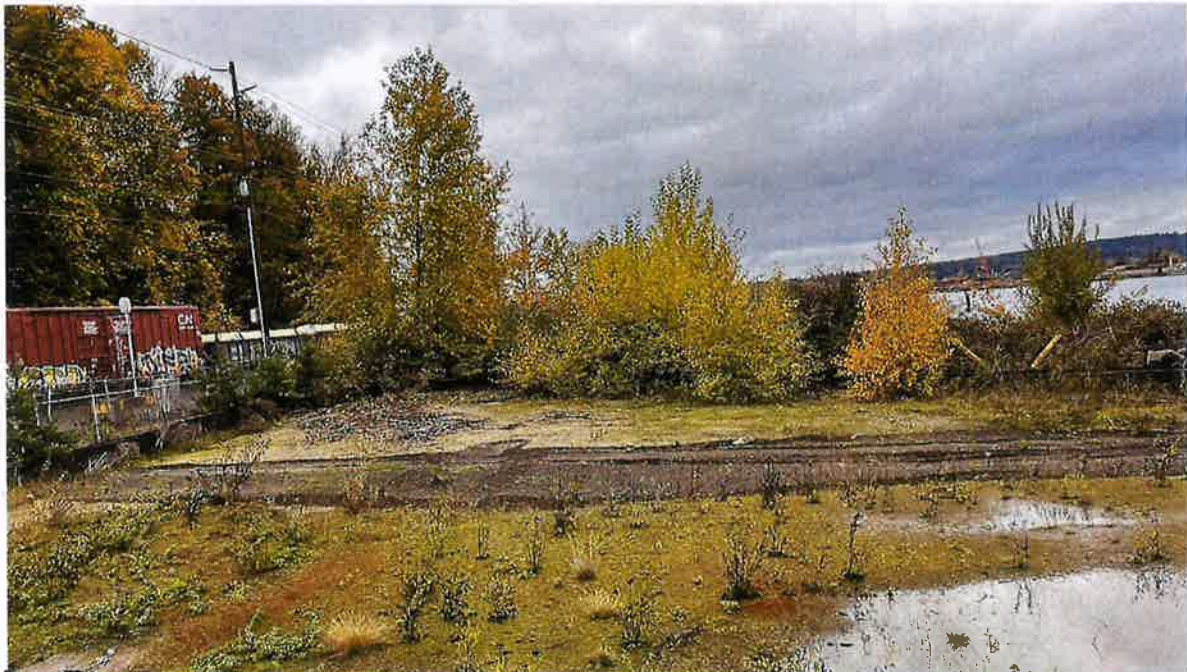
**Photo 2:** Northwest corner of the property (Cleanup Area 15 located in the forested area beyond gravel road).

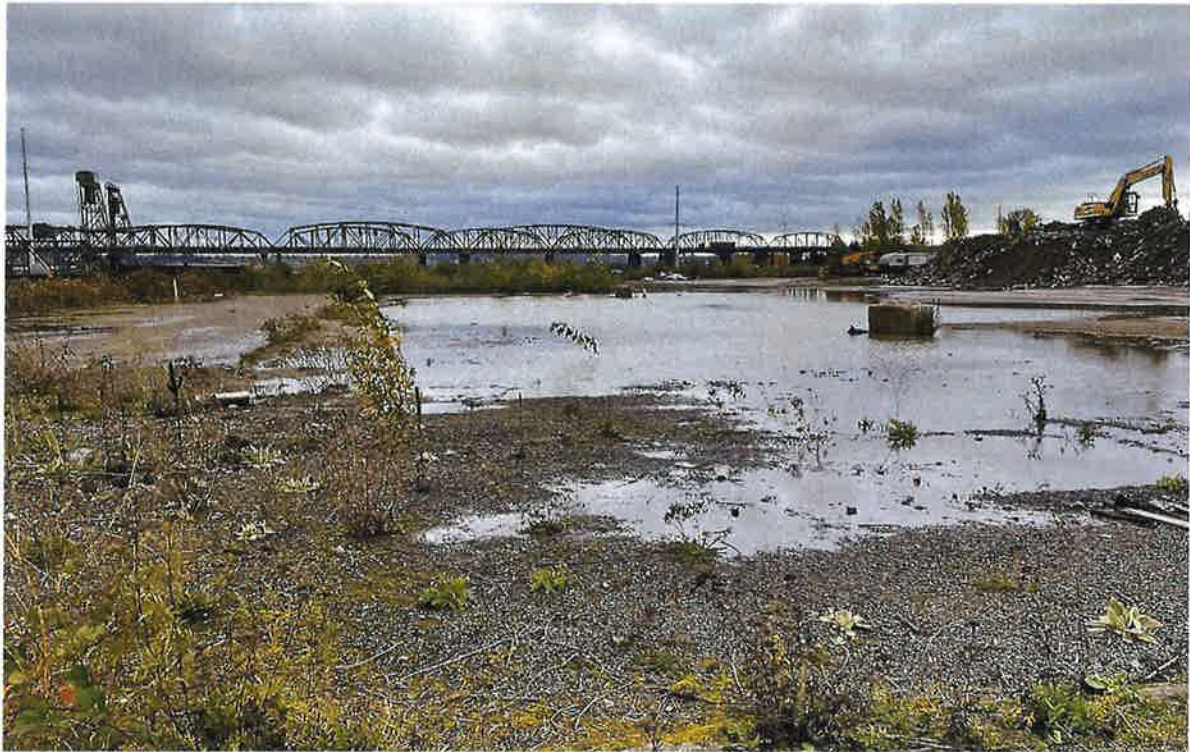
Protection of stormwater discharge to surface water bodies was not specifically discussed in the consent decree or environmental covenant. However, large areas of standing stormwater were observed in the northern paved portion of the property (particularly in cleanup area 12, see photograph 3).

**Photo 3:** Flooded ground surface, looking east toward former Mill C (Cleanup Area 12).

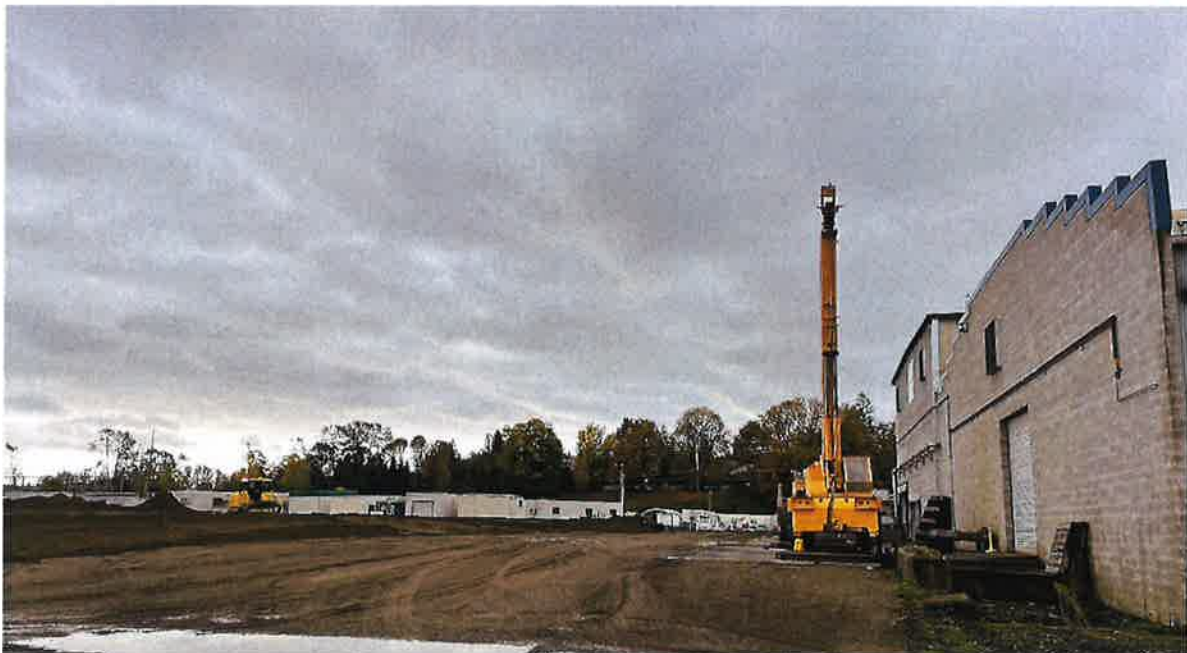
In addition, Ecology observed a portion of the Site being graded during the Site visit (in Area 17, where there was a structure fire in 2016). Ecology was not contacted regarding this work. However, this area does not appear to contain contaminated soils left in place as part of the cleanup action. Additionally, the grading may have been fill that was brought to the Site, based on the elevation of the ground surface (several feet above the surrounding surface), material characteristics (Type 17 fill), and satellite imagery of what appeared to be stockpiles of imported material in that area.

- Ecology observed grading activities during the Site visit. Ground disturbing activities could result in the release or exposure of contaminants contained as part of the cleanup action, which is restricted by the Covenant. Ecology's approval should be obtained in advance of ground disturbing activities in the future.

**Photo 4:** Looking south, footprint of former building, demolished following a 2016 structure fire. Area was being graded during Site visit.

Shadow Development is in concurrence with the Department of Ecology. The grading activities that were observed were stock piling efforts, all of which were performed at higher elevation than existing grade. Due to the nature of the observed work the release or exposure of contaminants contained as part of the cleanup action was not possible as the work was constructed on top of the existing grade.

Moving forward Shadow Development will notify the Department of Ecology of any below grade ground disturbing activities prior to commencement.

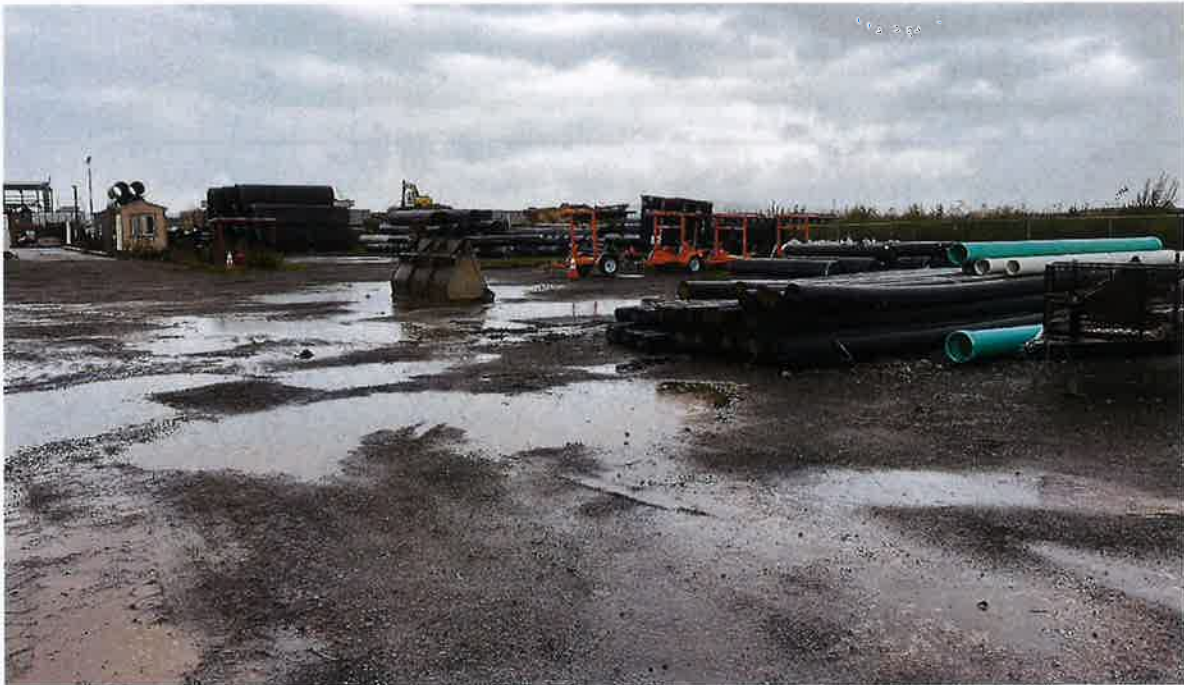
**Photo 5:** Graveled material/equipment storage area, looking northwest, toward Cleanup Area 12 (vegetated area in background).

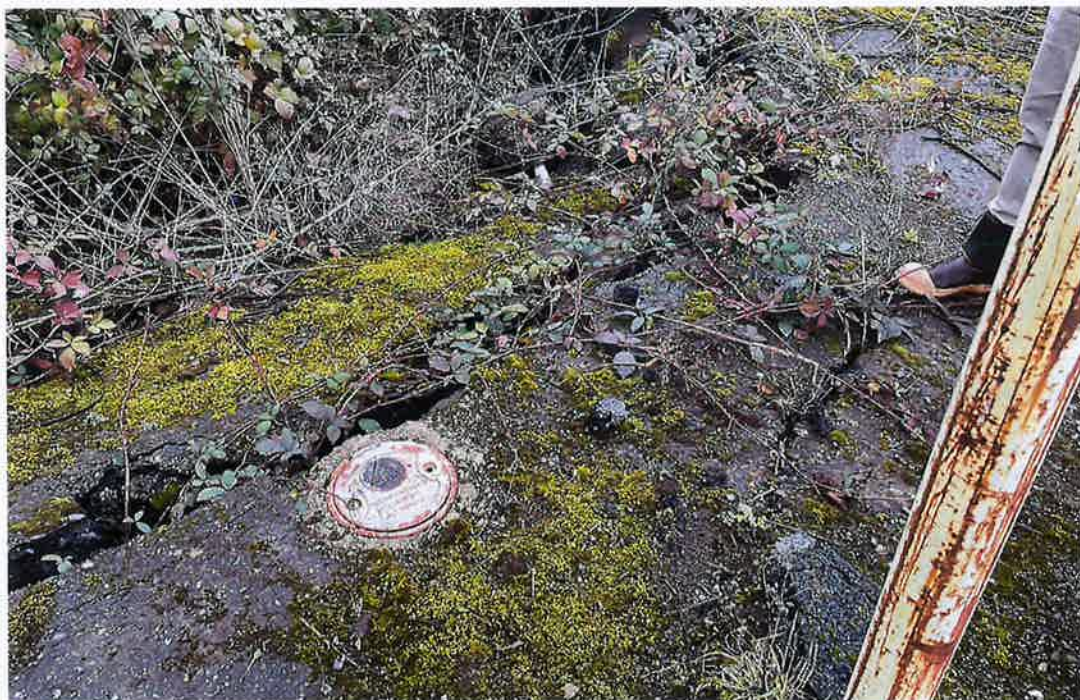
Well MW-1203R was identified during Ecology's October 2023 site visit. The well is located at the north end of the property, at the top of the Snohomish riverbank. Cracks were observed in the ground surface surrounding the well, and the slope appeared to be actively caving toward the river (see photograph 6 in Appendix C).

- Monitoring well MW-1203R is located at the north end of the Site, at the top of the Snohomish riverbank. Cracks were observed in the ground surface surrounding the well, and the slope appeared to be actively caving toward the river. This well should be repaired or replaced. Alternatively, if this well and the other 3 monitoring wells for the Site (MW-1202R, MW-1301R, and MW-1501R) are no longer being used for monitoring, they should be properly decommissioned.

**Photo 6:** Well MW-1203R looking northwest, toward the Snohomish River. Slope failure can be seen adjacent to the well.

Noted in the second Periodic Review, "Groundwater sampling will no longer be required for the periodic review (Periodic Review, July 2014, p. 9)." As such, these three wells will be decommissioned. Documentation of ECY's conclusion reproduced in Exhibit D.

Shadow Development will notify the Department of Ecology after the decommissioning of the existing wells.

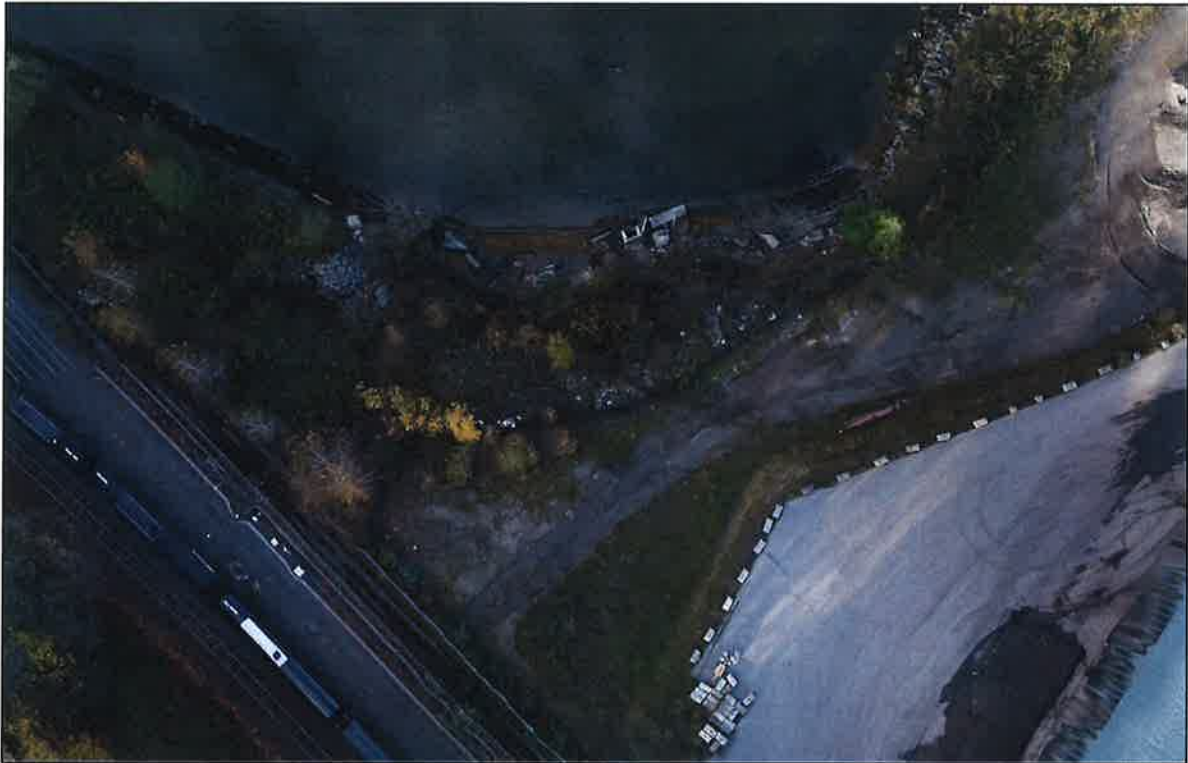
**Figure B3. Area 15 Aerial Photograph Taken July 07, 2024**

Finally, a recent aerial photograph of the heavily vegetated Area 15 is presented in Exhibit B. Shadow has never touched that area since acquiring the site, Shadow Development assumes the concrete foundation remains in-place as a de facto cap over the tank footprint. There are no plans to intervene with that area, should that change Shadow Development will follow the Restrictive Covenant protocol and notify Ecology.
