10 February 2026

**RE: Recommended Stormwater Evaluation
Baxter South Woodwaste Landfill, Arlington, Washington**

Photo Log of Baxter South Woodwaste Landfill

Stormwater Evaluation, 11 December 2025

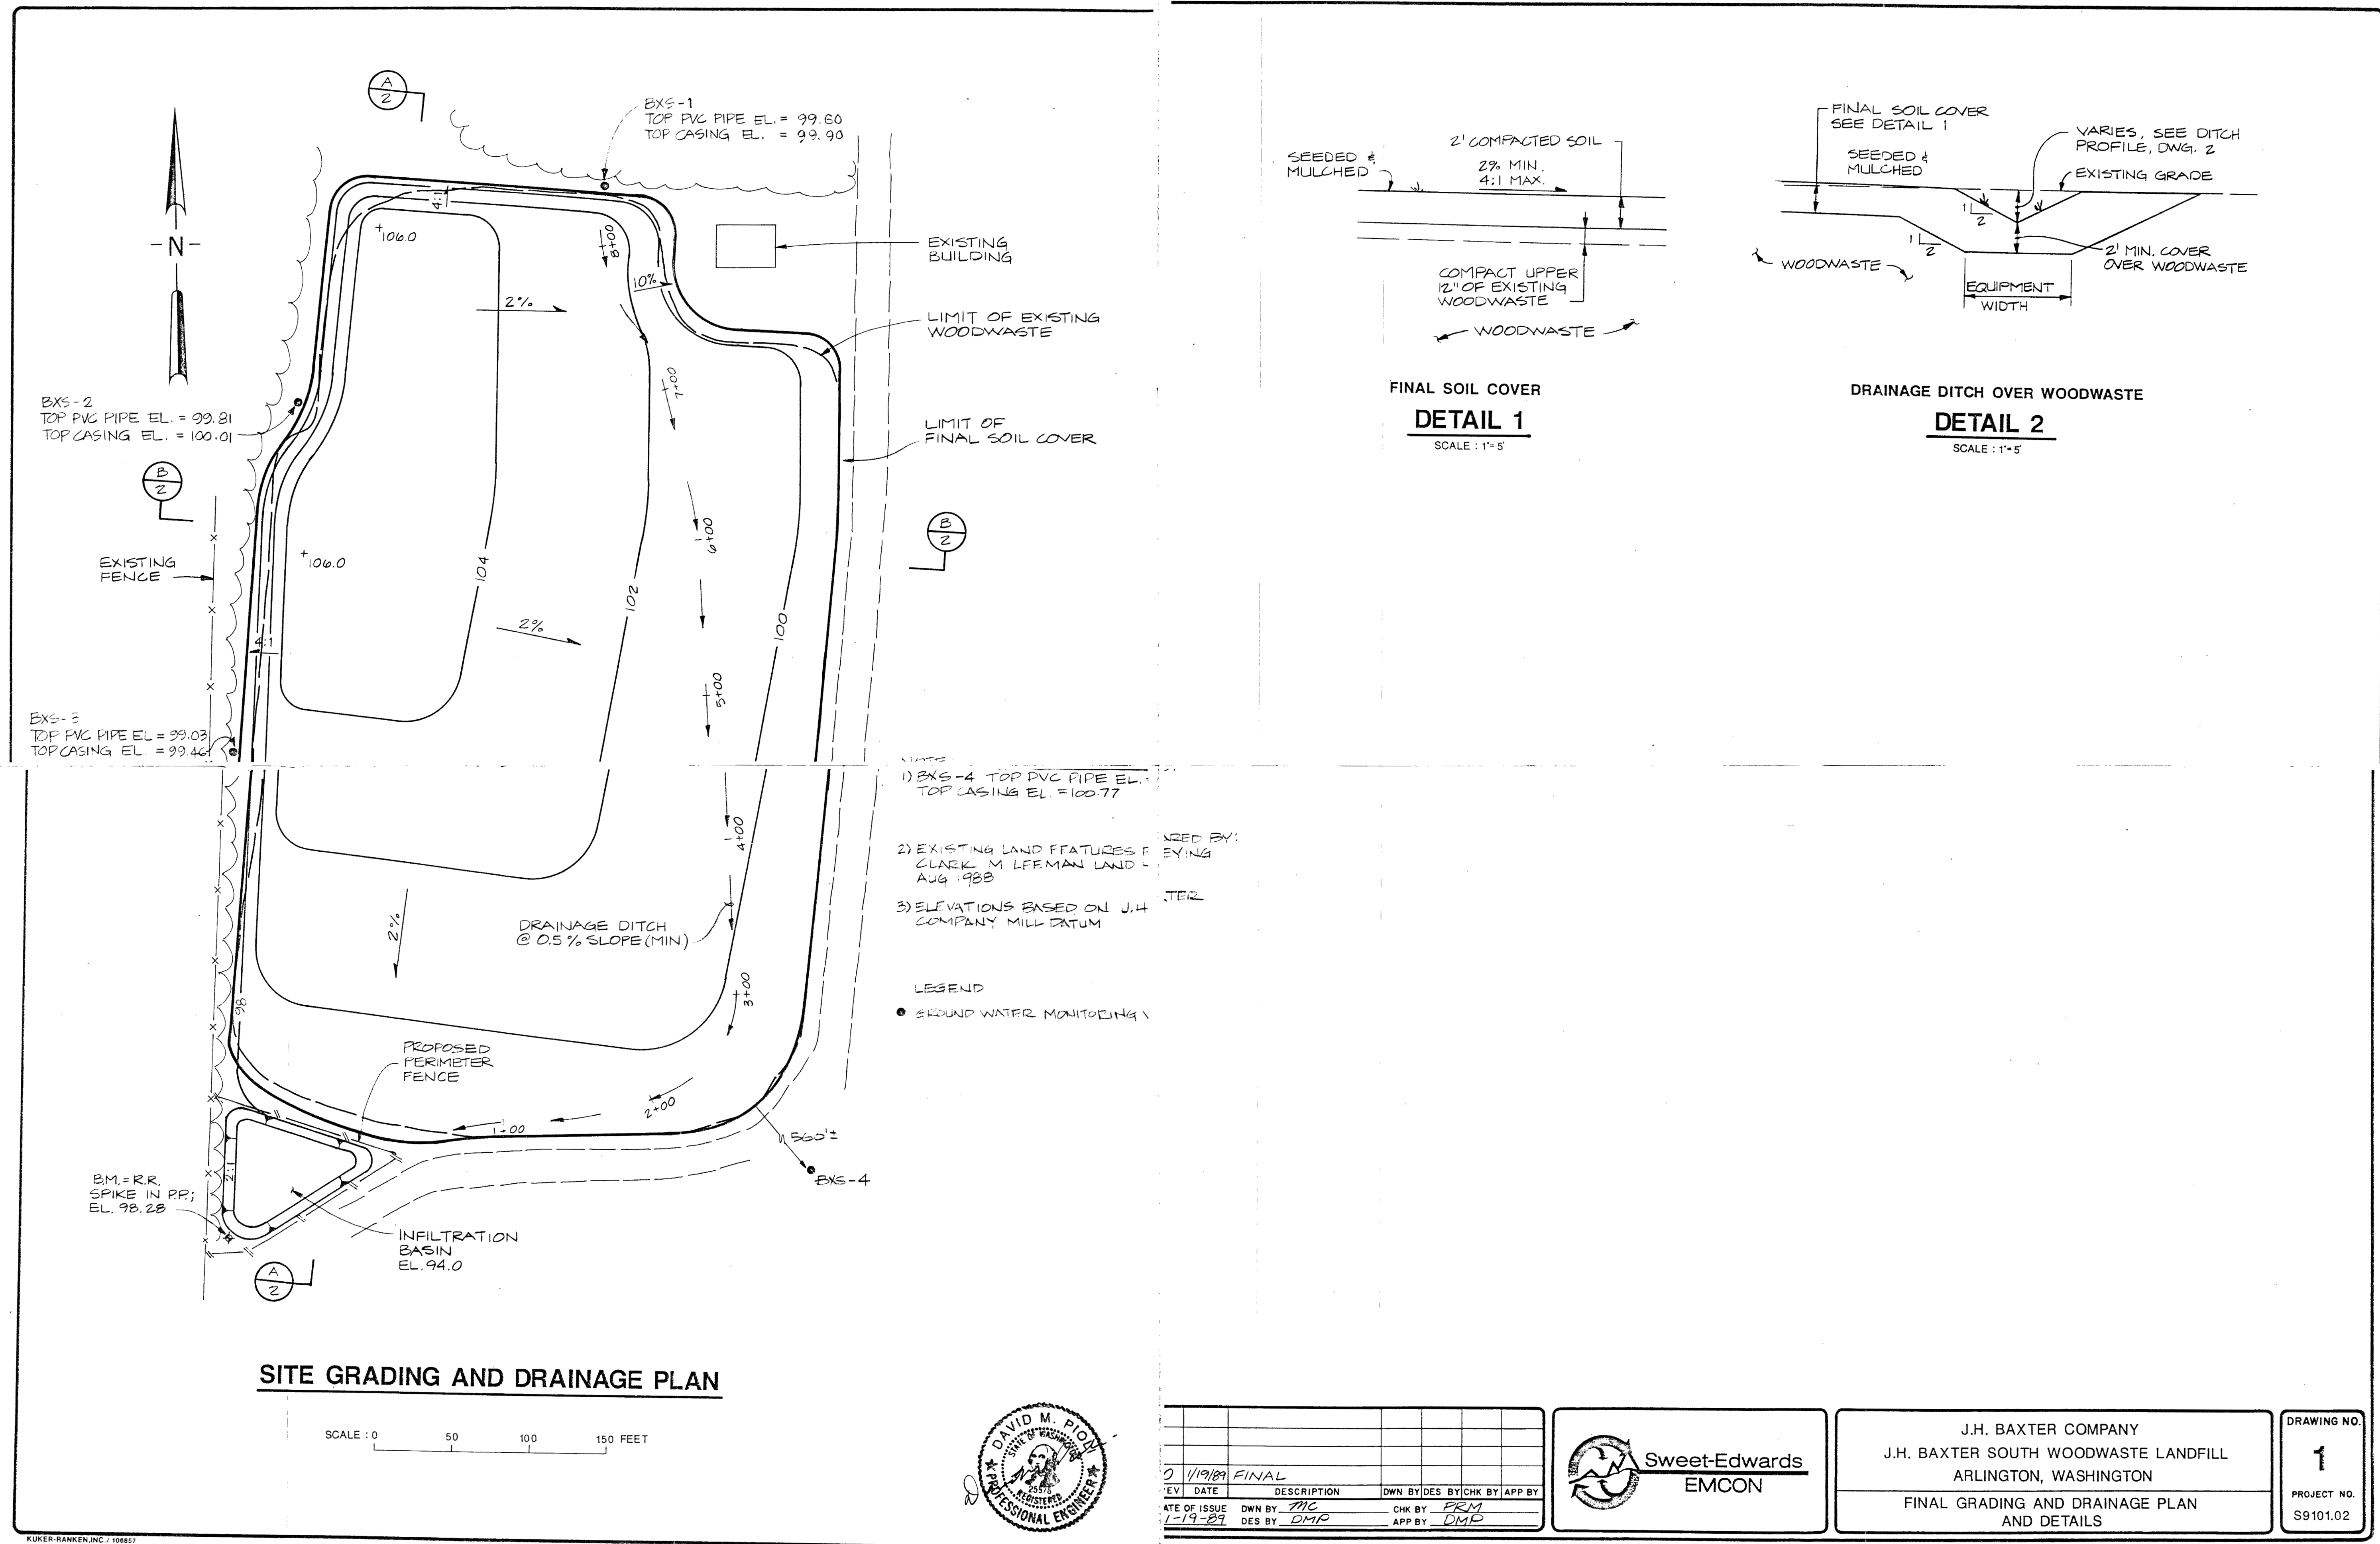
soil erosion from stormwater runoff is evident. The cap is fairly flat and slightly higher than surrounding ground. The “v”-shaped ditch is shorter than depicted in Figure 1 and instead bisects the southern half of the site from the northeast to the southwest and is directed toward the infiltration basin (Figure 2). The ditch is well vegetated. The infiltration basin seems to consist of a small, pre-treatment cell and second, larger cell. The basin also has a well-vegetated base and side slopes.

Figure 1. Site grading and drainage plan for the Baxter Company south woodwaste landfill, post closure. (Source: Sweet-Edwards EMCOM 1989).

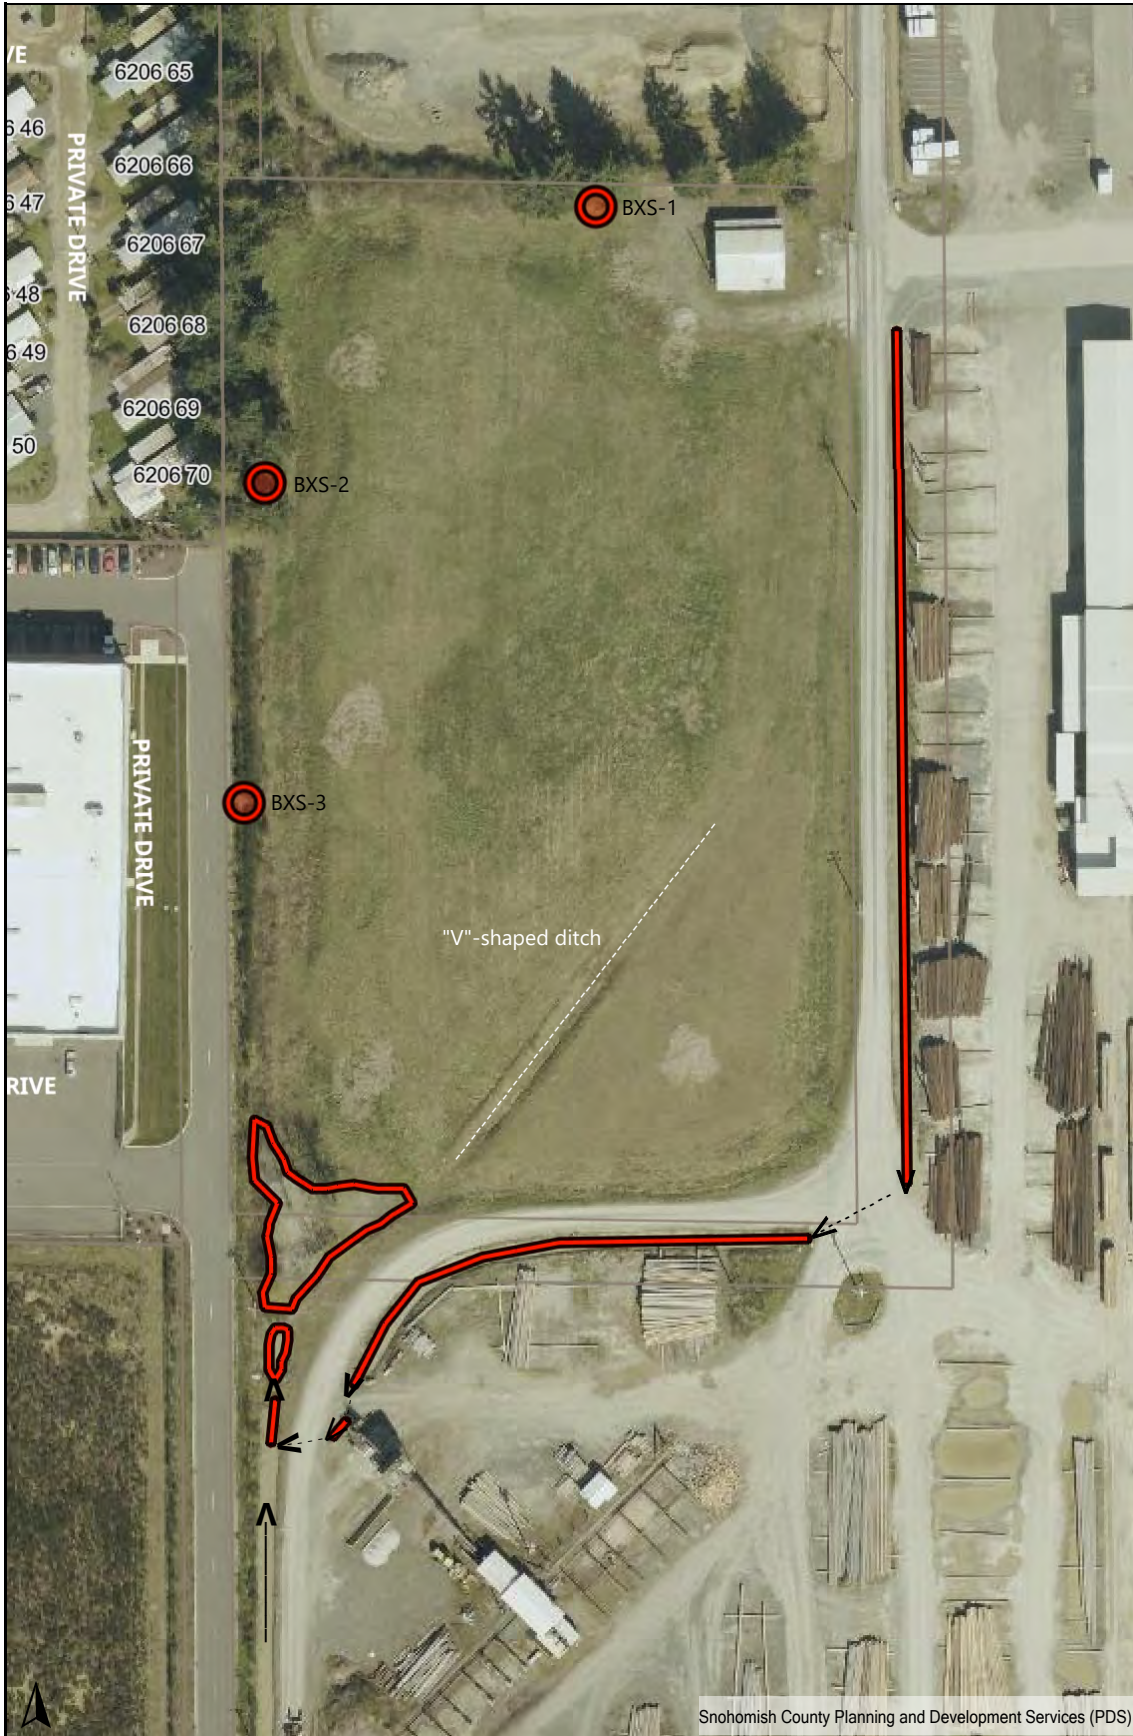
Figure 2 shows the direction of stormwater flow in these ditches on 11 December 2025 following a prolonged storm (referred to by local meteorologists as an “atmospheric river”). Conditions on 11 December reflected significant rainfall for the month (~1.8 inches thru the 11th, as measured at Paine Field). The east and southeast margins of the landfill and the “v”-shaped ditch bisecting the southern half contained no stormwater during this time, although some rainwater had collected in small pockets in the ditch. Figure 3 shows stormwater in the infiltration basin from photos taken on the 11th. Photos depict unusually high-water levels that had accumulated and show stormwater was present at the southwest margin of the landfill but did not extend onto the higher cap. The reconnaissance showed that even during very wet periods, stormwater does not infiltrate the landfill cap except for possibly the southwest corner where the infiltration basin encourages it.

Figure 2. Baxter South woodwaste landfill, stormwater routing to infiltration basin.

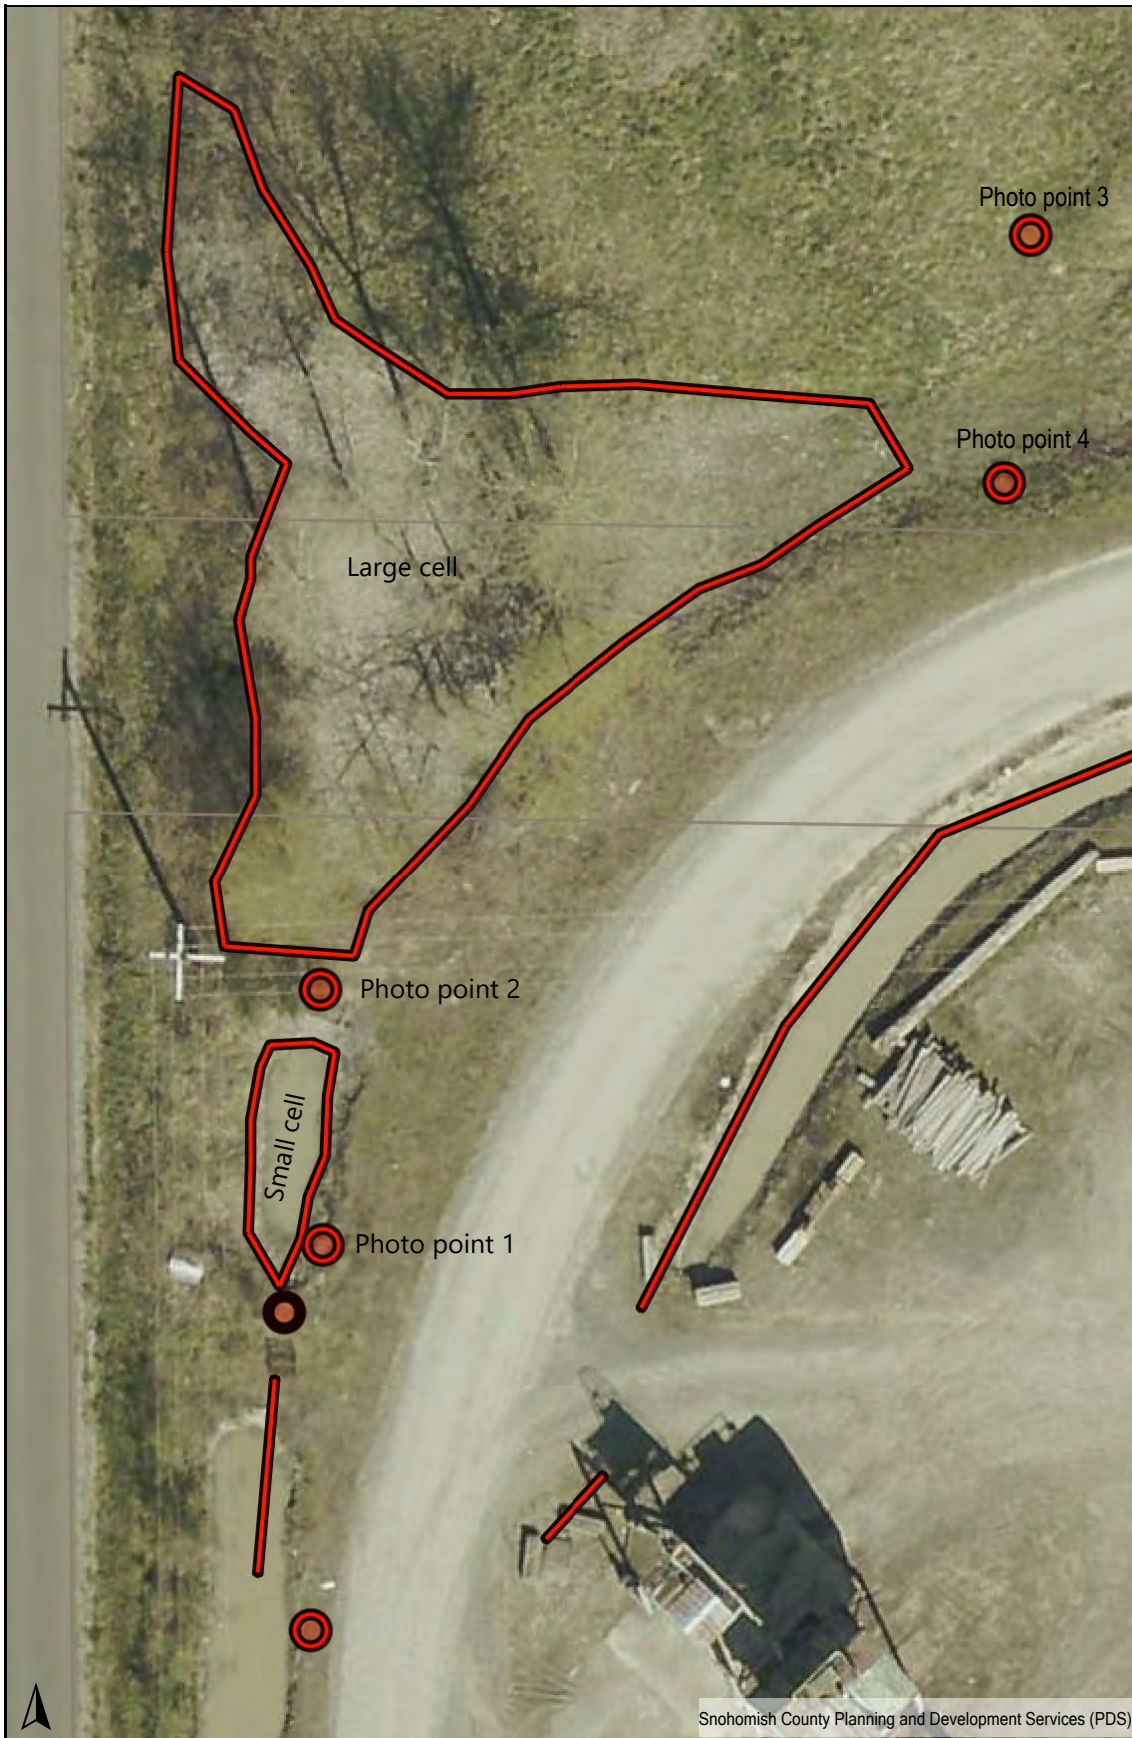
Figure 3. Baxter South woodwaste landfill, small and large cell of infiltration basin, w/photo points.

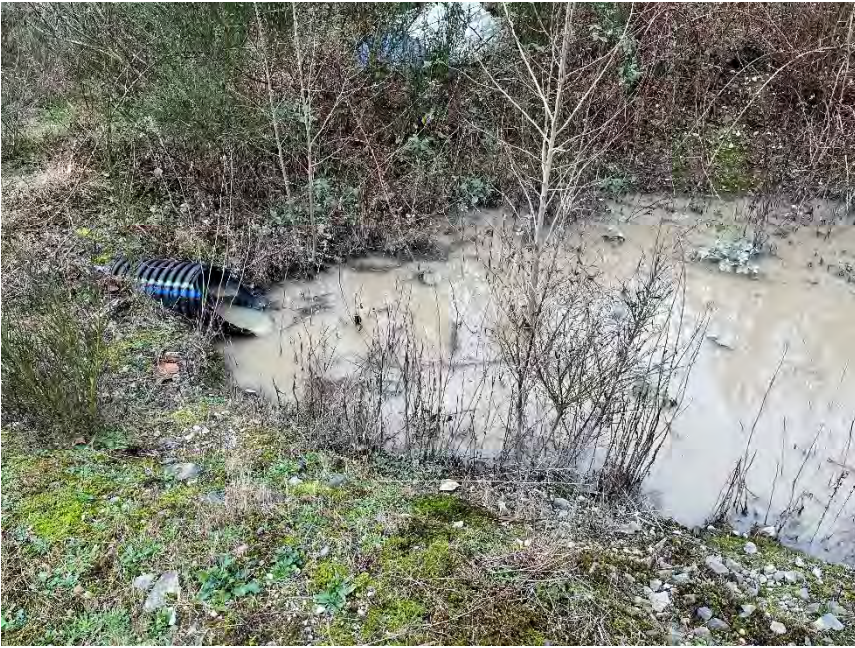
Photo point 1 Looking west at stormwater outfall into smaller cell of infiltration basin.

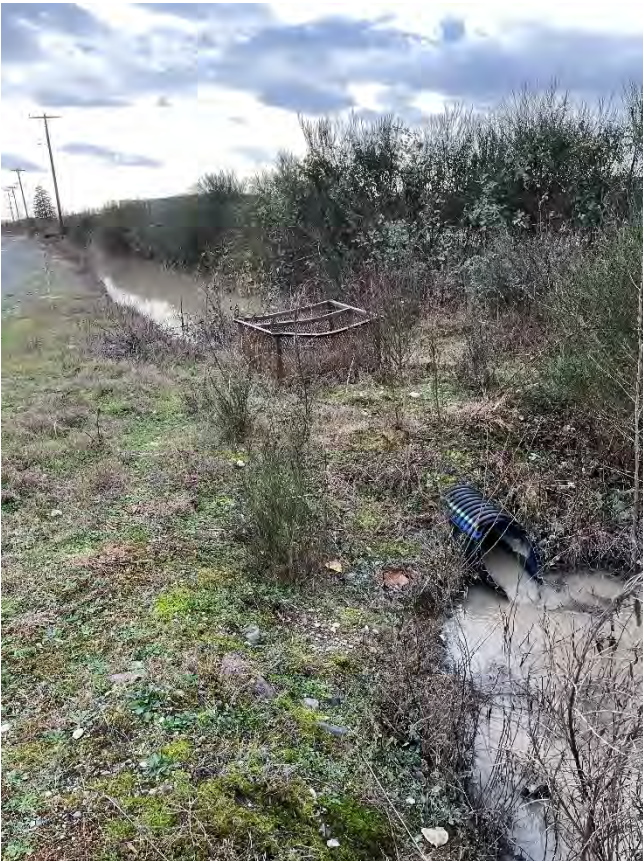
Photo point 1 Looking south at stormwater outfall and ditch from the south.

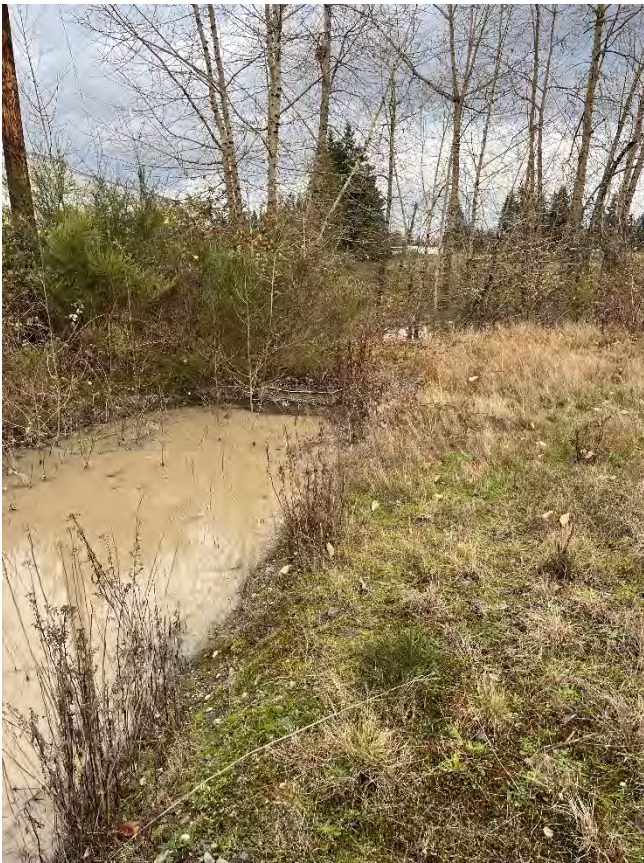
Photo point 1 Looking north at smaller cell of infiltration basin.

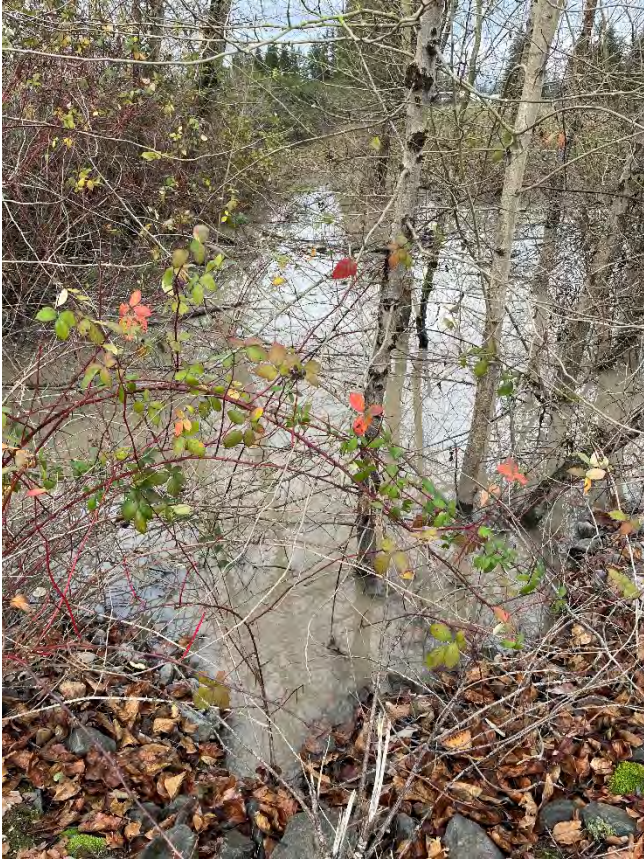
Photo point 2 Looking north at larger cell of infiltration basin.

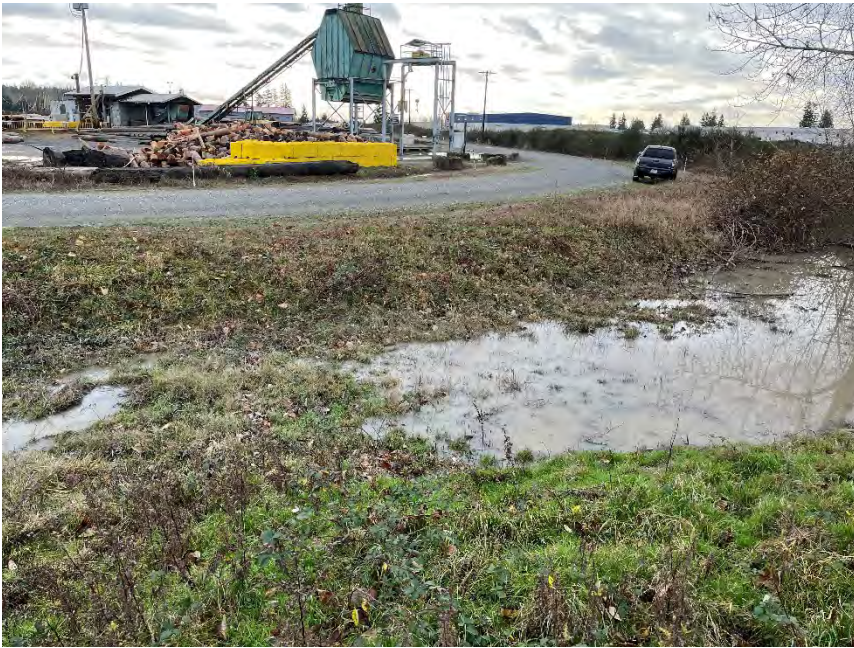
Photo point 3 Looking southwest showing NE extent of stormwater infiltration.

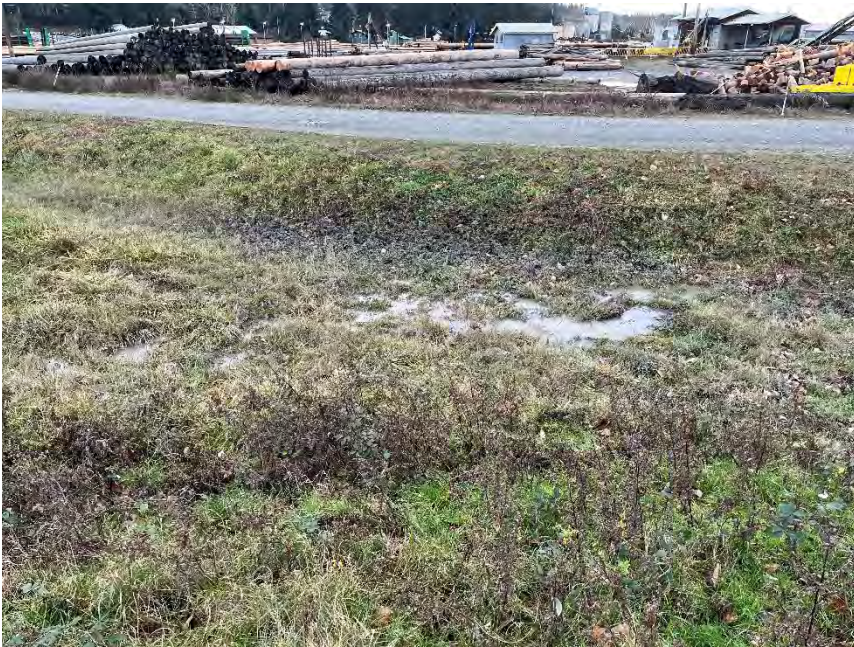
Photo point 3 Looking southeast showing NE extent of stormwater infiltration.

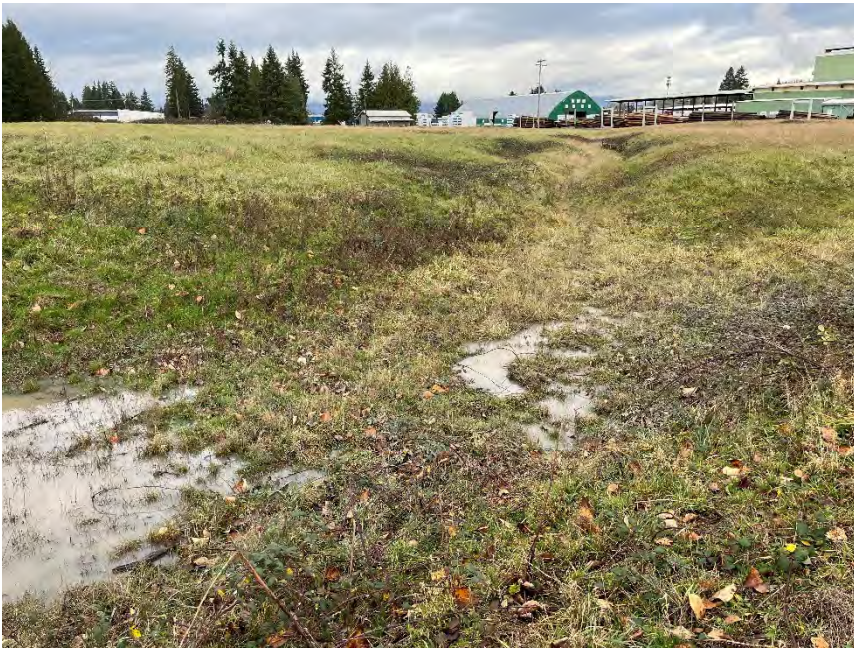
In addition to protecting the ground from erosion, landfill cap vegetation seems to be affectively intercepting rainfall and managing runoff. While present, the “v”-shaped ditch does not appear to be collecting stormwater or conveying any to the infiltration basin as there is no physical evidence of water flow. In addition, there is currently no stormwater run-on reaching the landfill from the south or east. Ditches along the east and south side of perimeter roads intercept stormwater from Baxter grounds and deliver it to the infiltration basin while bypassing the landfill.

Photo point 4 Looking northeast and up "v"-shaped drainage ditch.
