## **TECHNICAL MEMORANDUM**

**DATE:** February 18, 2026

**FROM:** Timothy S. Brown, LHG, Madrona Environmental Consulting, LLC

**RE:** **Former Mill E / Koppers Facility  
2025 Annual Performance and Compliance Monitoring Report**

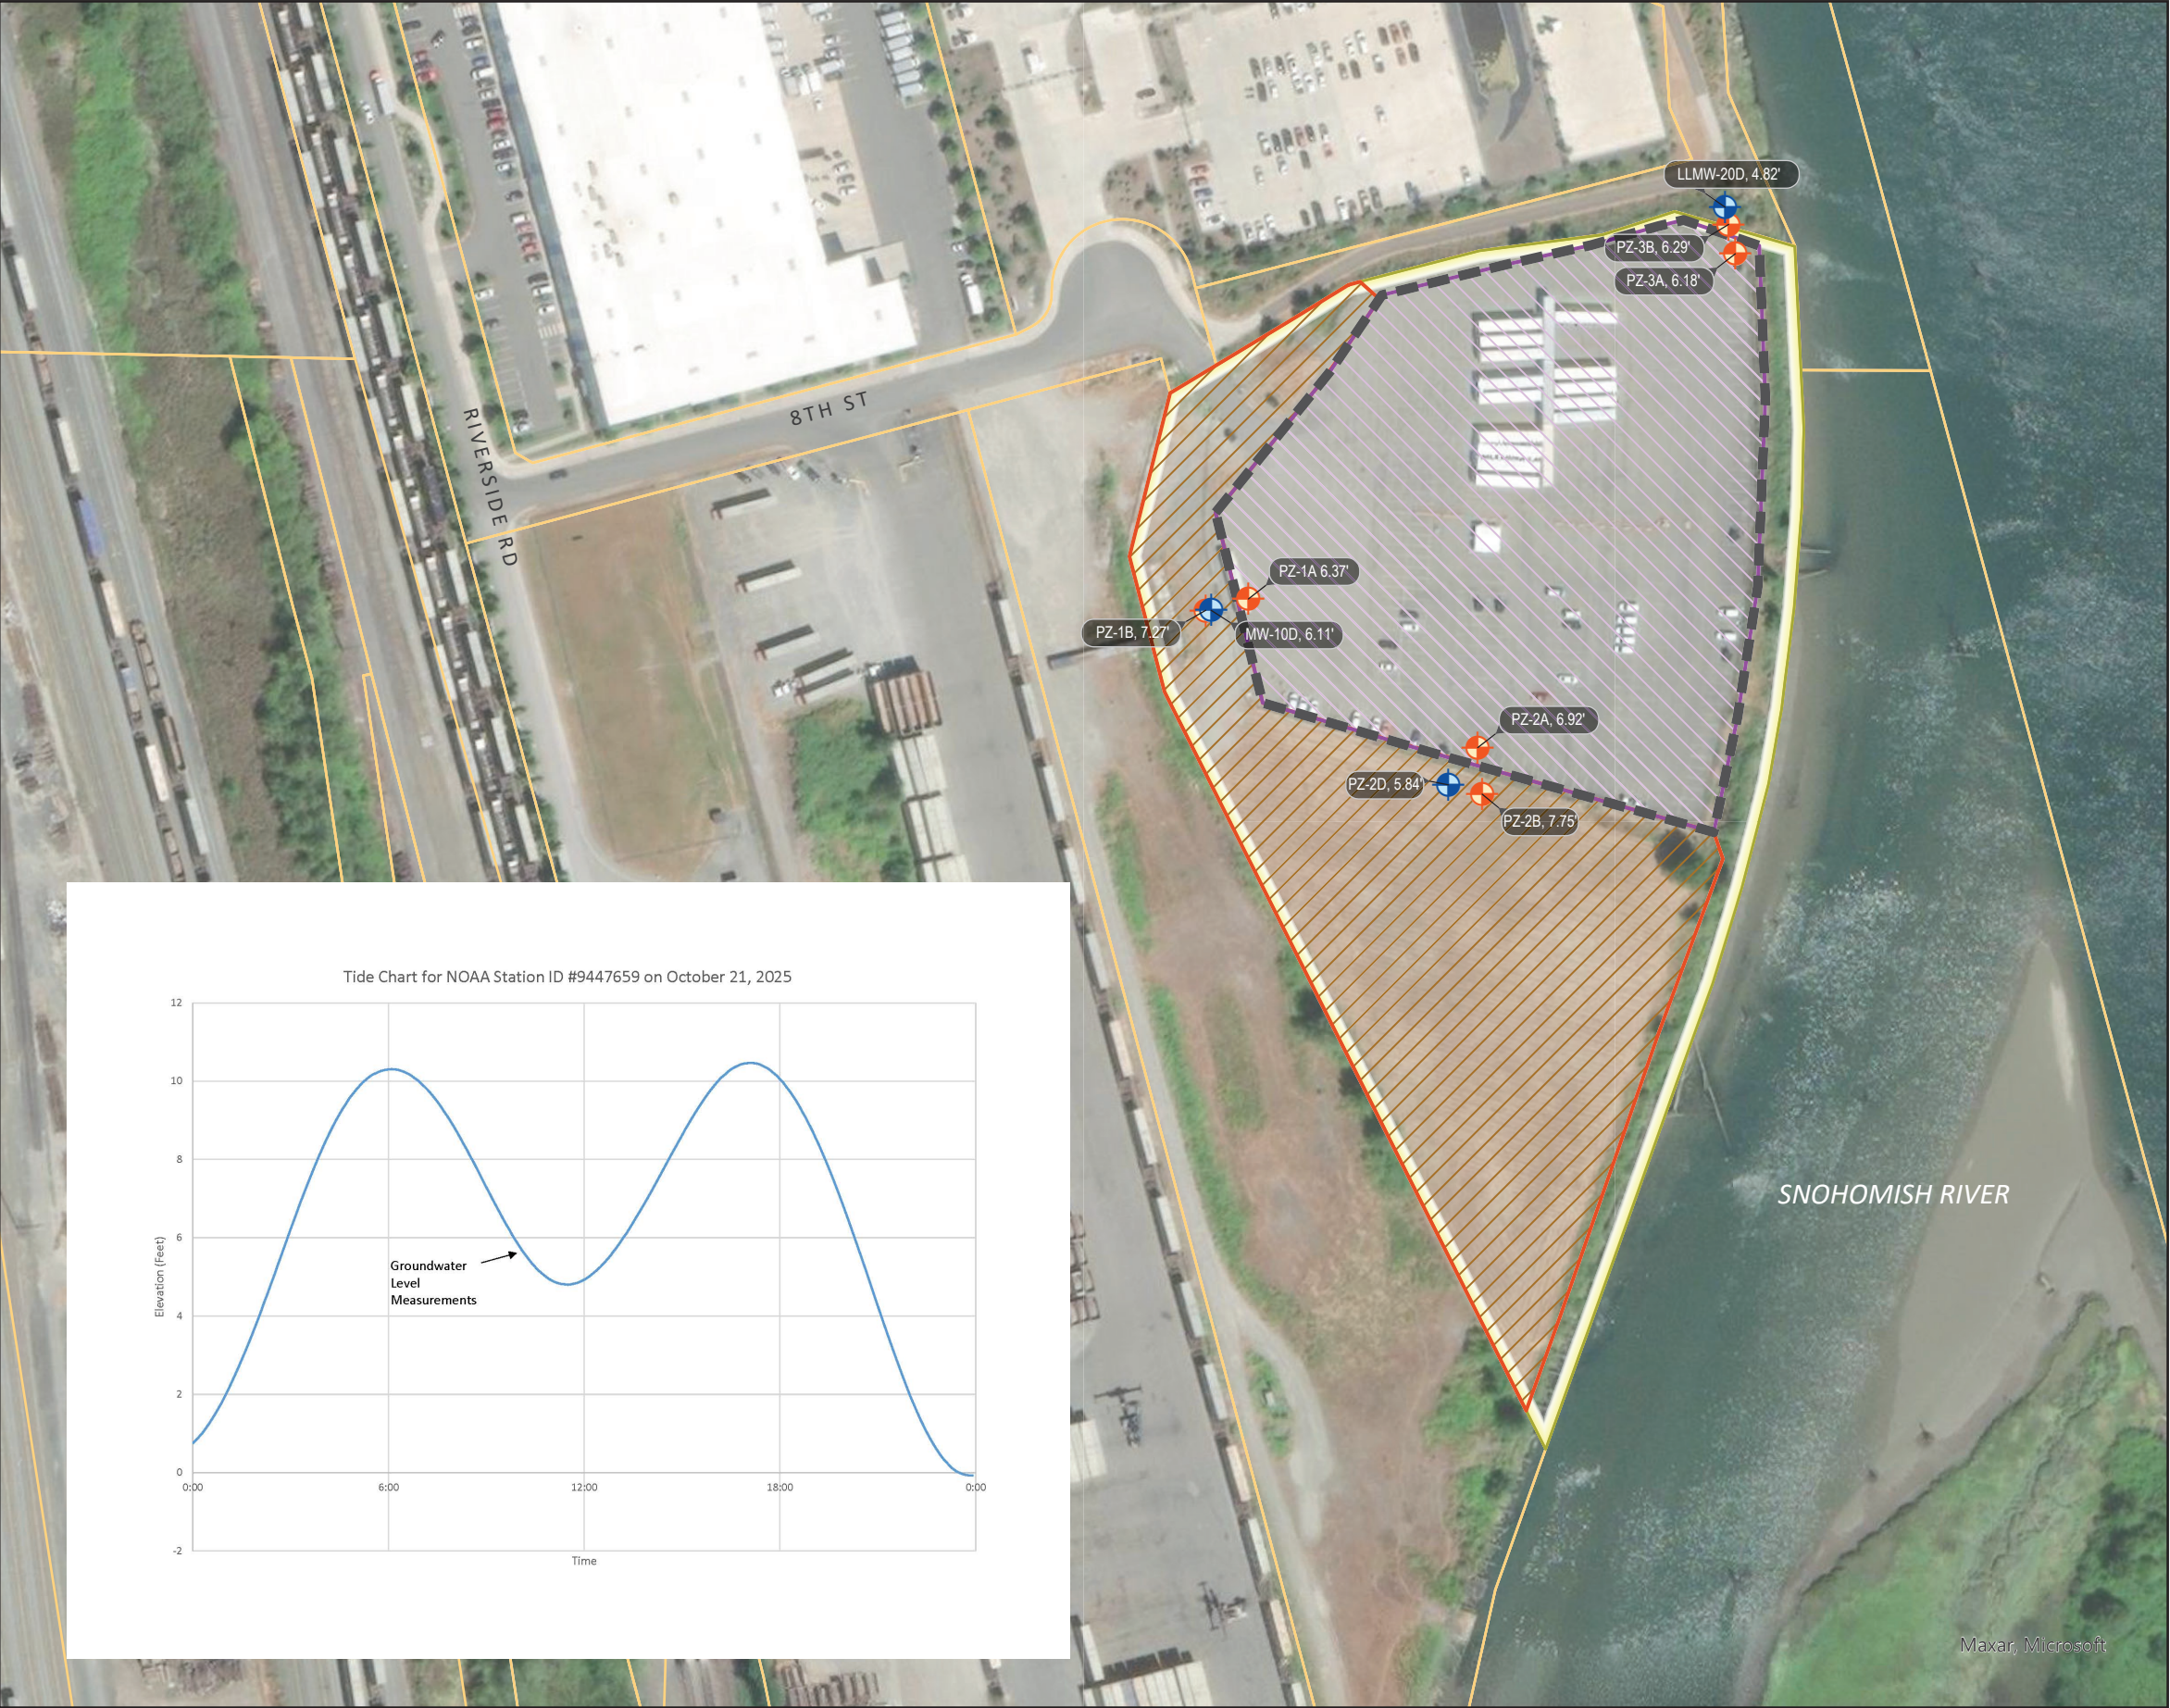
**SITE PLAN AND 2025  
GROUNDWATER ELEVATIONS**  
FORMER MILL E / KOPPERS FACILITY  
EVERETT, WASHINGTON

MEC performed annual groundwater monitoring at the Site on October 21, 2025. During the October 2025 monitoring event, water levels were measured in the three Upper Sand Aquifer piezometers inside the barrier wall (PZ-1A, PZ-2A, and PZ-3A), three piezometers outside the barrier wall screened in the Upper Sand Aquifer (PZ-1B, PZ-2B, and PZ-3B), and three wells/piezometers located outside the barrier wall and screened in the Lower Sand Aquifer (MW-10D, PZ-2D, and LLMW-20D). A Site plan showing the approximate well locations and

groundwater elevations in feet relative to North American Vertical Datum of 1988, and the approximate timing of the measurements relative to the 24-hour tidal cycle is presented on Figure 2.

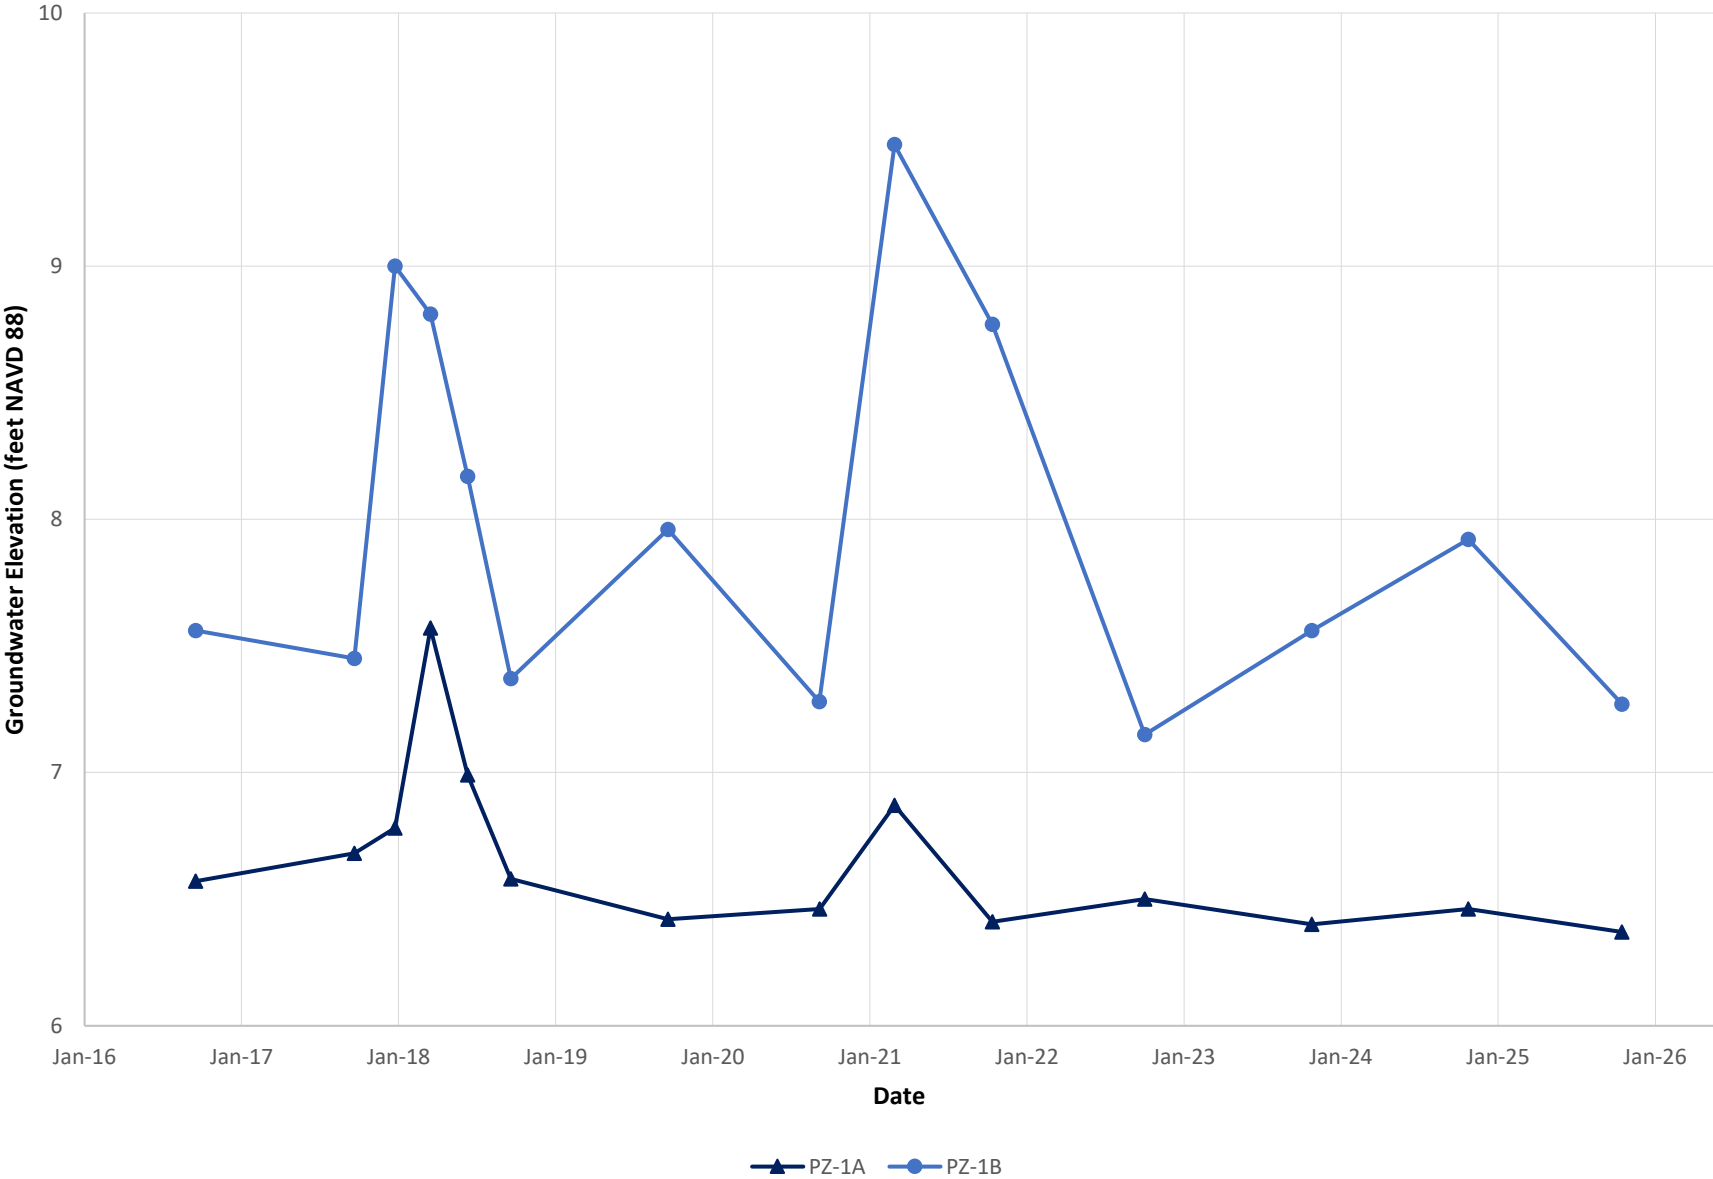
Figure 3  
Groundwater Elevation Trends  
PZ-1A and PZ-1B  
Former Mill E / Koppers Facility  
Everett, Washington

Groundwater elevation trends for each piezometer pair are presented on Figures 3 through 5 and show a comparison of historical groundwater elevation data from 2016 to 2025. Review of the data indicates the groundwater elevations outside of the barrier wall are higher than inside the barrier wall with the exception for piezometer PZ-3B in October and November 2022. The slightly lower than expected groundwater elevations observed in piezometer PZ-3B in October and November 2022 may be the result from the atypical dry summer months in 2022 (AESI, 2022).

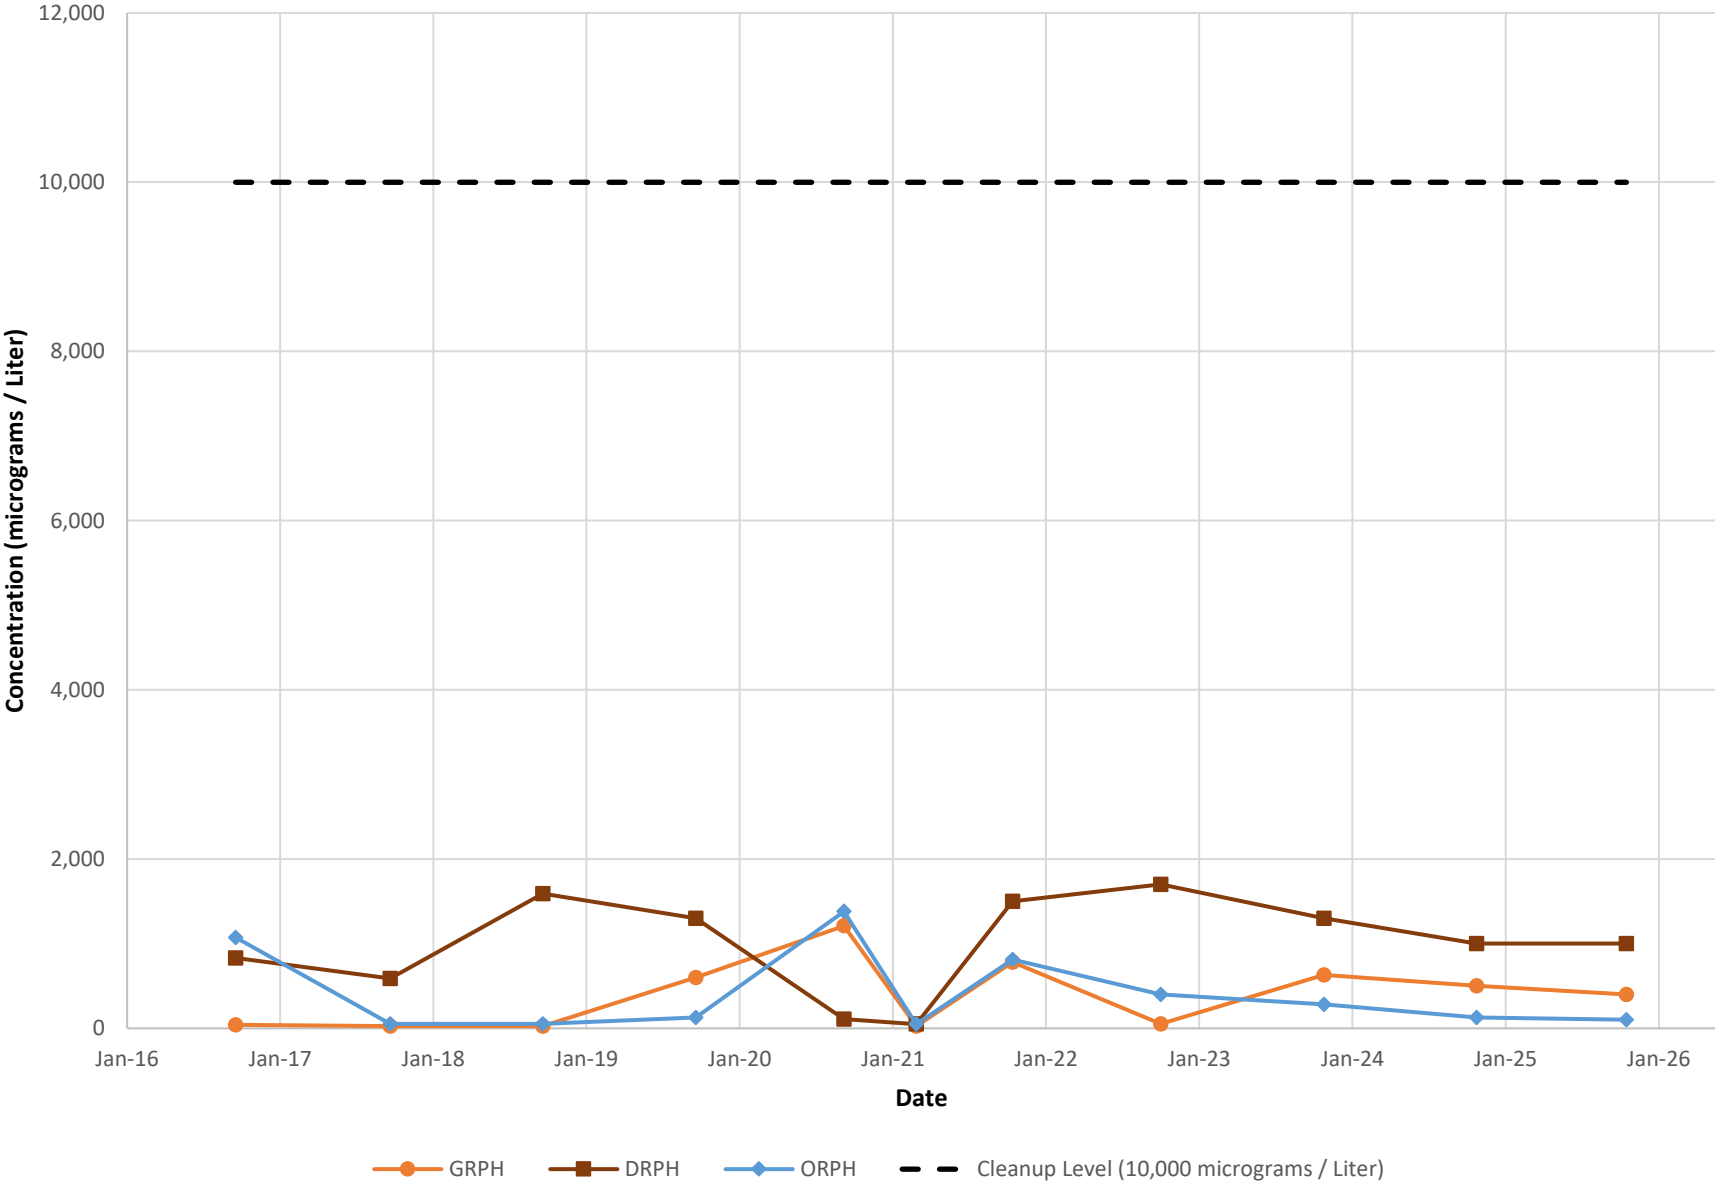
Figure 6  
Groundwater Quality Trends for PZ-3A  
Total Petroleum Hydrocarbons  
Former Mill E / Koppers Facility  
Everett, Washington

Groundwater analytical results are presented in Table 4 and a copy of the analytical laboratory report and chain of custody is included as Appendix A. The results are compared to the Washington State Model Toxics Control Act (MTCA) Method A and Method C cleanup levels that were established in the Cleanup Action Plan by Ecology (Ecology, 1998B) as part of the Consent Decree for the Site within the area of the containment wall. Concentrations of total petroleum hydrocarbons (TPH) including GRPH, DRPH, and ORPH were below the established MTCA cleanup level criteria of 10,000 micrograms per Liter ( $\mu\text{g/L}$ ). PCP was not detected at a concentration exceeding the laboratory reporting limit. Total arsenic was detected at a concentration of 550  $\mu\text{g/L}$ , which exceeds the established MTCA cleanup level criteria of 5  $\mu\text{g/L}$ . Groundwater quality concentration trend charts (time - concentration) over the past 10 years for TPH, PCP, and arsenic are presented on Figures 6 through 8, respectively.

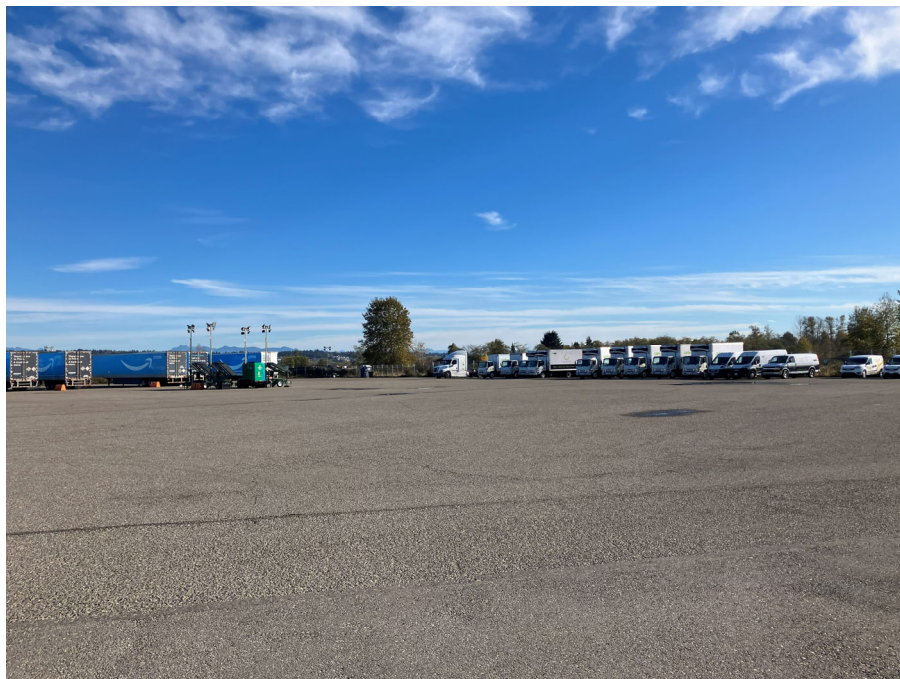
No obvious signs of major cracking, fissures, or surface pumping were observed. There are areas where shallow depressions were observed, which were less than 2-inches in depth from recent rainfall. These shallow depressions were less than 10 feet in diameter, like the previous year. Minor ponding on asphalt surface was observed in areas with shallow depressions.

Photograph 2 – Looking southeast at southern and central portions of the asphalt cap. Photograph shows repaired cracks and minor ponding on asphalt cap surface.

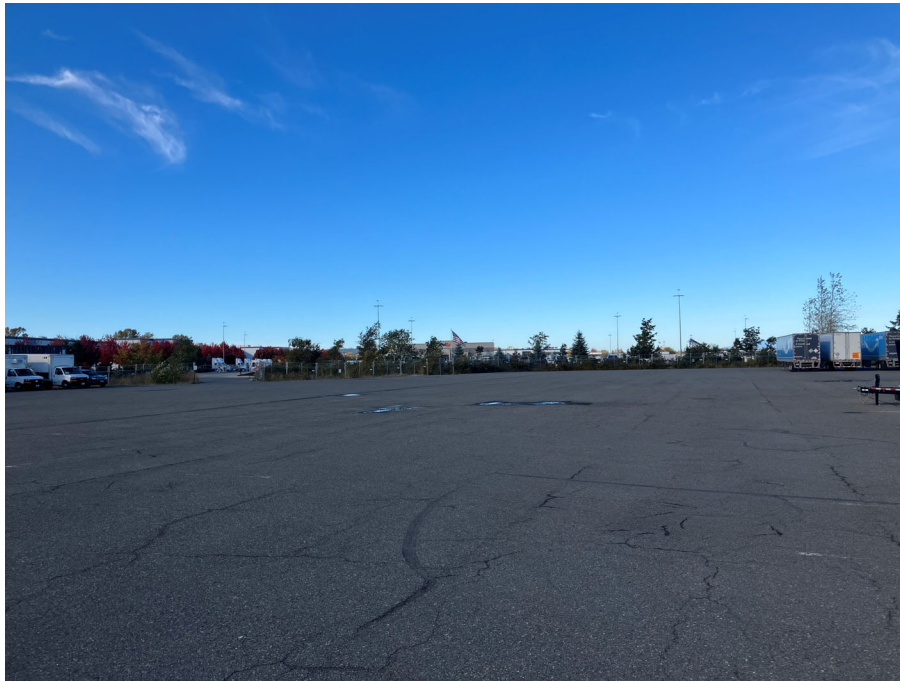
Photograph 3 - Looking northeast at central portion of the asphalt cap. Photograph shows repaired cracks and minoring ponding on asphalt cap surface. Photograph of typical asphalt crack repaired with a joint sealant.

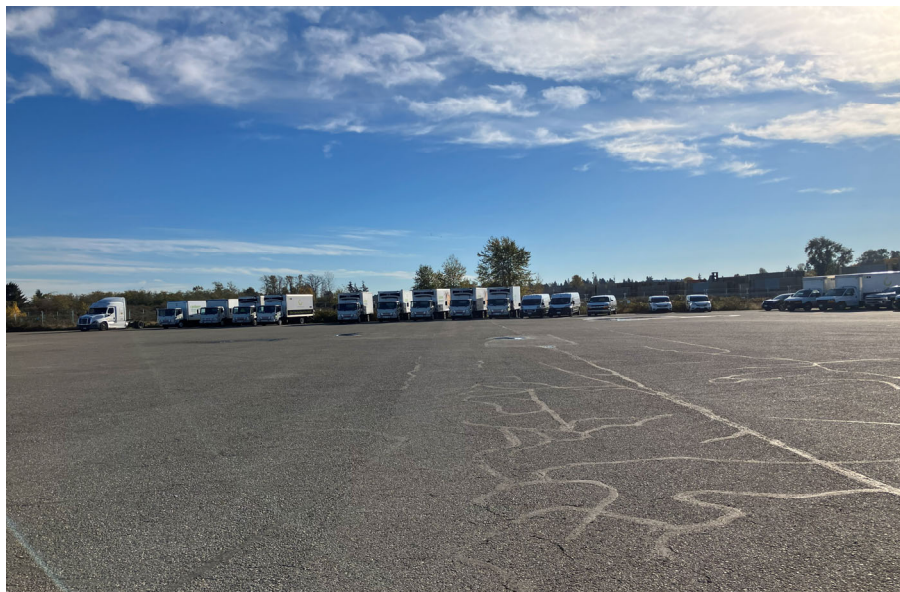
Photograph 4 – Looking south at the southern portion of the asphalt cap. Photograph shows repaired cracks and minoring ponding on asphalt cap surface.

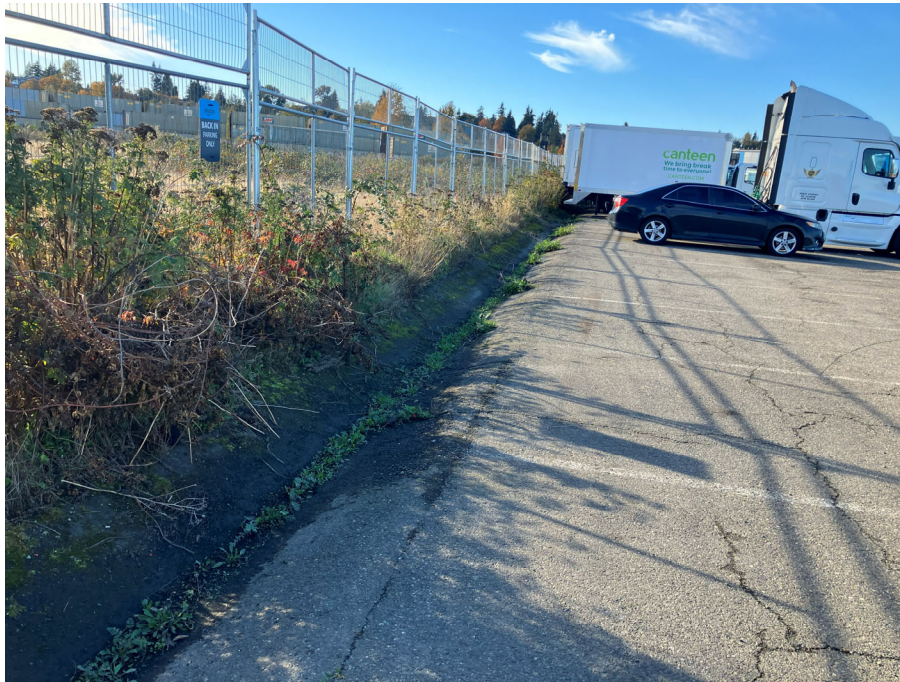
Drainage ditches had nominal amounts of accumulated sediment than previous year, and where present, the accumulated sediment amounts appeared to be less than 1/2-inch. Minor cracks with vegetation growing through were observed along the southern drainage ditch. In addition, vegetation was growing from the adjoining soil cap area into the southern drainage ditch. Vegetation was also observed growing over the asphalt cap surface from the eastern vegetated area and northern landscaped area.

Photograph 5 – Looking west at the southern portion of the asphalt cap. Photograph shows vegetation in the south drainage ditch. Vegetation was observed to be growing through minor cracks and over the asphalt cap from the adjoining soil cap area.

Madrona Environmental Consulting, LLC recommends maintaining the drainage ditches by removing visible vegetation from the minor cracks and sediment in the drainage ditches, and overlying vegetation in ditches and asphalt cap from soil cap areas and landscaped areas inside the fenced area. In addition, it is recommended that maintenance of the asphalt cap continue, if cracks are observed, to maintain the asphalt cap integrity in a serviceable condition and meet the performance objectives to prevent potential direct contact with contaminated soil and surface water infiltration at the site.

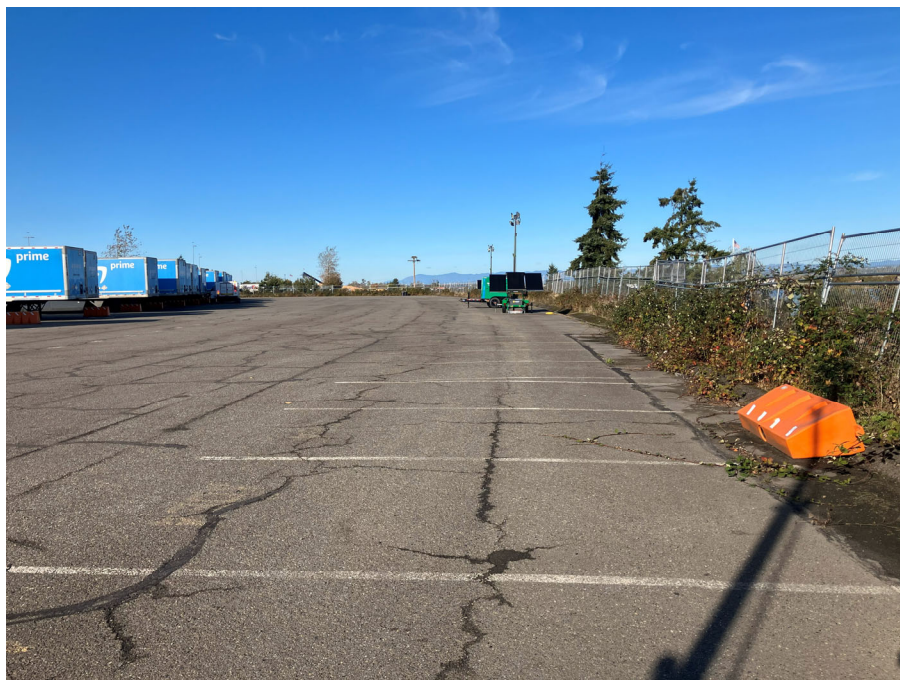
Photograph 6 - Looking north at the eastern portion of the asphalt cap. Photograph shows parked dry van trailers, and cracks, majority repaired, and vegetation growing over the asphalt cap surface.

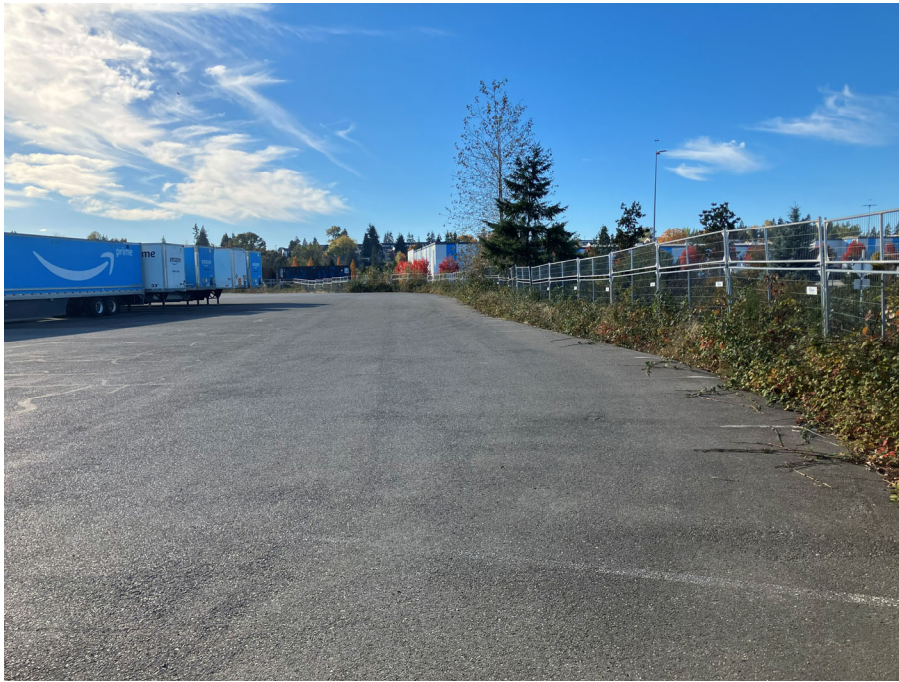
Photograph 7 - Looking west at the northern portion of the asphalt cap. Photograph shows vegetation growing over the asphalt cap surface from the northern landscaped area.
