## Technical Memorandum

PROJECT: Port of Tacoma Parcel 15 (Portac) – 4215 State Route 509

SUBJECT: 2025 Roller-Compacted Concrete (RCC) Cap Inspection and Maintenance

DATE: October 9, 2025

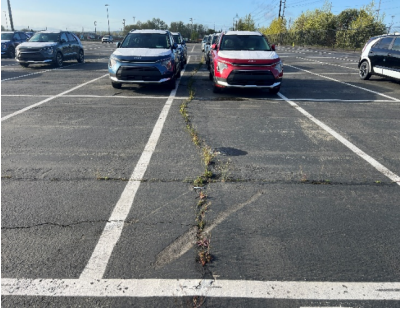
Location ID	Observations	Recommended Actions	Photographs
O1	Intermittent linear joint cracks in pavement; wider than 1/8 in; generally extending east/west; older asphalt sealant is cracking.	Remove vegetation as needed and re-seal cracks. Continue to observe at next inspection.

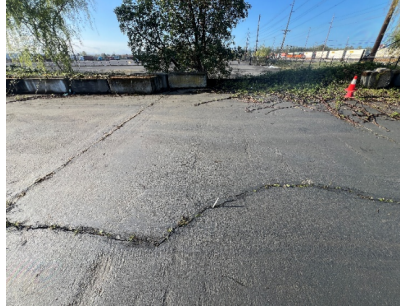
O2	Intermittent cracks; up to 1/4-inch; variable lengths and orientations; sealant present but gradually deteriorating and vegetation starting to grow in them.	Observe at next inspection.

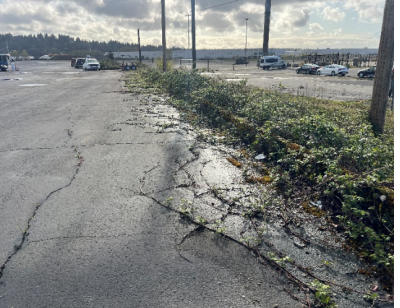
O3	Excessive vegetation around cap perimeter; vegetation infiltrating cracks	Clear/maintain vegetation; observe at next inspection.

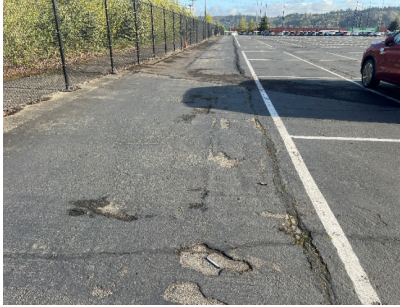
O4	Outer layer of asphalt flaking/chipping off in misc. patterns; lower layers of asphalt still intact.	Observe at next inspection.

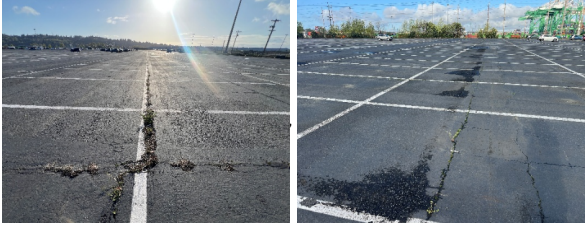
Location ID	Observations	Recommended Actions	Photographs
05	Intermittent linear joint cracks in pavement; wider than 1/8 in; generally extending east/west; older asphalt sealant is cracking.	Remove vegetation as needed. Continue to observe at next inspection.

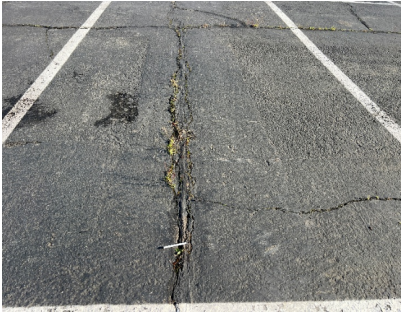
06	Intermittent linear joint cracks in pavement; wider than 1/8 in; generally extend north/south; older asphalt sealant is cracking.	Remove vegetation as needed. Continue to observe at next inspection.

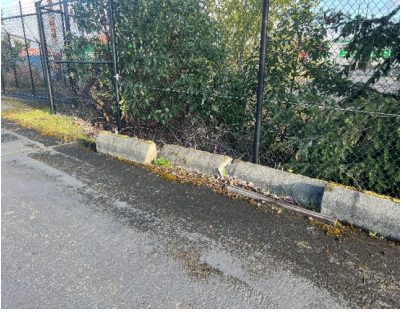
The edge of the cap was inspected and found to be in good condition. Some sections of curbs around the edge of the cap were observed to have been broken with sections pushed off the edge of the pavement in places (Table 2 observations O7). The condition of the curbs was not observed to be impacting the integrity of the cap or stormwater drainage system.

07	Perimeter curb broken and displaced, curbing is only in select sections, it does not appear to have a stormwater function.	Consider replacing/repairing, if needed.

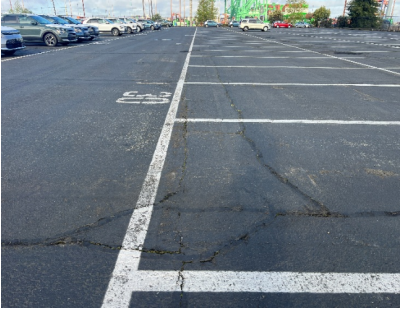
08	Cracks reforming through previously applied sealant. Sediment and minor vegetation taking root in re-opened cracks.	Continue to observe at next inspection.

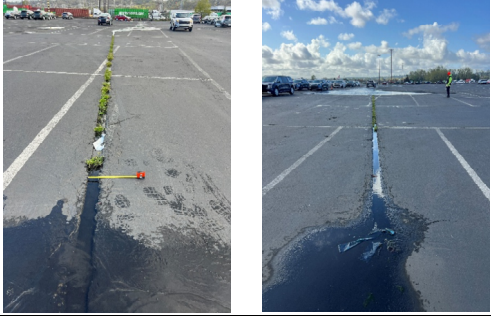
Location ID	Observations	Recommended Actions	Photographs
O9	channel in pavement; 3-4 in. wide; extends 50-70 ft. northwest/southeast	Clear debris and vegetation, observe at next inspection.

Cracks wider than 1/8 inch and any gouges in the slurry overlay have been identified as specified in Table 2 and shown on Figure 2. Because these cracks are not expected to result in substantial leakage, continued monitoring of the cracks and gouges is recommended at the next inspection event. It is recommended that channels at O9, O14, and O15 be cleaned out to allow water to flow out of areas with ponding.

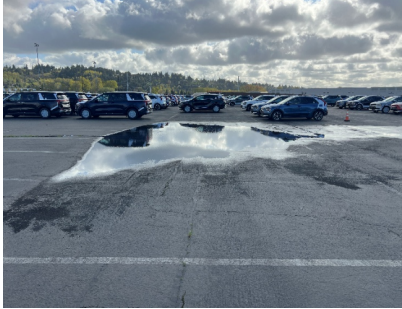
O10	Low area at end of cut channel. Storm water tends to pond here	Observe area at next inspection if excessive crack formations.

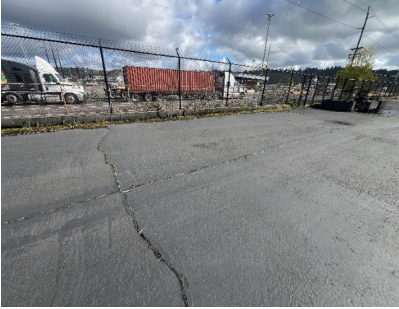
O11	Intermittent linear joint cracks in pavement; wider than 1/8 in; older asphalt sealant is cracking.	Continue to observe at next inspection.

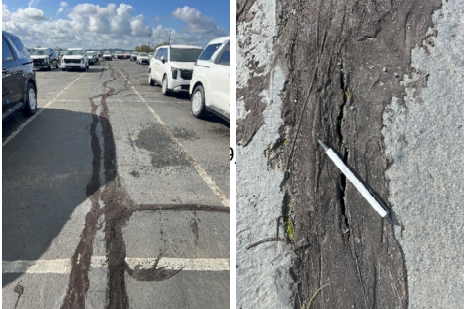
O12	Gaps forming in newer asphalt sealant along asphalt transition zone.	Continue to observe on next inspection.

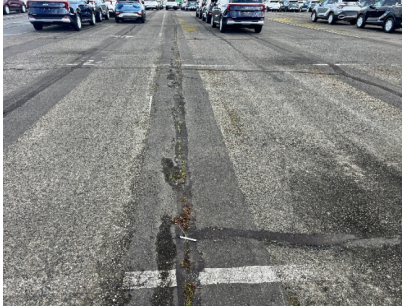
O13	Cracks reforming through previously applied sealant. Sediment and minor vegetation taking root in re-opened cracks. Cracks approximately 1/8 inch wide. Linear north/south cracks extend across a wide area.	Observe at next inspection for sealant crack growth.

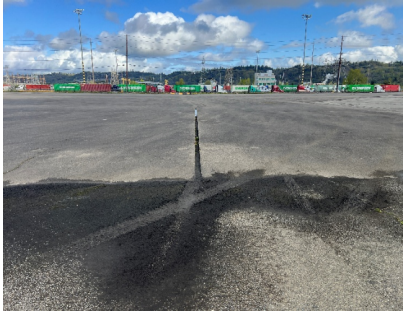
Location ID	Observations	Recommended Actions	Photographs
O14	Cut channel in pavement; 4-5 in. wide; extends 40-60 ft. northwest/southeast.	Clear debris sediment; observe at next inspection.

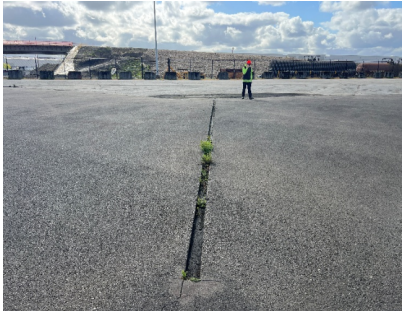
O15	Cut channel in pavement; 4-5 in. wide; extends about 40 ft. northwest/southeast.	Clear debris sediment; observe at next inspection.

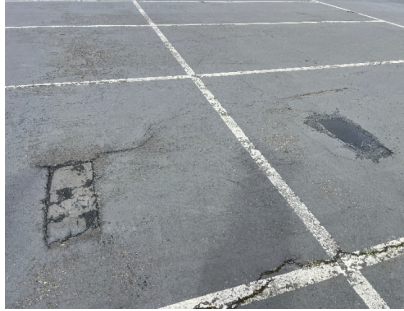
O16	Scours in pavement; scours not all the way through the pavement thickness.	Observe at next inspection.

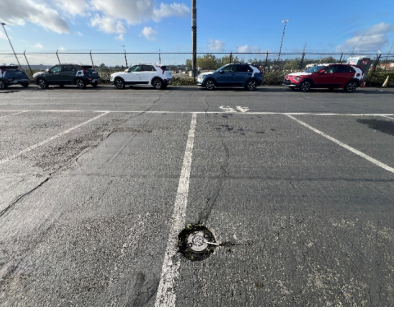
unmarked monitoring well	Various monitoring wells throughout cap that are not part of the OMMP compliance monitoring program.	Observe all monitoring wells at next inspection to insure lids/covers intact.

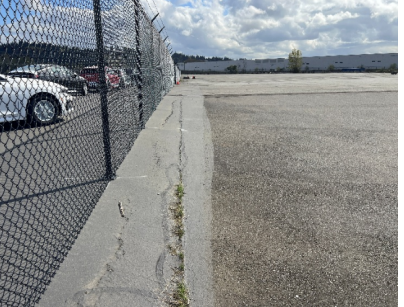
O17	Cracks reforming through previously applied sealant. Sediment and vegetation taking root in re-opened cracks. Cracks approximately 1/8 inch wide. Linear east/west cracks extend across a wide area.	Observe at next inspection for crack growth.
