Technical Memorandum

TO: Melisa Bod
FROM: Jamie Stevens, P.E. and Rusty Jones, L.G. – CRETE Consulting Inc.
PROJECT: Port of Tacoma Parcel 15 (Portac) – 4215 State Route 509
SUBJECT: 2023 Roller-Compacted Concrete (RCC) Cap Inspection and Maintenance
DATE: September 4, 2024
CC: Rob Healy – Port of Tacoma

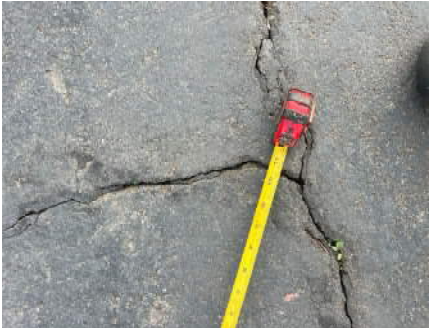
| Location ID | Observations | Recommended Actions | Photographs |
|---|--|---|--|
| X1 | crack in pavement; wider than 1/8 in; extends several >10 feet in three directions | observe at next inspection | |

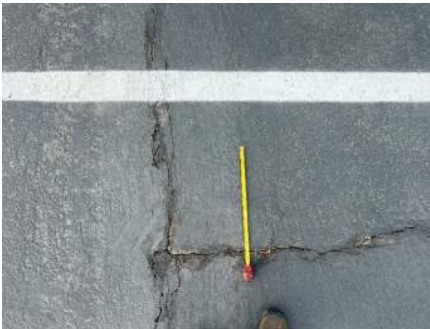
| Location ID | Observations | Recommended Actions | Photographs |
|---|--|---|--|
| X2 | crack in pavement; wider than 1/8 in; extends several >10 feet in three directions | observe at next inspection | |

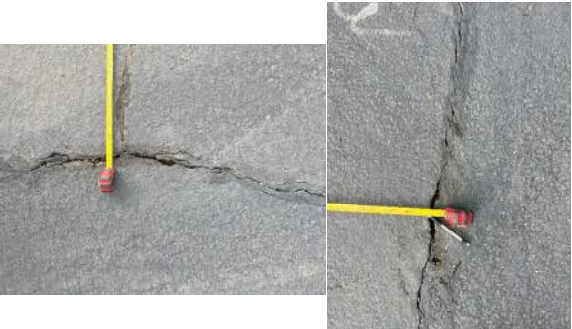
| Location ID | Observations | Recommended Actions | Photographs |
|---|--|---|--|
| X3 | several cracks in pavement; wider than 1/8 in; generally all less <1-foot | observe at next inspection | |

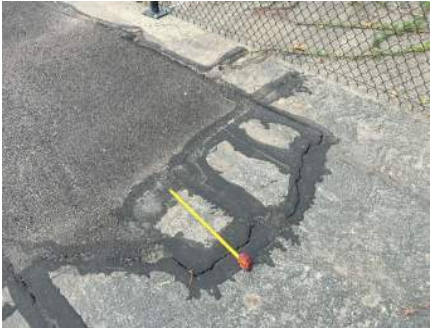
| Location ID | Observations | Recommended Actions | Photographs |
|---|--|---|--|
| X4 | cracks re-forming in patches; wider than 1/8 in; generally all less <1-foot | observe at next inspection | |

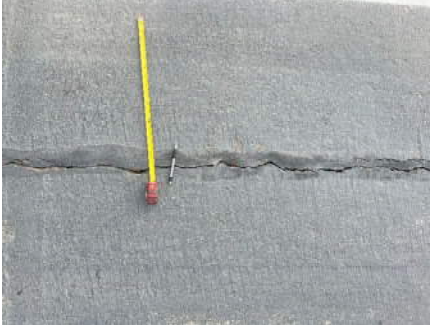
| Location ID | Observations | Recommended Actions | Photographs |
|---|---|---|--|
| X5 | intermittent cracks; wider than 1/8 in; generally all less 1 to 4-feet in length | observe at next inspection | |

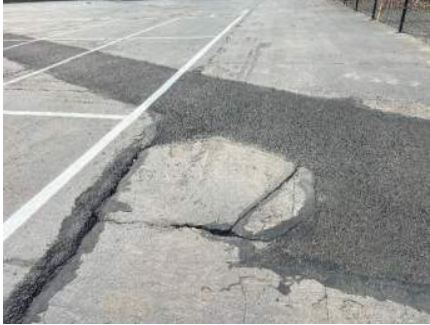
| Location ID | Observations | Recommended Actions | Photographs |
|---|---|---|--|
| X6 | cracks re-forming in patches; wider than 1/8 in; generally all less <1-foot | observe at next inspection | |

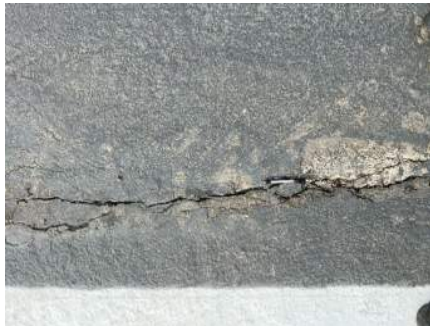
| Location ID | Observations | Recommended Actions | Photographs |
|---|---|---|--|
| X7 | intermittent cracks; wider than 1/8 in; generally all less 1 to 6-feet in length | observe at next inspection | |

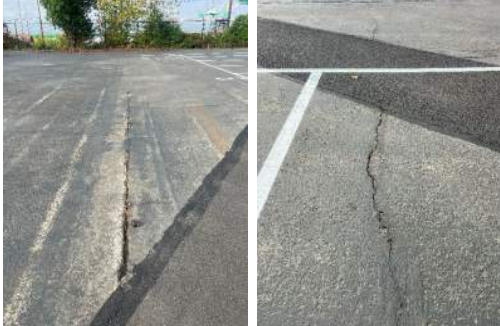
| Location ID | Observations | Recommended Actions | Photographs |
|---|---|---|--|
| X8 | crack in pavement; wider than 1/8 in; one long linear joint extends >25 ft. east/west; another north/south ~25 ft | observe at next inspection | |

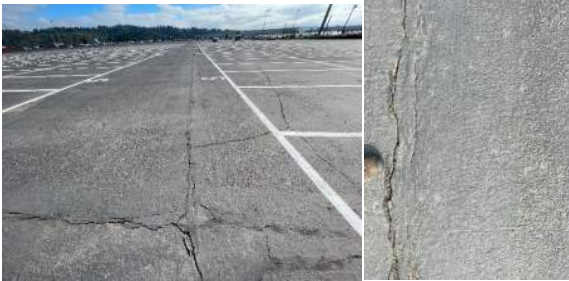
| Location ID | Observations | Recommended Actions | Photographs |
|---|--|---|---|
| X9 | intermittent cracks; wider than 1/8 in; generally all less 1 to 4-feet in length; extends east/west forming a linear joint | observe at next inspection | |

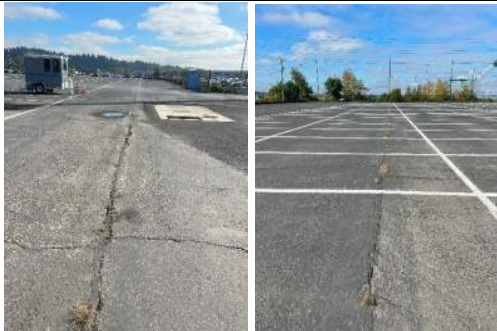
| Location ID | Observations | Recommended Actions | Photographs |
|---|--|---|---|
| X12 | intermittent cracks; wider than 1/8 in; generally all less 1 to 10-feet in length; vegetation forming in cracks | observe at next inspection | |

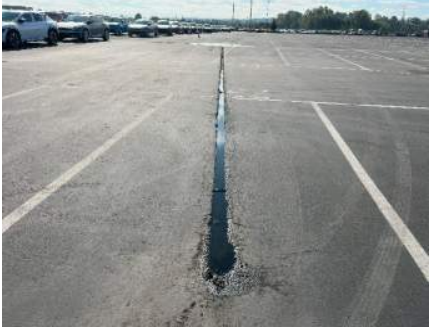
At the time of CRETE's inspection, the general appearance of the environmental cap at the Site was good and was generally consistent with the previous cap inspection. Observed cracks wider than 1/8 inch are documented in Table 2 and locations are shown on Figure 2. Three engineered channels (X13, X16, and X17; Table 2) contained sediment and vegetation that is blocking water from flowing out of areas with ponding.

| Location ID | Observations | Recommended Actions | Photographs |
|---|---|---|---|
| X13 | channel in pavement; 3-4 in. wide; extends 40 ft. northwest/southeast | clear debris and vegetation, observe at next inspection | |

Cracks wider than 1/8 inch and any gouges in the slurry overlay have been identified as specified in Table 2 and shown on Figure 2. Because these cracks are not expected to result in leakage, continued monitoring of the cracks and gouges is recommended at the next inspection event. The channels at X13, X16, and X17 should be cleaned out to allow water to flow out of areas with ponding.

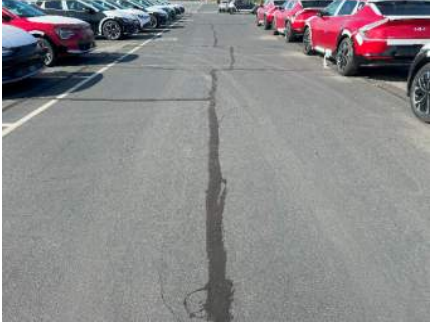
| Location ID | Observations | Recommended Actions | Photographs |
|---|---|---|---|
| X14 | recent joint patching; extends east, west, north, south | observe at next inspection | |

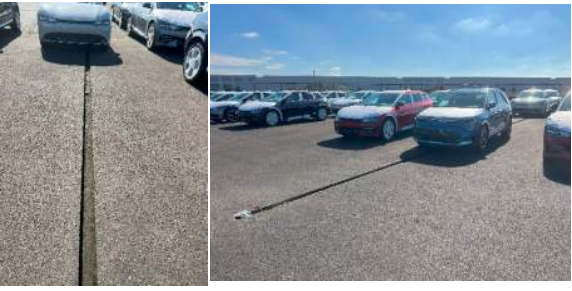
| Location ID | Observations | Recommended Actions | Photographs |
|---|---|---|---|
| X16 | cut channel in pavement; 4-5 in. wide; extends 40 ft. north/south | clear debris and vegetation, observe at next inspection | |

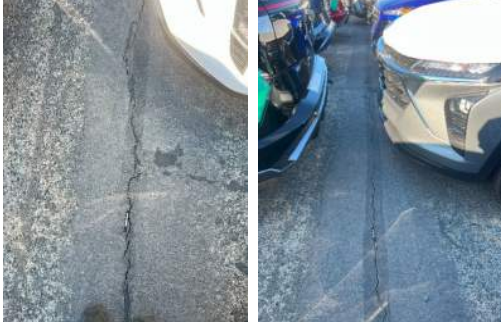
| Location ID | Observations | Recommended Actions | Photographs |
|---|---|---|---|
| X20 | crack in pavement; wider than 1/8 in; one long linear joint extends >25 ft. north/south | observe at next inspection | |

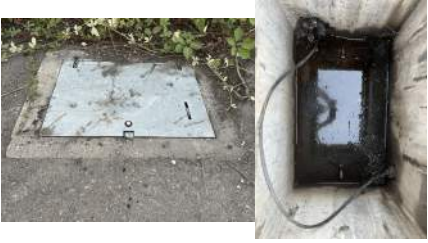
| YC-SL | unknown junction box | structurally intact; conduit and electrical wire through junction box | NM | uncertain of vault utility purpose; does not appear to be the oil/water separator; contains standing water | observe structure during next inspection | |
