**PUBLIC REVIEW DRAFT  
REMEDIAL INVESTIGATION REPORT  
ICS/NWC RI/FS  
SEATTLE, WASHINGTON**

**APPENDIX A**  
**DOF TECHNICAL MEMORANDA**  
**REMEDIAL INVESTIGATION REPORT**  
**ICS/NWC**  
**SEATTLE, WASHINGTON**

SUBJECT: Results of Embayment Site Reconnaissance  
Work Plan Task EB-1  
Industrial Container Services, Seattle, Washington

REF. NO: SUM-008-00

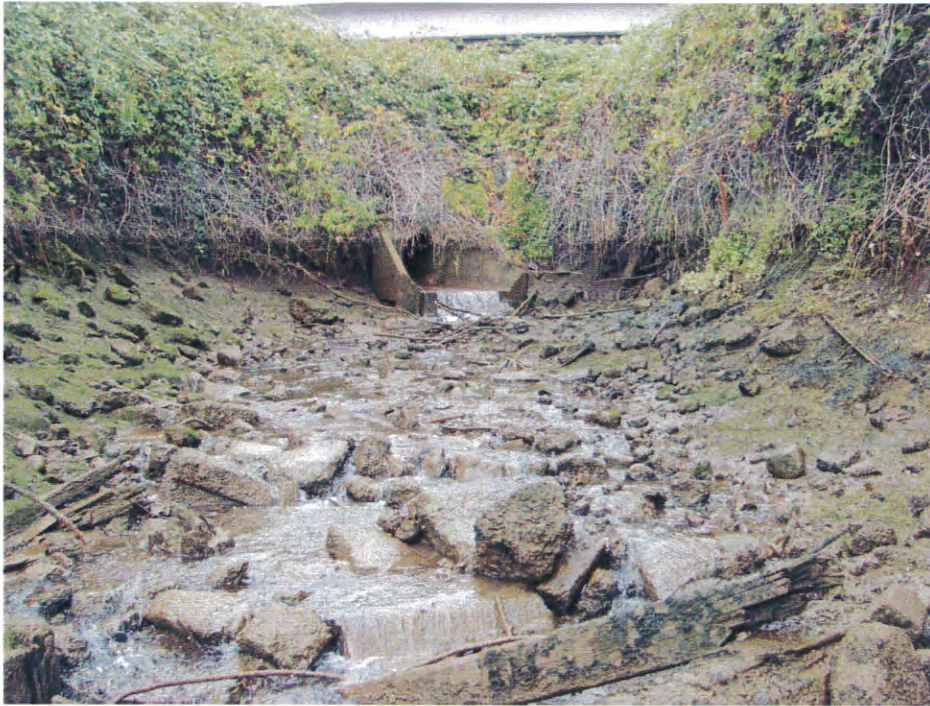
***West End (Head) of Embayment*** - The west end of the embayment is covered with broken concrete, rebar, wood and other debris (Figure 3, top photograph). The broken concrete appears to have been placed as a scour protection apron for discharges from a reservoir overflow outfall. The relatively steep bank walls are covered with blackberries and other vegetation.

West End of Embayment  
(view to west toward  
reservoir overflow  
outfall)

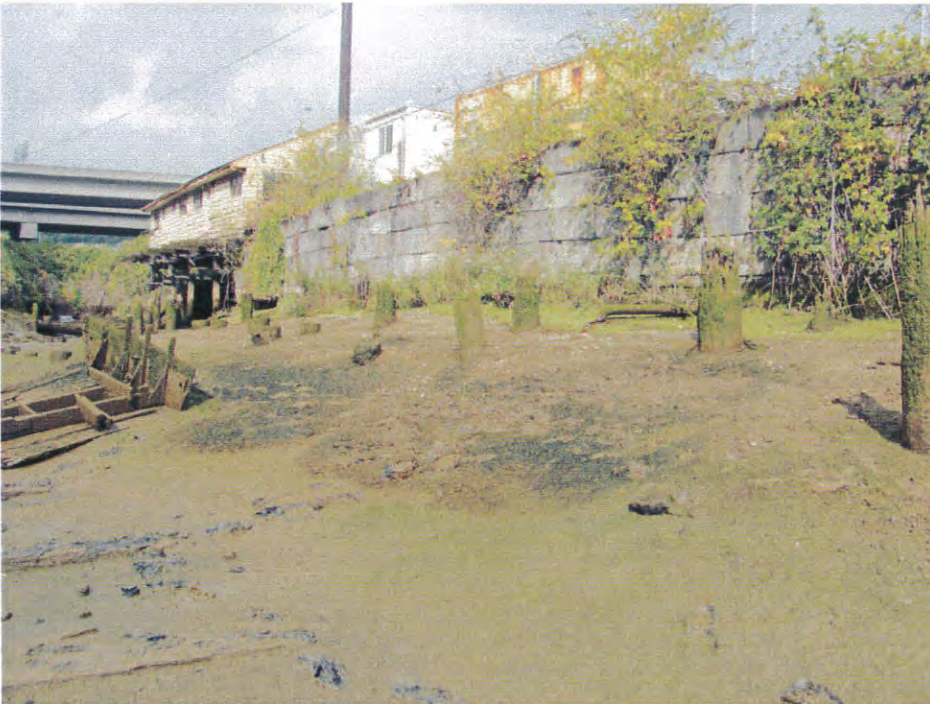
***North Embayment Shoreline (Bank)*** - Figures 3 (bottom photograph) to 10 show the general condition of the north embayment shoreline. A partially pile supported wood frame structure and concrete ecology block wall are present along approximately 135 feet of shoreline (Figures 3, bottom photograph and 4). The north end of the structure is supported by fill, including large boulders. The top of the ecology block wall (composed of at least five levels of blocks) rises approximately eight to ten feet above the bottom sediment. A partially buried concrete truck drum was observed on the west end of the wood frame structure (Figure 4, top photograph).

West End of North  
Bank (view to  
northwest)

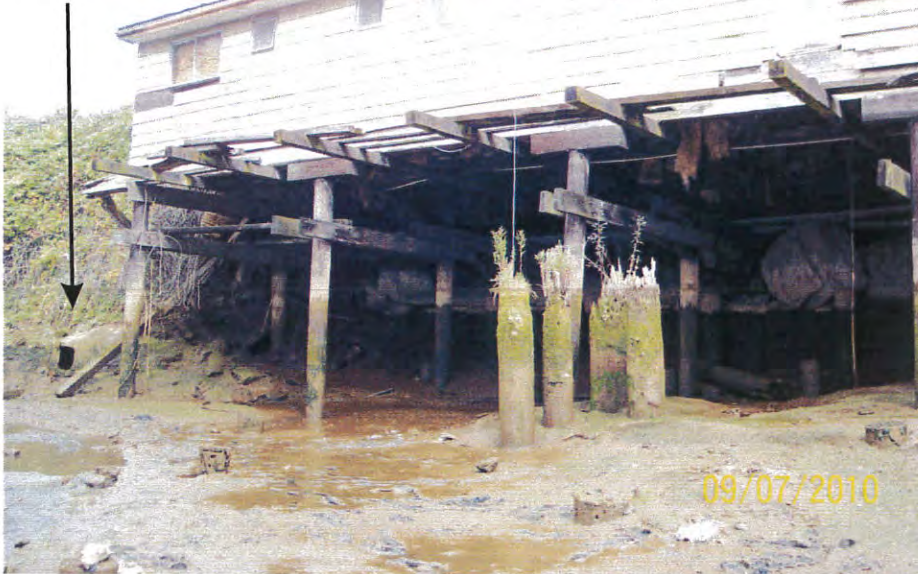
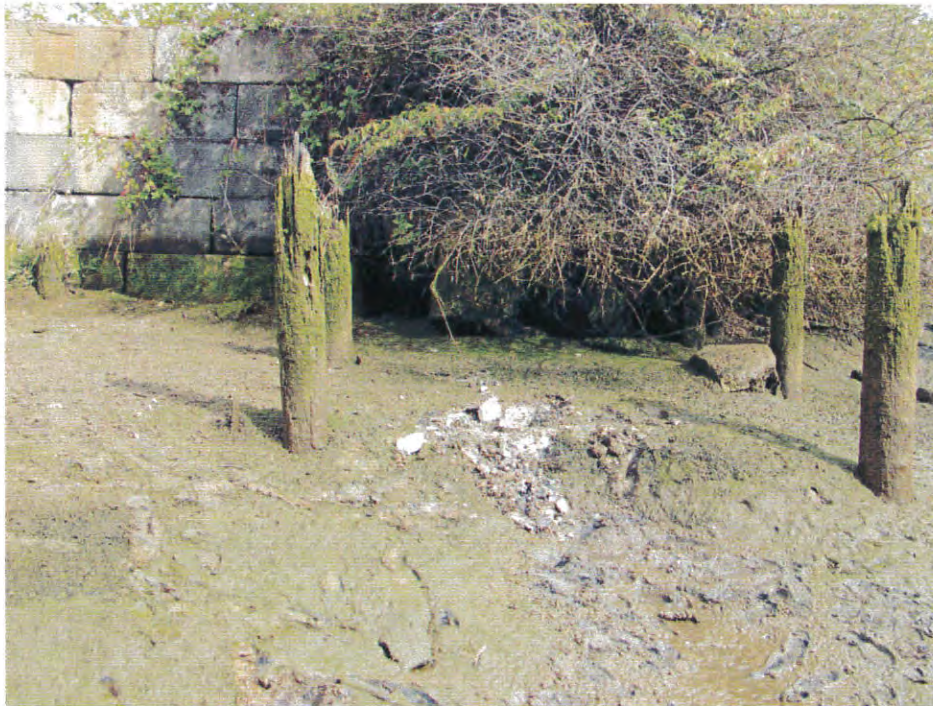
**FIGURE  
4**

**Partially Buried  
Concrete Truck  
Drum**

Structure West End of  
North Bank  
(view to northwest)

East End of Block Wall  
(view to north)

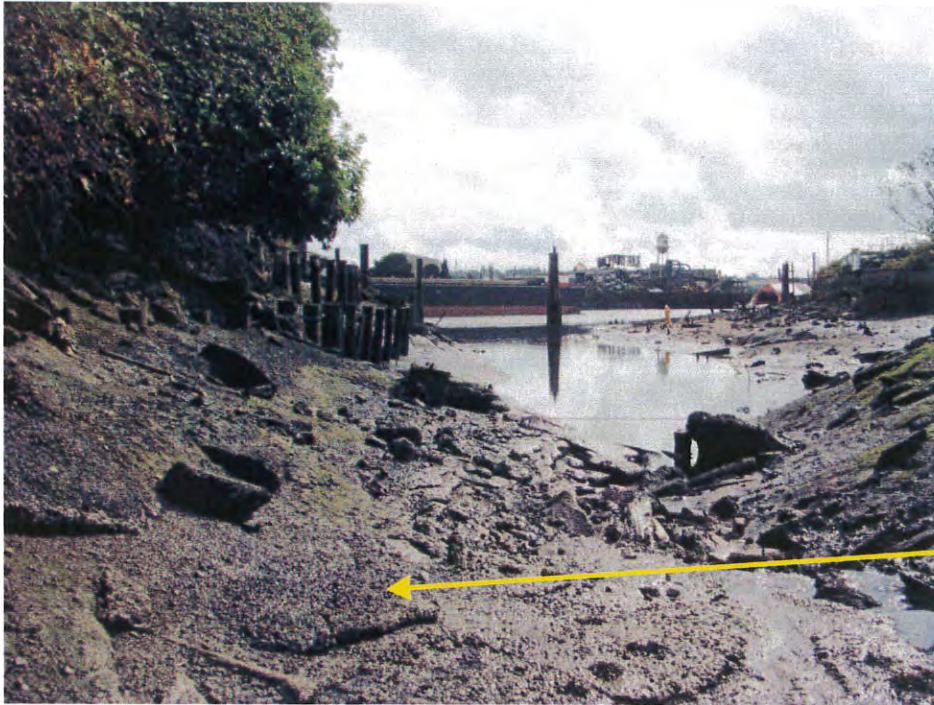
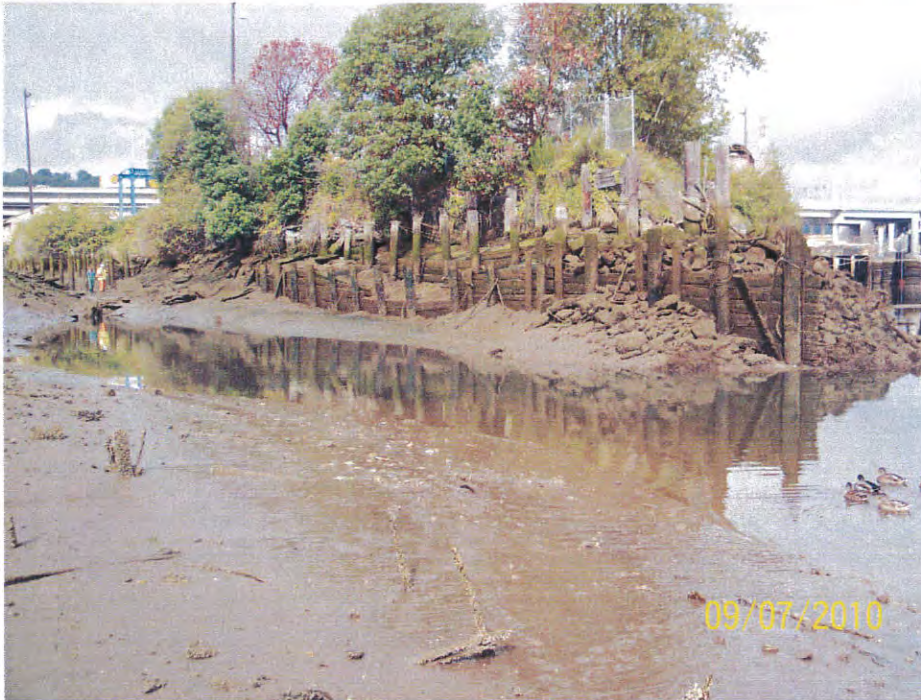
Mouth of Embayment  
North and South Banks  
(view to east)

*Waste Concrete  
Flows*

East End of North Bank  
(view to northwest)

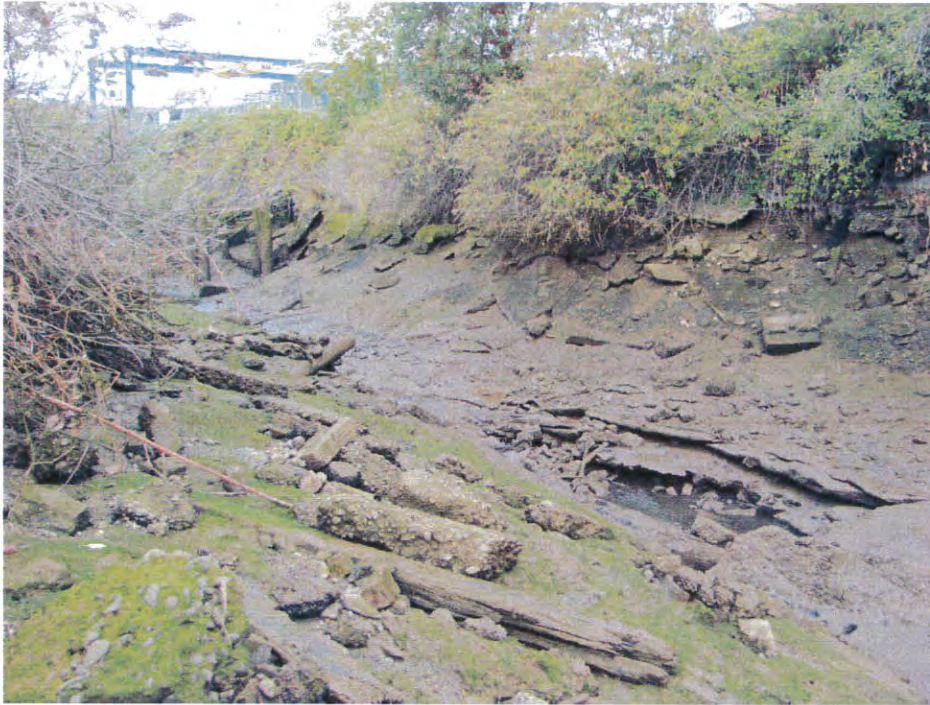
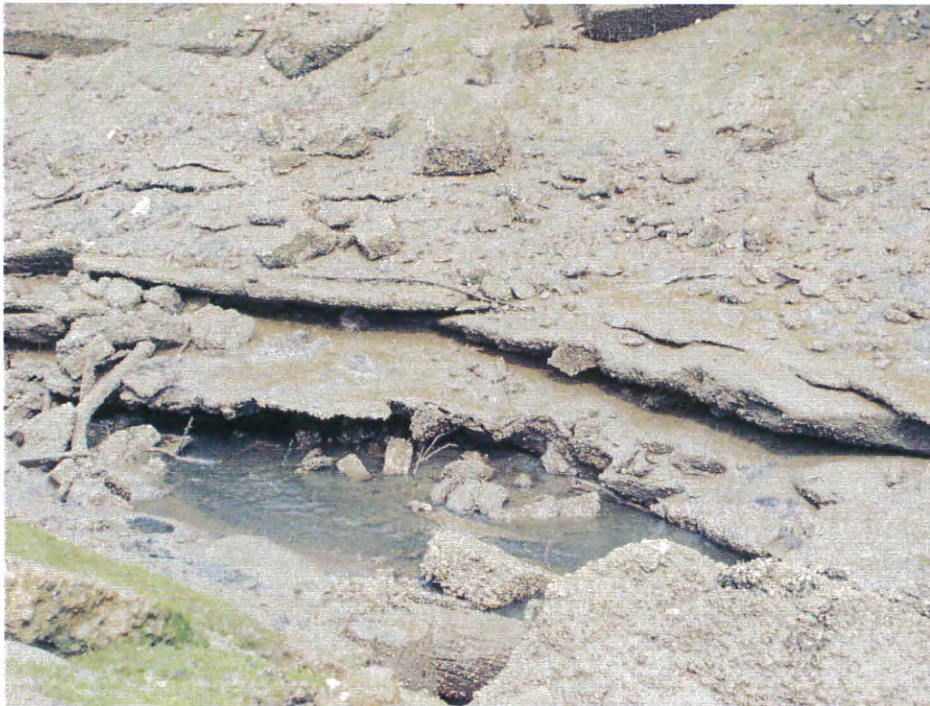
Waste Concrete Flows -  
North Bank - East Side of  
Neck  
(view to northwest)

Waste Concrete Flows -  
North Bank - East Side  
of Neck  
(view to north)

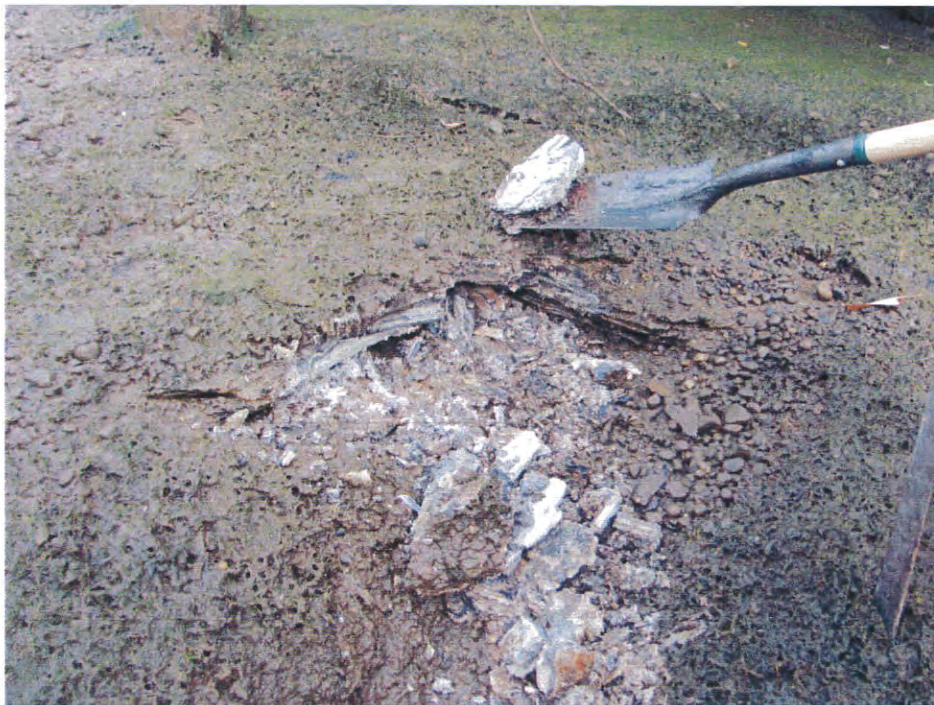
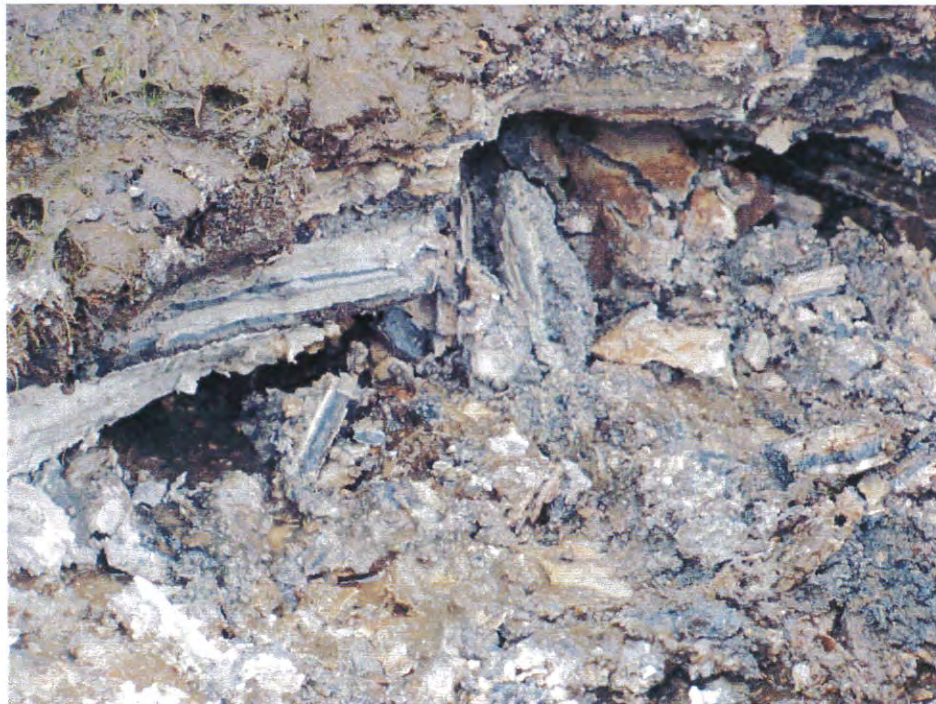
Chemical Precipitate -  
North Bank -  
(view to north)

Chemical Precipitate -  
North Bank -  
(closer view)

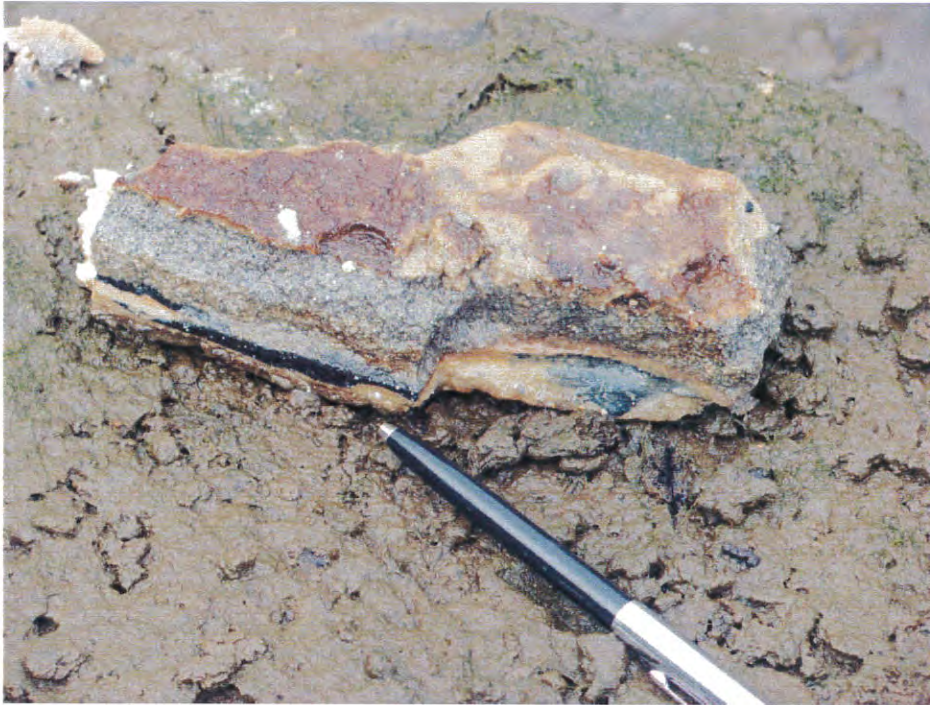
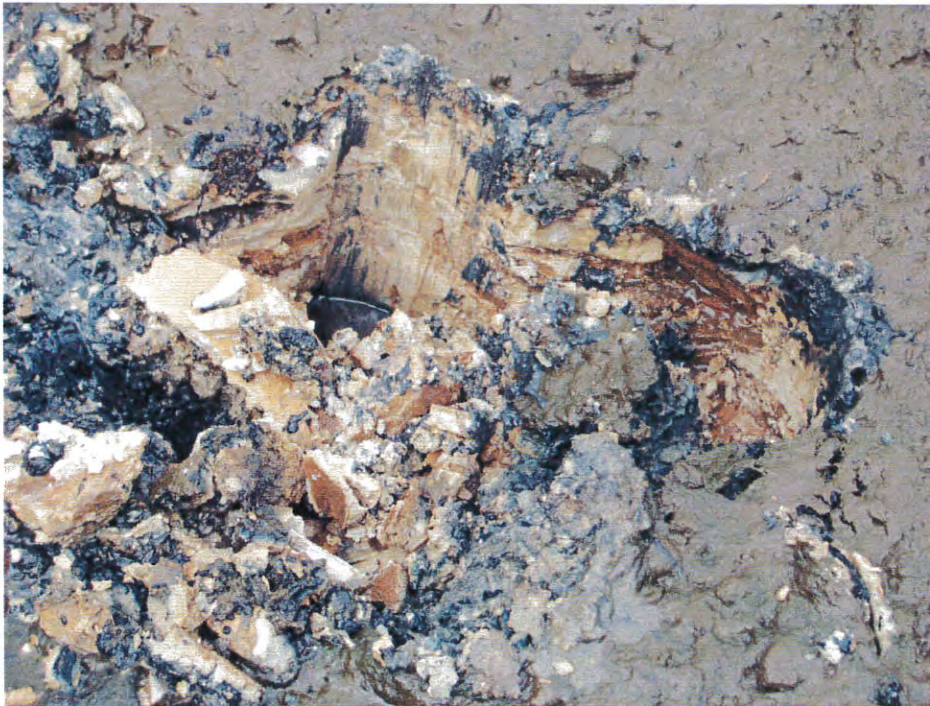
Chemical Precipitate -  
North Bank -  
(cemented material)

Chemical Precipitate -  
North Bank -

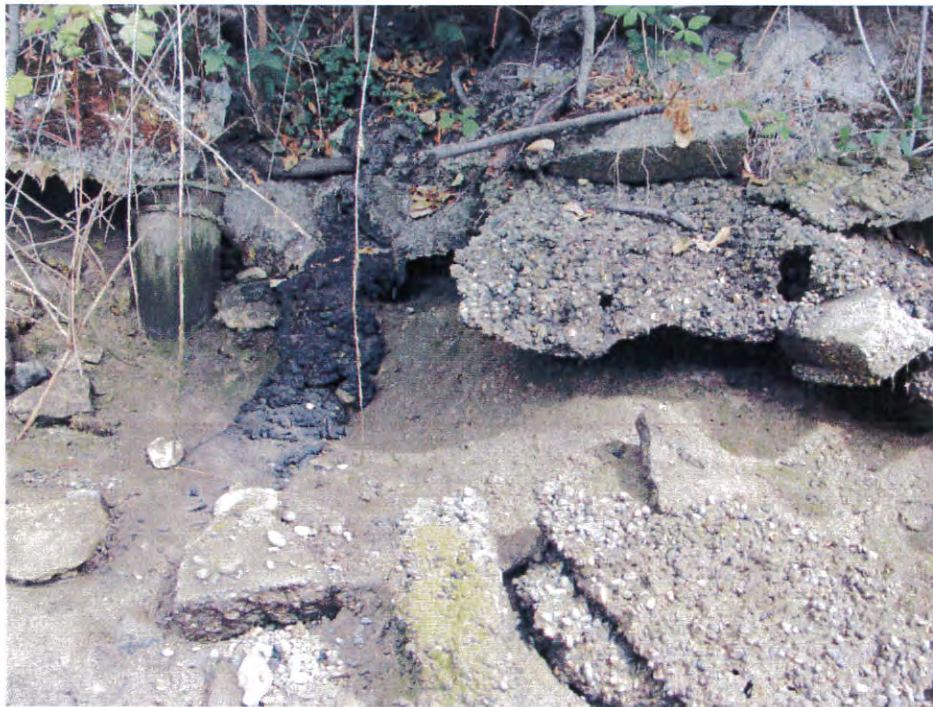
A small amount of asphalt-like material was observed within the neck area on the north bank (Figure 10). This material appears to have flowed out from the north bank.

Asphalt-Like Material  
North Bank  
(view to north)

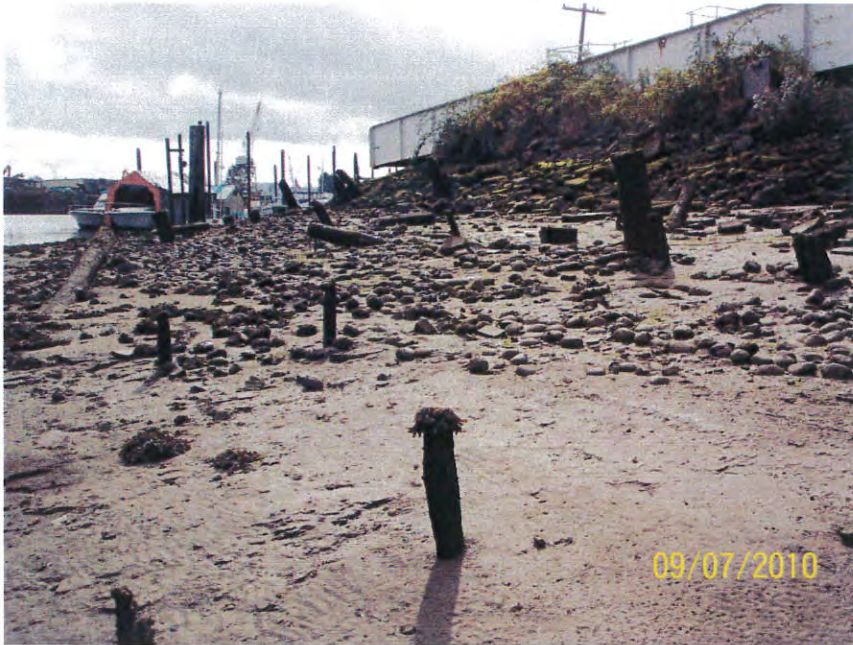
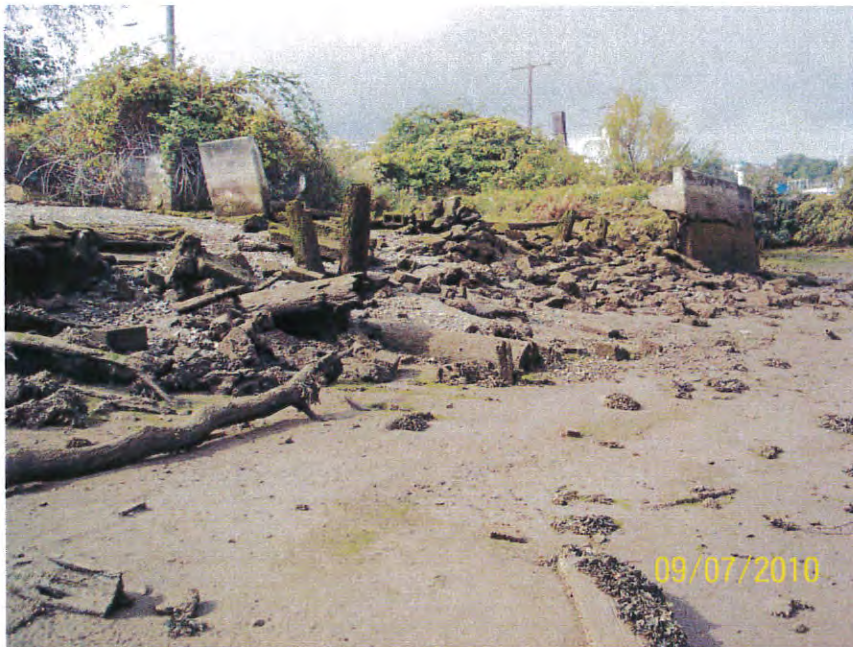
***South Embayment Shoreline (Bank)*** - Figures 11 to 15 show the general condition of the south embayment shoreline. The south shoreline east of the neck is relatively gentle in slope (Figures 11 and 12, top photograph). Cobbles, wood and other debris are scattered on the sediment surface, along with the remains of a number of wooden piles. Large woody debris, large cobbles and the remains of concrete foundations are present along the shoreline. The top of bank is heavily vegetated.

East End of South Bank (view to east)

South Bank - Near Mouth of Embaymnet (view to east)

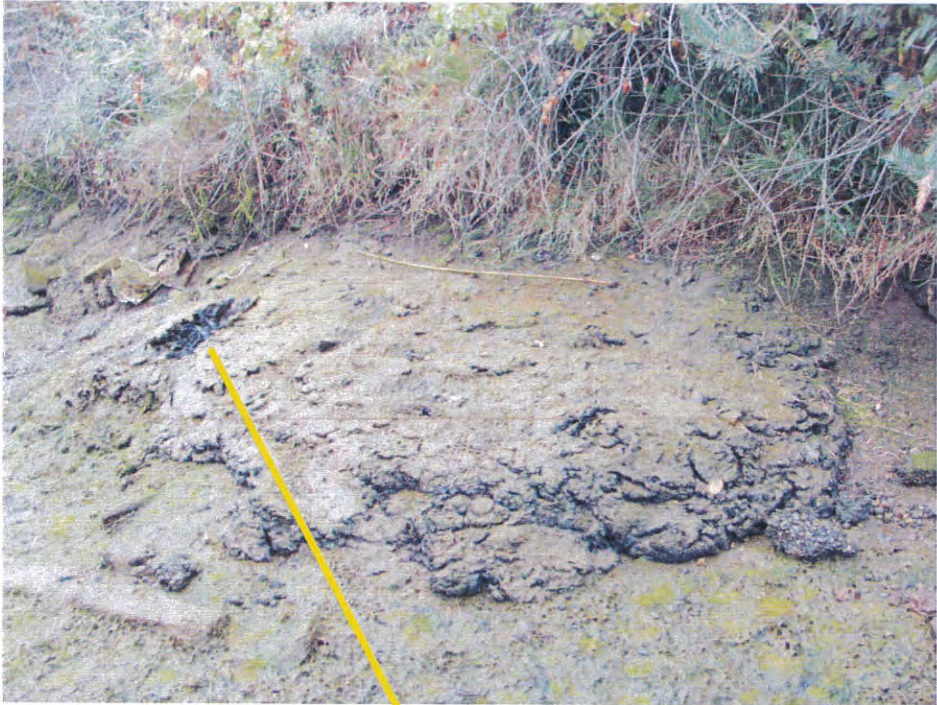
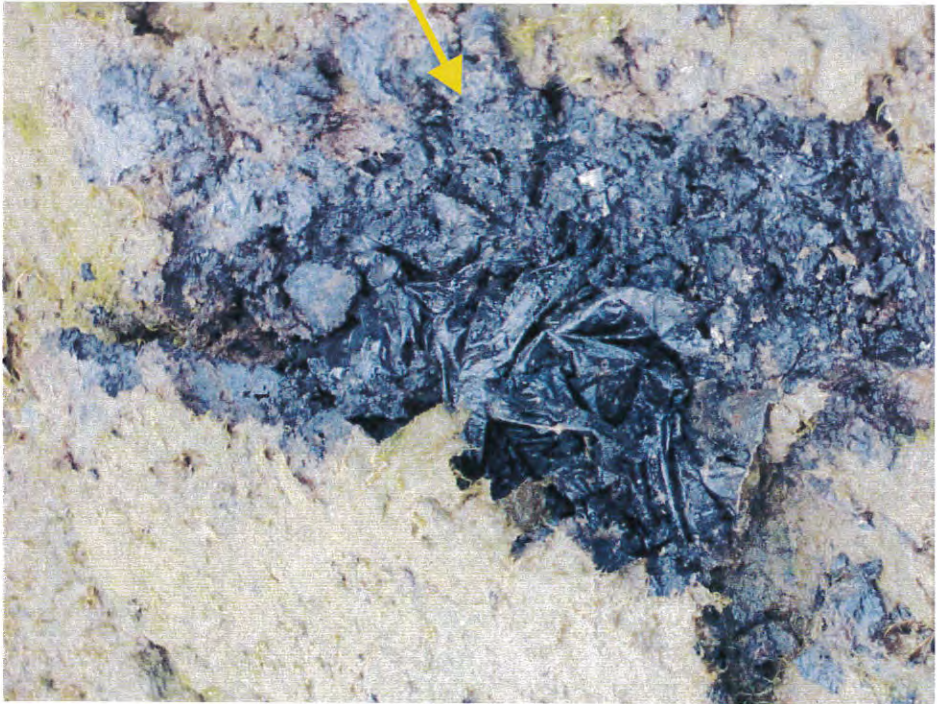
A asphalt-like material was observed on the west side of the neck and east of the 2nd Ave. Outfall, along the south shoreline (Figures 2 and 15). The deposit appears to be a localized, surface feature. Plastic sheeting/bag material was observed to be entrained in the matrix.

Asphalt-Like Material  
South Bank  
(view to south)

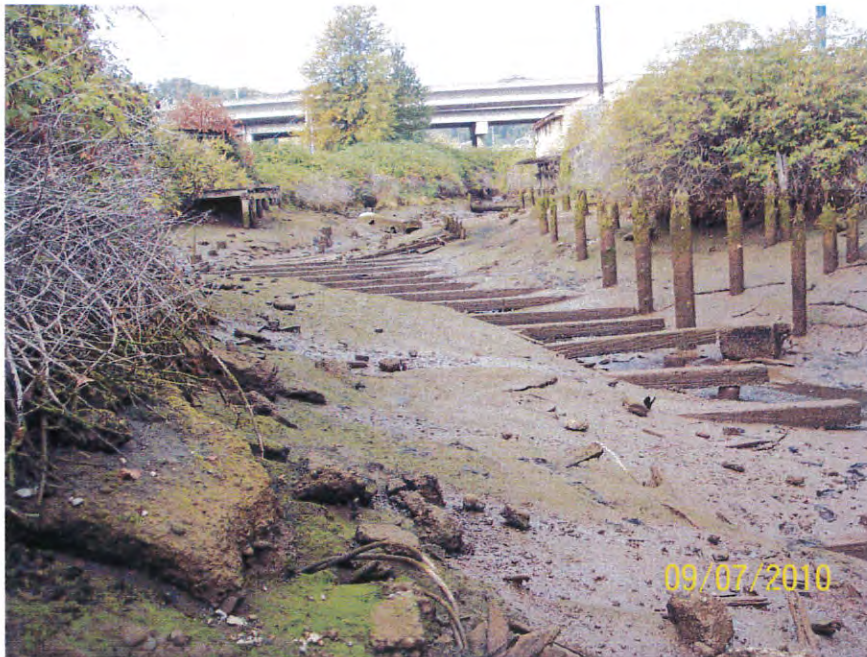
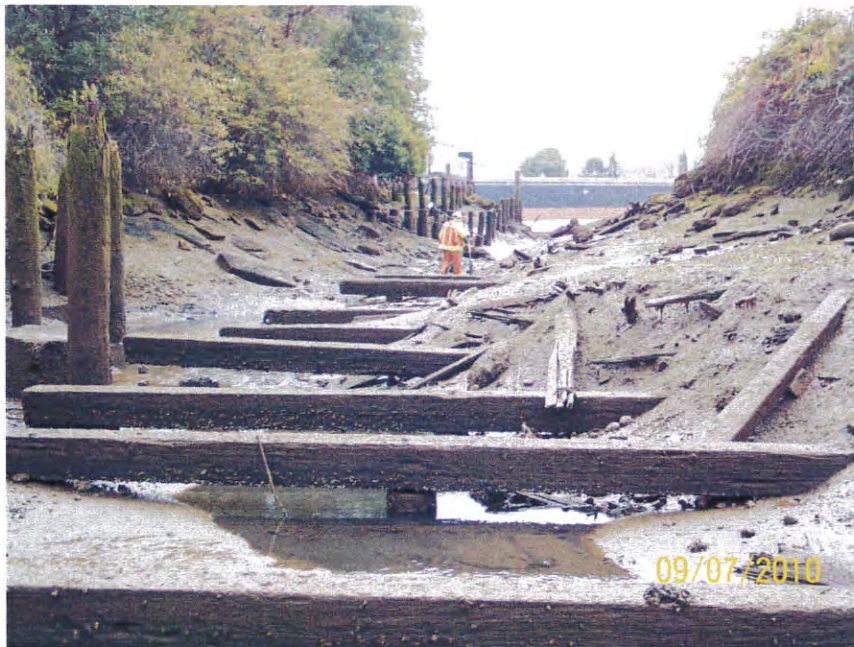
***Other Features/Observations*** - Within the central portion of the embayment, pile supported, heavy milled timbers were observed (Figures 13 and 16). These timbers

West Portion of Embayment - West of Neck  
(view to west)

Central Portion of Embayment - Near Neck  
(view to east)

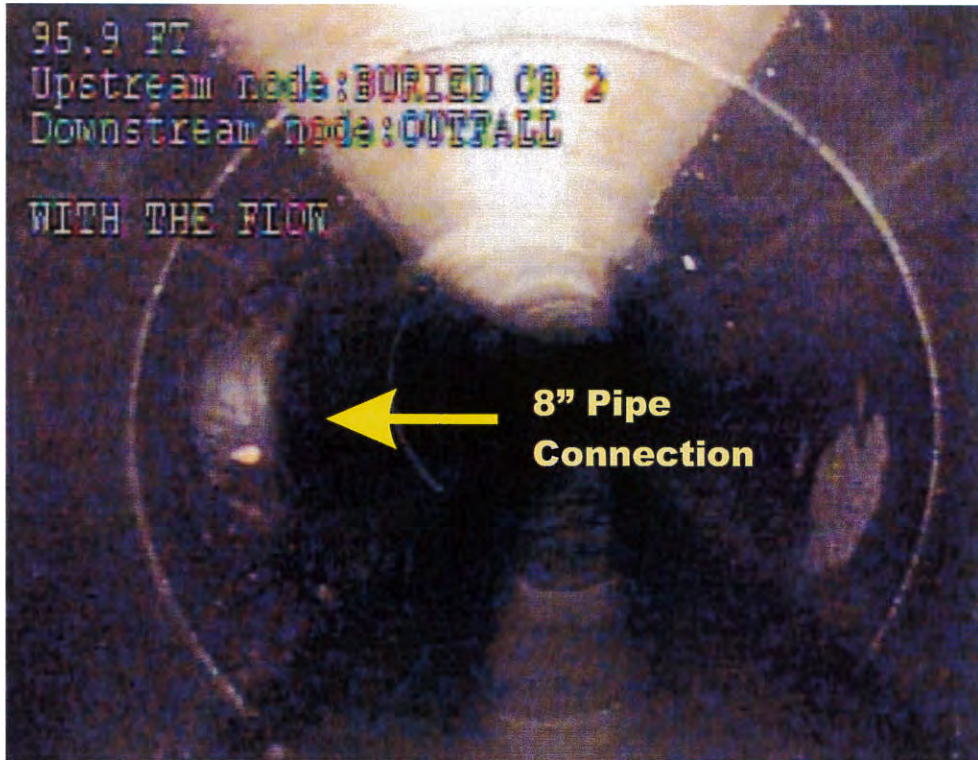
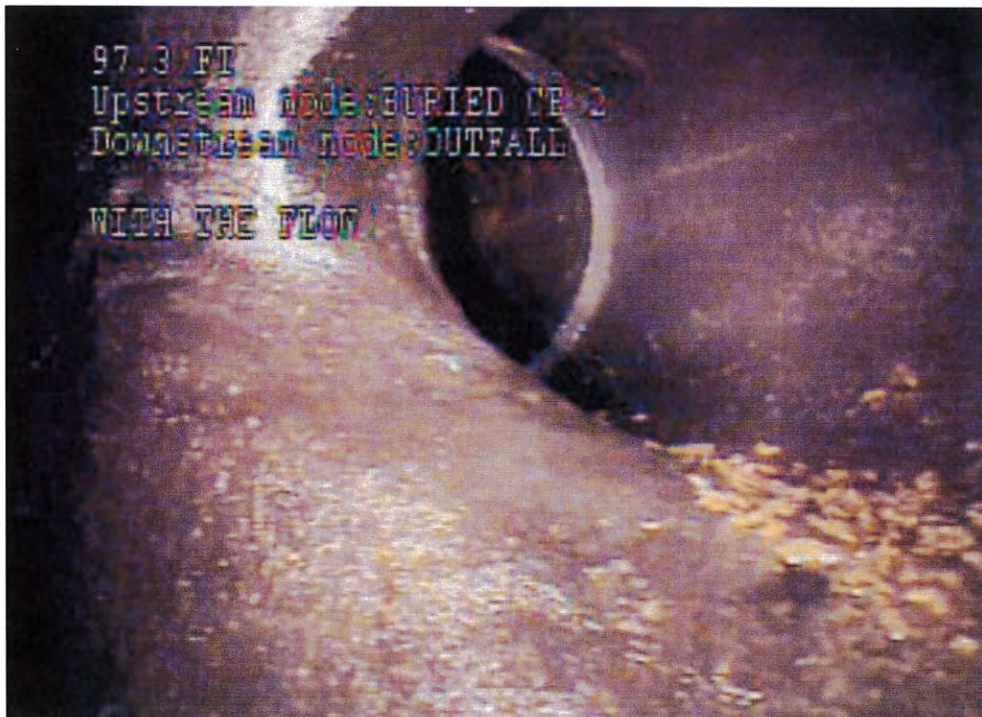
**Outlet Box Pipe Connection  
to 24-Inch RCP**

- An 8-inch diameter lateral pipeline was observed on the west side at station +97 to +98 feet (Figure 2). This likely represents the connection to the former outlet box. The location was marked on the surface (shown on Figure 1). Horizontal coordinates are included in Attachment B.

**Location of the Outlet Box.** The outlet box and its connection to the 24-inch RCP is shown on a portion of the 1962 design drawing prepared by Dodd & Millegan (Figure 4). The video survey found the connection with the existing sewer pipeline to be approximately 98 feet down stream of MH2 (Figure 1). If the design drawing is representative of what was constructed, the outlet box should lie 5 to 10 feet south and southeast of the pipe connection. The design drawing shows the outlet box to be constructed of concrete and approximately 7.5 feet x 5 feet in plan view and 6 feet deep.
