**UNDERGROUND STORAGE TANK  
SITE CHECK/SITE ASSESSMENT REPORT  
FOR  
WHITTEN OIL, INC.  
COLVILLE, WASHINGTON  
SEACOR Job No. 00004-008-01**

**Submitted by  
SEACOR**

**For  
Whitten Oil, Inc.  
P.O. Box 150  
Colville, Washington 99114**

October 1, 1993

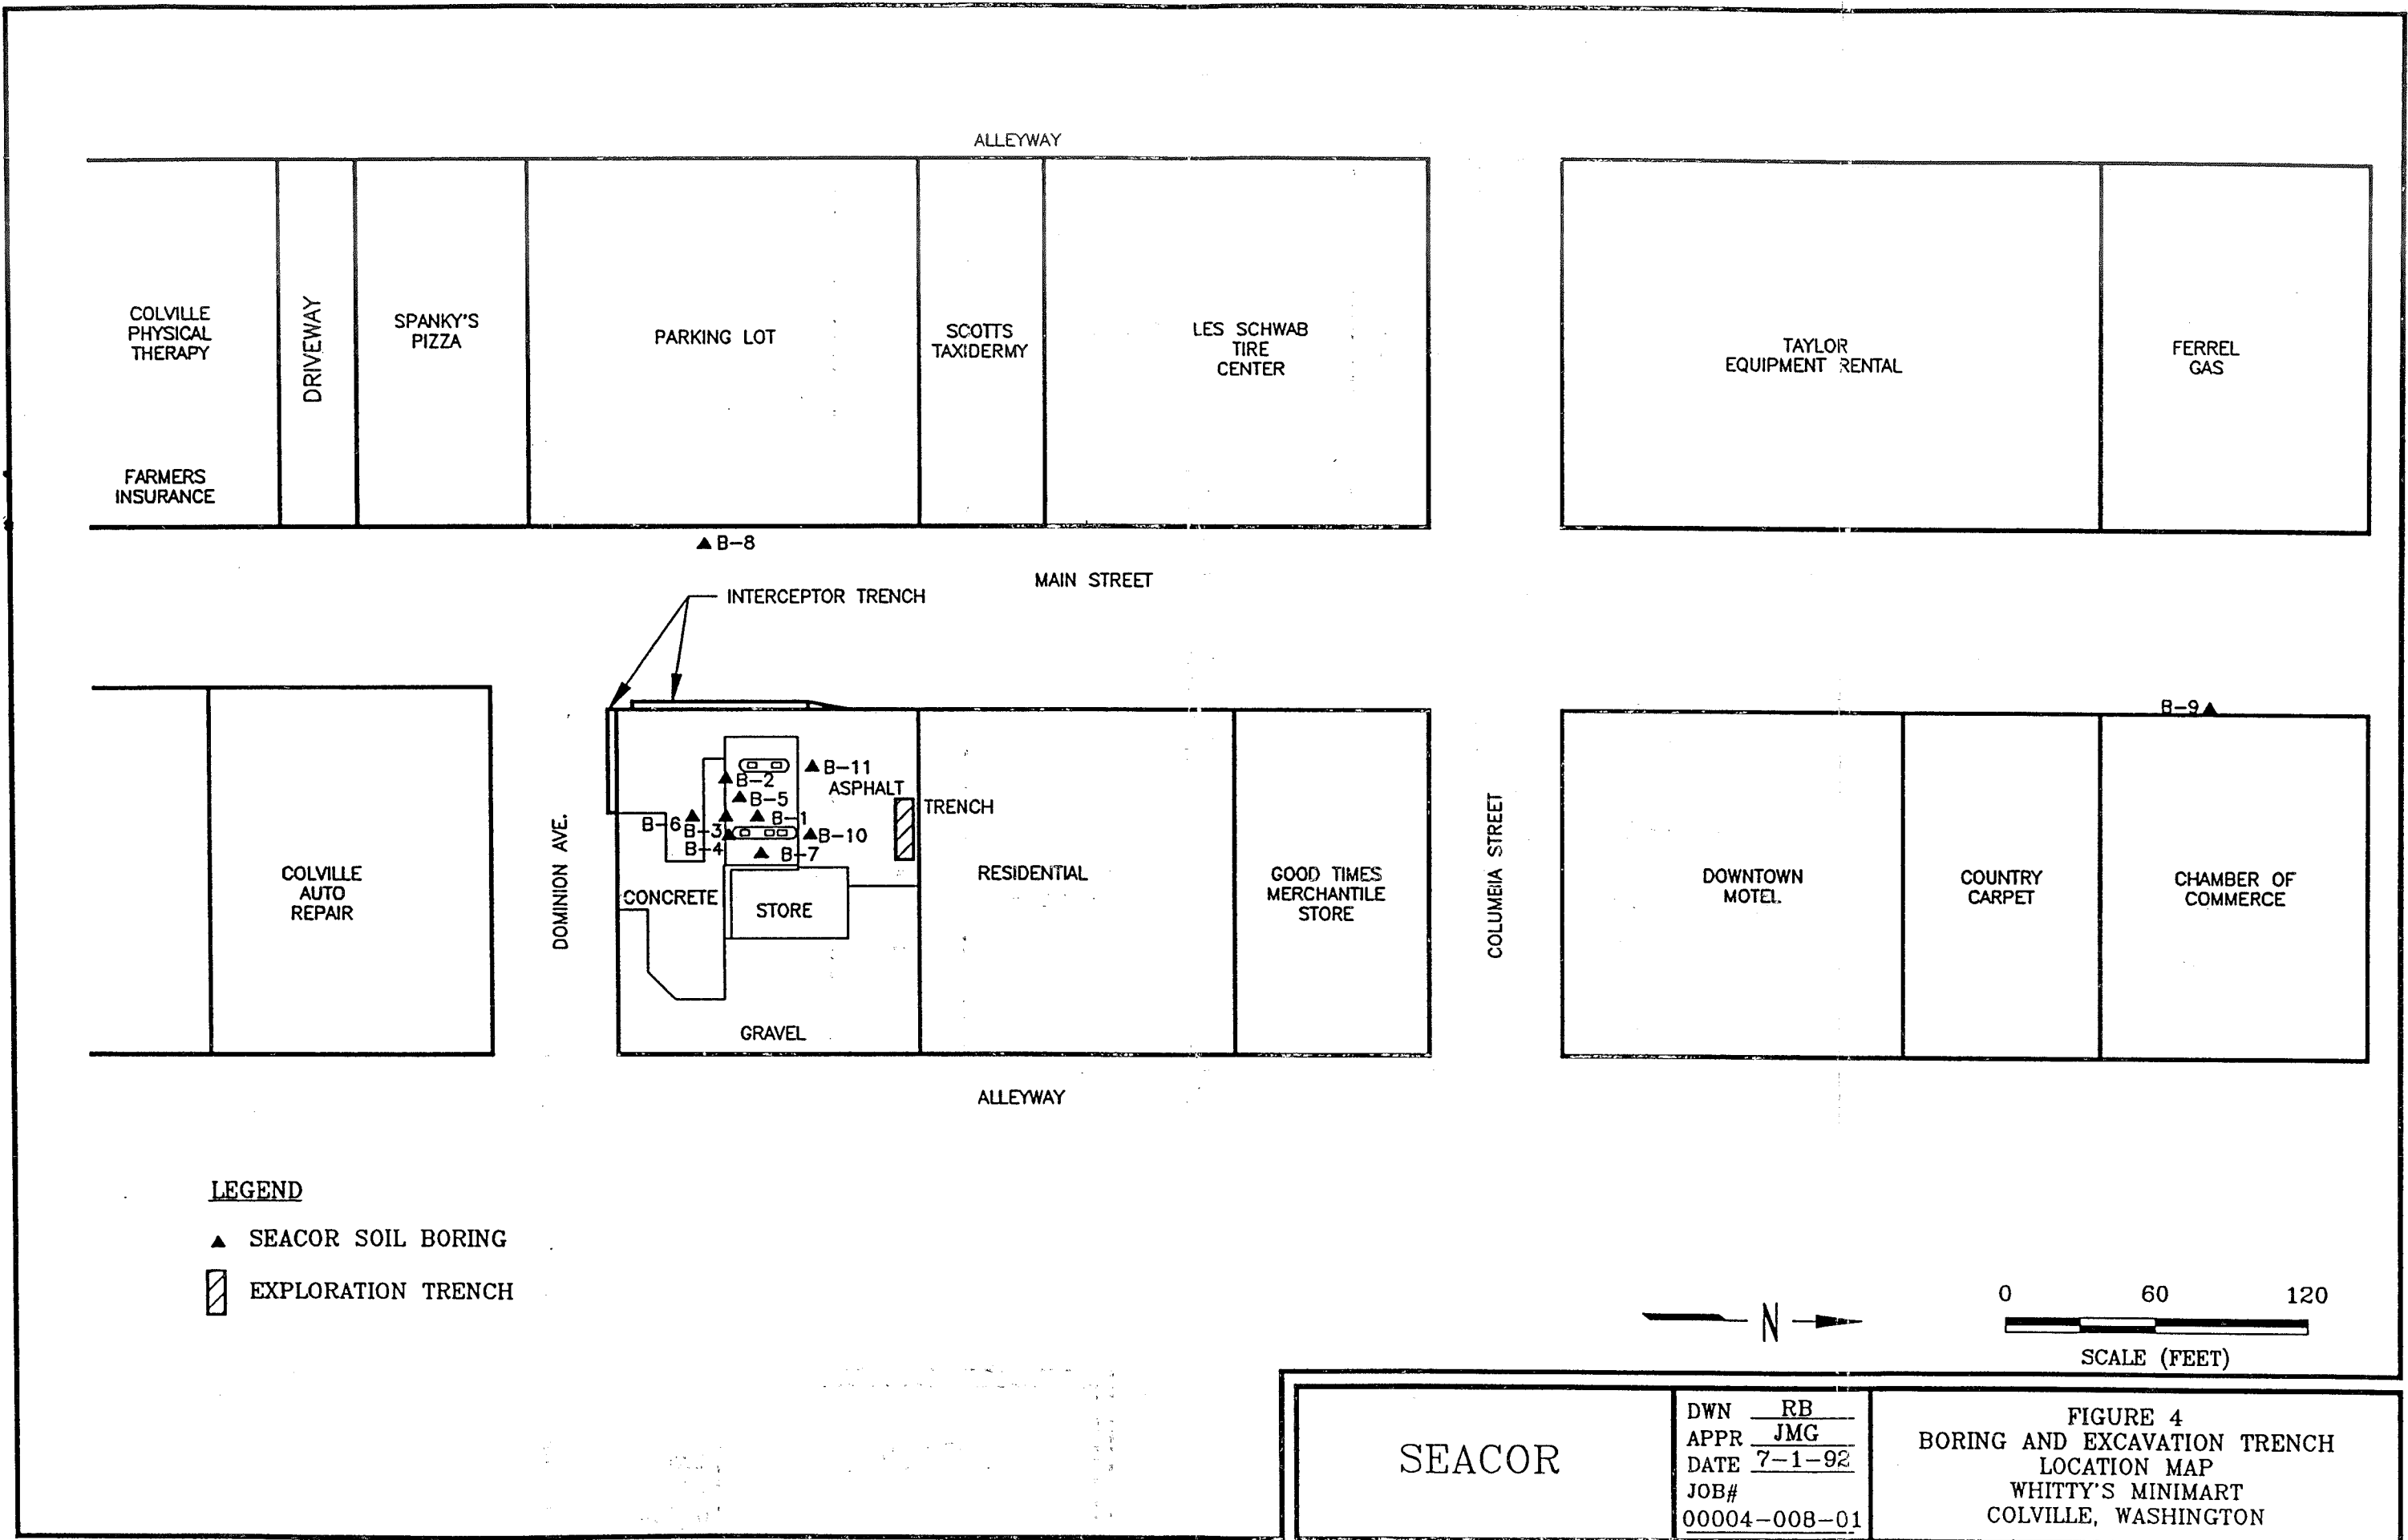
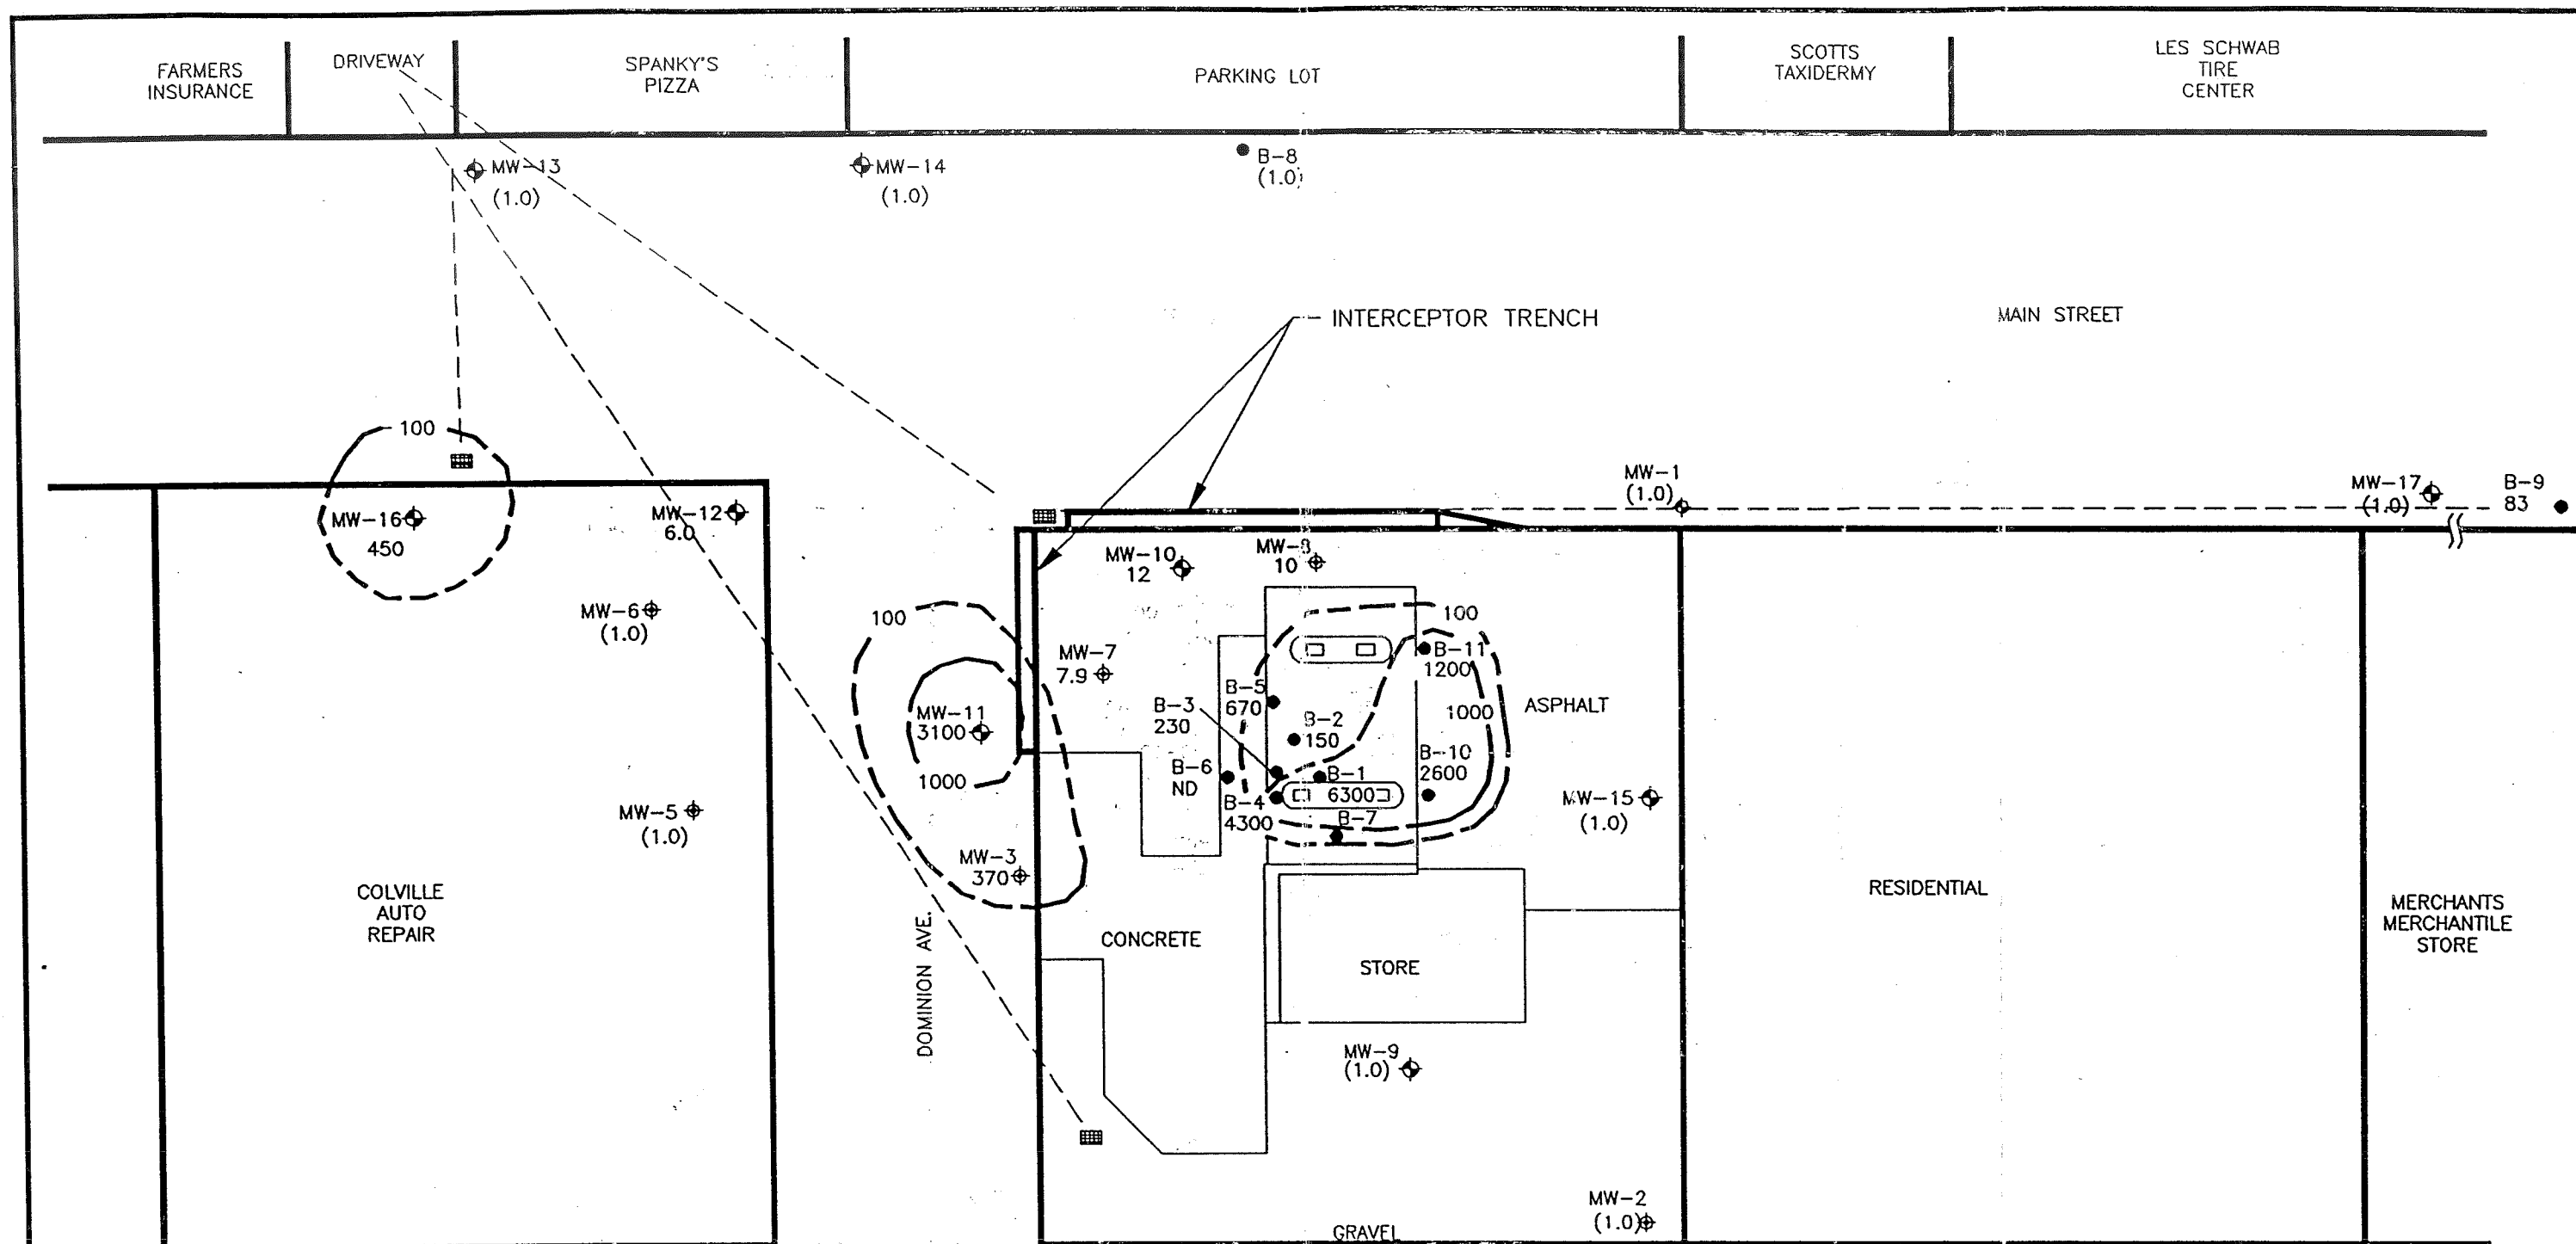
FIGURE 5  
SOIL TPH CONCENTRATION  
CONTOUR MAP  
WHITTY'S MINIMART  
COLVILLE, WASHINGTON

Based on the results of the soil vapor and soil samples collected as part of the RI, there are three areas that exhibit concentrations of petroleum hydrocarbons in excess of MTCA Method A soil cleanup levels. These areas are shown on Figure 5. These areas include soil sampled from the boring for MW-16 located west of the Colville Auto Repair facility, MW-11 located in Dominion Avenue south of the Whitten Oil facility, and the Minimart site as evidenced by samples from Well MW-10 southwest of the pump islands and by borings B-10 and B-11 located immediately north of the pump islands. The Minimart site appears to be the source for the petroleum hydrocarbons detected in soil at the Minimart and under Dominion Avenue. Colville Auto Repair appears to be the source for the petroleum hydrocarbons detected in the soil at boring MW-16. The highest concentrations of petroleum hydrocarbons in the soil were detected at, or very near, the groundwater

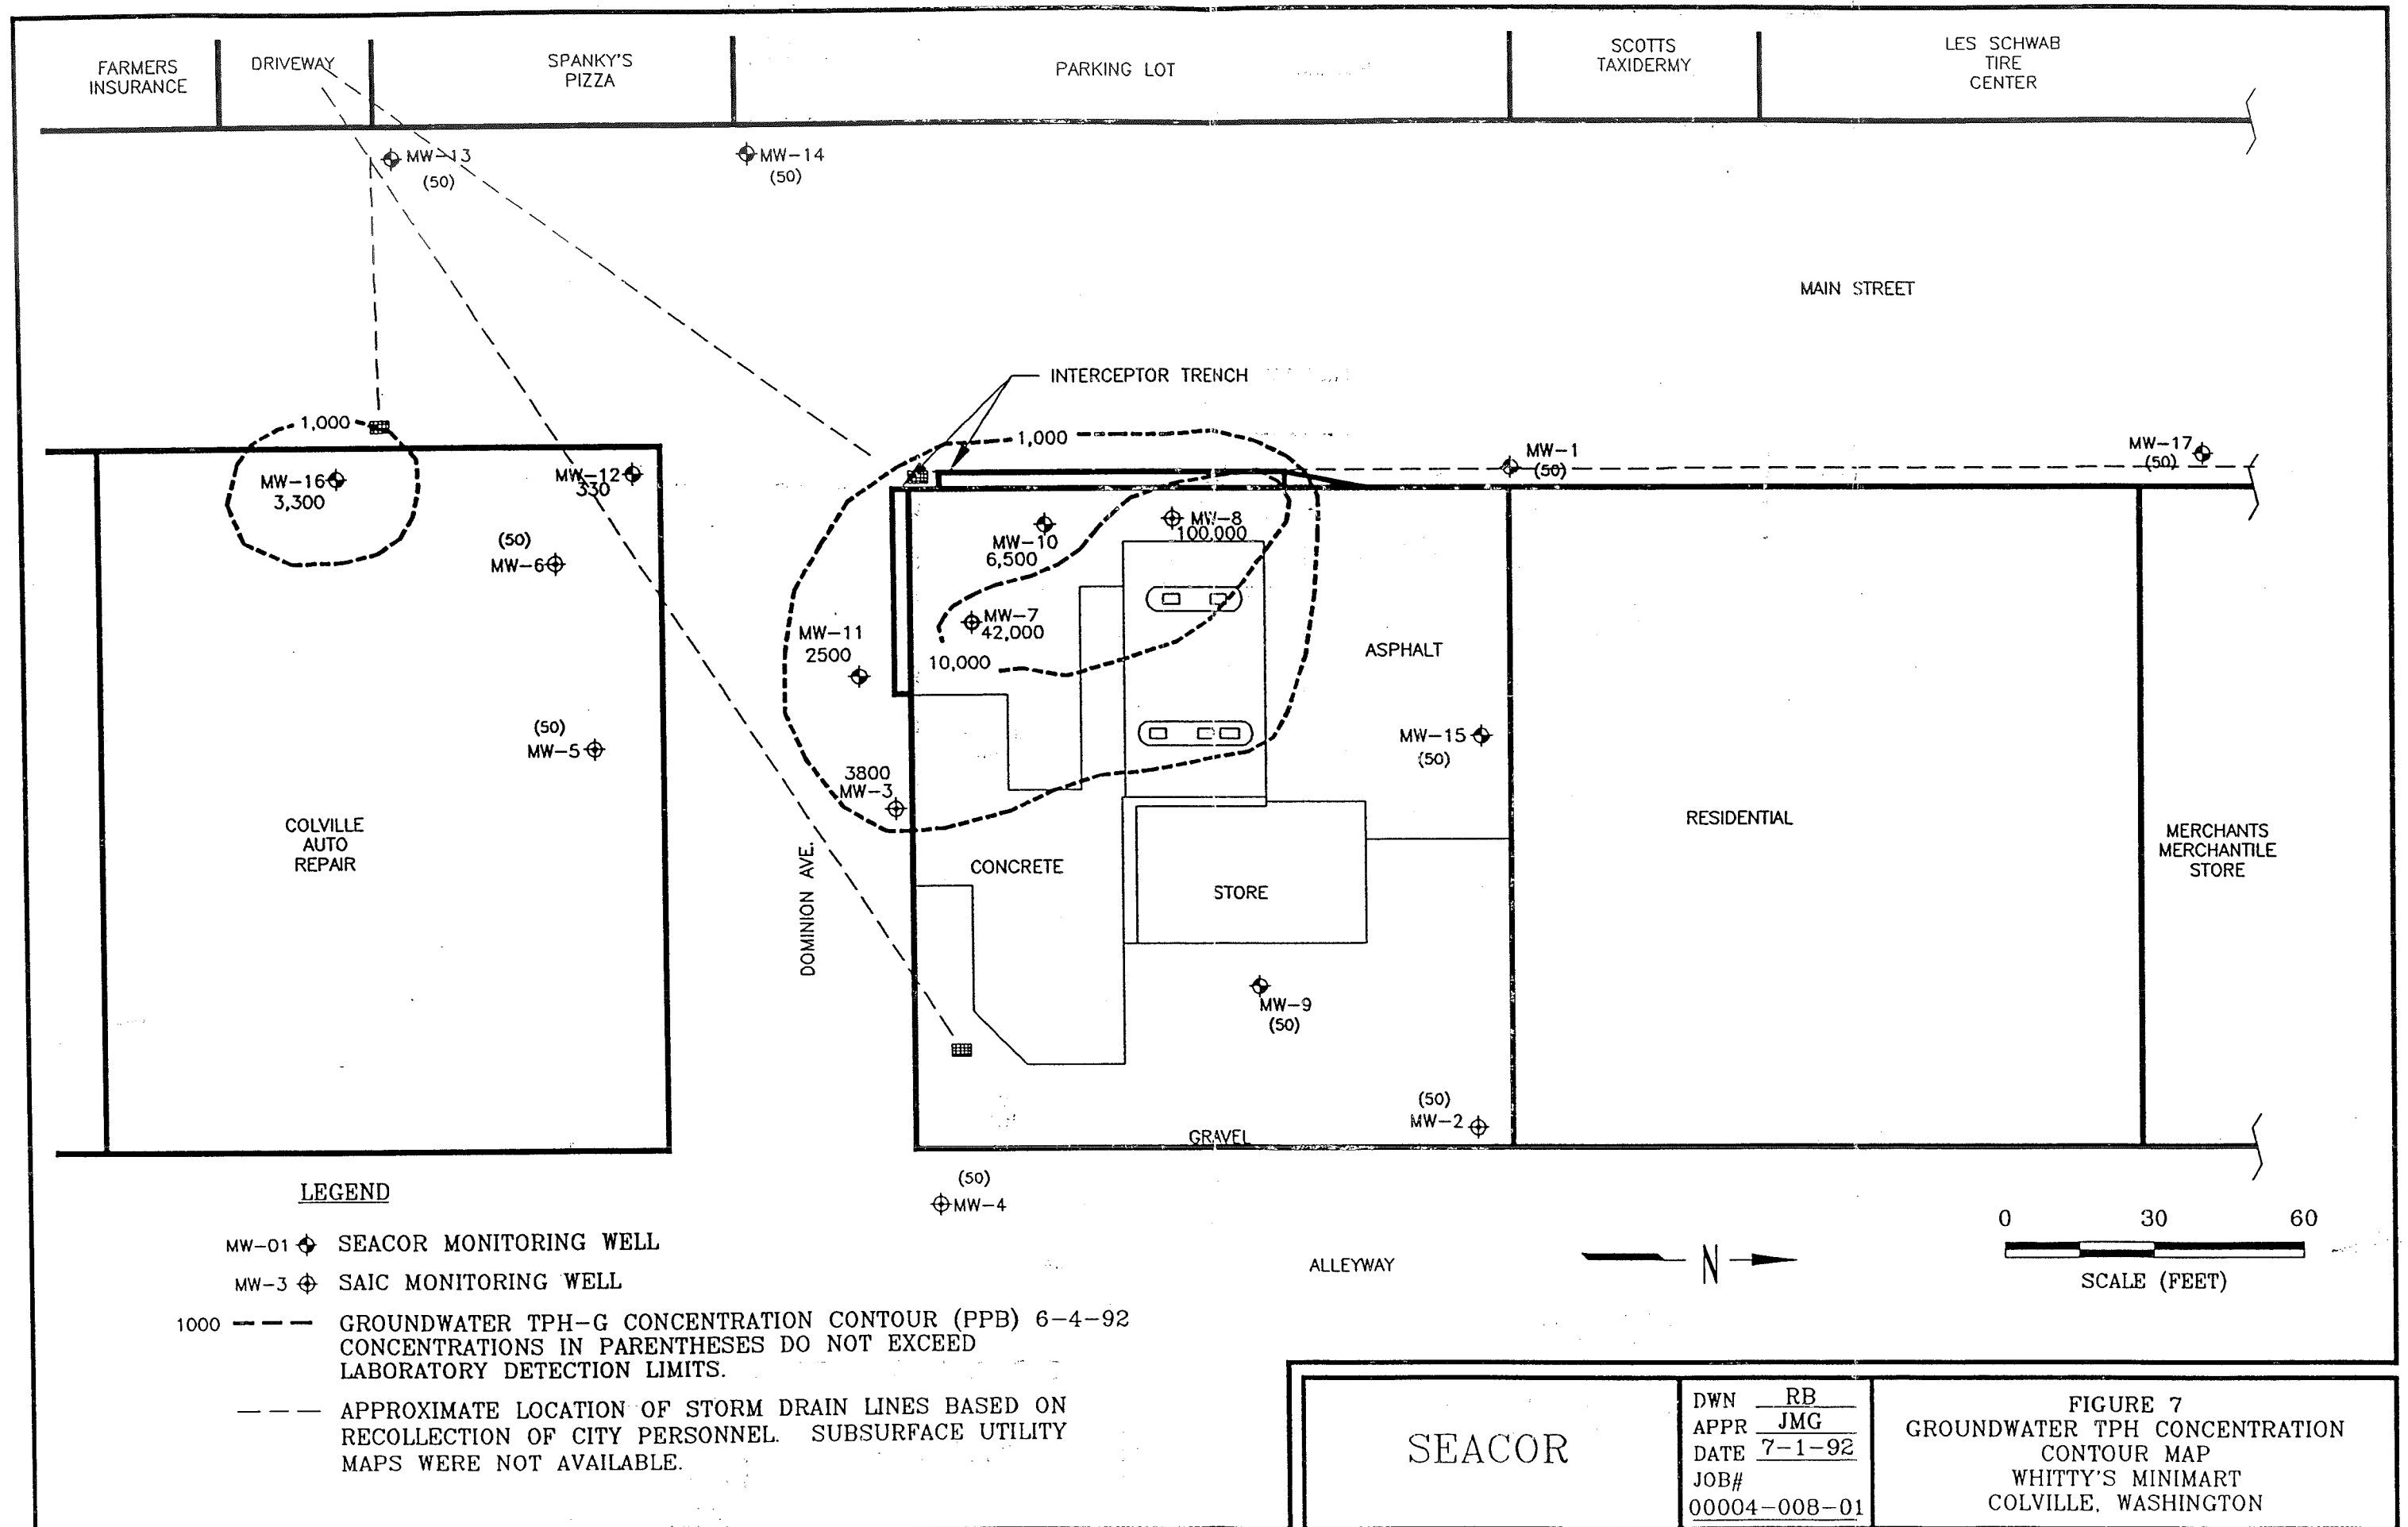
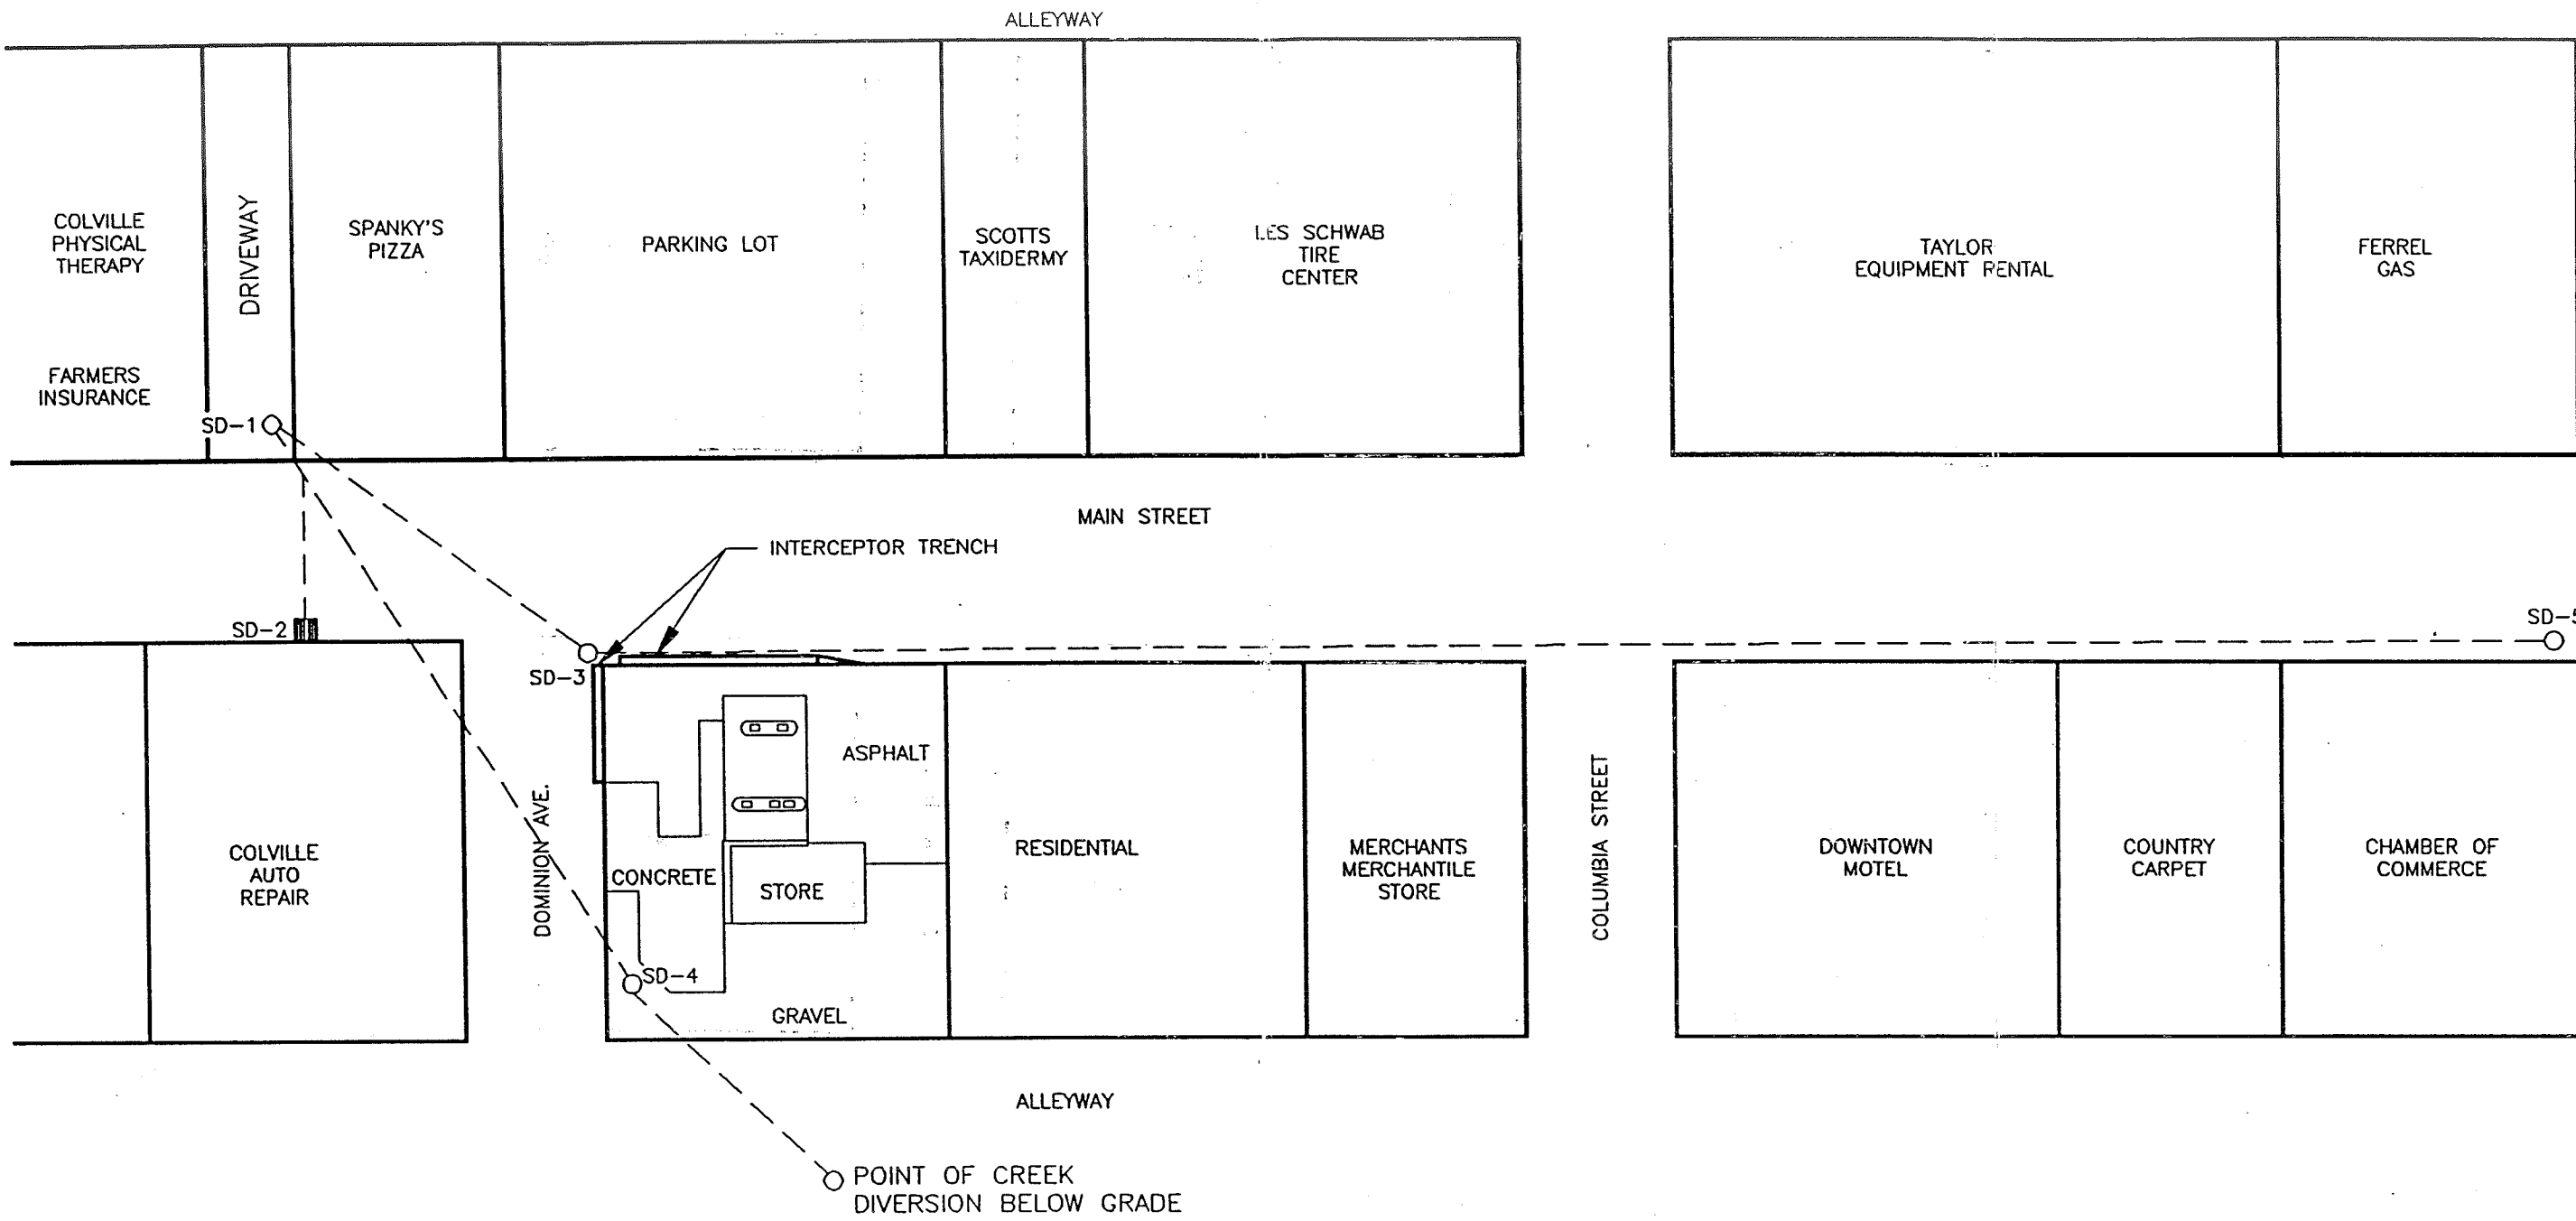
FIGURE 8  
SURFACE WATER SAMPLE LOCATION MAP  
WHITTY'S MINIMART  
COLVILLE, WASHINGTON

Water samples from the storm drains and the unnamed creek were collected at the locations shown on Figure 8. Analytical results of surface water samples indicate that the concentration of petroleum hydrocarbons in the storm sewer located upstream of the site (SD-5) contained diesel fuel constituents during the first sampling episode. This was not verified during subsequent sampling. The sump water at the Colville Auto Repair site (SD-2) contained diesel constituents and low levels of toluene. This sump does not appear to be downgradient of the SD-3 or SD-4 locations on the Minimart and may be a separate contributing source for hydrocarbons observed in the storm sewer.

During each of the sampling events southwest of the site at SD-3, the surface water contained a mixture of diesel and gasoline constituents. In the creek upstream of the site at SD-4, no petroleum hydrocarbon constituents were detected. Downstream in the creek (SD-1 and the creek outfall), the surface water samples contained low levels of BTEX gasoline constituents during each sampling event. TPH-G was detected in SD-1 only during the first event.
