Results of Remedial Action at Whitten Oil  
in Colville, Washington

Prepared for Washington Department of Ecology

Submitted by Olympus Environmental, Inc.  
October 18, 1990

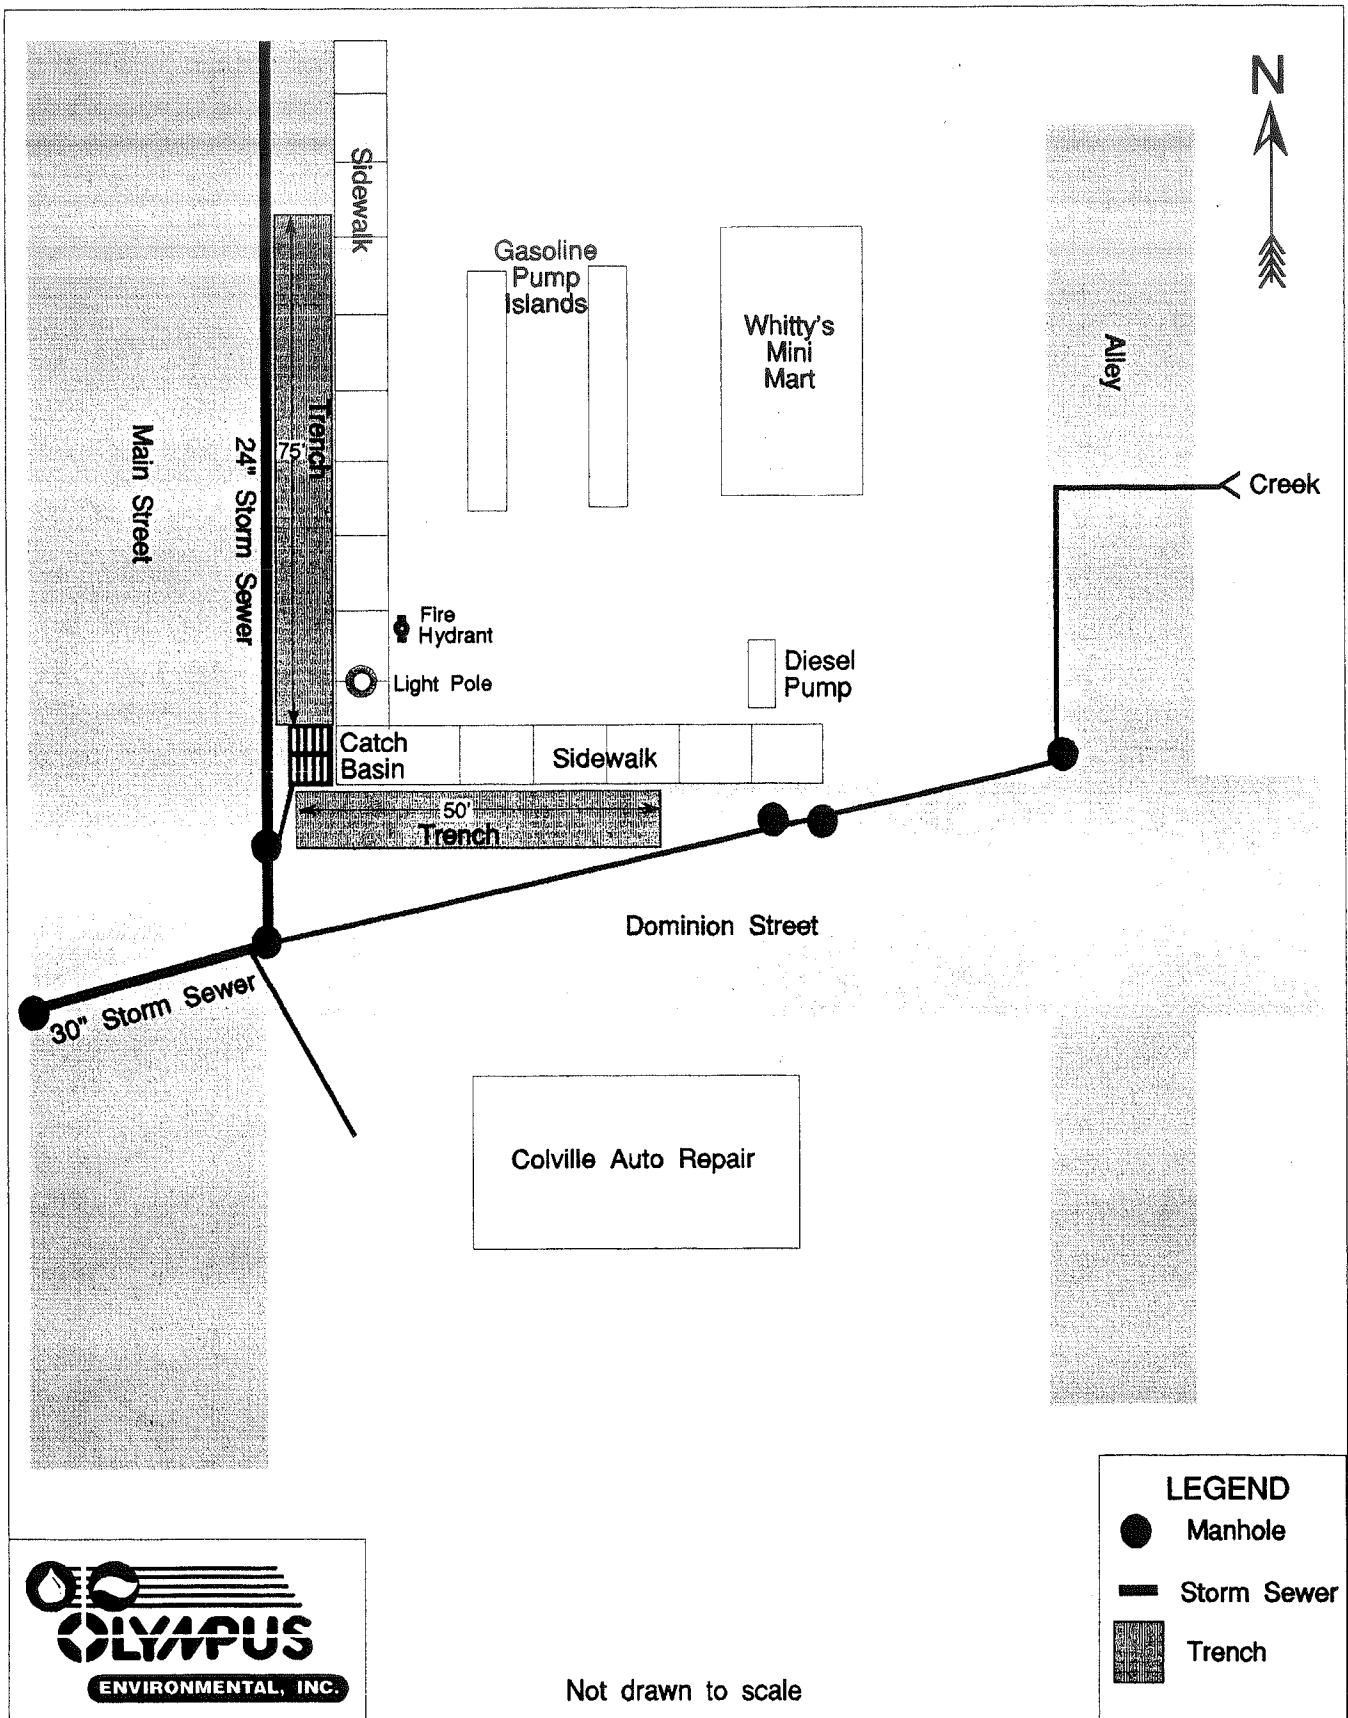
Site Map with Storm Sewer and Trench Locations

Trenches were located along Main and Dominion Streets as shown on site map in Appendix A. During trenching, the trenches were extended north and east from the corner until contamination was no longer observed in the soils.

Site Map showing location of trenches and storm sewers.

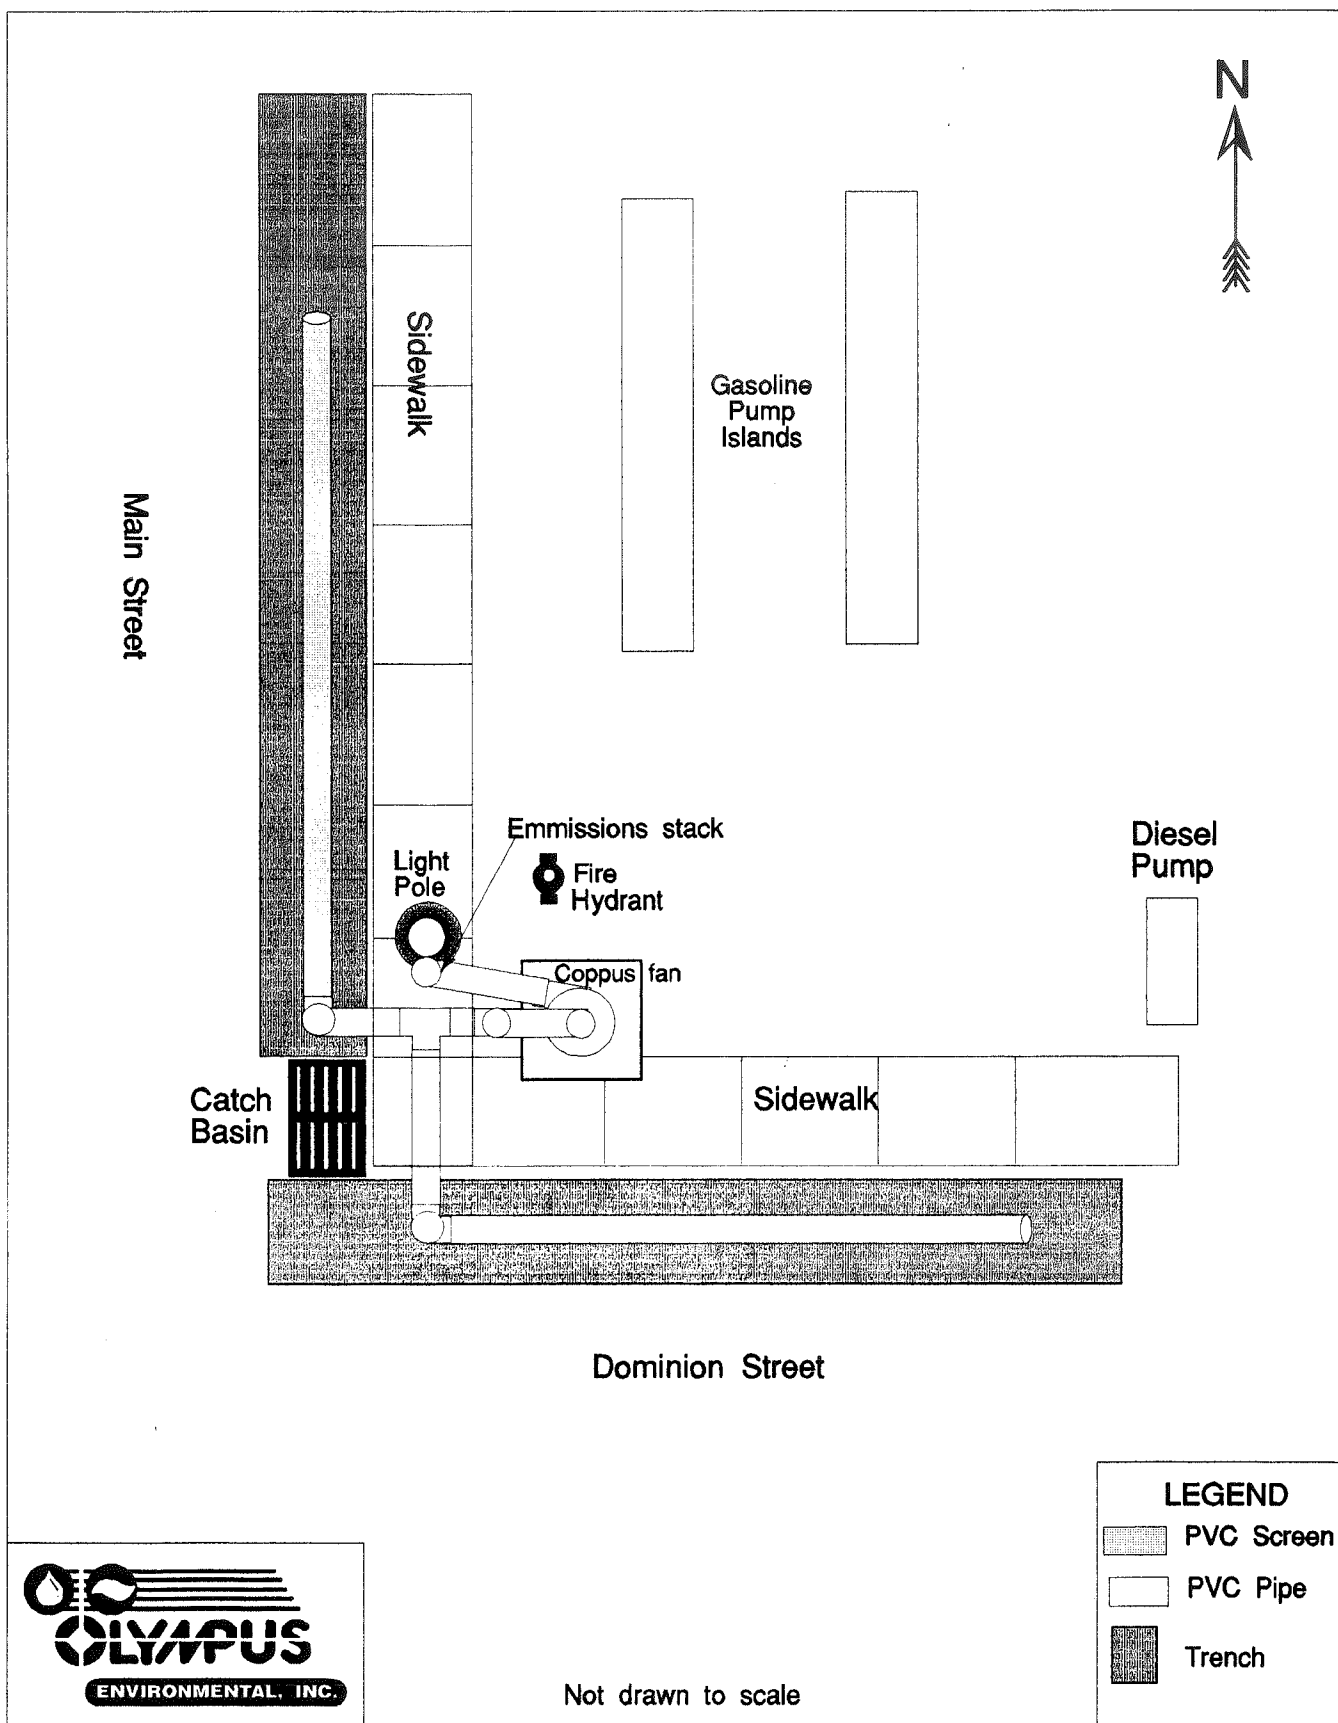
### Diagrams of Vapor Extraction System Design

The design of the vapor extraction system took into account the seasonal fluctuation of the ground water surface elevation. Coarse, washed gravel was backfilled from the bottom of the trench at 8 to 9 feet to a depth of 3 feet below grade. 100 feet of 4" diameter .020 slot PVC perforated screen was layed horizontally in the trenches, manifolded together and connected to a 4" PVC standpipe. 60 feet of screen was used in the N-S trench and 40 feet of screen was used in the E-W trench. The perforated screens were covered with coarse, washed gravel to a depth of 2 feet below grade. 1/4" crushed gravel was backfilled to the surface and compacted. The asphalt surface was then replaced. A Coppus Portavent 3/4 horse power blower, Model PV-750, was connected to the standpipe and a 10 foot air emissions stack was attached to the light pole on the corner. A plywood security building was built to house the fan. A sample port was installed on the stack to monitor the air emissions. Operation of the blower is being monitored by the Washington DOE. Diagrams of the system design are provided in Appendix B.

Sketch Map of vapor extraction ststem

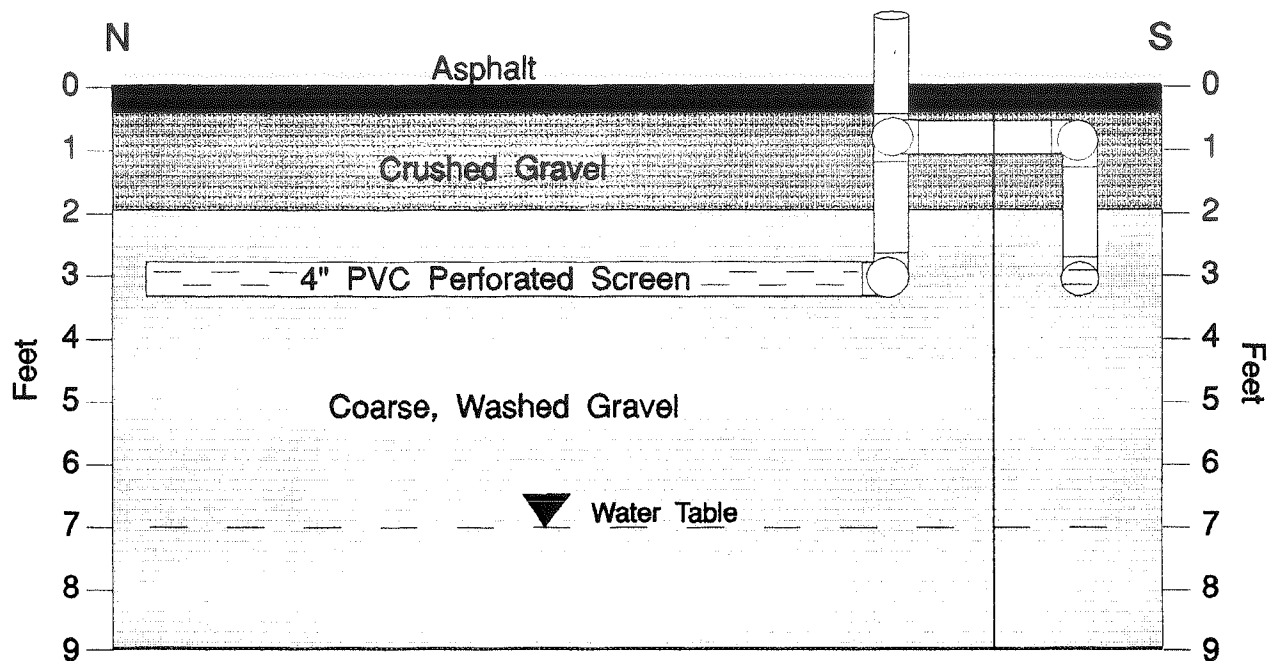
# North-South Cross-Section

The north-south trench was started at the catch basin at the corner of Main and Dominion. The trench that had been installed in 1984 was opened during this investigation. Water and free product (gasoline) flowed in the trench at a depth of 6 feet. Contaminated soils and free product were encountered to 66 feet north of the catch basin (approximately at north end of pump island). Contamination is present in the silty sand layer 5 to 7 feet below grade and in the silty clay beneath it. At 75 feet from the catch basin, the silt layer 8 feet below grade was saturated with water but had no gasoline odor. The total length of the north-south trench was 75 feet.

Cross-section diagrams of vapor extraction trenches

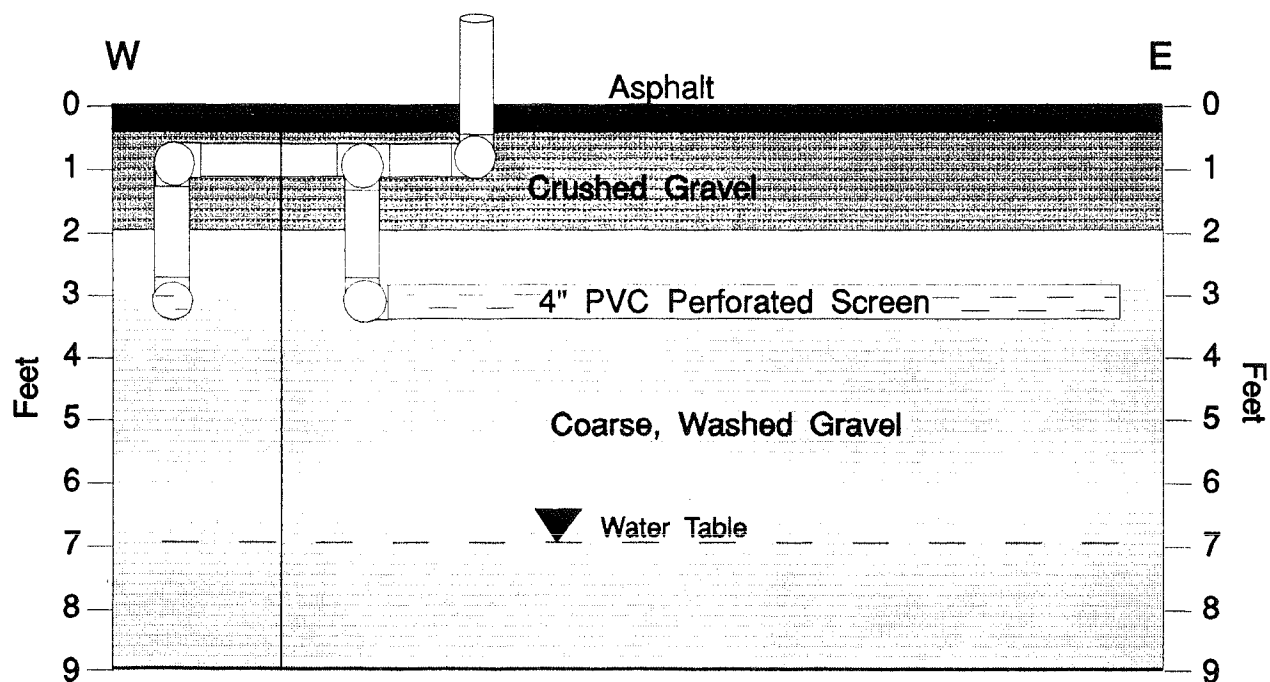
# East-West Cross-Section

Hydrocarbon levels in the subsurface have been evaluated through visual and olfactory observations. Free product was observed flowing on the surface of the ground water in the westernmost 20 feet of the east-west trench (along Dominion). A strong product odor was noted in the silty sand layer 4 to 6 feet below grade to 40 feet east of corner. No contamination was observed in the easternmost 10 feet of the trench. The total length of the east-west trench was 50 feet.
