2025 Annual Compliance Monitoring Report

Terminal 91 Tank Farm Affected Area

Project number: 60692669

February 23, 2026

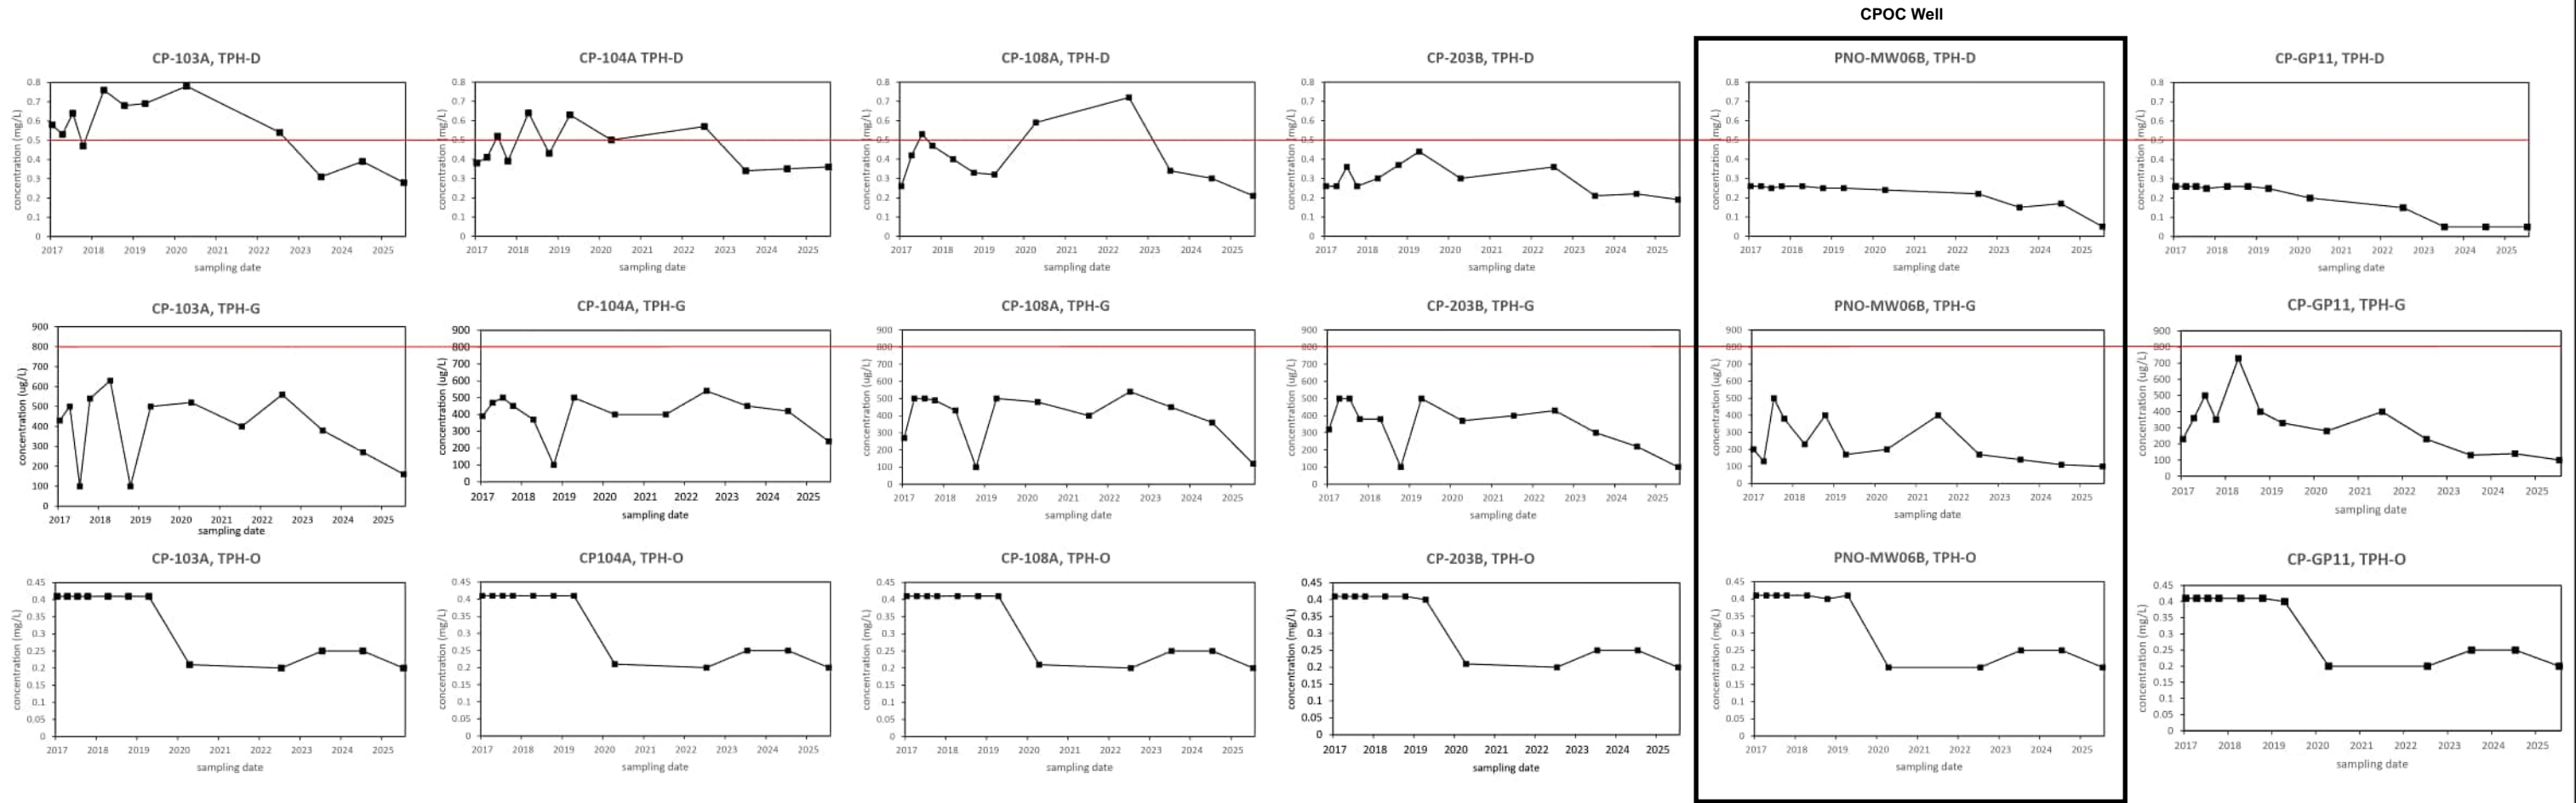
Figure 4a. TPH Time Series Plots (1 of 2)

TPH: total petroleum hydrocarbon; diesel (D)-, heavy oil (O)-, and gasoline (G)-range
 Only wells used for the Mann-Kendall trend analysis shown.
 See Table 4 for data qualifiers shown in blue text and additional qualifiers not shown.
 Red lines are the cleanup levels for TPH-G (800 ug/L) and TPH-D/O (0.5 mg/L); line not shown where
 cleanup levels are off-scale.
 Z-flagged data from 2021 and shown in Table 4 was not included in these time series plots as the data was not included in trend analysis.

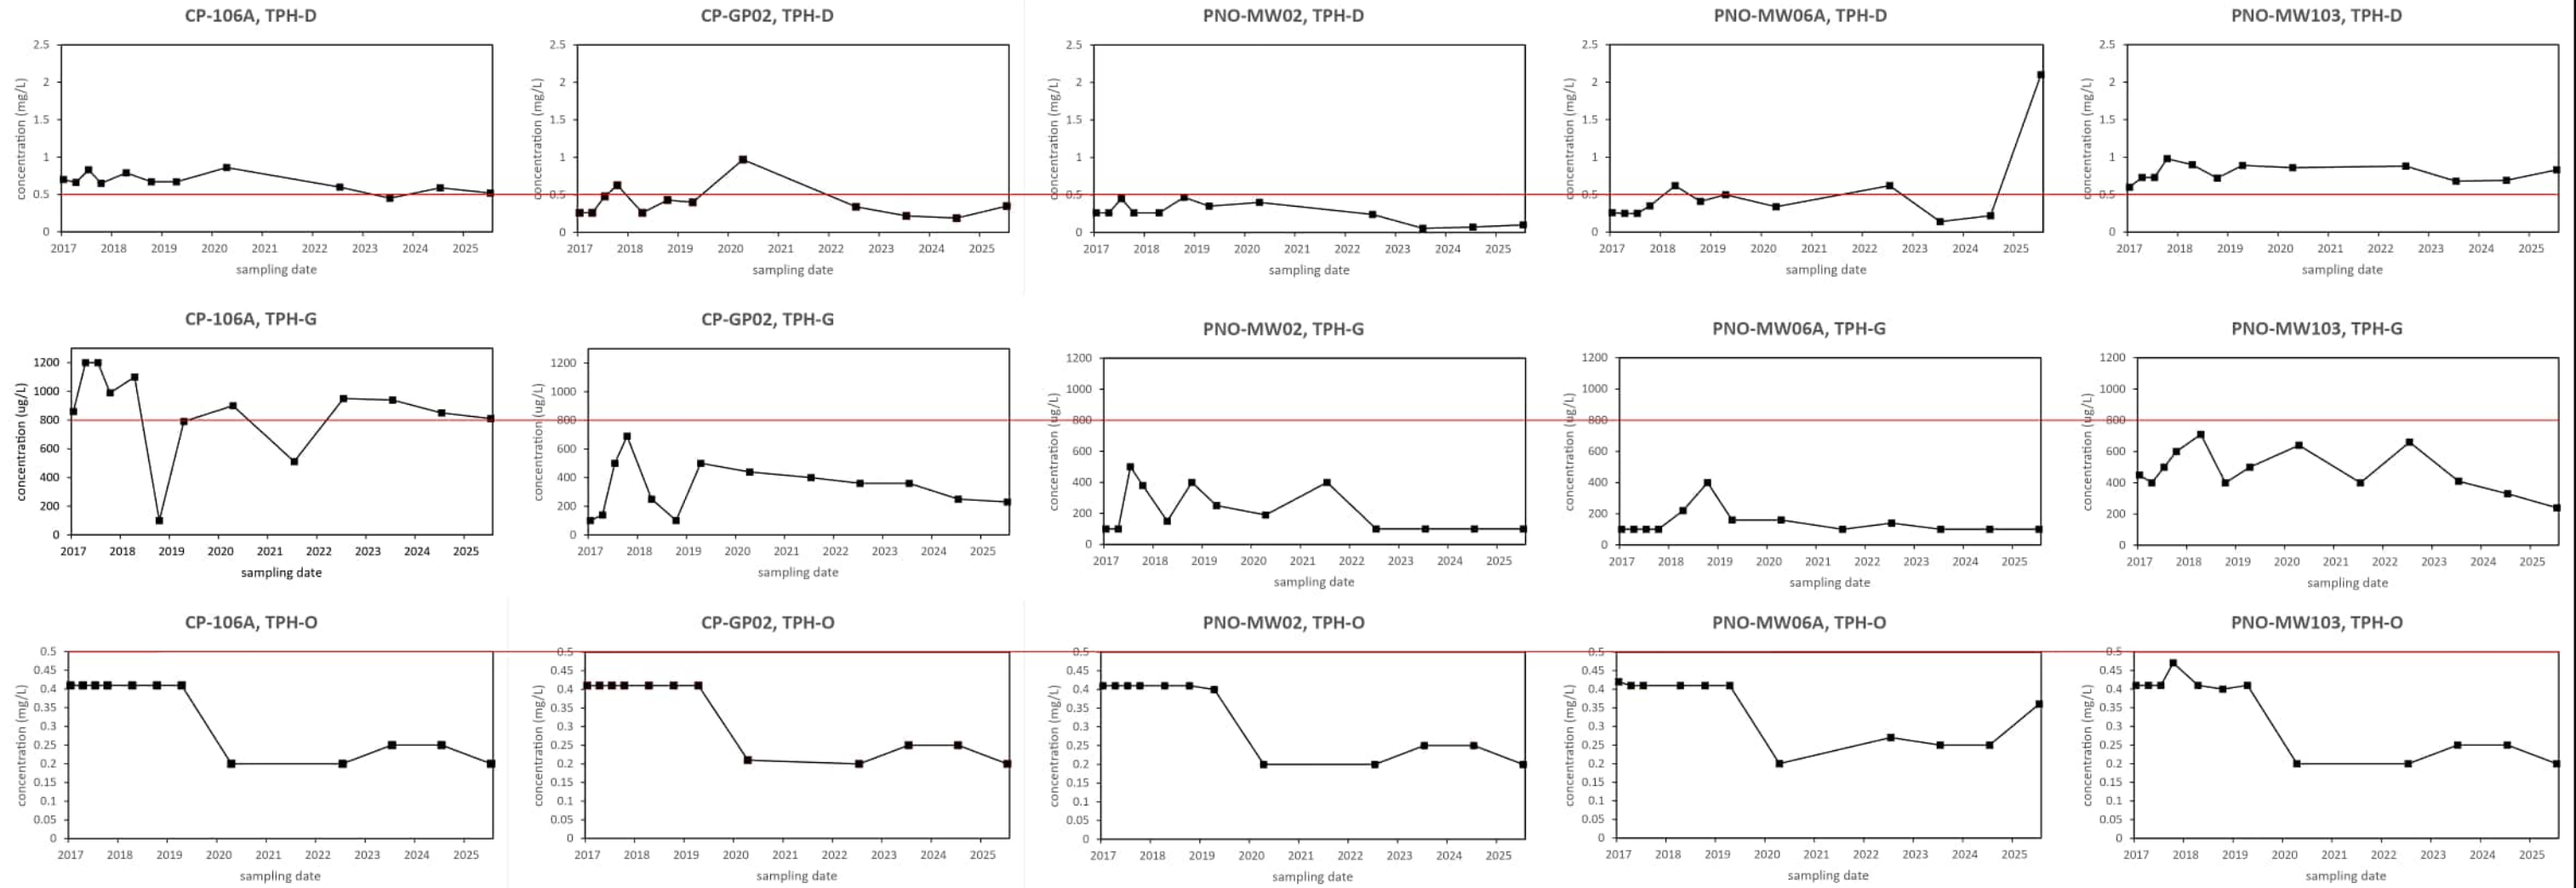
Figure 4b. TPH Time Series Plots (2 of 2)

TPH: total petroleum hydrocarbon; diesel (D)-, heavy oil (O)-, and gasoline (G)-range
 Only wells used for the Mann-Kendall trend analysis shown.
 See Table 4 for data qualifiers shown in blue text and additional qualifiers not shown.
 Red lines are the cleanup levels for TPH-G (800 ug/L) and TPH-D/O (0.5 mg/L); line not shown where cleanup levels are off-scale.
 Z-flagged data from 2021 and shown in Table 4 was not included in these time series plots as the data was not included in trend analysis.
