Re: Port of Friday Harbor Albert Jensen & Sons Site (Agreed Order No. DE 18071)

This letter summarizes best management practices (BMPs) that were implemented at the Albert Jensen and Sons, Inc. Boatyard and Marina (Jensen's) site to address potential future releases associated with the shop floor drain and the former aboveground storage tank (AST). This work was performed consistent with our phone conversation on April 3 and our follow-up e-mails on April 10, 2026.

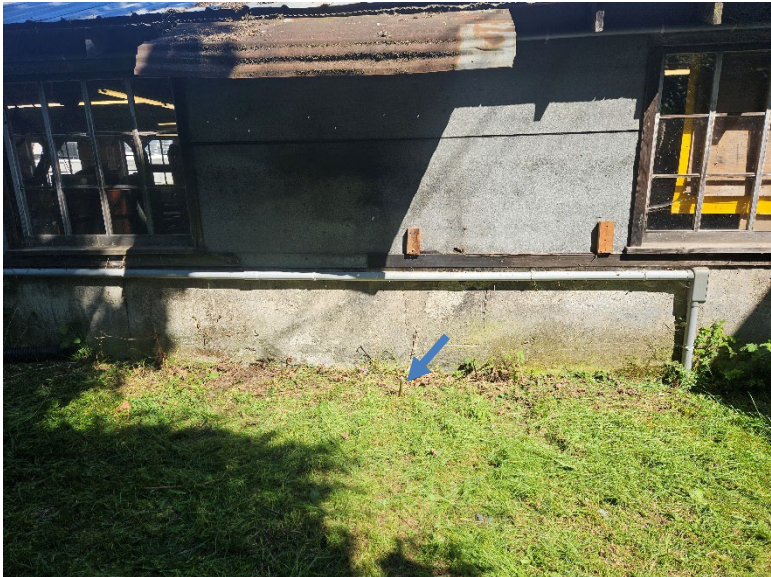
| Photographic Record #1 – Former Aboveground Storage Tank Area | |
|---|---|
| Photo ID: PoFH AST BMP 1 | |

A former AST is believed to have been located on the exterior of the south wall of the former shop building. There is no documentation regarding the size or contents of the former AST. Soil sampling was performed in this area during the remedial investigation (RI). Soil sampling locations AST-1 and AST-4 were located close to the southern exterior wall of the building; centered under a small roof extension. Data from these locations indicate presence of total TPH-Dx at concentrations in soil ranging 7,500 mg/kg (AST-4) to 18,000 mg/kg (AST-1) at depths extending to 2 feet below ground surface (bgs). Review of these data, which exceed the preliminary cleanup level (PCUL) of 2,000 mg/kg, suggest that the AST may have contained a heavier fuel such as heating oil (TPH-Gx was not detected). TPH was not detected in deeper soil samples collected at AST-4 from between 2 to 5 feet bgs.

| Photographic Record #1 – Former Aboveground Storage Tank Area | |
|---|---|
| Comments:<br>Former aboveground storage tank (AST) area prior to BMP installation. Suspected former AST believed to have been installed underneath roof extension. Blue arrow indicates wooden stake marking AST-4 sampling location. | |

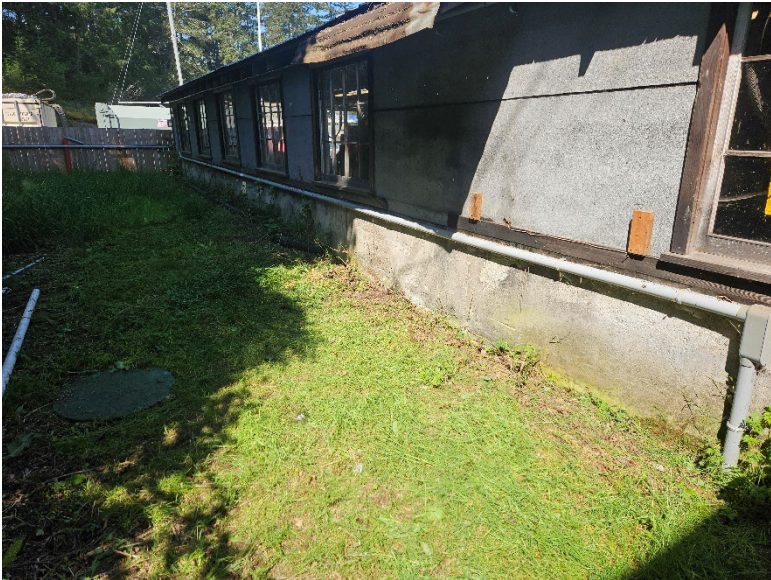
| Photographic Record #1 – Former Aboveground Storage Tank Area | |
|---|---|
| Photo ID: PoFH AST BMP 2 | |

| Photographic Record #1 – Former Aboveground Storage Tank Area | |
|---|---|
| Comments: Former AST area prior to BMP installation. | |

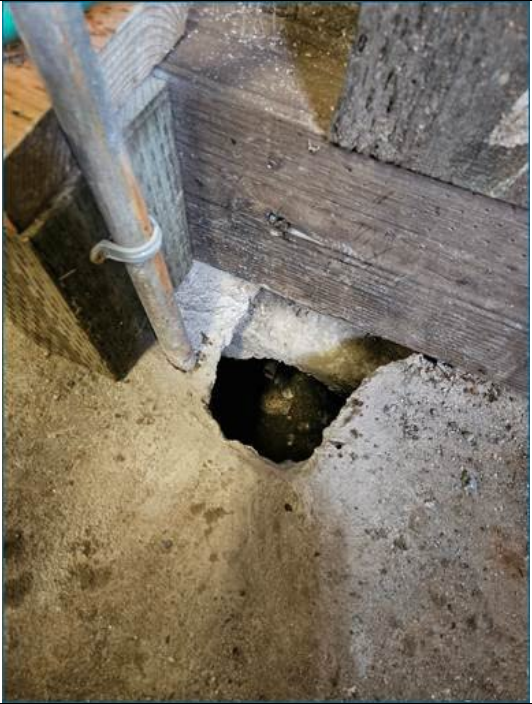
| Photographic Record #2 – Shop Floor Drain | |
|---|---|
| Photo ID: PoFH SFD BMP 1 | |

Within the marina's existing shop building, an approximately 4-inch by 6-inch hole was present in the concrete floor of the building directly adjacent to the foundation in the northwest corner. This hole is referred to as the shop floor drain and, based on prior site documents indicating the building was used as a machine shop, may have been used as a drain for liquids containing lubricants and/or solvent-based cleaners. During the Phase I Environmental Site Assessment, the former owner noted that a tank or drum was present in the void beneath the hole in the shop floor and may have been perforated or may have contained a drain line for the contents to drain. The Port advanced a scope into the shop drain in November 2025 and confirmed the presence of a partial metal drum underneath the concrete floor but did not observe perforations or a drain line.

| Photographic Record #2 – Shop Floor Drain | |
|---|---|
| Comments:<br>Shop floor drain consists of approximately 4-inch by 6-inch wide hole in concrete slab. Photo shows condition prior to BMP installation. | |

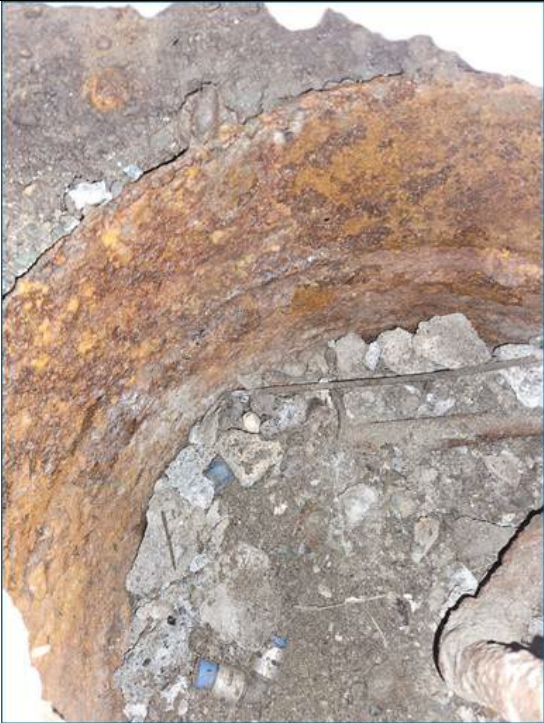
| Photographic Record #2 – Shop Floor Drain | |
|---|---|
| Photo ID: PoFH SFD BMP 3 | |

| Photographic Record #2 – Shop Floor Drain | |
|---|---|
| Comments:<br>Interior view of former shop floor drain, prior to BMP installation. A cut-off segment of steel drum is present underneath shop floor slab. A disconnected former water pipe extends through the steel drum to a spigot. | |

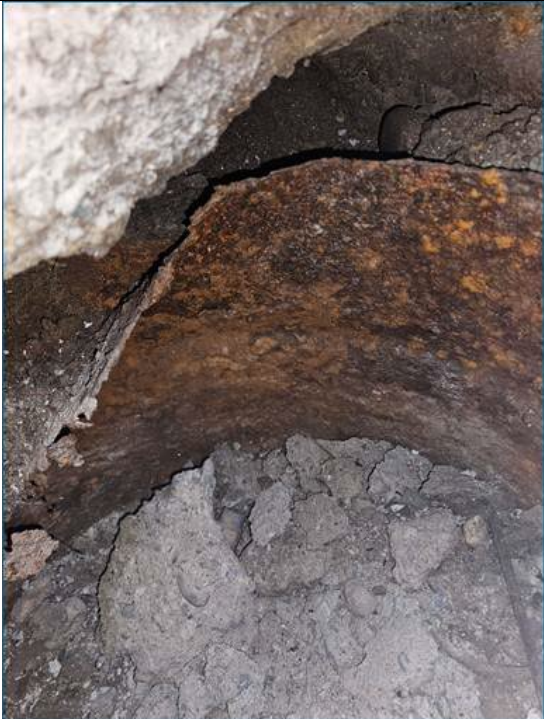
| Photographic Record #2 – Shop Floor Drain | |
|---|---|
| Photo ID: PoFH SFD BMP 4 | |

| Photographic Record #2 – Shop Floor Drain | |
|---|---|
| Comments:<br>Interior view of former shop floor drain. Void was approximately 22-inch by 24-inch wide. Estimated to be approximately 5 cubic feet in volume. | |

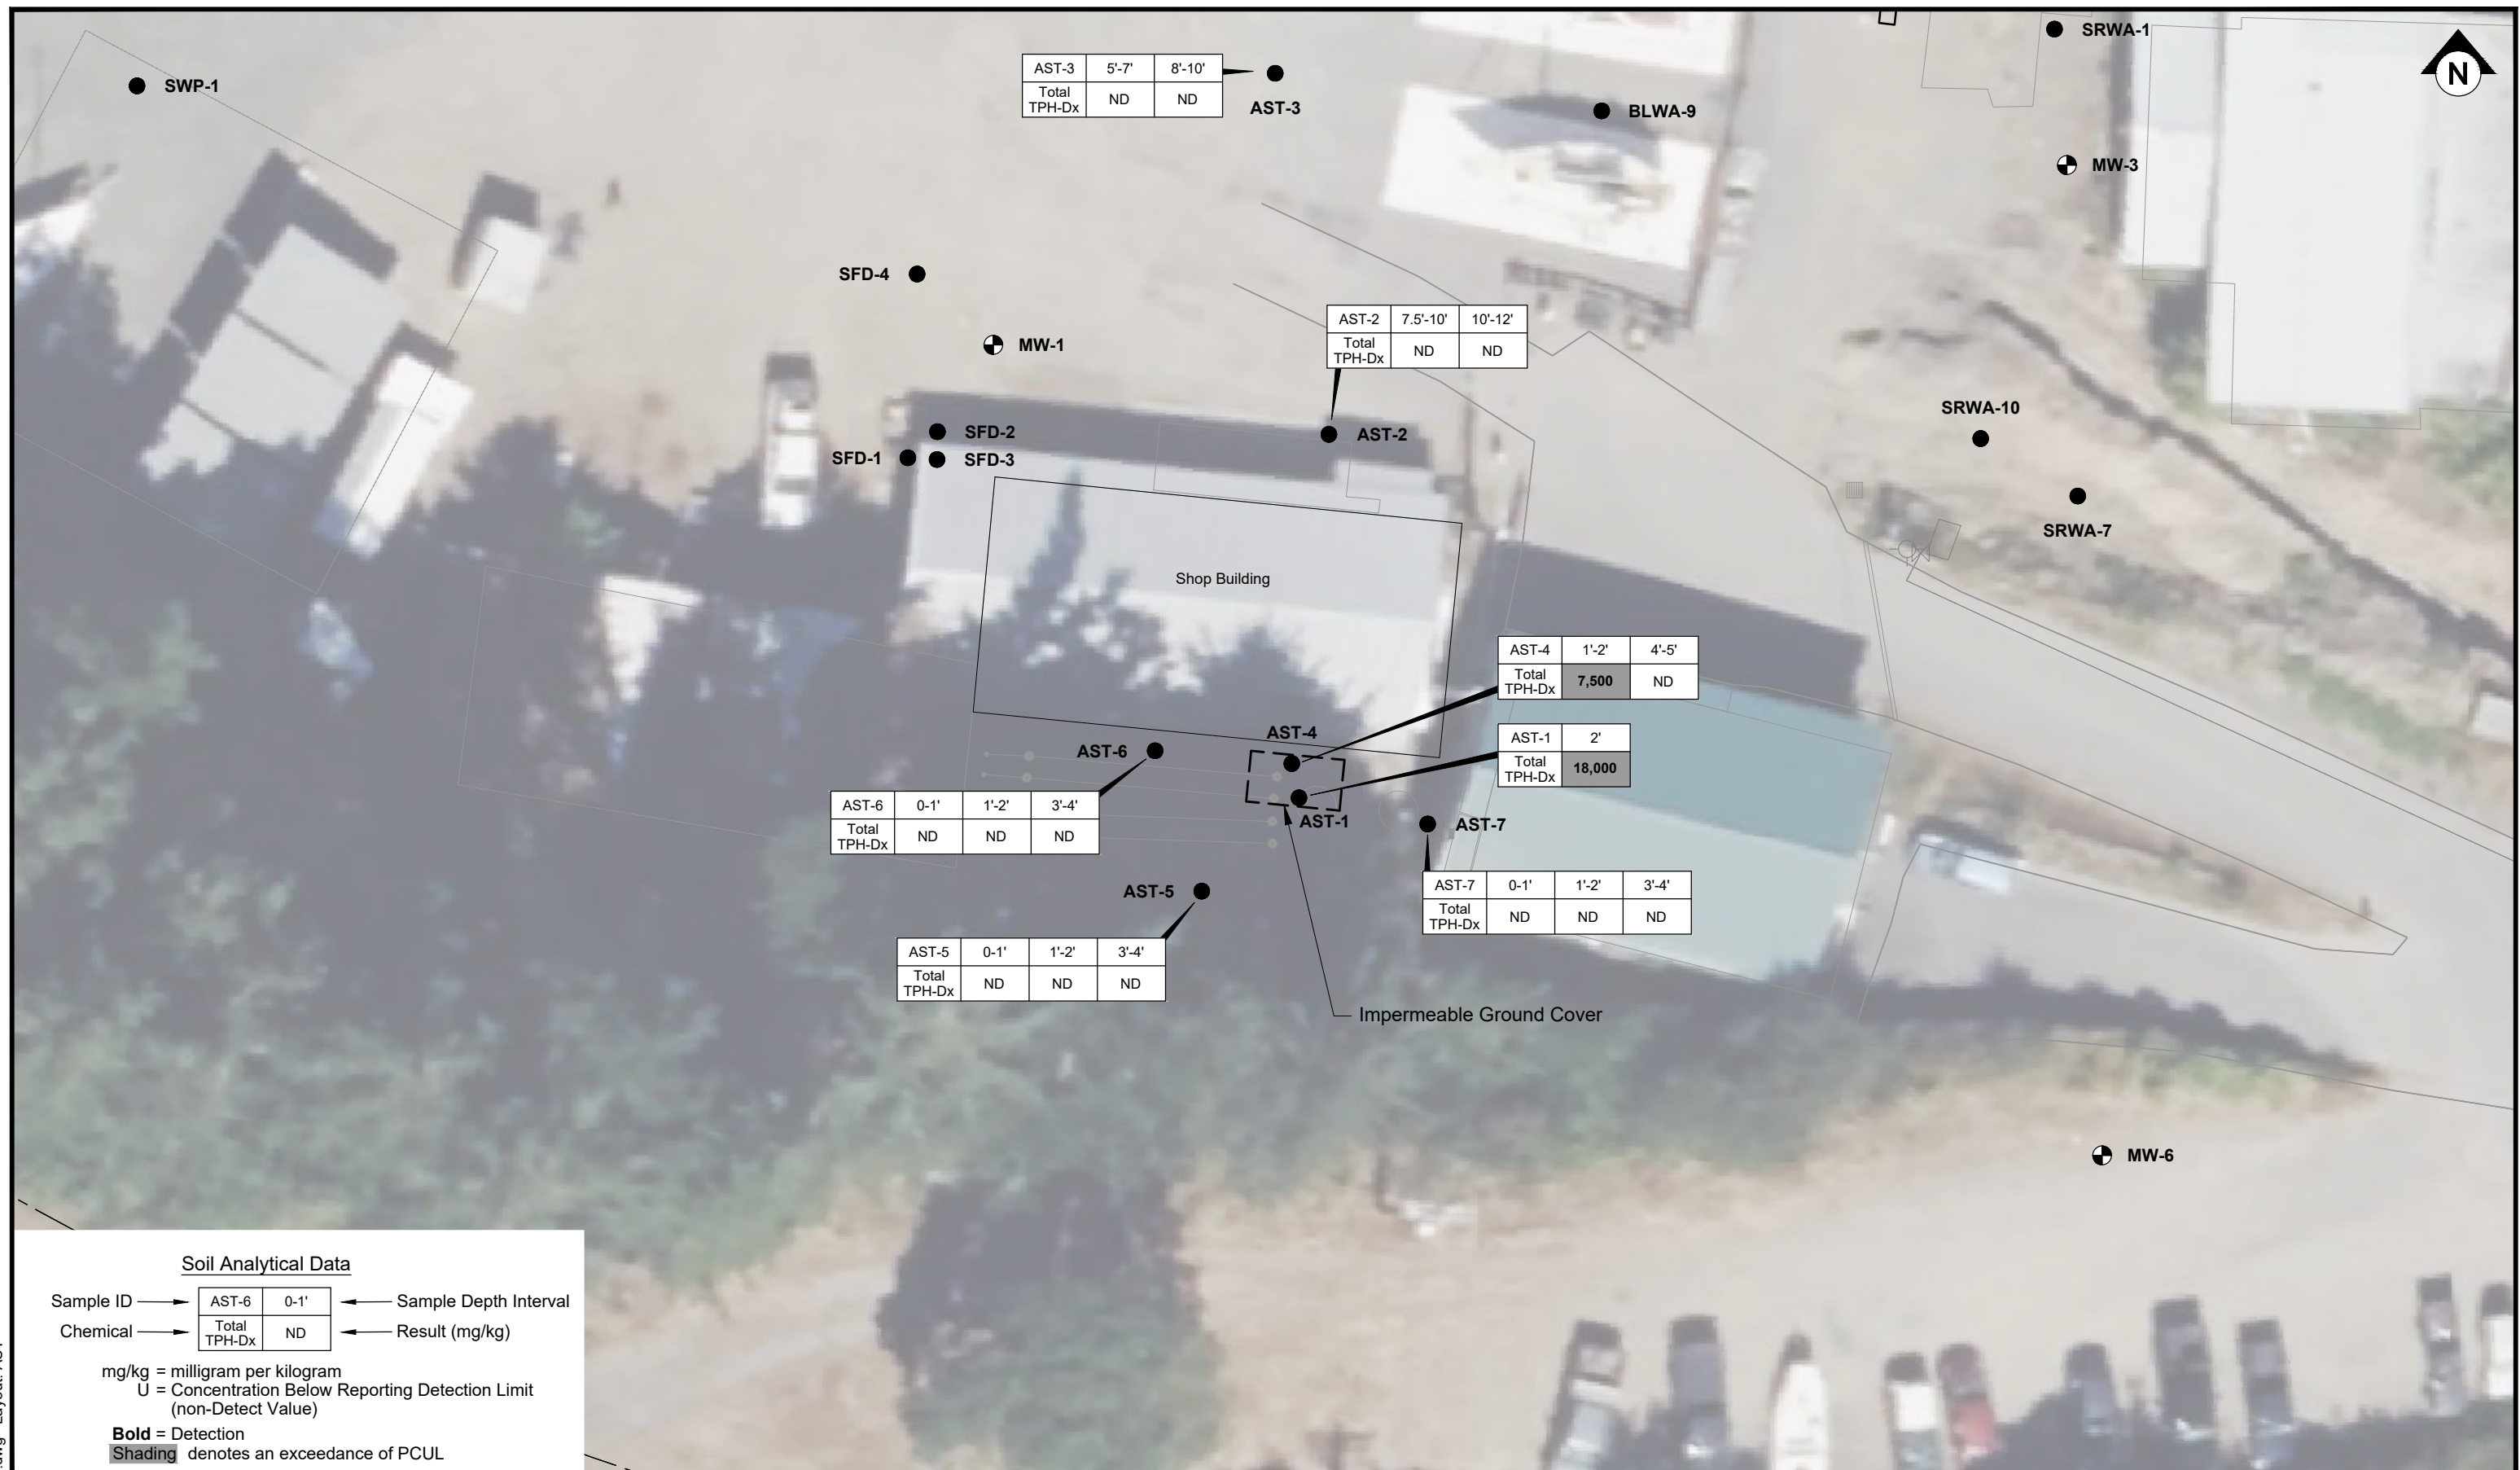
During the RI, soil was analyzed at an additional five locations to determine the extent of TPH impacts. TPH was not detected at three locations (AST-5, -6, and -7) located immediately to the east, south, and west of AST-4 (Figure 1). Similarly, TPH was not detected in two samples collected on the north side of the shop building (AST-2, and -3).

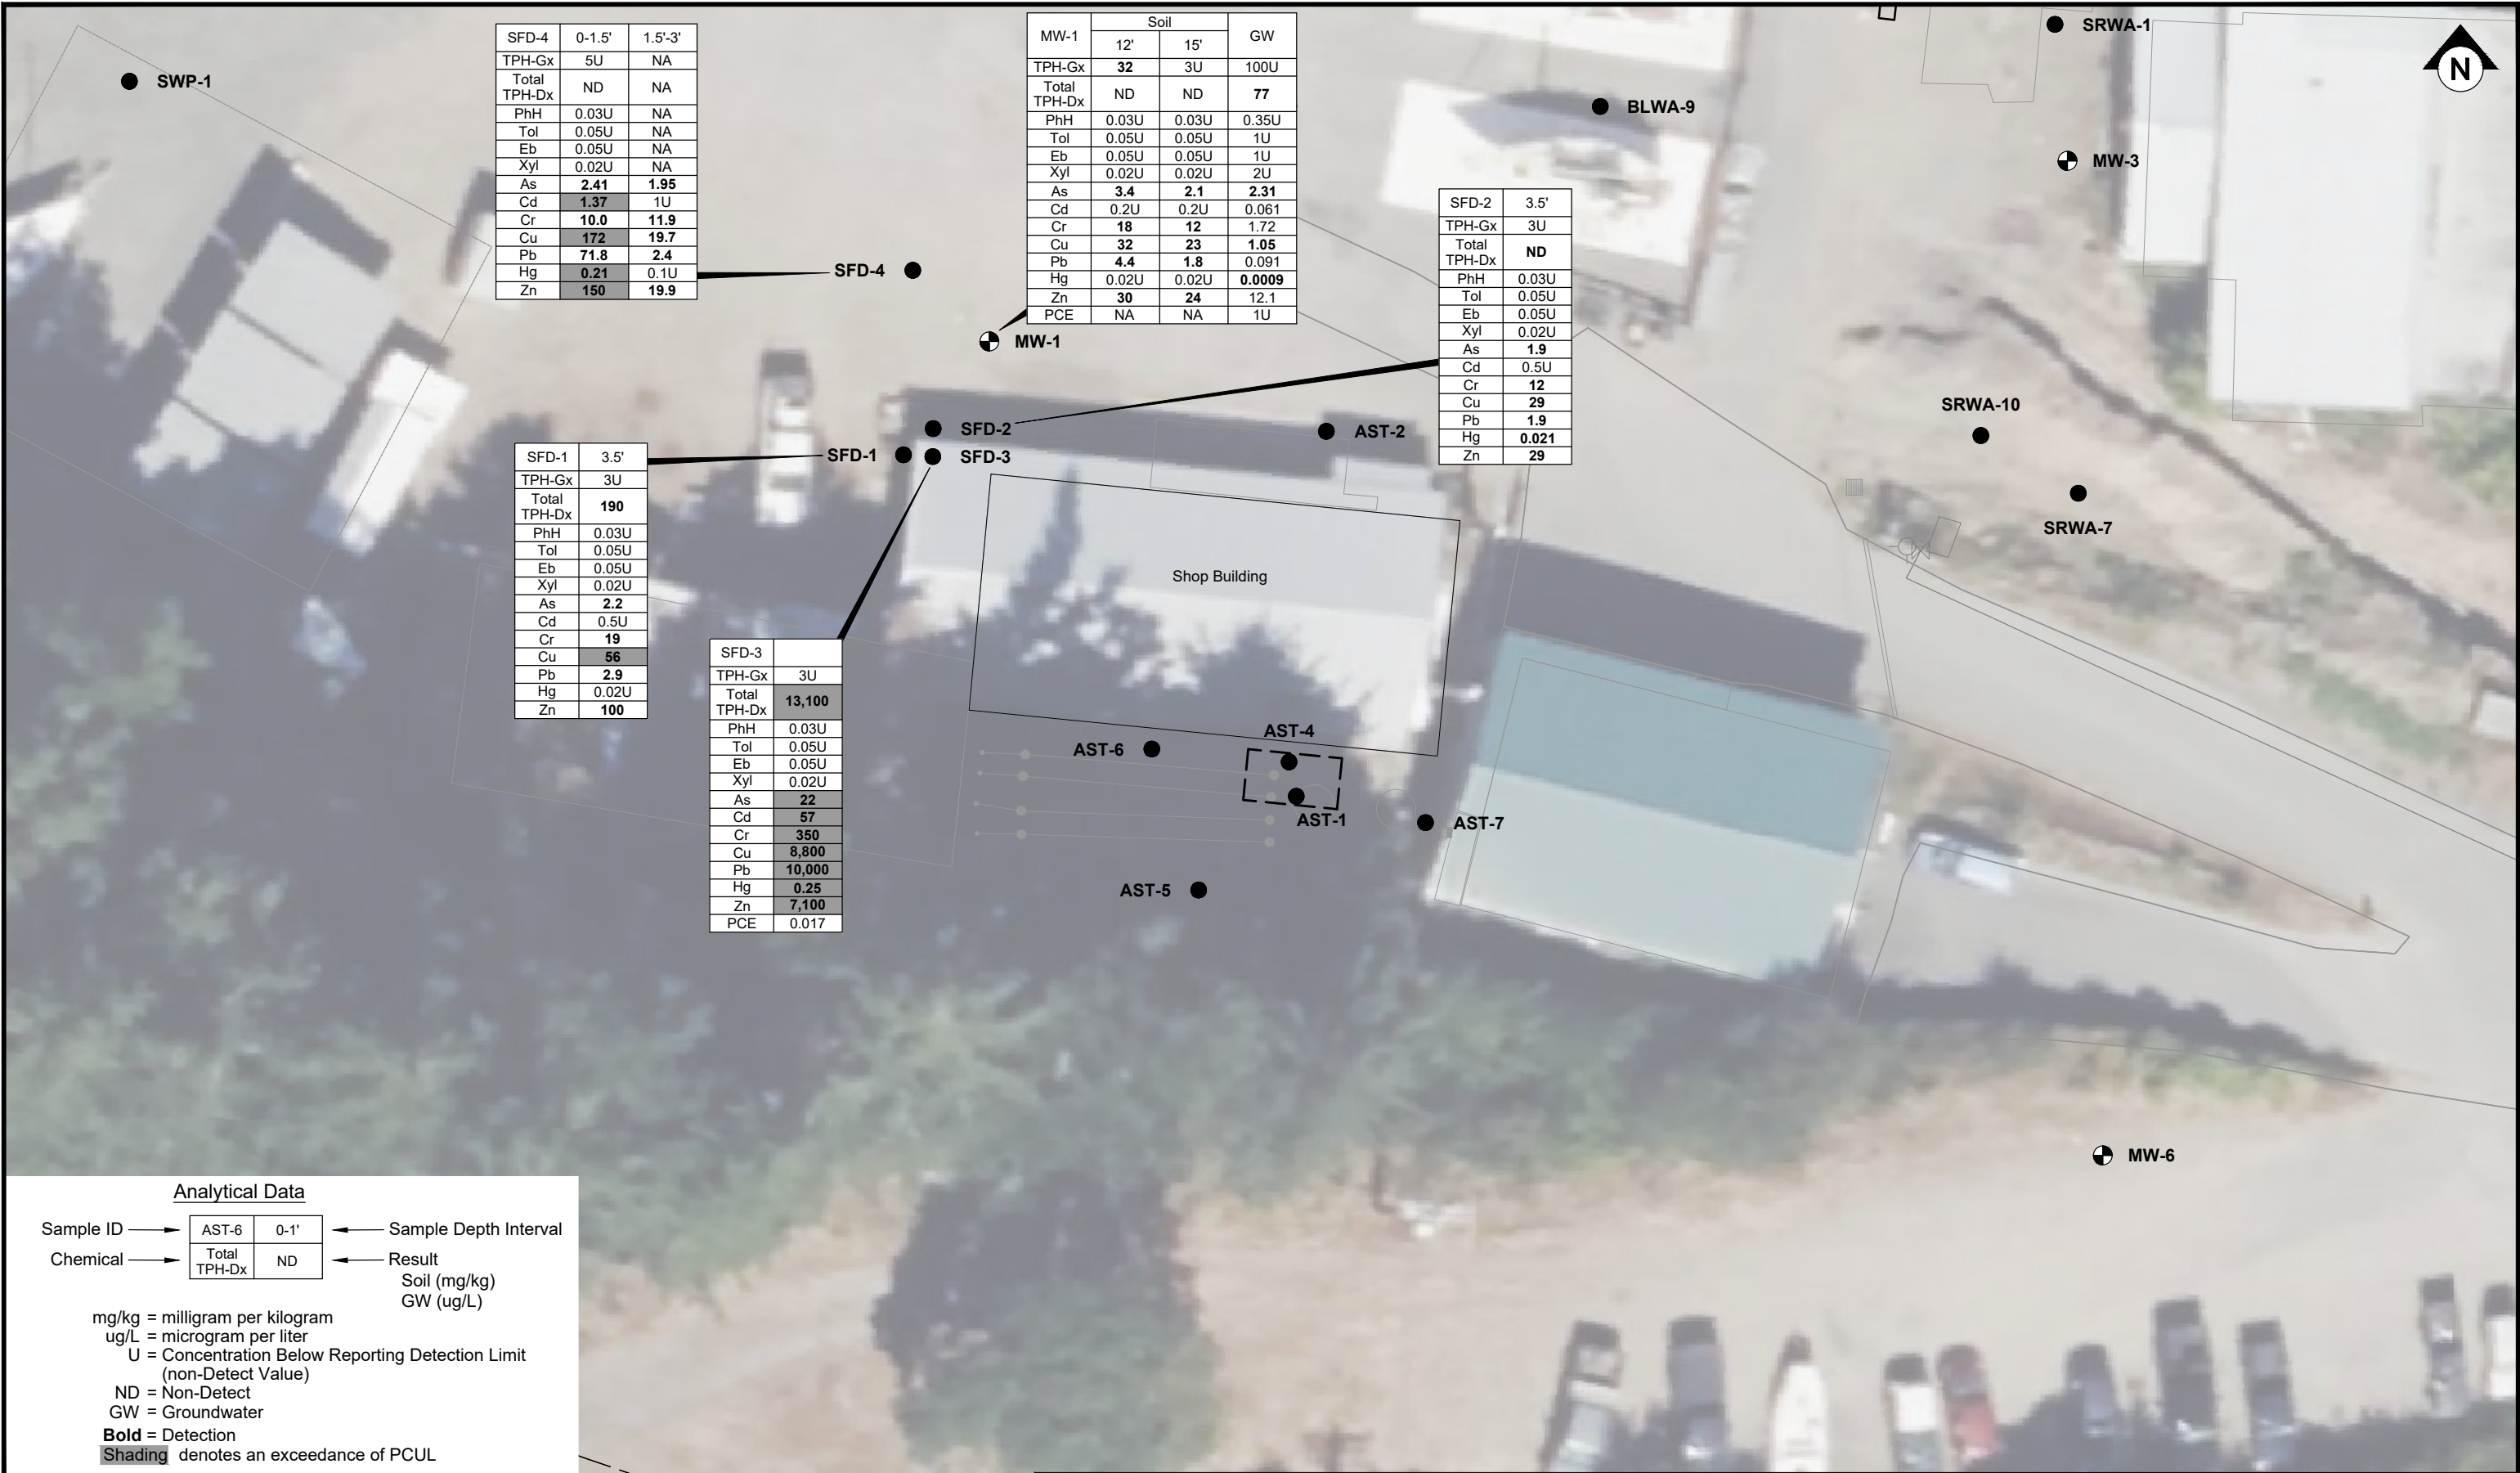
A sample of solids collected from the drain (SFD-3) during the remedial investigation contained TPH-Dx and metals (arsenic, cadmium, chromium, copper, lead, mercury, zinc) at concentrations exceeding the PCULs. Tetrachloroethene was also detected, but at a concentration below the most stringent PCUL. Additional RI data was obtained from soil collected at five locations adjacent to the northwest corner of the building. These data showed no detections of TPH. The results indicated concentrations of several metals (i.e., copper, mercury, zinc) exceeding PCULs; however, these data are consistent with soil sampling results throughout the broader boat lift work area of the site. Groundwater samples collected from MW-1 had detected concentration of dissolved metals and TPH-Dx that were below PCULs. Existing data are summarized in Figure 2.
