# Memorandum

**To:** Ron Woolworth, W&W Everett Investments, LLC  
**Copies:** Frank Winslow, Washington State Department of Ecology  
**From:** Kristin Anderson, LHG, Floyd|Snider  
**Date:** June 16, 2026  
**Site Name:** Jeld-Wen Site  
**Re: Cap Condition Survey**

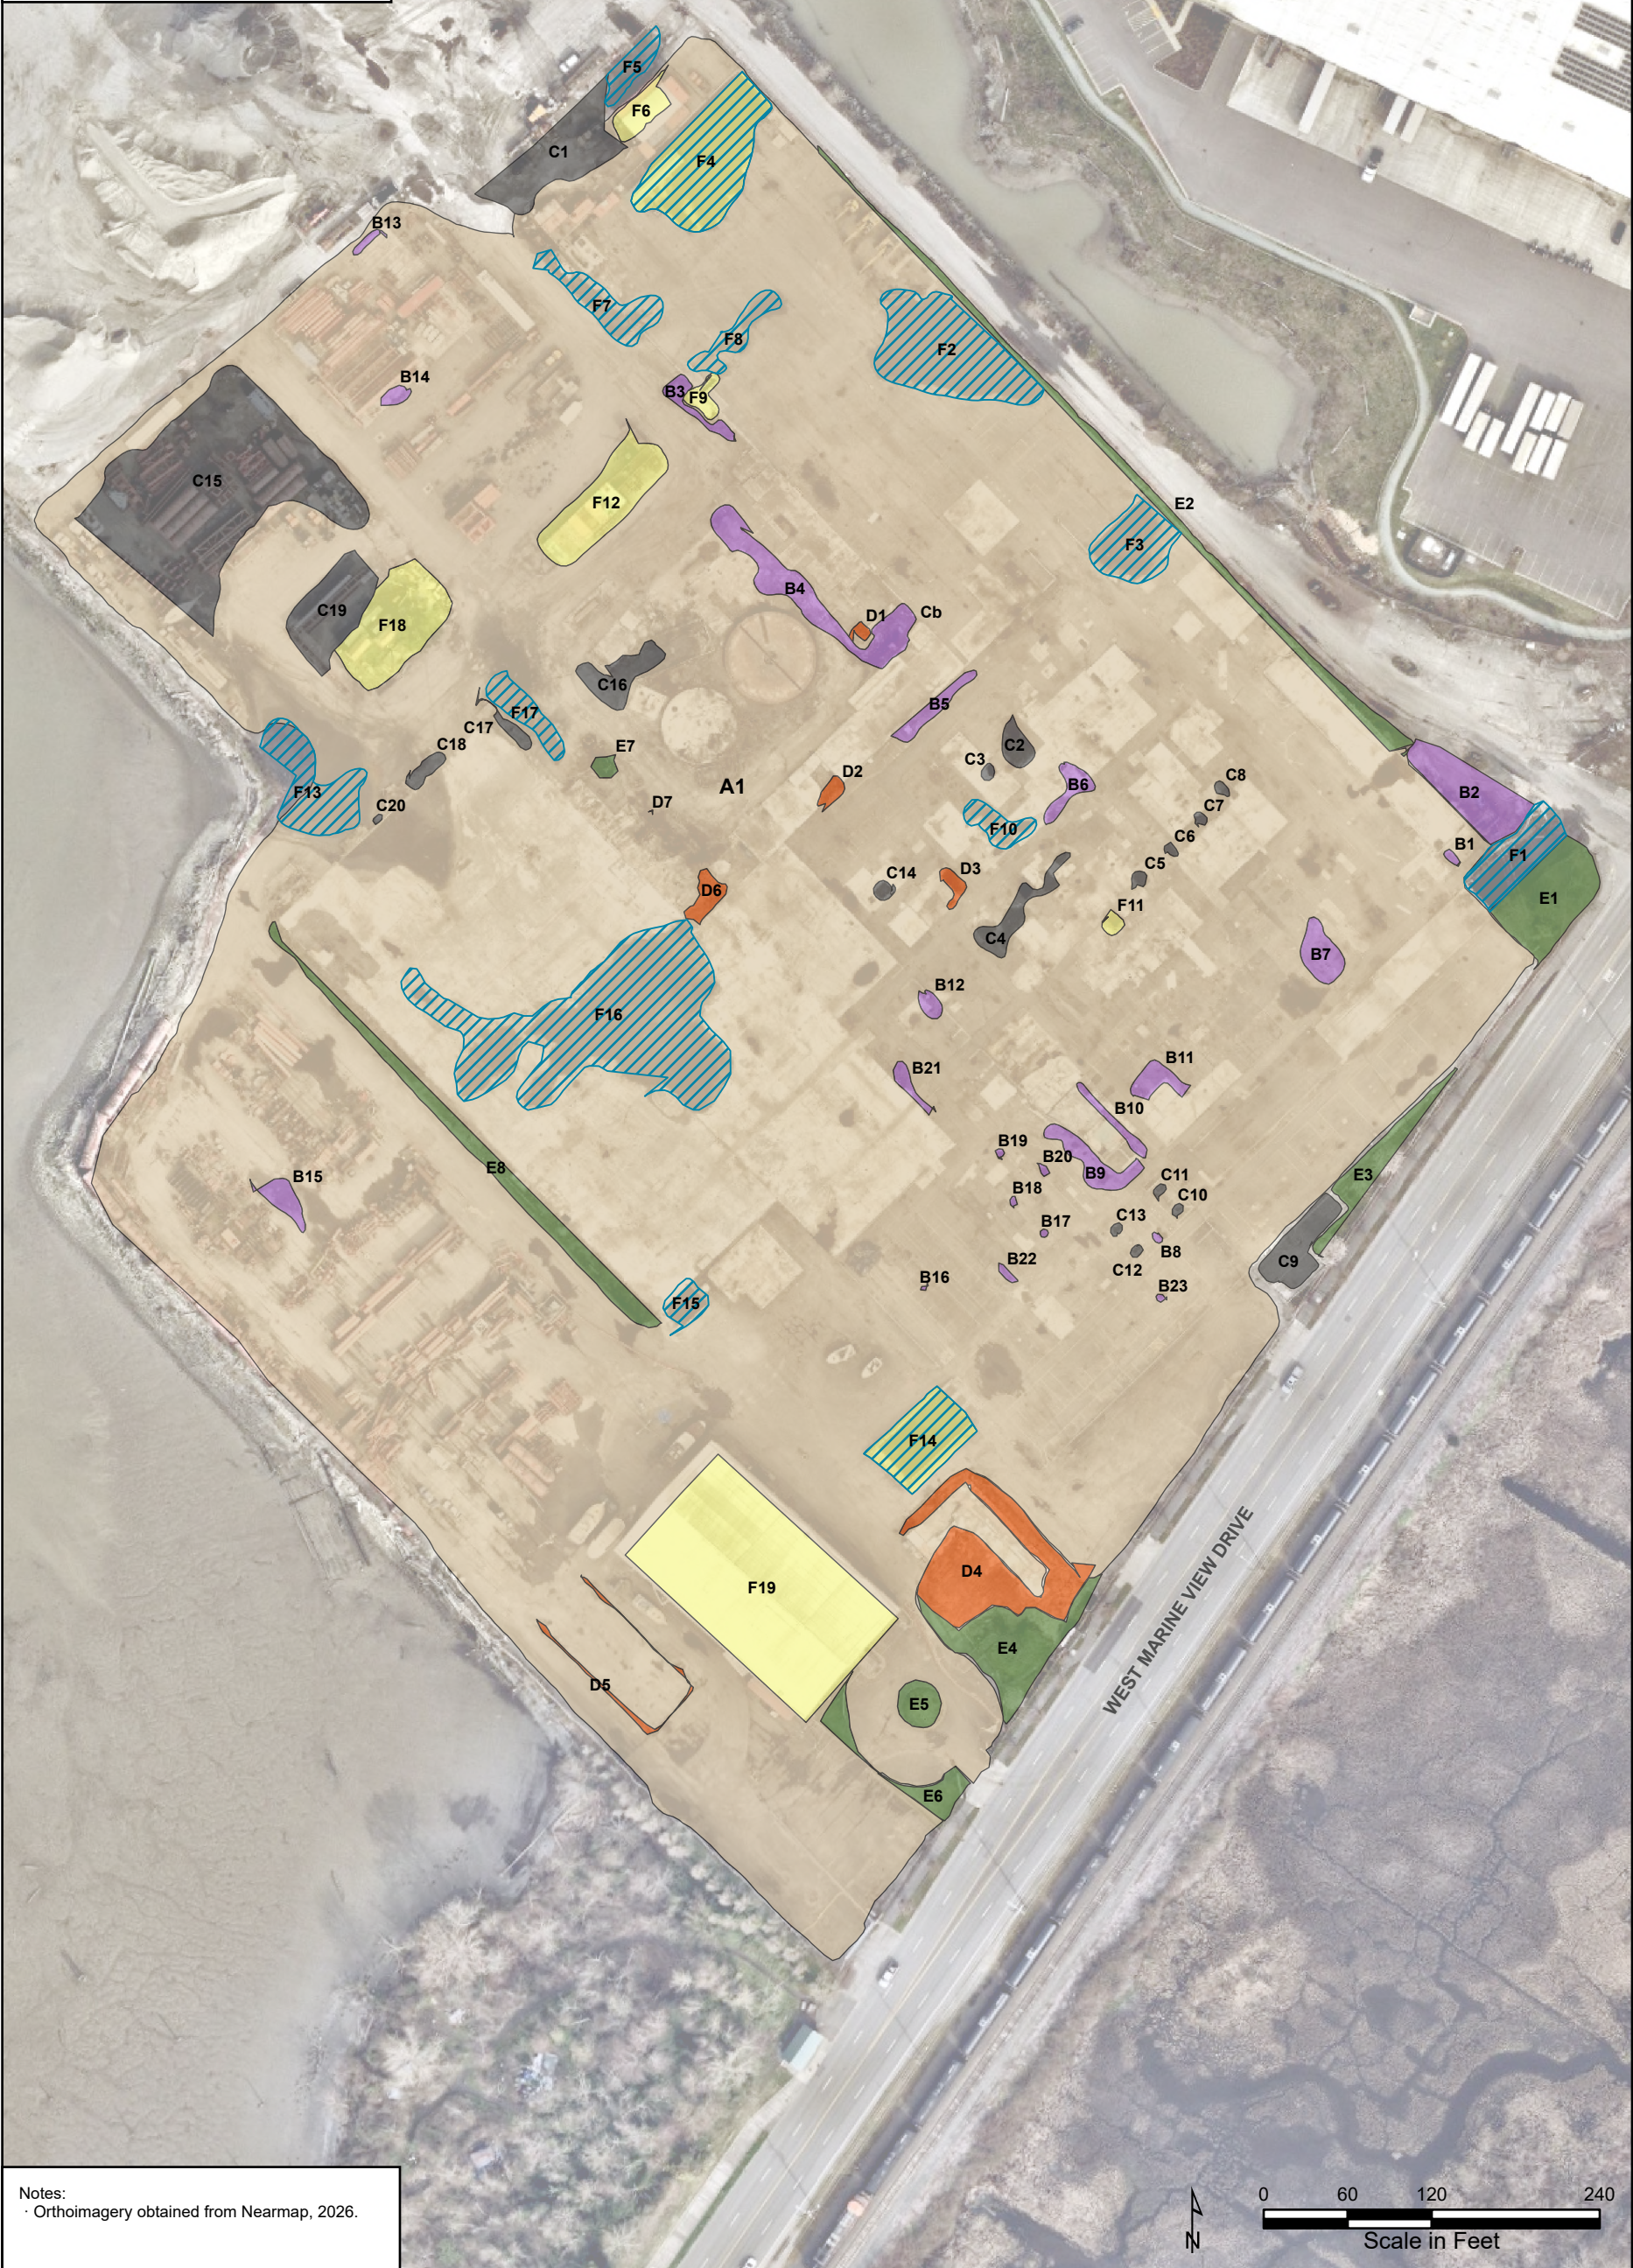
Figure 1        Cap Inspection Survey

Areas of broken concrete/asphalt total 0.3 acres and are labeled on Figure 1 as B1 through B23. Polygons B1-B6, B8, B11, B13-B14, B17-B23 presented erosion indicators, primarily exposed underlying fill material, and sediment accumulation or deposition within the damaged pavement areas. In several areas, the deterioration of the concrete and asphalt surface appeared to contain accumulated surface water, contributing to the formation of shallow depressions and uneven surface conditions. Minor vegetation was present in B2, B3, and B4, suggesting that some of the damaged areas function as localized collection points for stormwater runoff rather than active sources of sediment migration with the potential to reach surface water. Sediment deposits were commonly seen along the margins of broken pavement, indicating that sediment transport has occurred during precipitation events.

areas are labeled on Figure 1 as C1 through C20. Polygons C1-C8 and C15-C20 were identified as having the potential to wash out during storm events due to their exposed configuration and lack of containment by berms or curbing. Erosion or migration of gravel from these areas could contribute suspended solids to stormwater runoff; however, the gravel is from a clean quarry source provided by HM and is therefore unlikely to contribute contaminants to stormwater. Polygons C9-C14 were observed to be contained within concrete berms, which are expected to reduce the transport of sediment during precipitation events.

Ponded areas (as shown in Figure 1) with the potential to discharge to surface water include polygons F1, F2, F4, F5, F7, F8, F10, F16, and F17. These areas were generally associated with depressional and impermeable surfaces of the Site where accumulated stormwater could overflow, migrate across impermeable surfaces, or flow toward surface water during precipitation events. The proximity of ponded water to drainage pathways or sloped surfaces increases the likelihood that suspended sediment could be transported in stormwater during precipitation events. A pump was observed at the north truck bay ponding (polygon F1), with piping extending along the north side of the concrete pad, consistent with active water management to maintain driveway access in this area. However, no water flow from the pump was observed during the site visit.

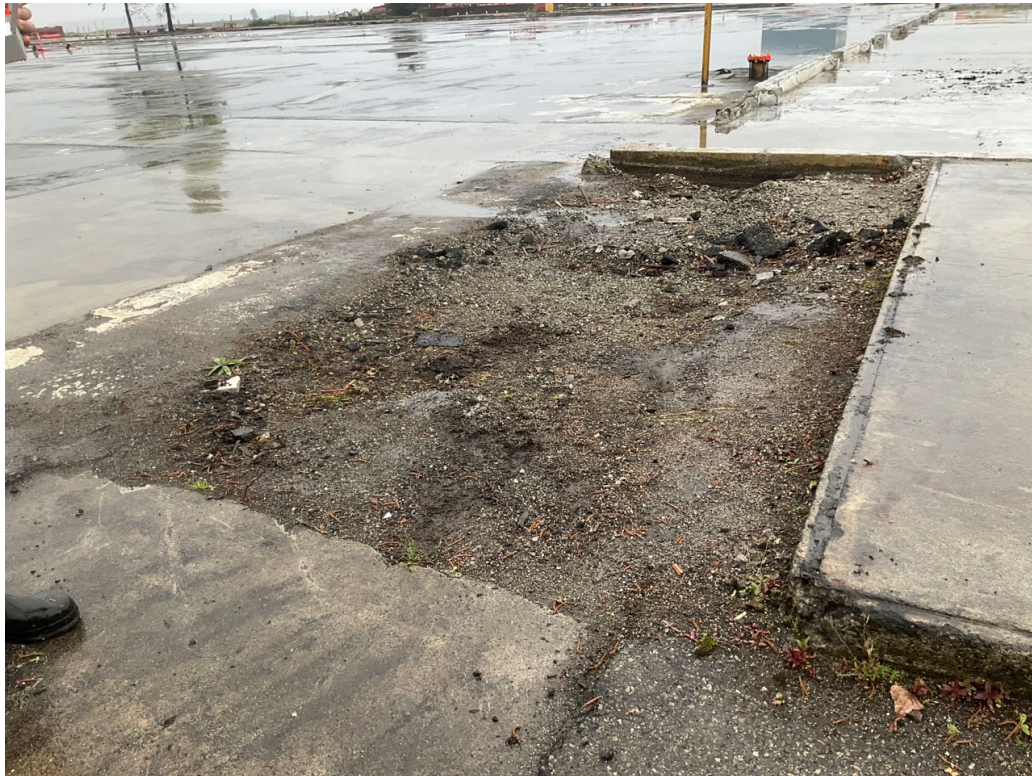
Photograph 5. Polygon B1 with broken asphalt and debris.

| Area ID | Surface Type | Erosion | % Bare Soil | Notes |
|---|---|---|---|---|
| B1 | Broken asphalt/gravel | Yes | 70 | Exposed fill |

- Stabilize larger areas of broken asphalt/concrete.
  - Erodible areas to stabilize with HMA pavement include B1, B3, B4, B14, B15, D2, D3, and D5.
- Stabilize areas of gravel with no berm or curb containment.
  - Erodible areas of gravel to stabilize with HMA pavement include C1 to C8, and C15 to C20.
- Stabilize bare soil in unvegetated areas.
  - Bare soil areas to stabilize with hydroseed include D1, D4, D6, and D7.
- Stabilize erodible areas of imported gravel as a general turbidity reduction measure.
  - Implement perimeter turbidity controls such as weighted wattles or temporary berms.
- Prevent ponding to the extent possible.
  - Install an asphalt berm to prevent run-on from West Marine View Drive to the property in the north truck bay area.

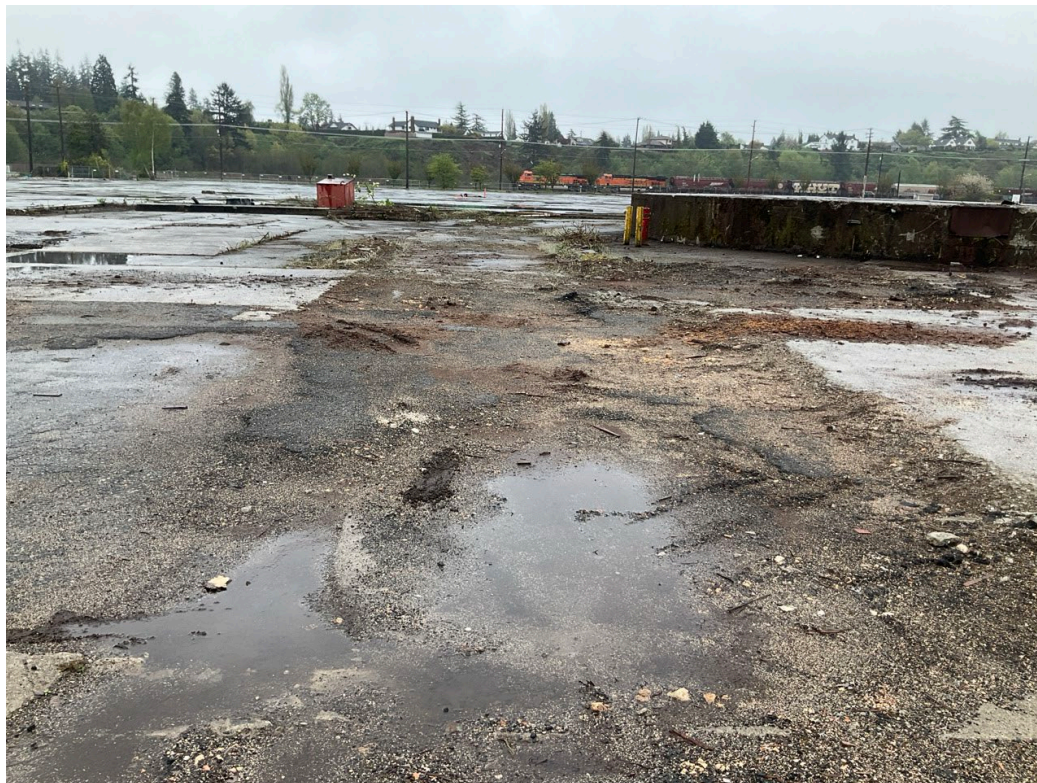
Photograph 6. Polygon B4 with broken concrete/asphalt between slabs.

| B4 | Broken asphalt | Yes | 40 | Deteriorating asphalt, some exposed soil and vegetation |

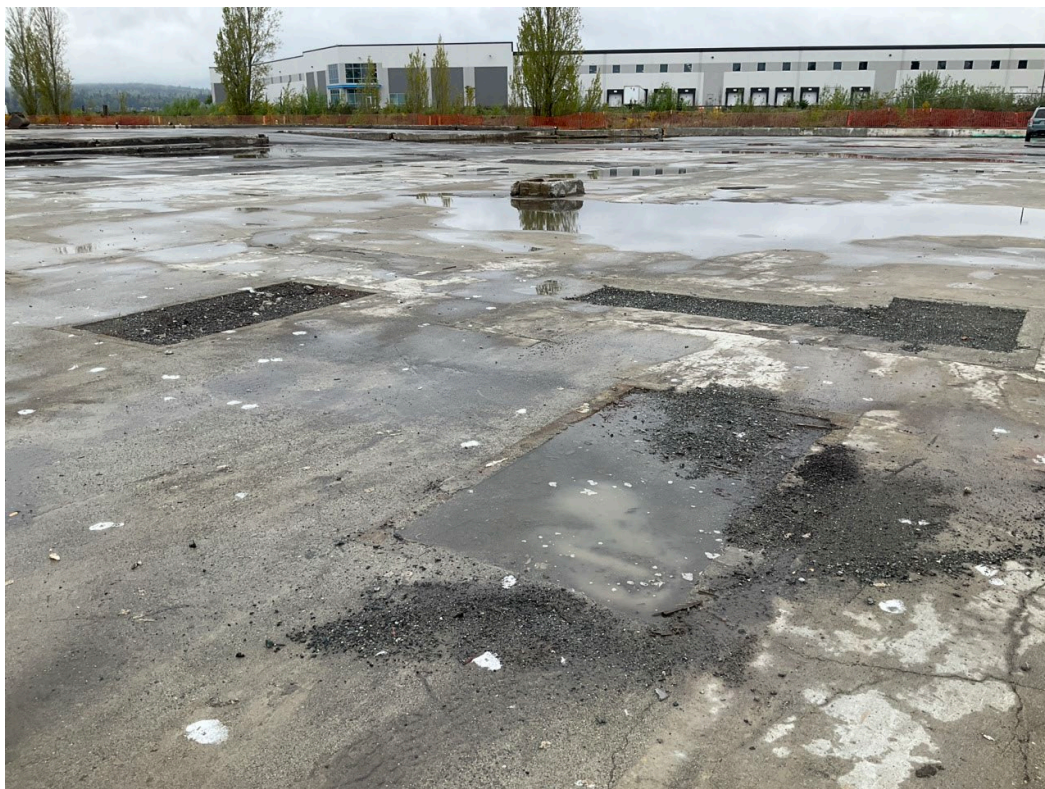
Photograph 7. Polygon B6 showing gaps in concrete with fill.

| B6 | Broken concrete/asphalt | Yes | No | Deteriorating concrete/asphalt. Soil buildup |

- Repair broken asphalt and concrete areas with exposed soil in general accordance with Washington State Department of Transportation principles of roadway crack and pothole repair.<sup>1</sup> Some areas are listed in multiple repair categories to accurately represent the damage in a single mapped area.
  - Areas with cracks to repair using rubberized sealant include B2, B4, B5, and B13.
  - Areas with potholes to repair with full-depth hot mix asphalt (HMA) patch include B2, B6 to B12, and B16 to B23.

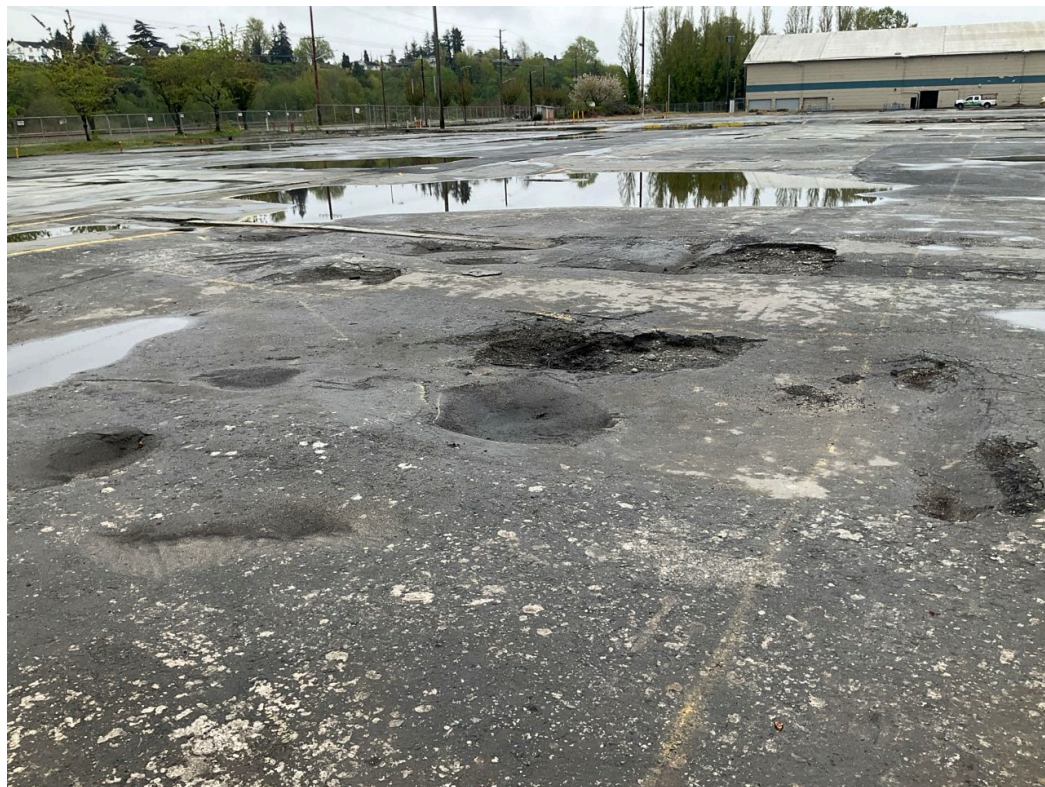
Photograph 8. Polygon B7 showing small areas of broken asphalt.

| B7 | Broken asphalt | No | 20 | Deteriorating asphalt, pockets of exposed soil |

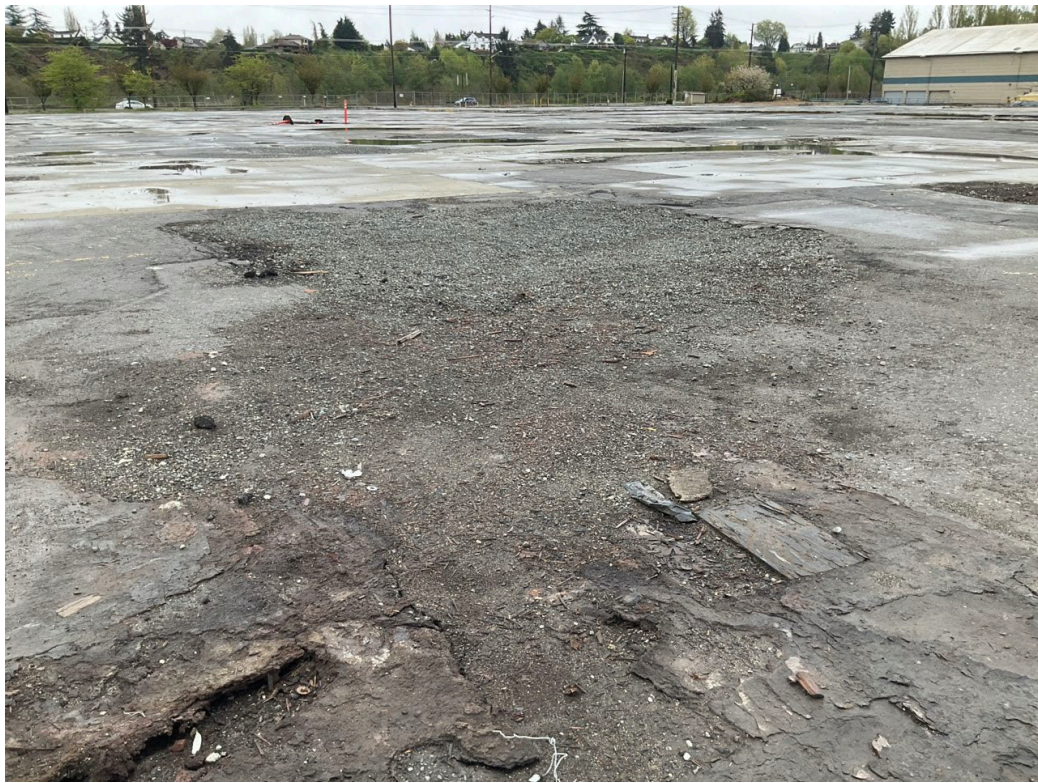
Photograph 9. Polygon C2 with crushed gravel.

| C2 | Gravel | No | 0 | Exposed crushed gravel |

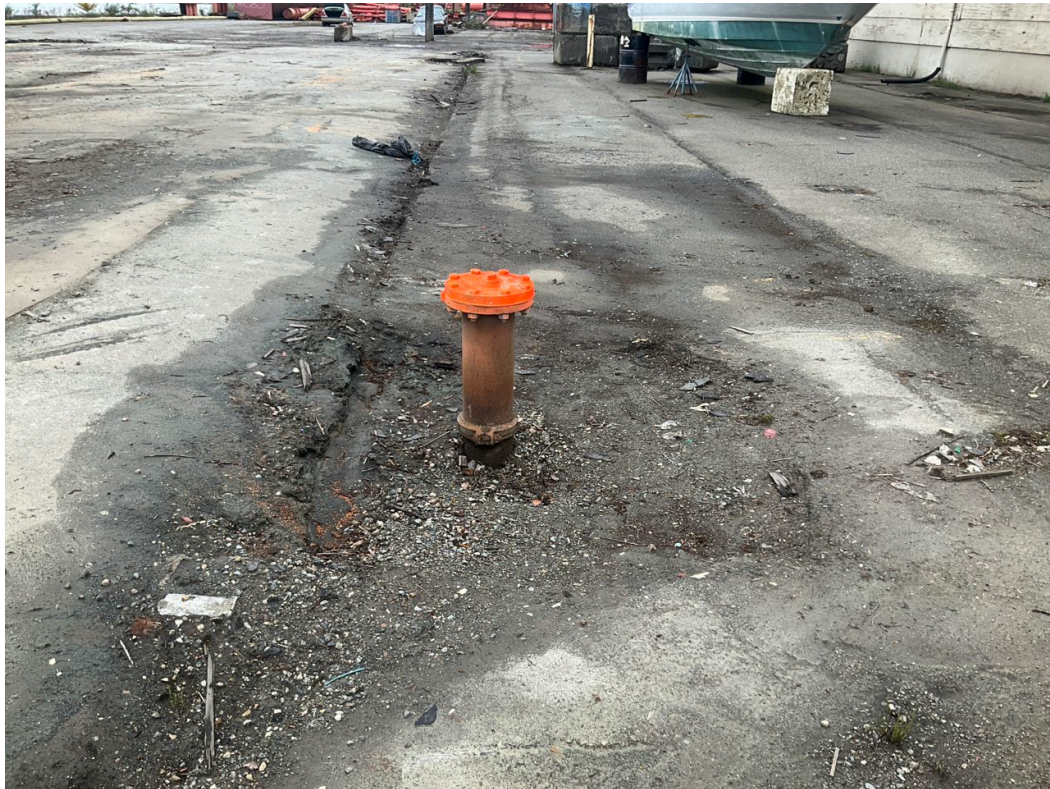
Photograph 15. Polygon D5: exposed soil between asphalt and foundation.

| Area ID | Surface Type | Erosion | % Bare Soil | Notes |
|---|---|---|---|---|
| D5 | Exposed soil | Yes | 100 | Exposed soil between asphalt and concrete foundation |

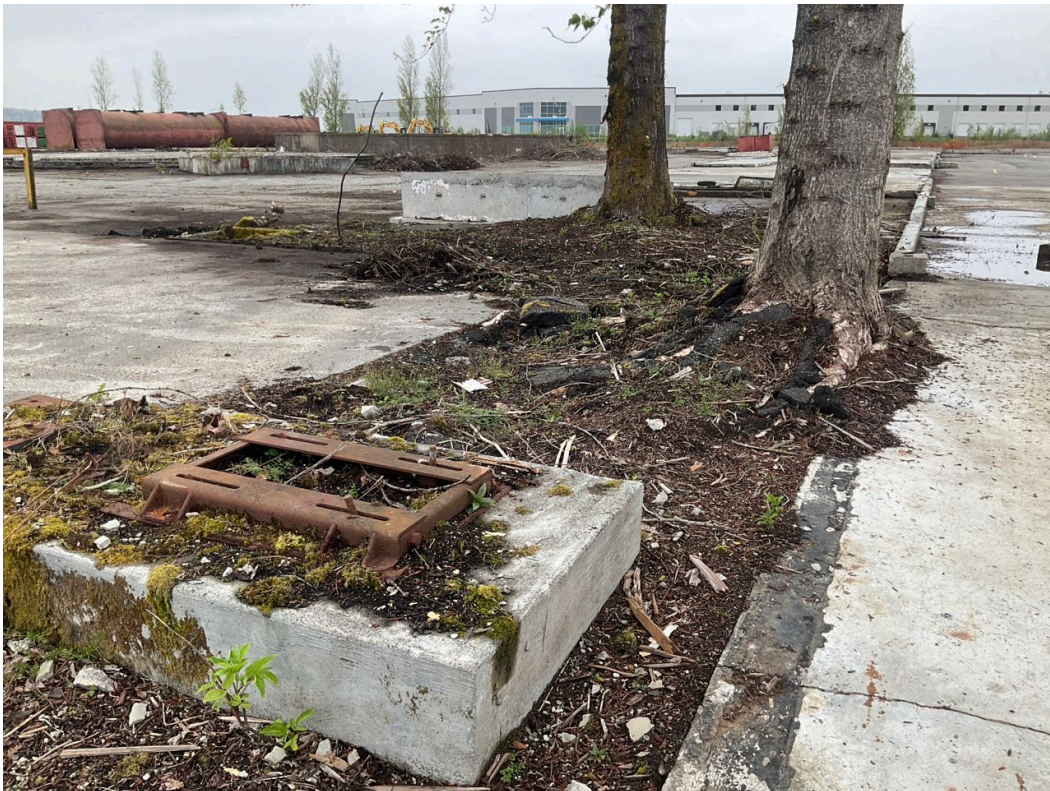
Photograph 16. Polygon D6: exposed soil with trees and debris.

| Area ID | Surface Type | Erosion | % Bare Soil | Notes |
|---|---|---|---|---|
| D6 | Exposed soil | Yes | 80 | Two large trees, some asphalt |
