## Cramer Property

### Site Hazard Assessment and Ranking Process (SHARP) Report

587 Cramer Property 20260722

## SHARP Report — Part 2 of 2

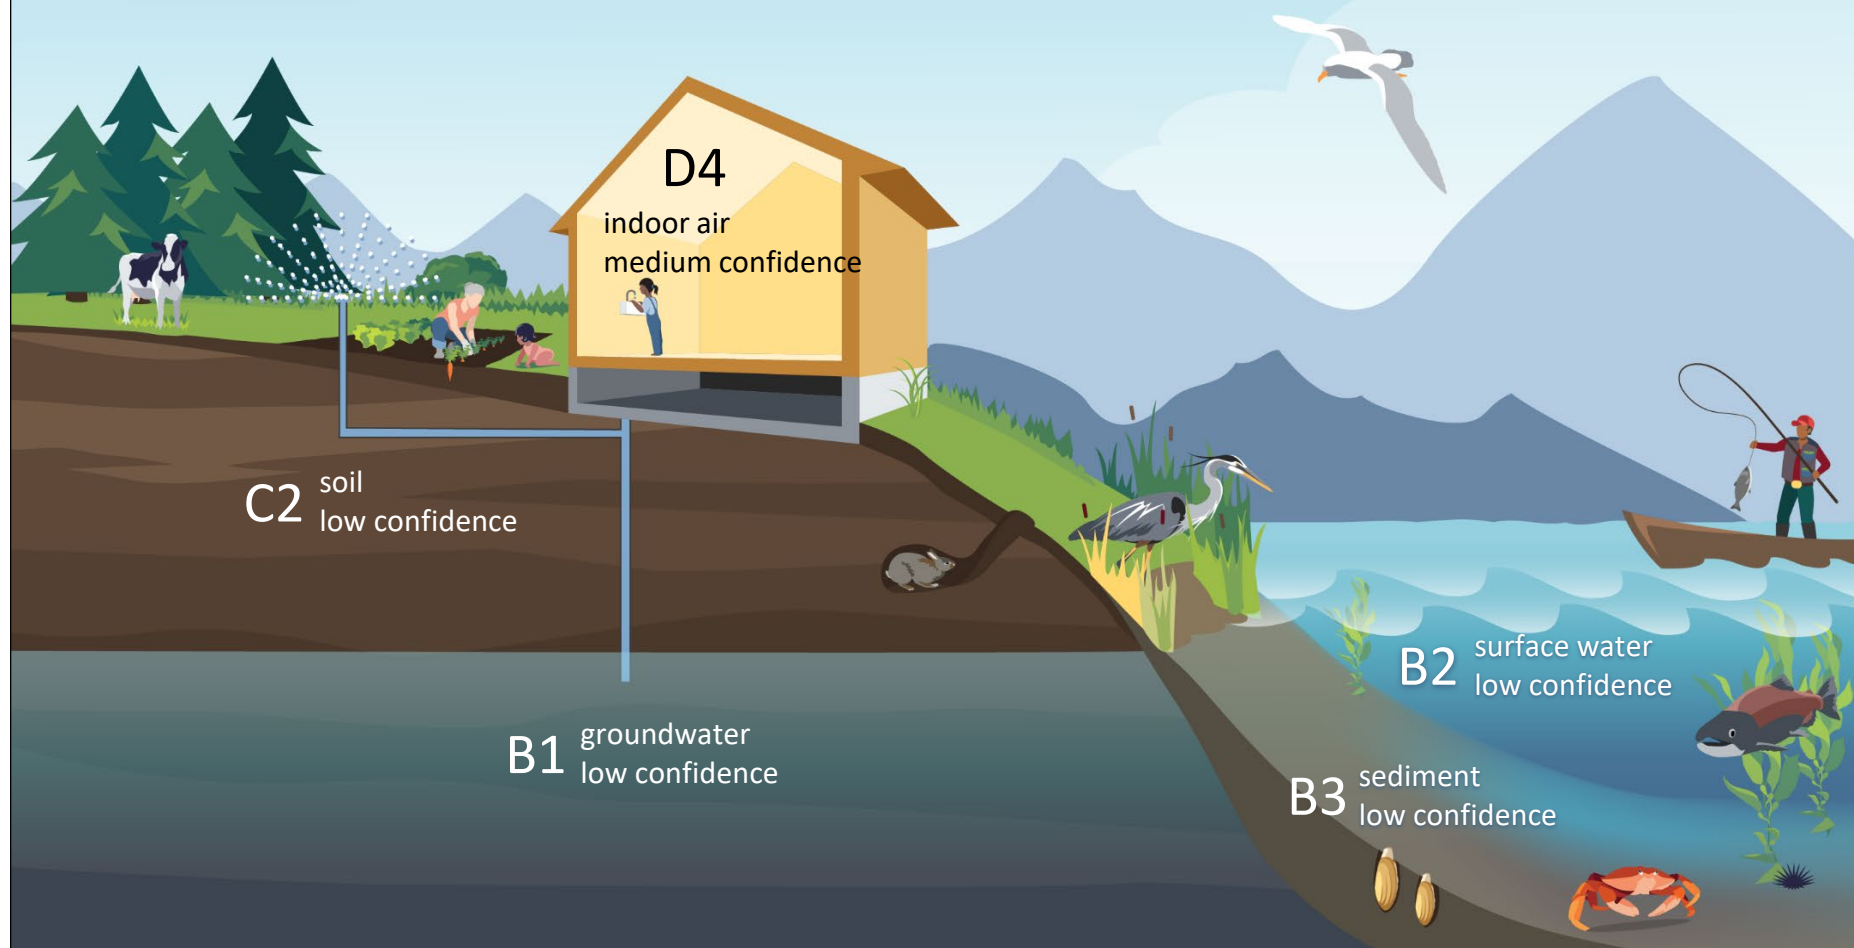
### Assessment scores by environmental medium

Conceptual site model
