Property Address: 300 W Laurel St, Bellingham, WA 98225

Date: 6/29/2022

## FORM 1 - CAP INSPECTION RECORD

Cap Inspection and Maintenance Plan, Pulp & Tissue Mill Remedial Action Unit, Georgia-Pacific West Site,  
Bellingham, WashingtonINSPECTION ITEM<sup>1</sup>

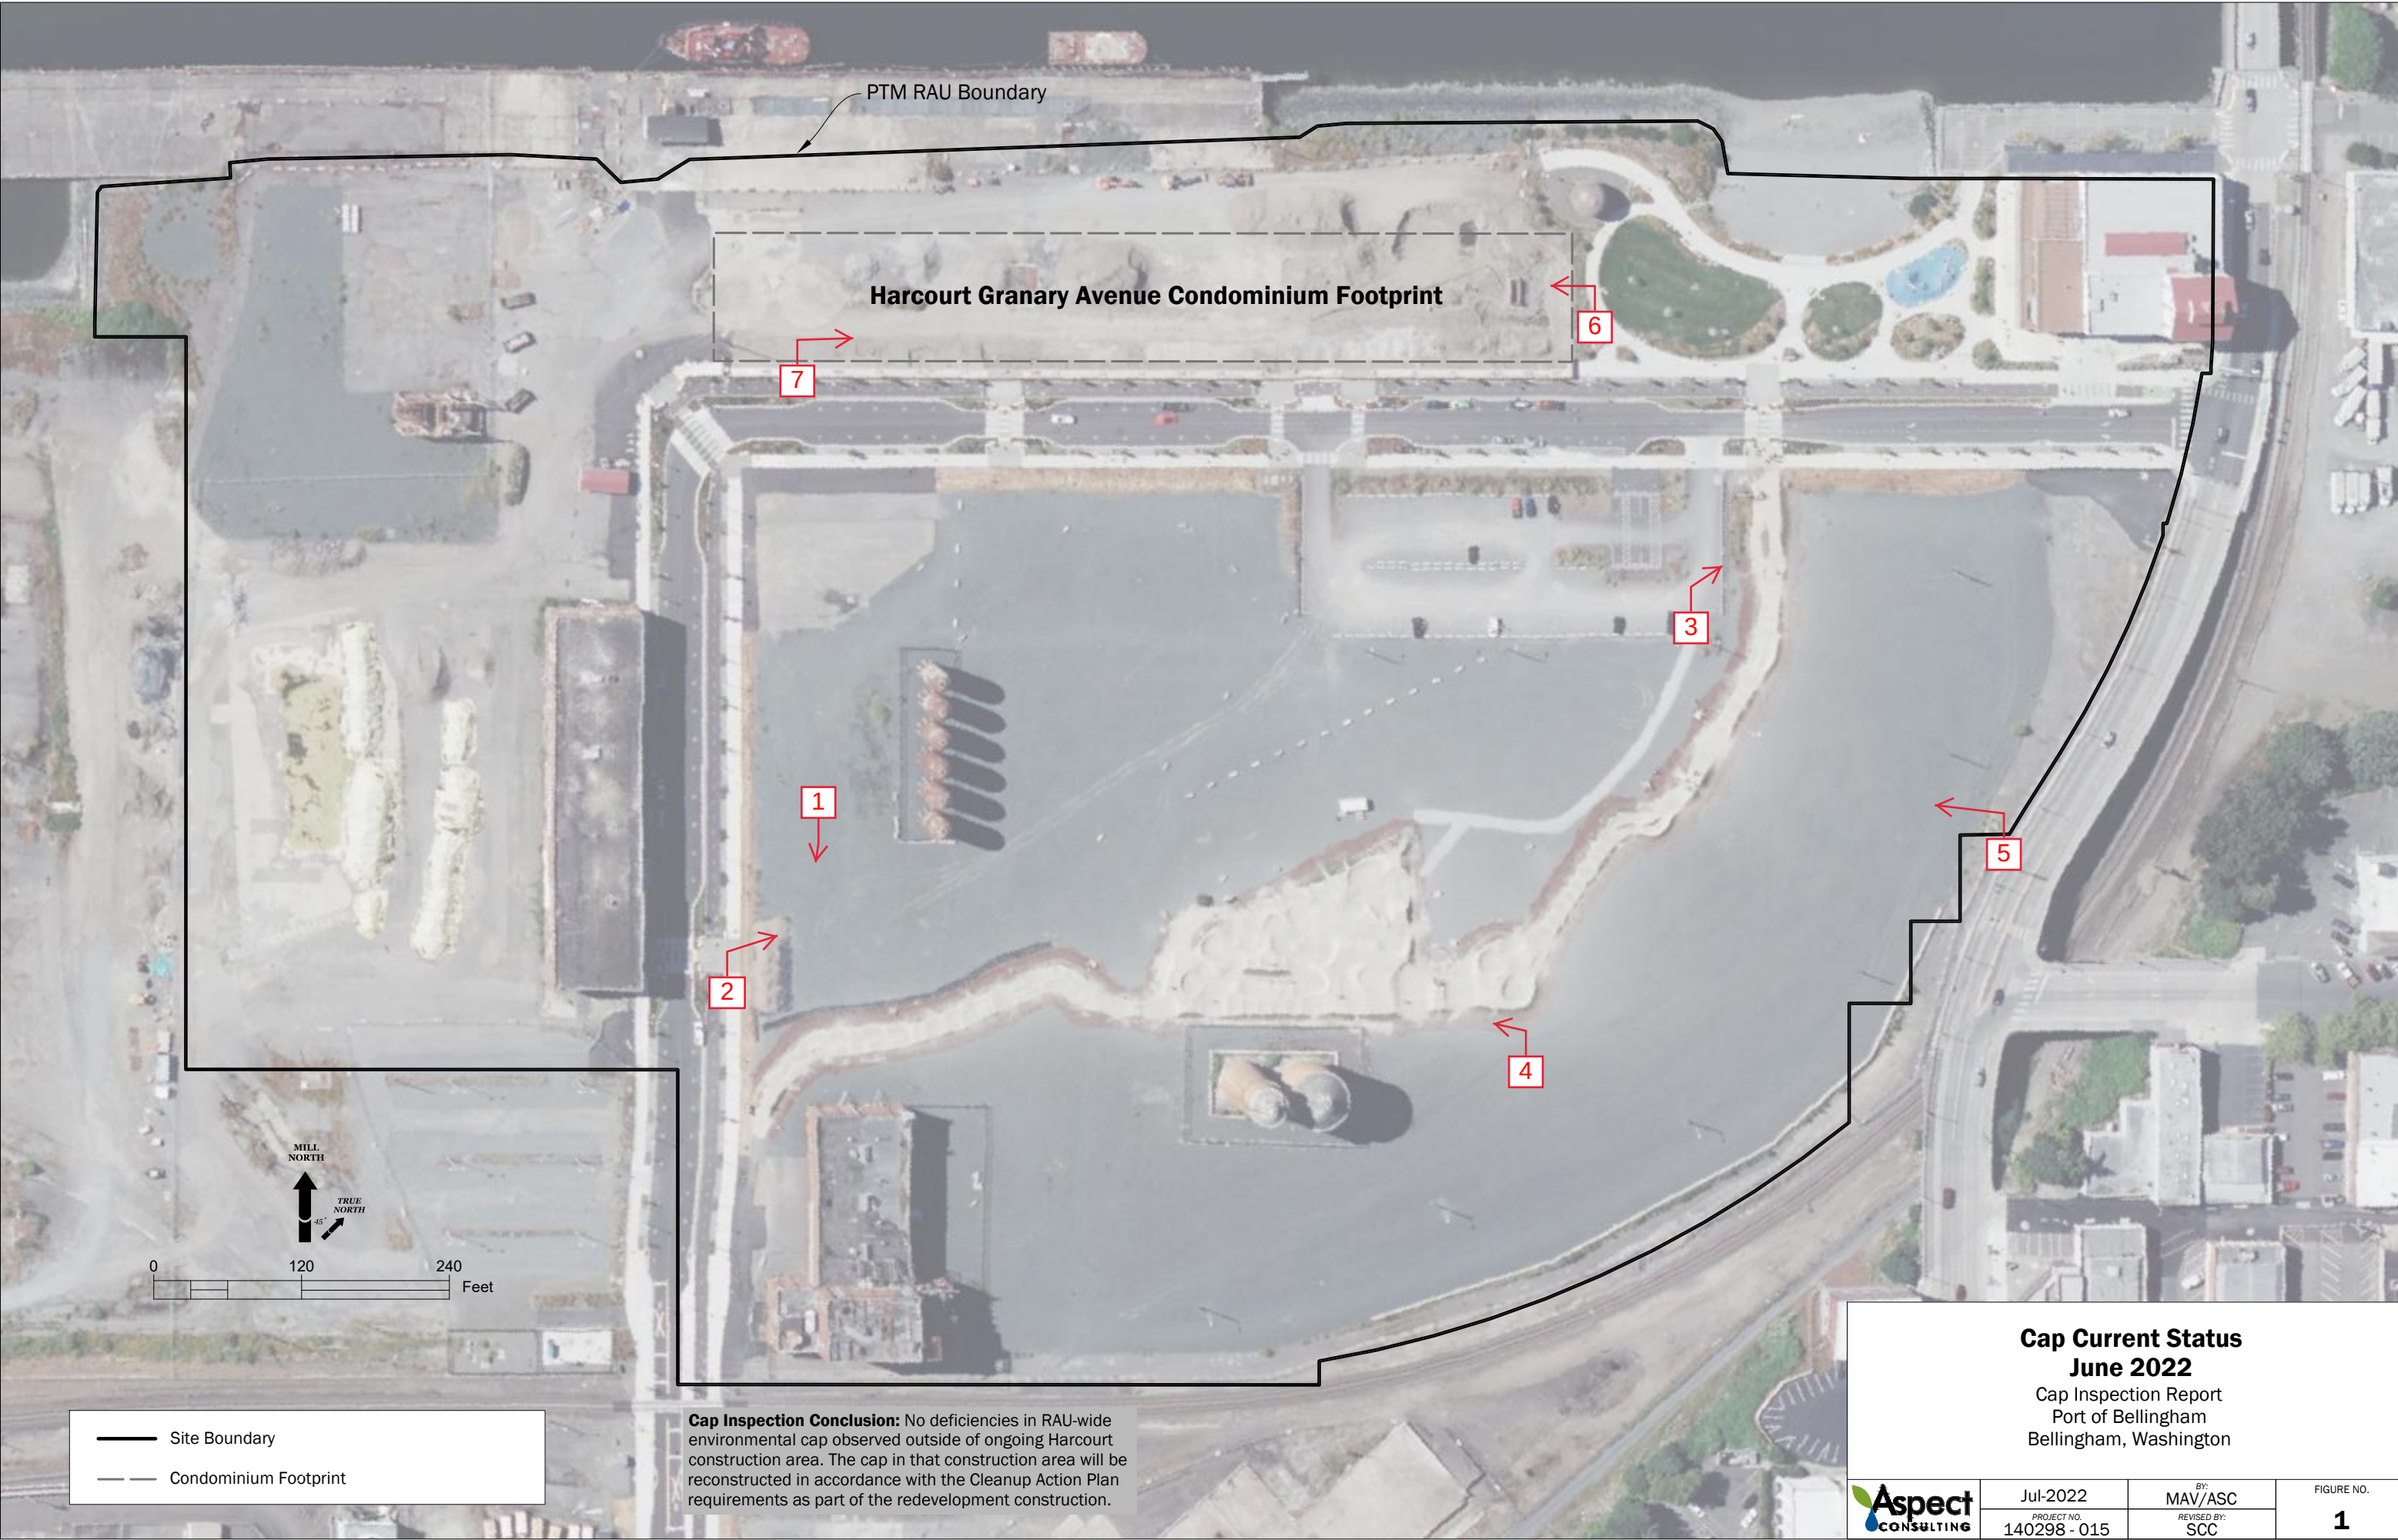
No deficiencies noted outside of the Harcourt Granary Avenue Condominium construction area, which is in process and noted on Figure 1. Comments:

- Harcourt's condominium project construction is ongoing north of Granary Ave (Figure 1), as referenced in the 2021 annual report. The construction area has restricted access to the public by means of temporary plywood or chain-link fencing on all landward sides (Photos 6 and 7). Capped areas within this area will continue to be disturbed during the construction process and will then be restored with the redevelopment features. No cap maintenance is required at this time.

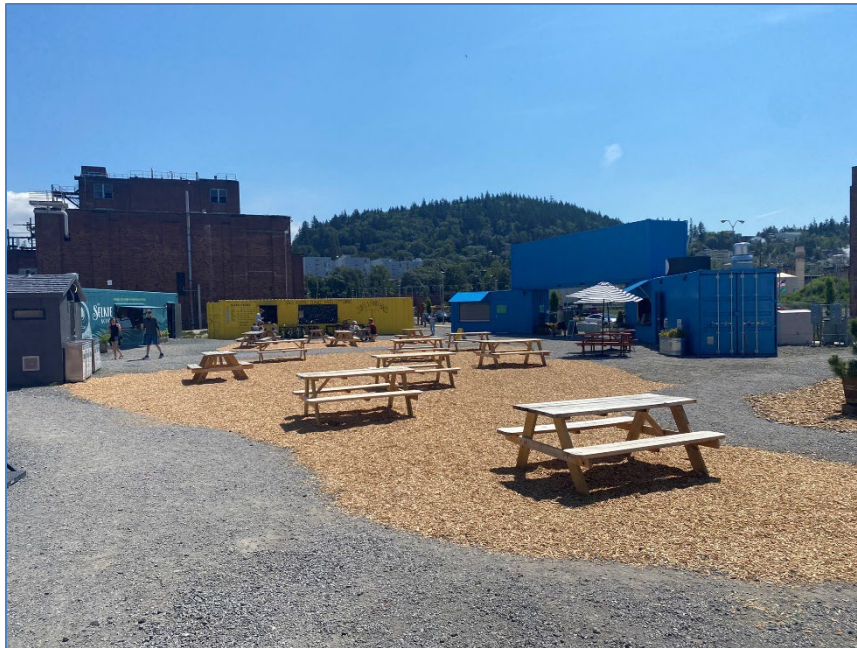
- An outdoor "container village" has been constructed adjacent to the brew pub (Photos 1 and 2). We understand that portions of the cap had been removed to install utilities to the structures. Disturbed sections of the cap appear to have been restored to near-original condition. We observed no compromises in the cap condition. Some parts of the cap in the container village have been covered with mulch or crushed gravel for walking surfaces (Photo 1).

Photograph 1. Container village and surface improvements.

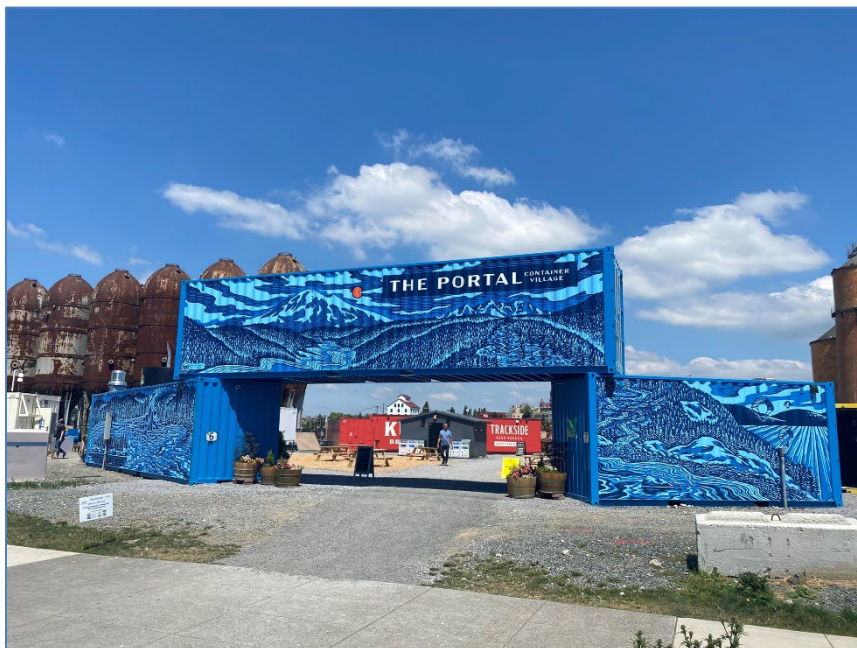
Photograph 2. Container village looking east.

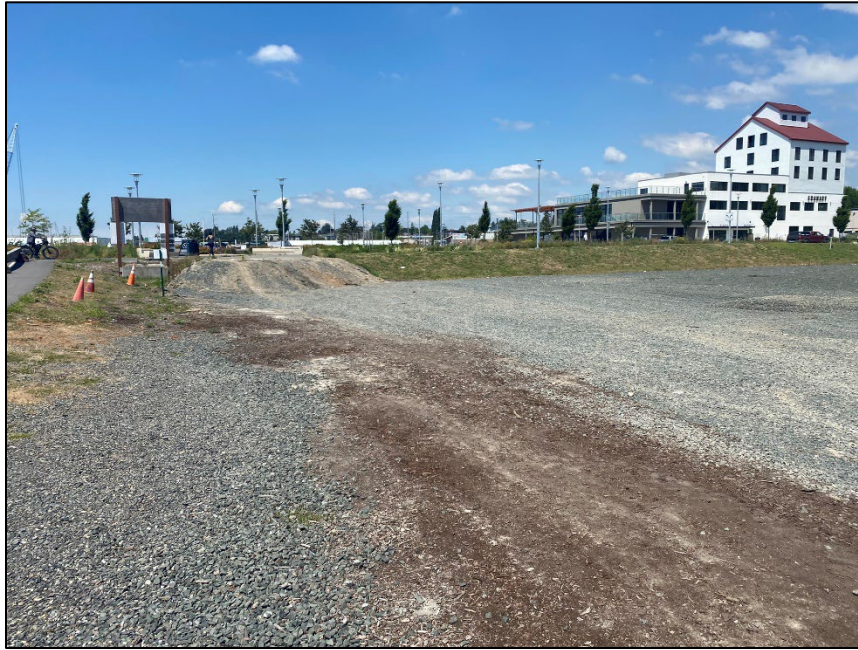
- The northeast part of the pump track has been removed and/or reconstructed (Photos 3, 4, and 5). Areas where the pump track has been removed have been restored to the original cap condition.

Photograph 3. Area east of the parking lot where the pump track was removed.

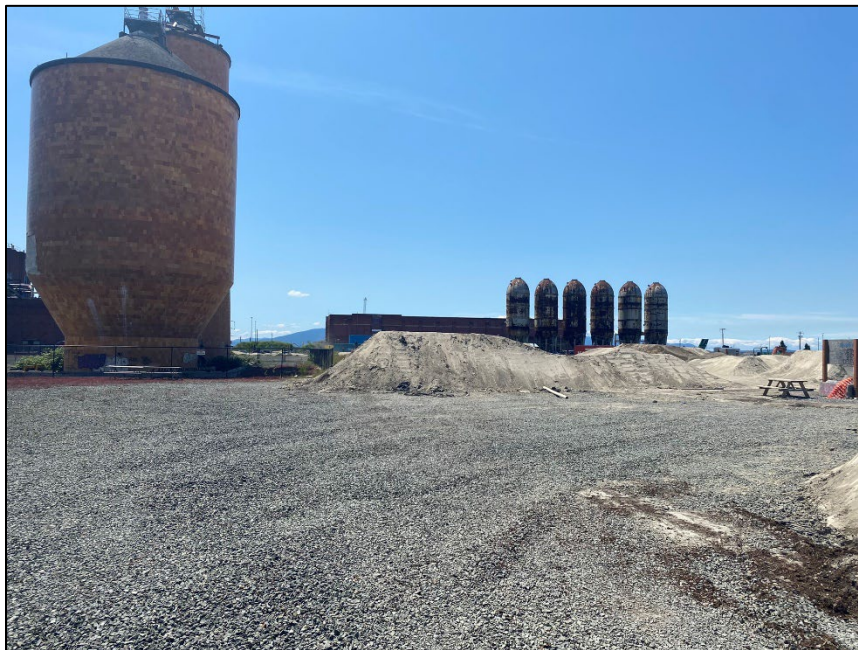
Photograph 4. Area northeast of the tile silos where the pump track was removed.

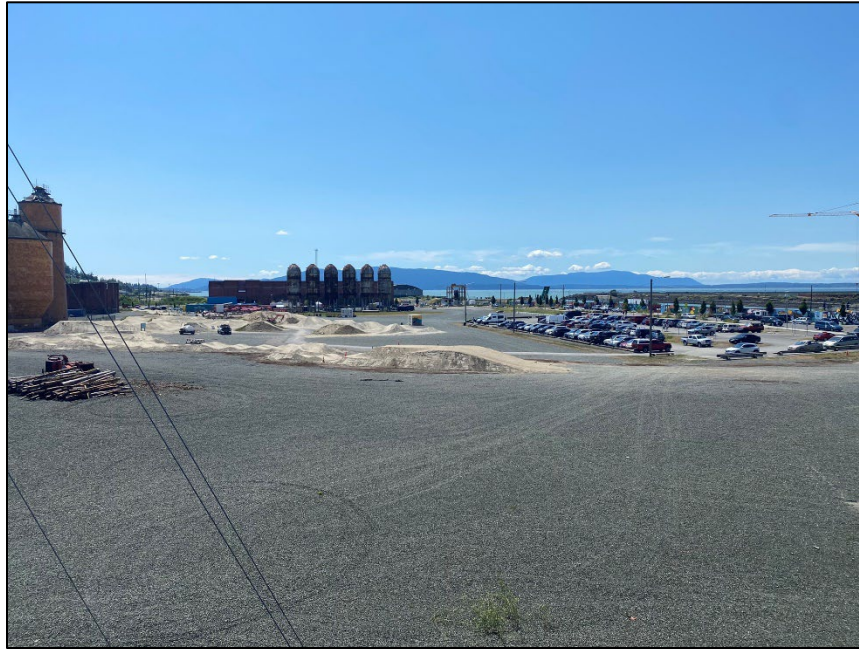
Photograph 5. View showing majority of cap area looking west.

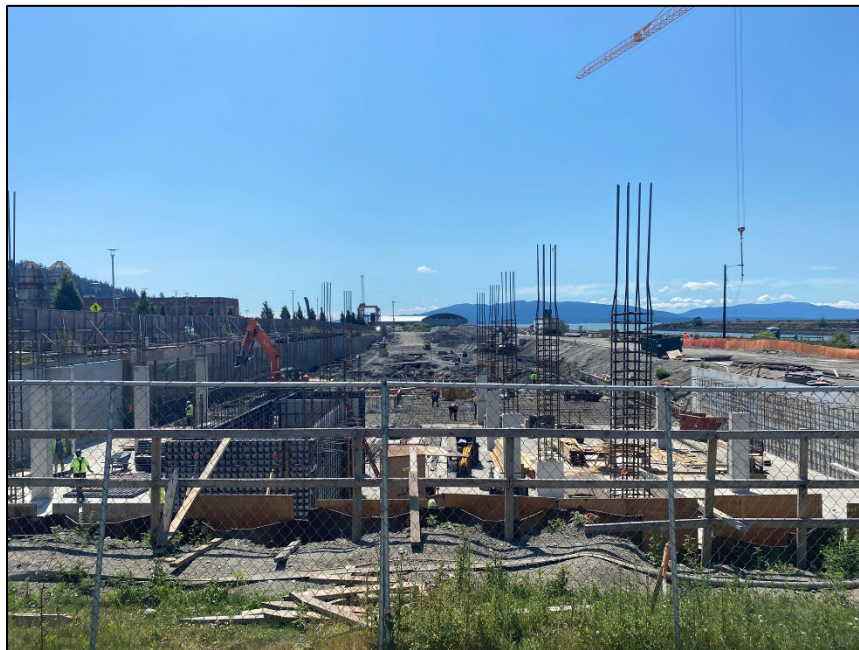
Photograph 6. Harcourt construction in process north of Granary Ave with temporary fencing on the left. Photo looking west.

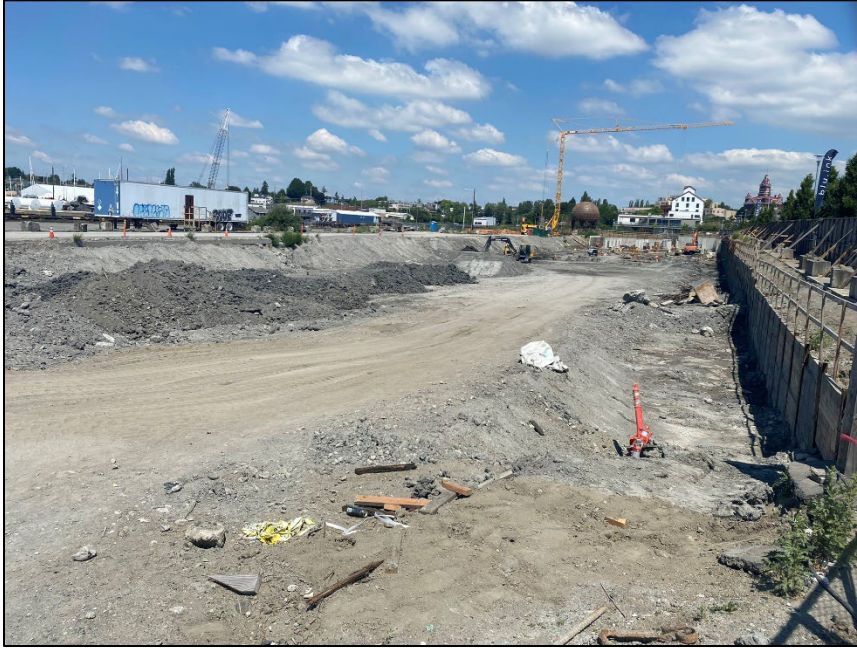
Photograph 7. Harcourt construction in process north of Granary Ave with temporary fencing on the right. Photo looking east.
