Property Address: 300 W Laurel St, Bellingham, WA 98225

Date: 2024.06.17

**FORM 1 - CAP INSPECTION RECORD**

Cap Inspection and Maintenance Plan, Pulp &amp; Tissue Mill Remedial Action Unit, Georgia-Pacific West Site, Bellingham, Washington

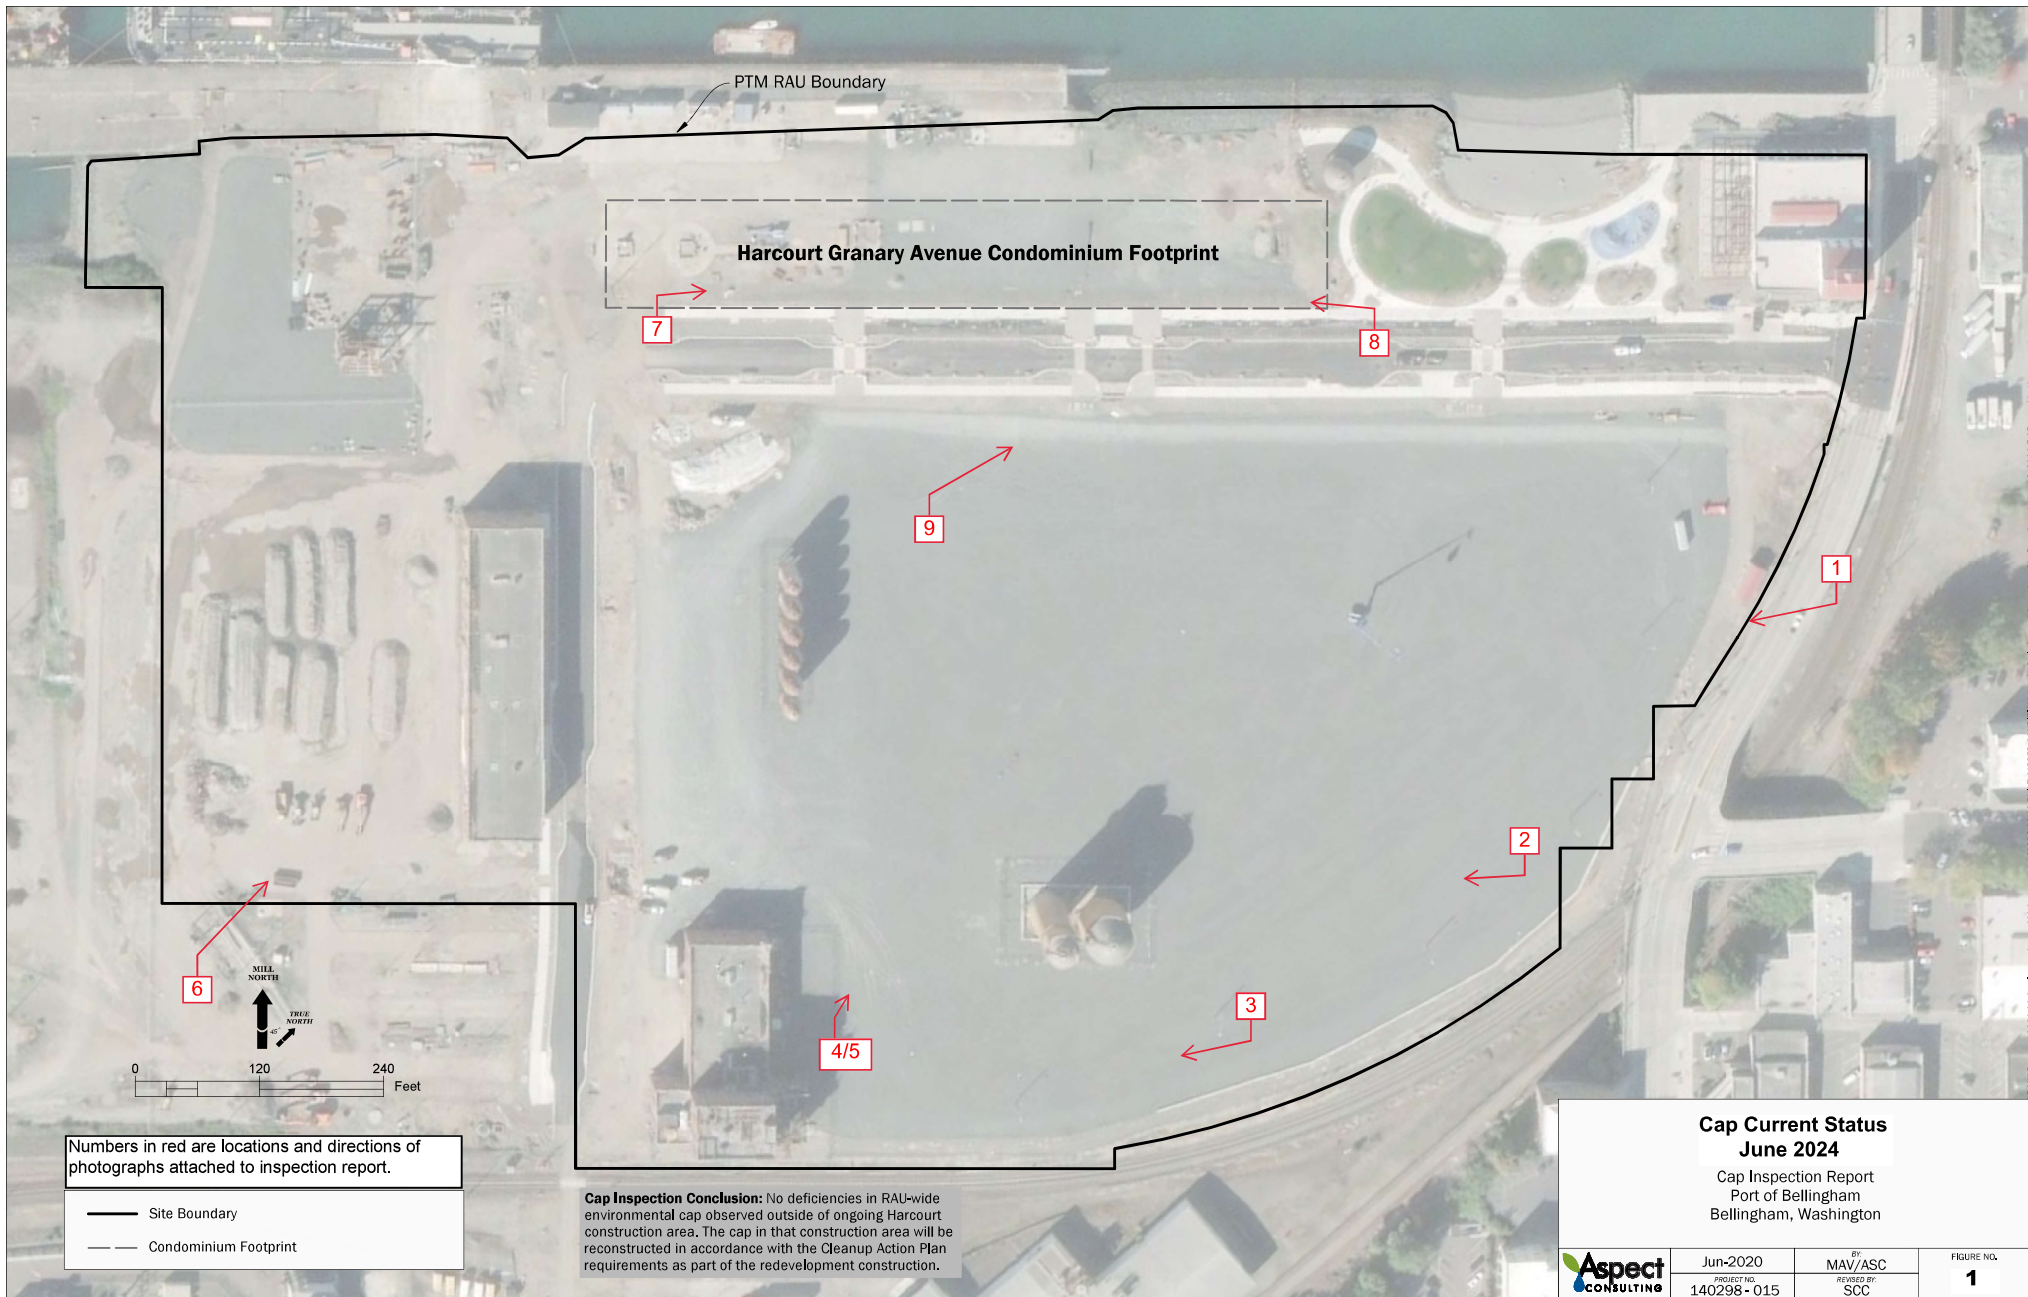
- Harcourt's condominium project construction is ongoing north of Granary Ave (Figure 1), as referenced in the 2021, 2022, and 2023 annual inspection reports. The construction area has restricted access to the public by means of temporary plywood or chain-link fencing on all landward sides (Photographs 7 and 8). This area will continue to be disturbed during the construction process and its cap will then be restored with the redevelopment features. No cap maintenance in this area is required at this time.

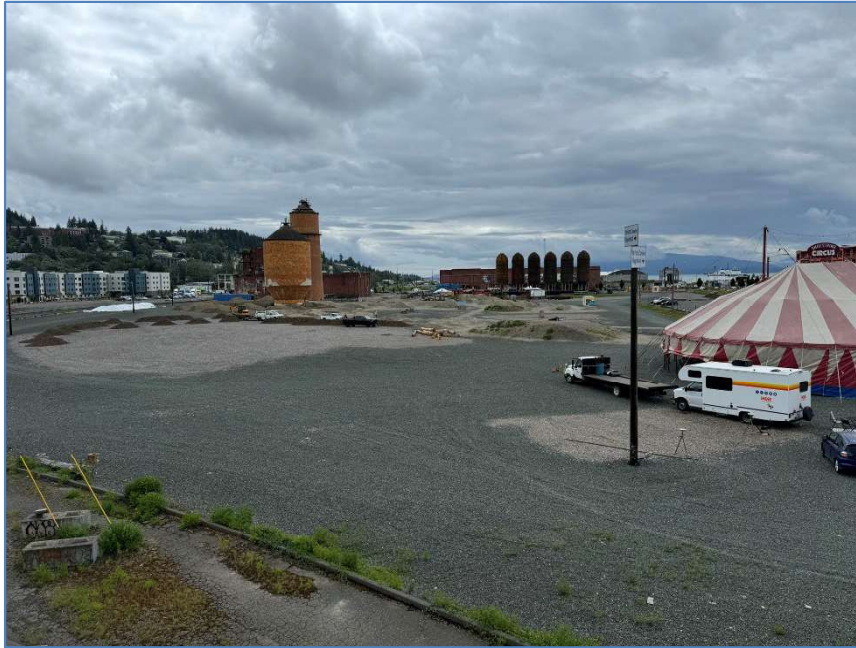
Photograph 1. General site conditions. Temporary circus tent is on the right-hand (mill-north) side of the photograph. Photo looking mill-west.

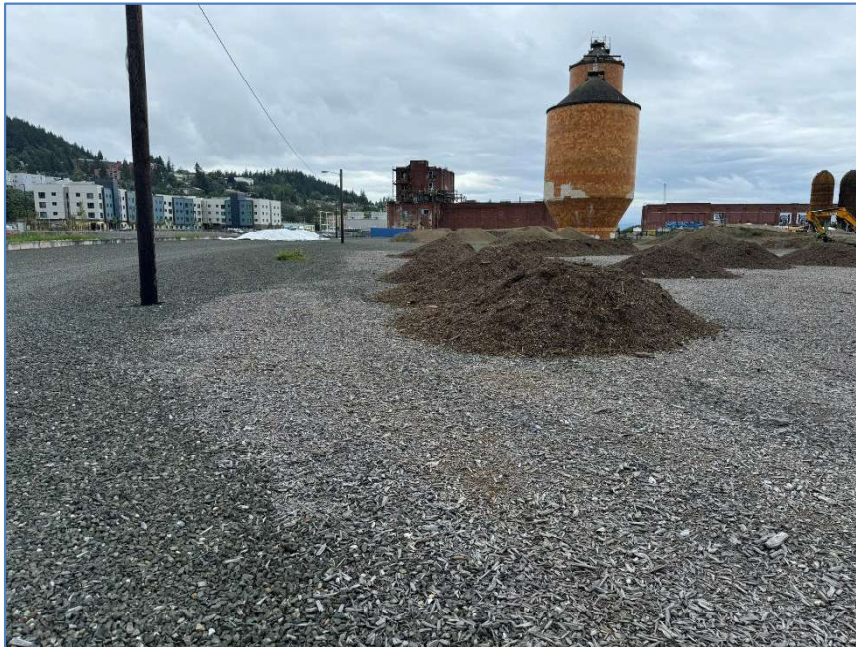
Photograph 2. Wood chip piles in southeast corner of the Site. Mulch will be spread out for an upcoming festival. Photograph looking mill-west.

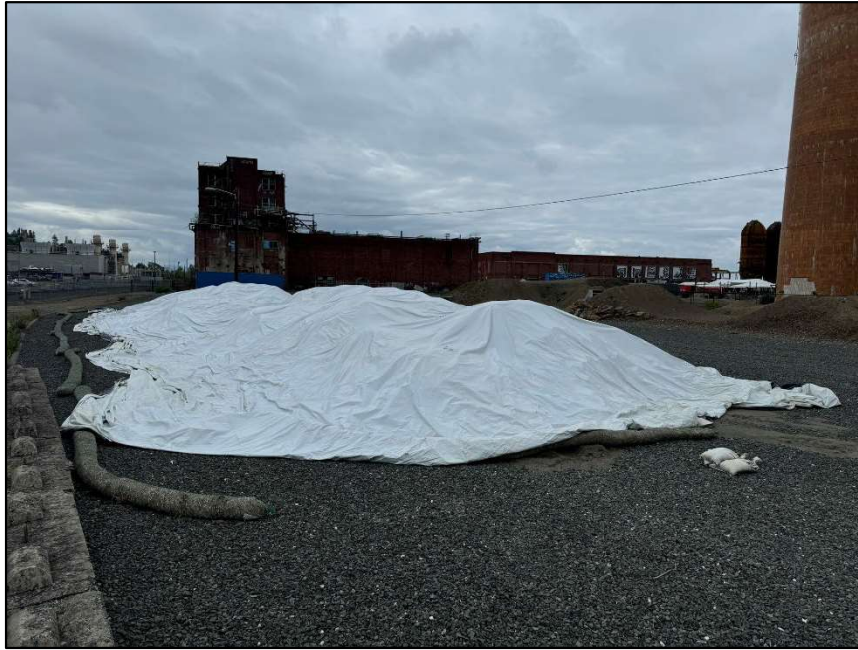
- There is a stockpile of soil in the southern part of the Site (Photograph 3), adjacent to the bike park jump track. The soil is reportedly import material for the pump track. It is covered with a tarp and straw waddles are placed along the downslope side. No evidence of soil movement was observed.

Photograph 3. Stockpile of covered soil (reportedly import) along southern side of Site. Photograph looking mill-west.

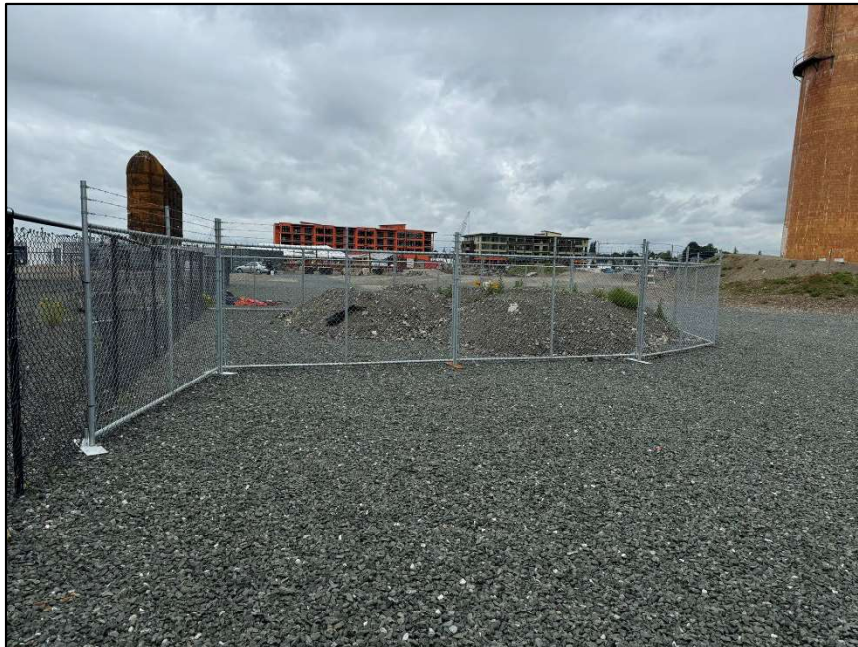
- There is a stockpile of soil between the alcohol plant and the tile-silos (Photograph 4). The stockpile was uncovered at the time of our initial site visit but protected by fencing. Stockpile was covered during a return visit to the Site on September 13, 2024 (Photograph 5). No evidence of soil movement was observed during either site visit.

Photograph 4. Soil stockpile between the alcohol plant and the tile silos, protected by fencing. Photograph looking mill-north.

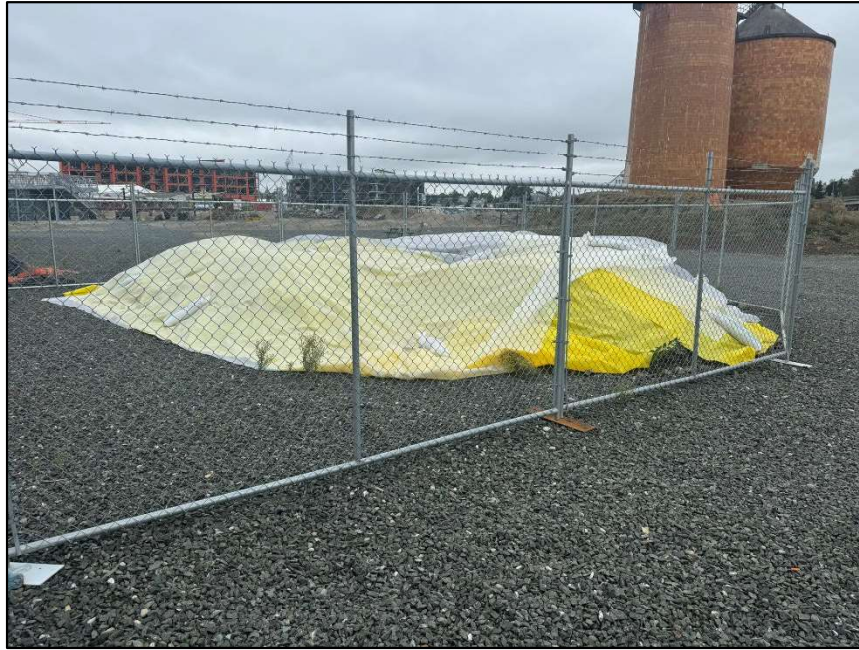
Photograph 5. Soil stockpile between the alcohol plant and the tile silos, covered with a tarp as of September 12, 2024. Photograph looking mill-northeast.

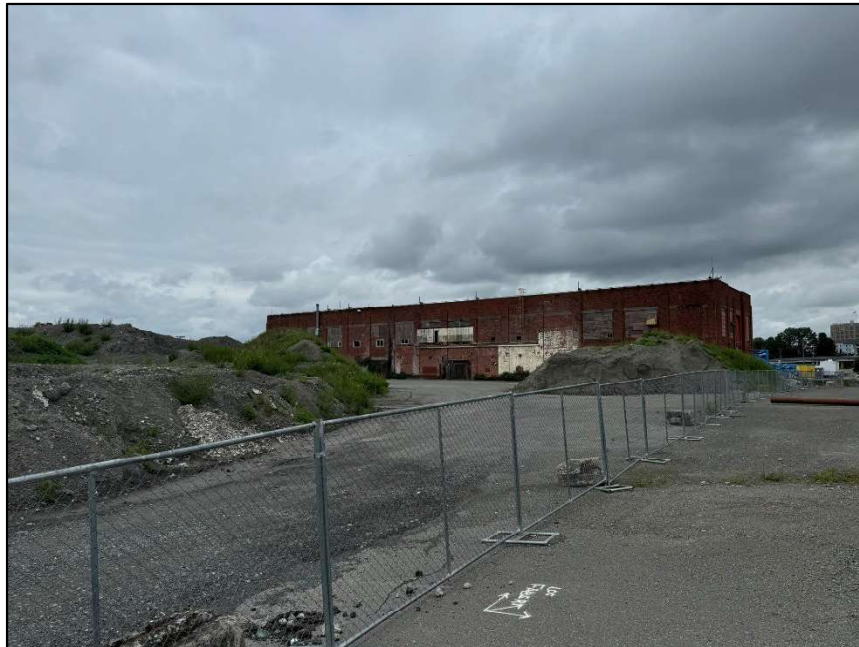
Photograph 6. Working area behind the Board Mill. Area is protected from public access by fencing. Photograph looking mill-northeast.

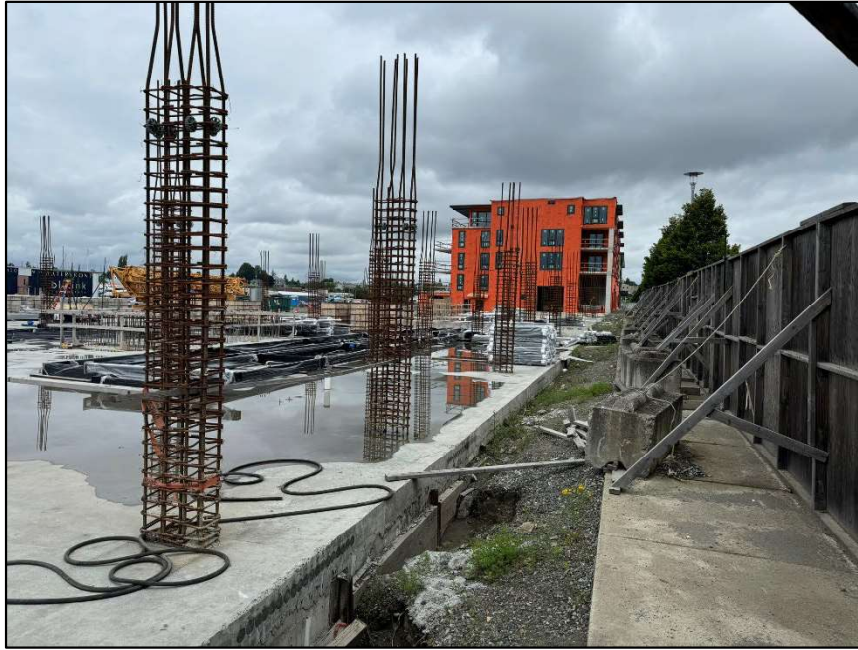
Photograph 7. Harcourt construction in process north of Granary Ave with temporary fencing on the right. Photograph looking mill-east.

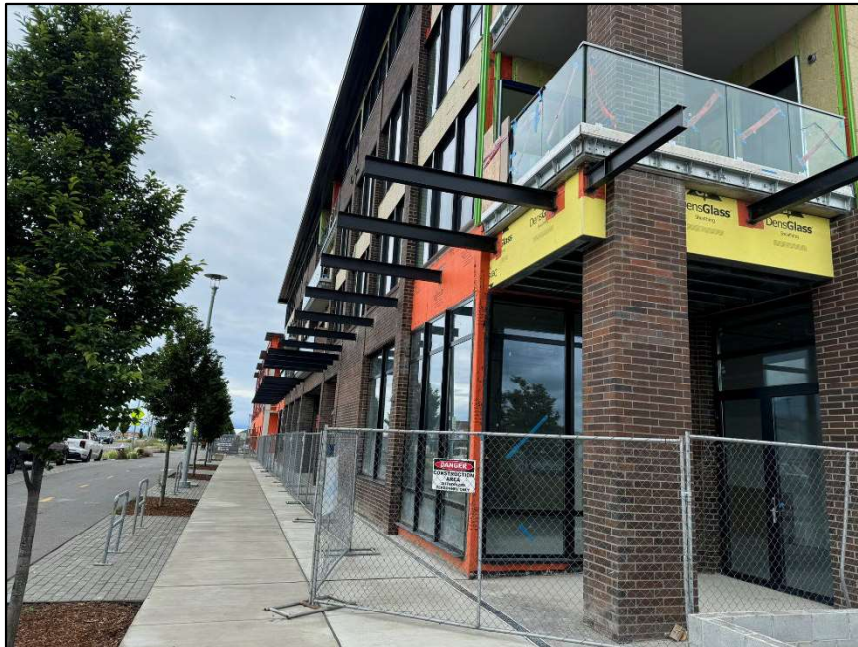
Photograph 8. Harcourt construction in process north of Granary Ave with temporary fencing. Photograph looking mill-west.

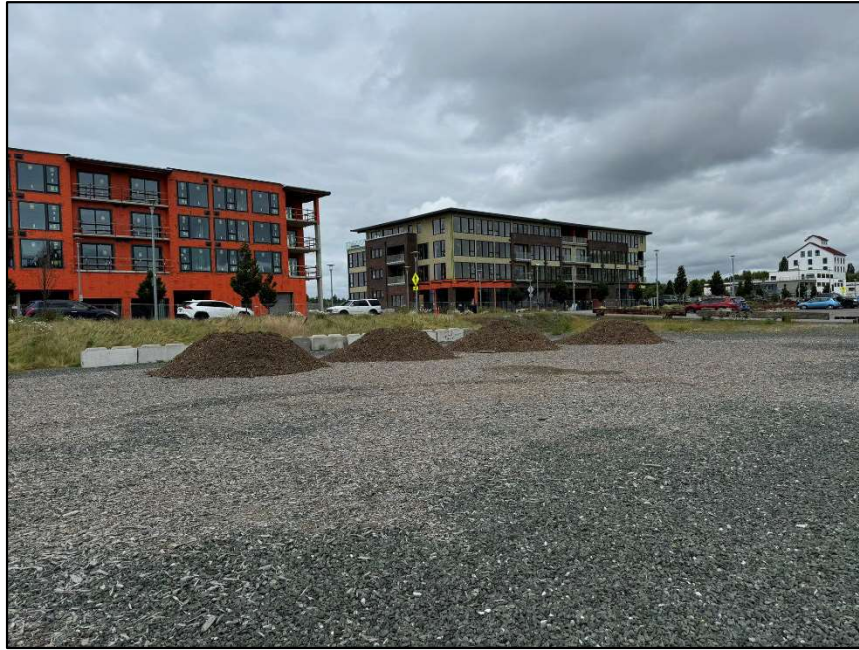
Photograph 9. Additional piles of import wood chips adjacent to Granary Ave. Wood chips will be used for upcoming festival. Photograph looking mill-northeast.
