Property Address: 300 W Laurel St, Bellingham, WA 98225

Date: 06.04.2025

## FORM 1 - CAP INSPECTION RECORD

Cap Inspection and Maintenance Plan, Pulp & Tissue Mill Remedial Action Unit, Georgia-Pacific West Site, Bellingham, Washington

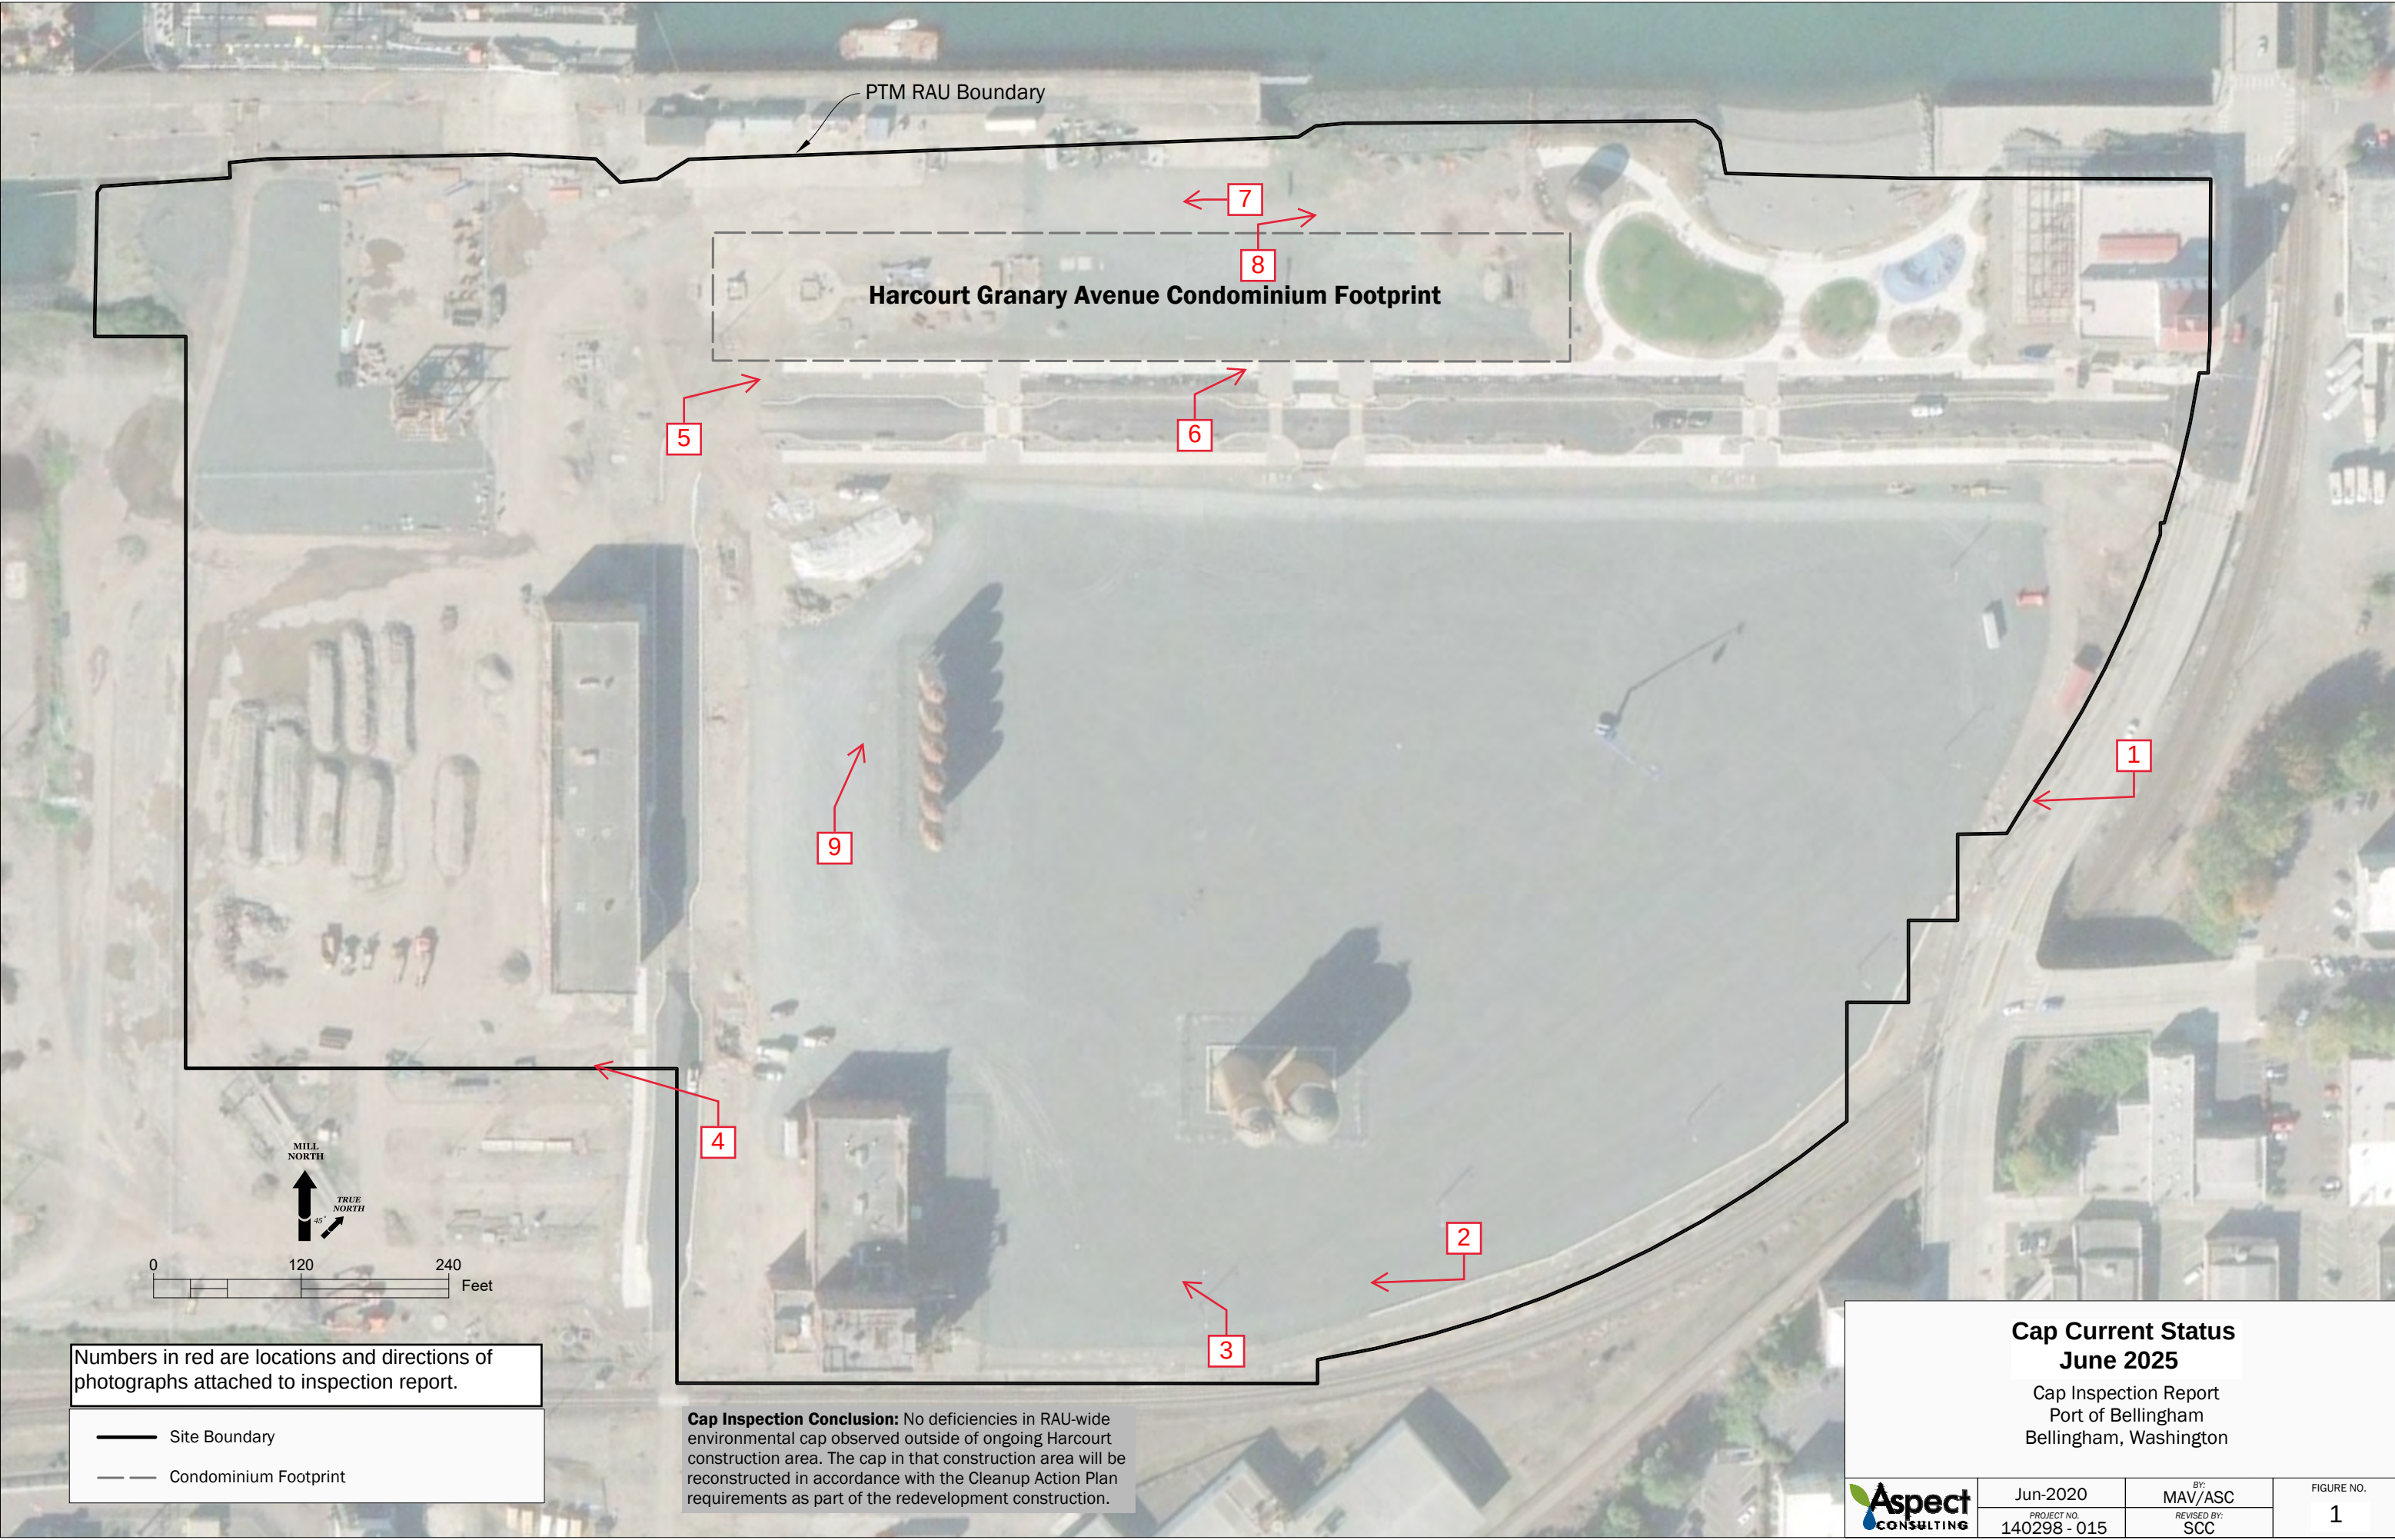
FIGURE NO.  
1

- Harcourt's condominium project construction is ongoing north of Granary Ave (Figure 1), as referenced in the 2021, 2022, 2023, and 2024 annual inspection reports. The mill-east condo is completed with finished landscaping (Photographs 6 and 8); the redeveloped condition for the completed unit complies with capping requirements as per the CAP. The central and mill-west condos are under construction and have restricted access to the public by means of temporary plywood or chain-link fencing on all landward sides (Photographs 5 and 7). This area will continue to be disturbed during the construction process and its cap will then be restored with the redevelopment features. No cap maintenance in this area is required at this time.

**Cap Inspection Conclusion:** No deficiencies in RAU-wide environmental cap observed outside of ongoing Harcourt construction area. The cap in that construction area will be reconstructed in accordance with the Cleanup Action Plan requirements as part of the redevelopment construction.

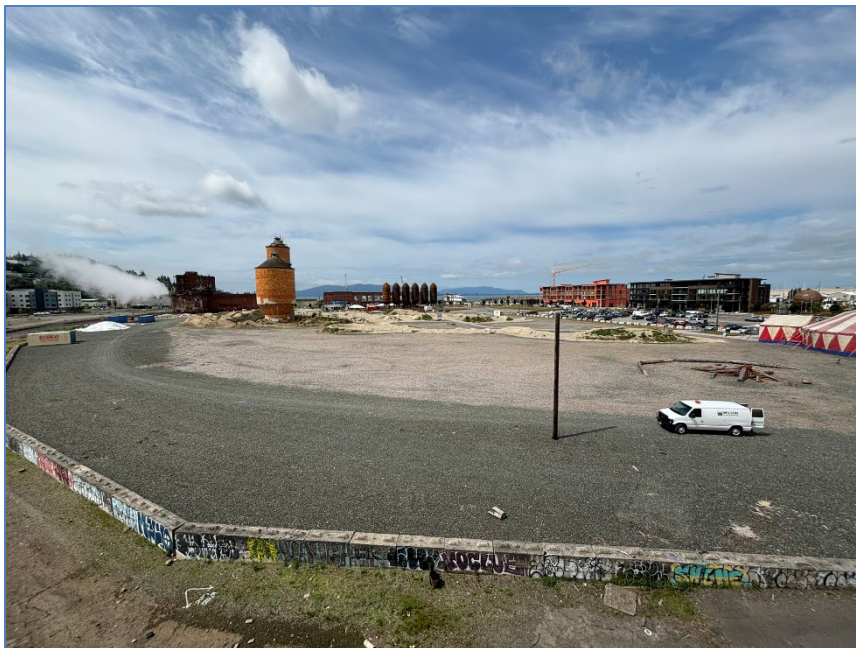
Photograph 1. General site conditions. Photo looking mill-west.

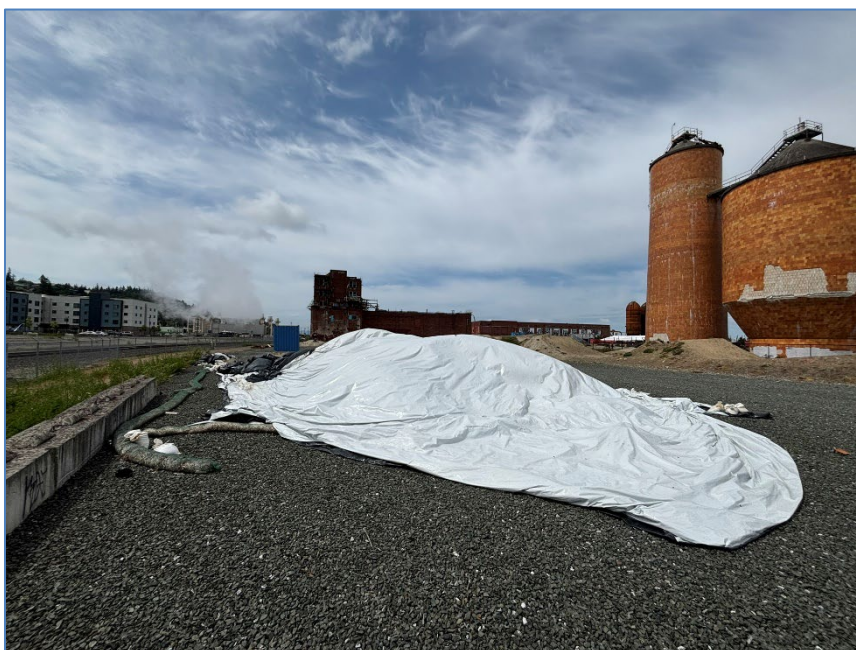
- There is a stockpile of soil in the southern part of the Site (Photograph 2), adjacent to the bike park jump track. The soil is reportedly import material for the pump track. It is covered with a tarp and straw waddles are placed along the downslope side. No evidence of soil movement was observed.

Photograph 2. Stockpile of tarped soil along southern side of Site. Photograph looking mill-west.

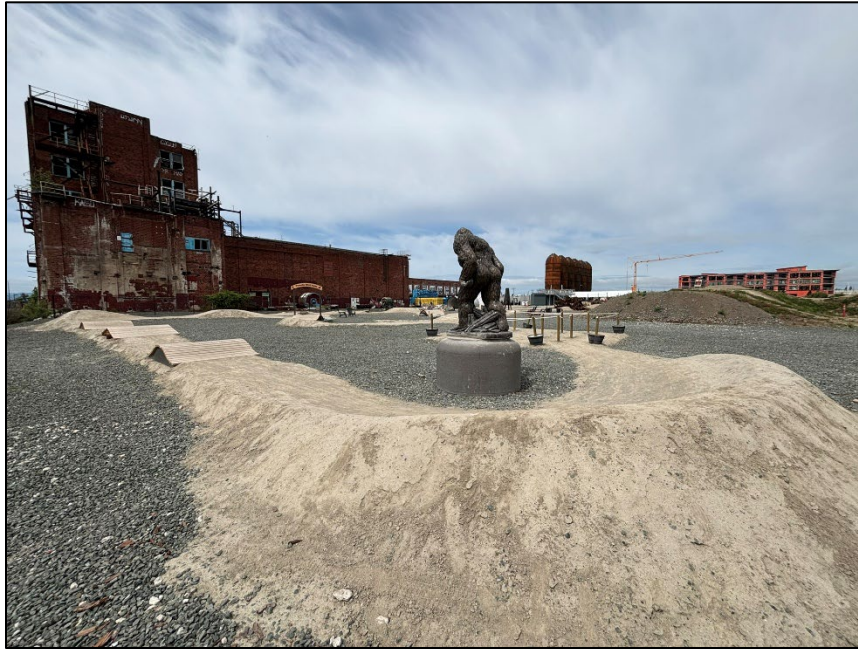
- There are various new features and structures including a new section of pump track mill-east of the alcohol plant (Photograph 3) and new bathrooms adjacent the digester towers (Photograph 9). Structures comply with requirements for a hard cap as per the Cleanup Action Plan (CAP).

Photograph 3. New Children's bike skills area to mill-east of the alcohol plant.

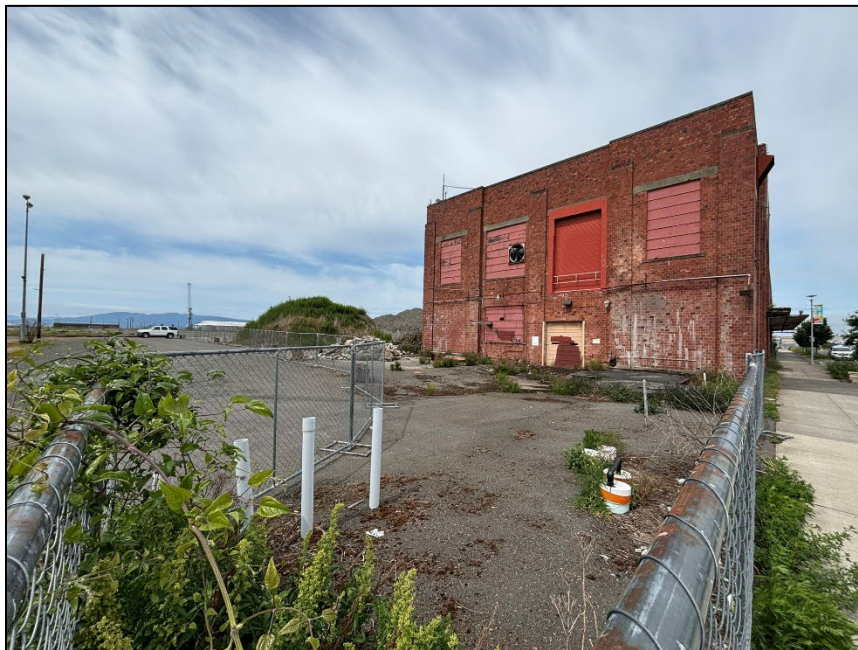
Photograph 4. Working area behind the Board Mill. Area is protected from public access by fencing. Photograph looking mill-northwest.

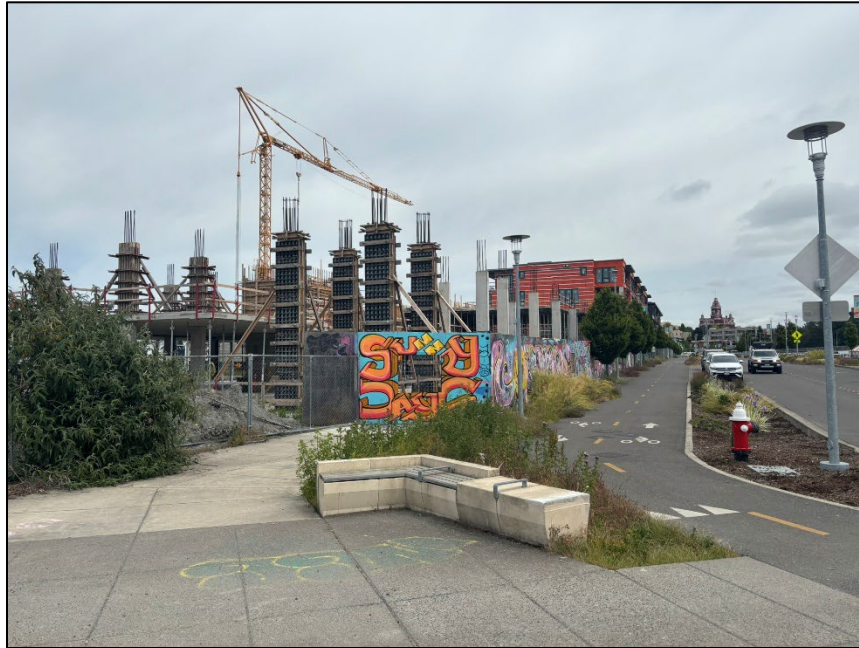
Photograph 5. Harcourt construction in process north of Granary Ave with temporary fencing. Photograph looking mill-east.

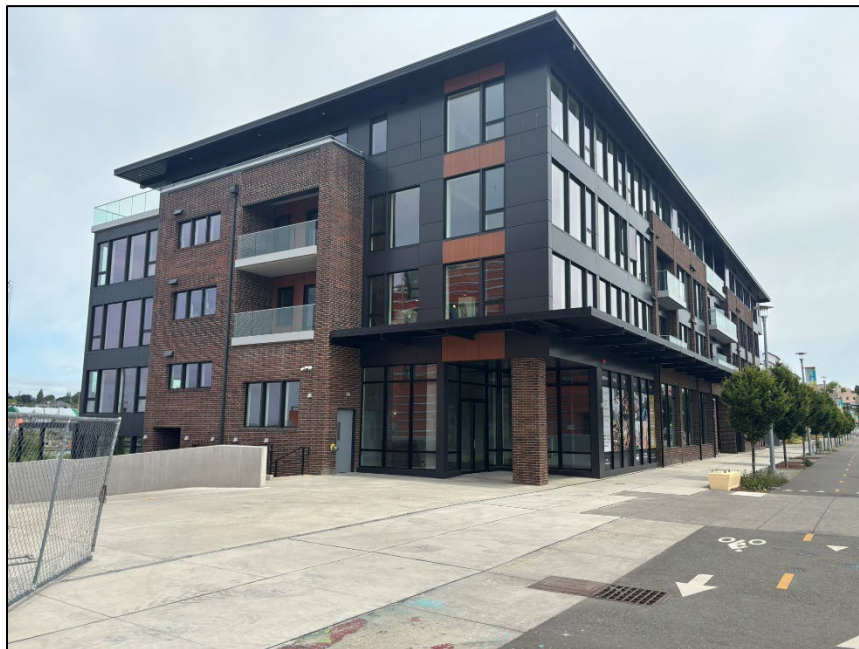
Photograph 6. Completed condo with finished grading open to the public. Photo looking mill-northeast.

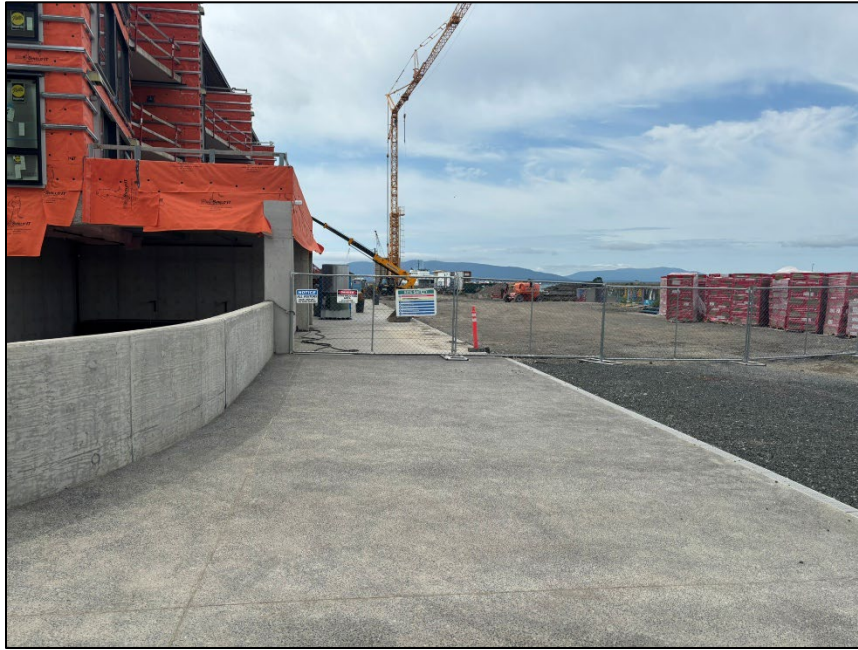
Photograph 7. Harcourt construction in process north of Granary Ave with temporary fencing on north side. Photograph looking mill-west.

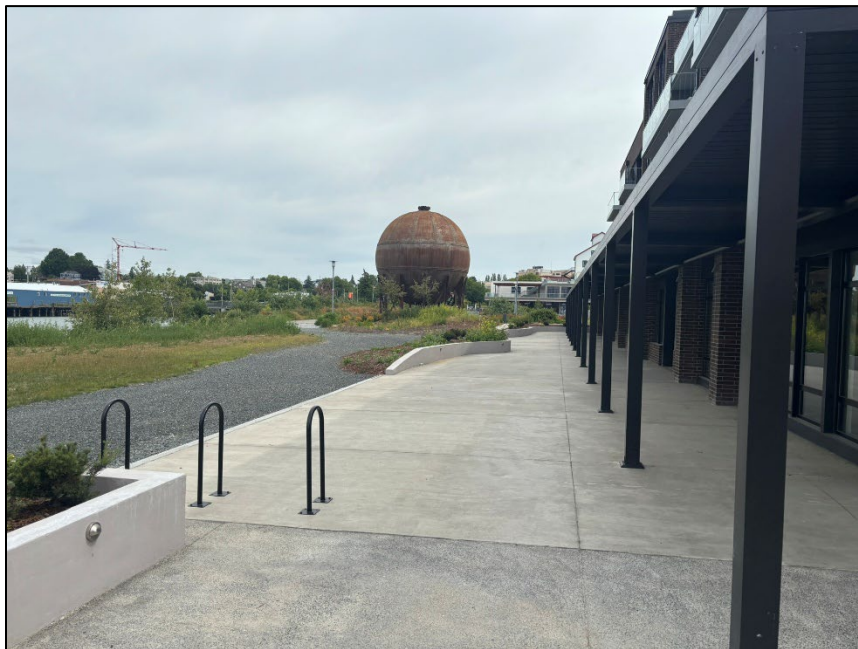
Photograph 8. Completed condo area with finished grading open to the public. Photo looking mill-east.

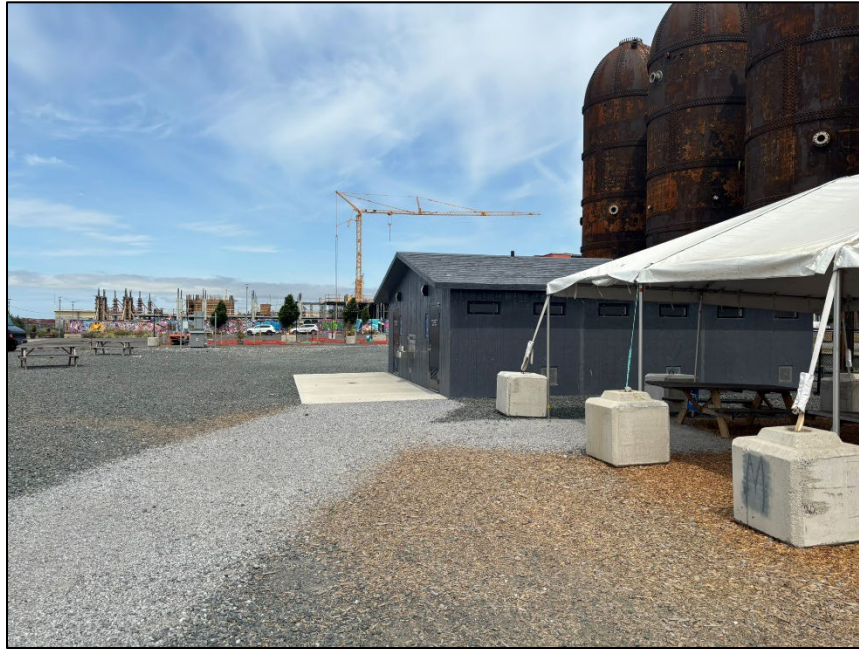
Photograph 9. New bathroom structure to the mill-west of the digester towers. Photo looking mill-north.
