# **2023 OILY WATER SEWER SUMMARY REPORT MATRIX RANKING ADDENDUM**

**BP Cherry Point Refinery  
Blaine, WA**

**December 2024**

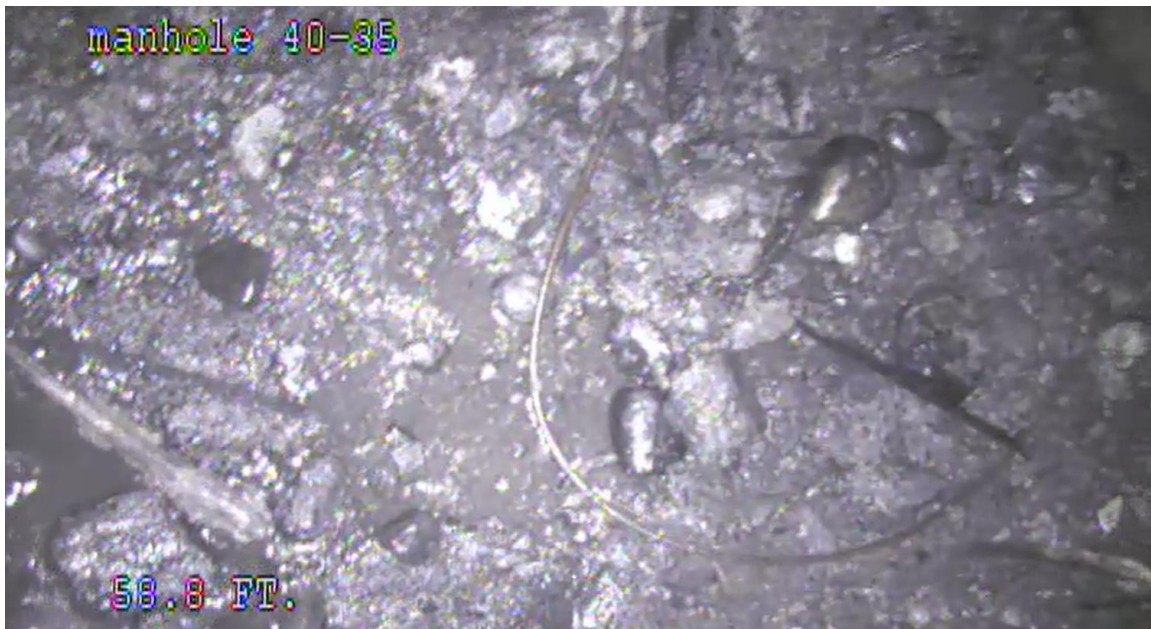
The camera operator observed that there was an accumulation of debris, including rocks and gravel, obscuring a complete view of the bottom of the vault. It was also noted that the cable lifting loops used during installation were visible. This is a common observation in manholes as they are permanent features of the concrete structure and are used during installation.

**Figure 1:** Video still from MH 40-35 showing rocky debris and cable lifting loops.

MH 40-35 was given a structural rating of three and an O&M rating of two (see *Attachment 1: 2023 Oily Water Sewer Ratings*).

Liner material was noted to be wearing off near the middle of the manhole and this was captured in the structural rating. Wire, debris and gravel was obscuring the view of the bottom of the manhole and this was captured in the O&M rating.

**MH 40-35 Structural Rating: 3**

Per *Attachment 2: OWS Rating Matrix*, a defect with rating three in continuous service would trigger confirmation sampling soil sampling if the structural integrity of the feature is at risk. MH 40-35 is an epoxy lined concrete structure. The inspection noted that the epoxy liner was observed to be wearing off. No integrity issues were observed in the structure of the underlying concrete manhole, therefore no confirmation soil sampling was conducted.

**MH 40-35 O&M Rating: 2**

Per *Attachment 2: OWS Rating Matrix*, a defect with rating two in continuous service, could trigger confirmation sampling soil sampling if the structural integrity of the feature is at risk. Because the O&M rating was due to debris obscuring the view of the manhole bottom surface, and there was no indication that this debris contributed to increased concern for the structural integrity of the manhole, no confirmation soil sampling was conducted.

Although there are no structural concerns nor evidence of a release or threatened release observed, because the bottom of the manhole was not completely visible to the camera operator, this manhole will be reinspected at a future date. Results of that inspection, when complete, will be included in the Oily Water Sewer Summary Report.

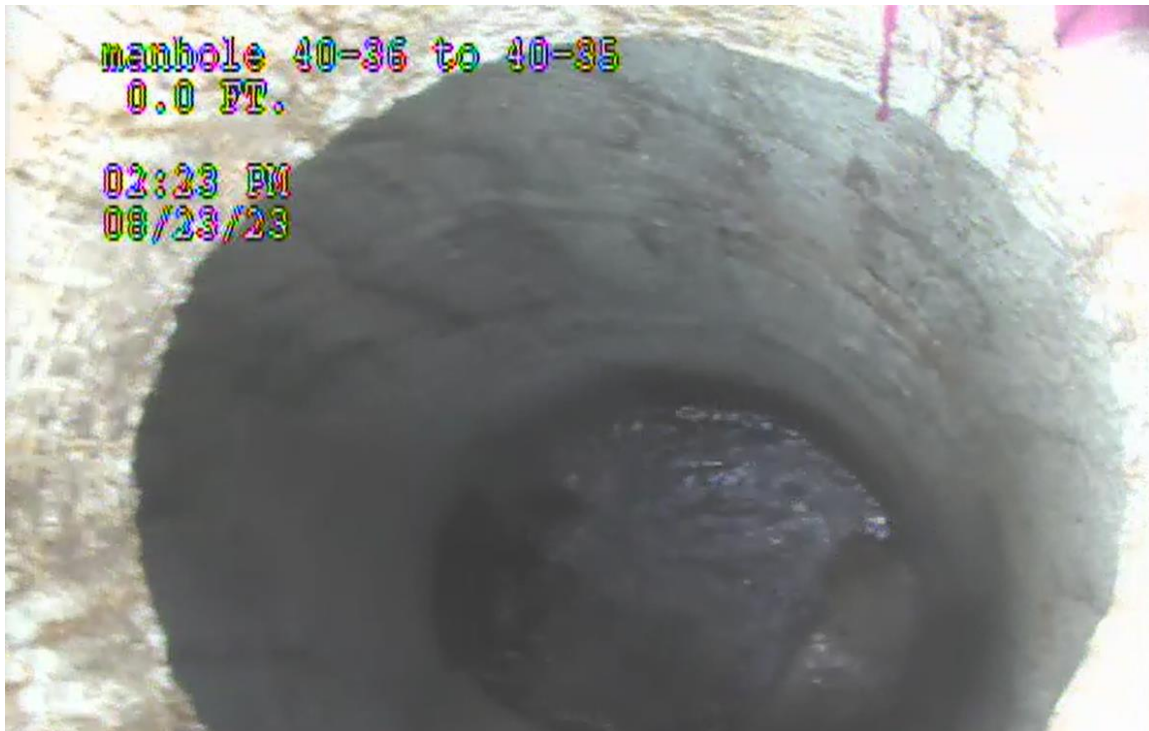
The camera operator observed that there was approximately 6" of water in the bottom of this manhole, which prevented the inspection of the bottom-most portion. The portion of the manhole visible from the top down to the water line near the bottom is epoxy lined and appeared in good repair, without defects or missing sections of liner.

**Figure 2:** MH 40-36 showing approximately 6" of water in the bottom of the manhole.

MH 40-36 was given a structural rating of zero and an O&M rating of zero (see *Attachment 1: 2023 Oily Water Sewer Ratings*).

Although there are no structural concerns or evidence of a release or threatened release observed, because the bottom of the manhole was not completely visible to the camera operator, it will be reinspected at a future date. Results of that inspection, when complete, will be included in the Oily Water Sewer Summary Report.

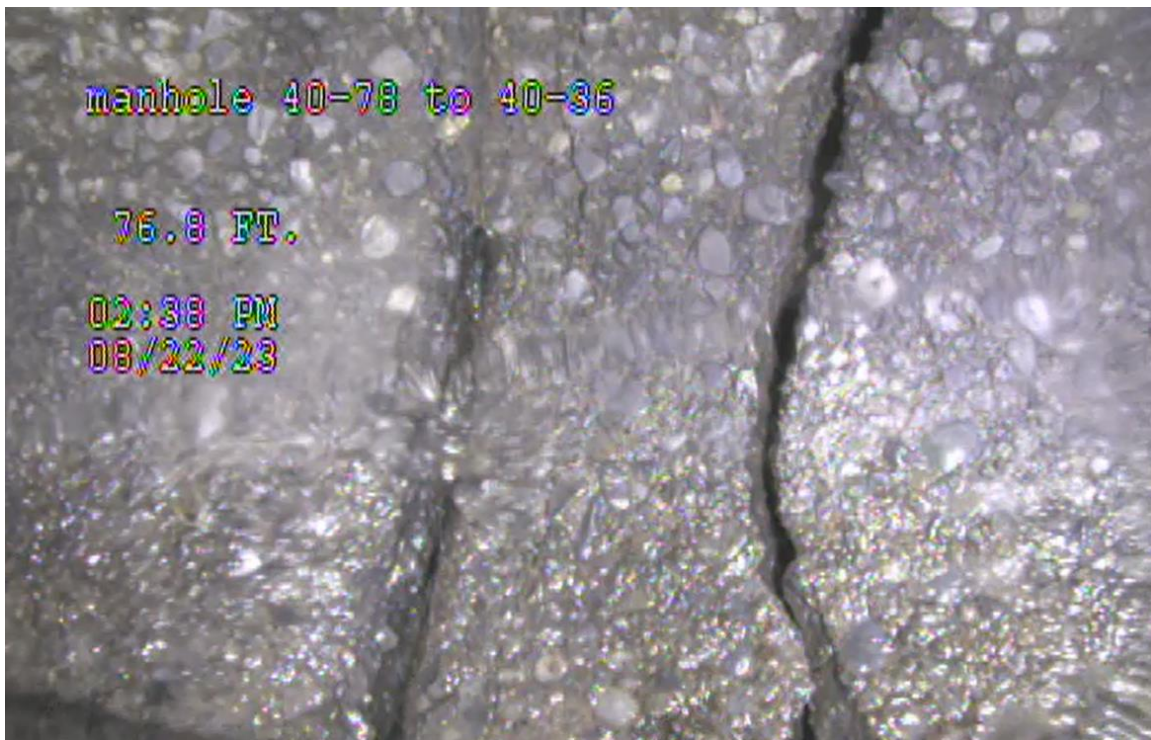
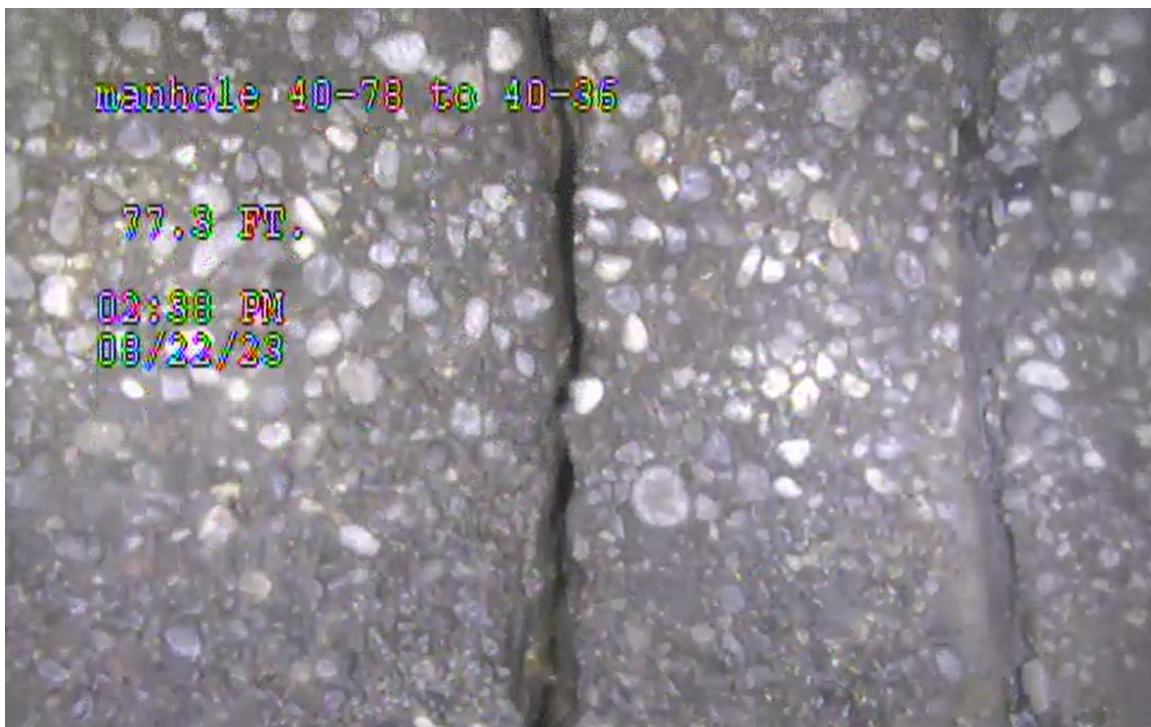
The camera operator observed a circumferential crack at a pipe joint approximately 76' south/southeast of MH 40-78. There was evidence of groundwater intrusion by staining, but no active water inflow at the time of inspection.

**Figure 3:** Circumferential crack on line MH 40-78 to MH 40-36

**Figure 4:** Circumferential crack on line MH 40-78 to MH 40-36

MH 40-78 to MH 40-36 was given a structural rating of 2.4 and an O&M rating of two (see Attachment 1: 2023 Oily Water Sewer Ratings).

**MH 40-78 to MH 40-36 Structural Rating: 2.4**

Per *Attachment 2: OWS Rating Matrix*, a defect with rating two would only trigger consider conducting confirmation sampling if the line was in high or continuous flow or high BTEX or hydrocarbon content.

This line service does not meet either of these requirements, as it conveys mainly seasonal rainwater runoff and intermittent flow from the refinery training grounds. Confirmation sampling was not conducted as a result of this inspection activity.

Although there are no structural concerns or evidence of a release or threatened release observed, it is recommended that this section of sewer pipe is relined to strengthen it because this section is subjected to heavy traffic and equipment loads.

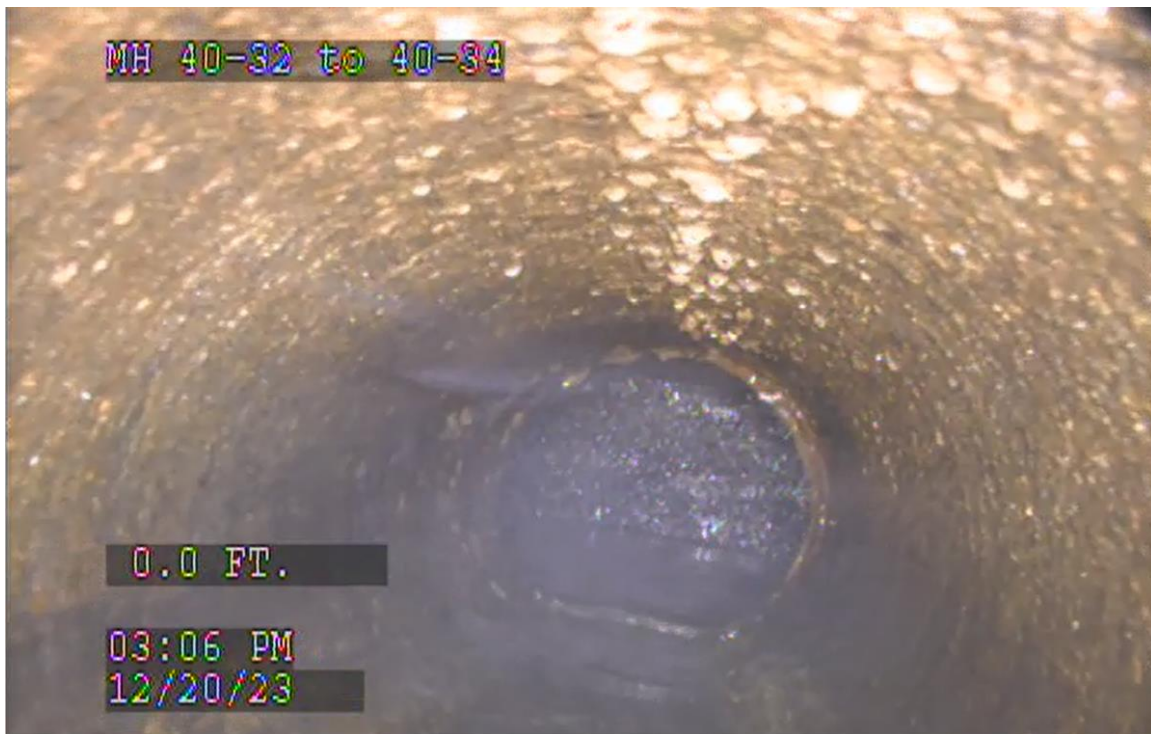
This line was intact and no evidence of releases or threatened releases were observed. It was in good repair, with no observed damage or degradation.

**Figure 5:** Video still of the line from MH 40-32 to 40-34.

MH 40-32 to 40-34 was given a structural rating of zero and an O&M rating of two (see *Attachment 1: 2023 Oily Water Sewer Ratings*).

No actions were taken or repairs to the system were planned based on the results of these inspections. No corrective actions or interim measures were taken to remediate soil or groundwater.
