**Monte Cristo Mining Area  
Remedial Investigation Phase 3  
Characterization of Aquatic  
Sampling Reaches  
Reconnaissance Report**

**Prepared for  
Washington State  
Department of Ecology**

**March 29, 2013  
17800-35**

Prepared by  
**Hart Crowser, Inc.**

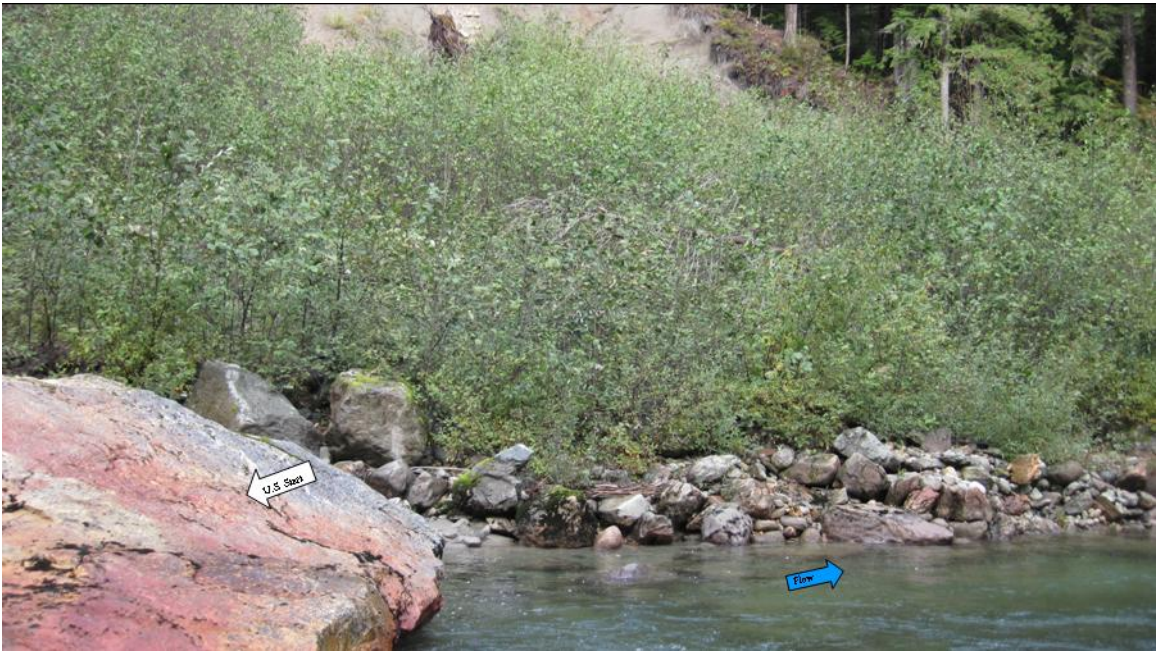
From the road, we scoped out three or four potential reaches near the CES sample location, SFSR-09. Ultimately, we selected a reach approximately 300 meters downstream of the CES station based on access from the road and wadeability for ease of sampling in 2013. There was a pullout/roadside camping area where we were able to park and access the right bank of the river. Because of the high flow conditions, we were not able to wade across to the left bank, but lower flow conditions should allow for wading in this reach in late summer. Photographs, field datasheets, and site sketches for this site can be found on pages A-19 through A-28 in Appendix A. An orange staining was visible on many of the boulders and cobbles throughout this reach, especially in Photograph 7 (Appendix A).

Photograph 7 – View across to the left bank from the upstream end of the sampling reach.

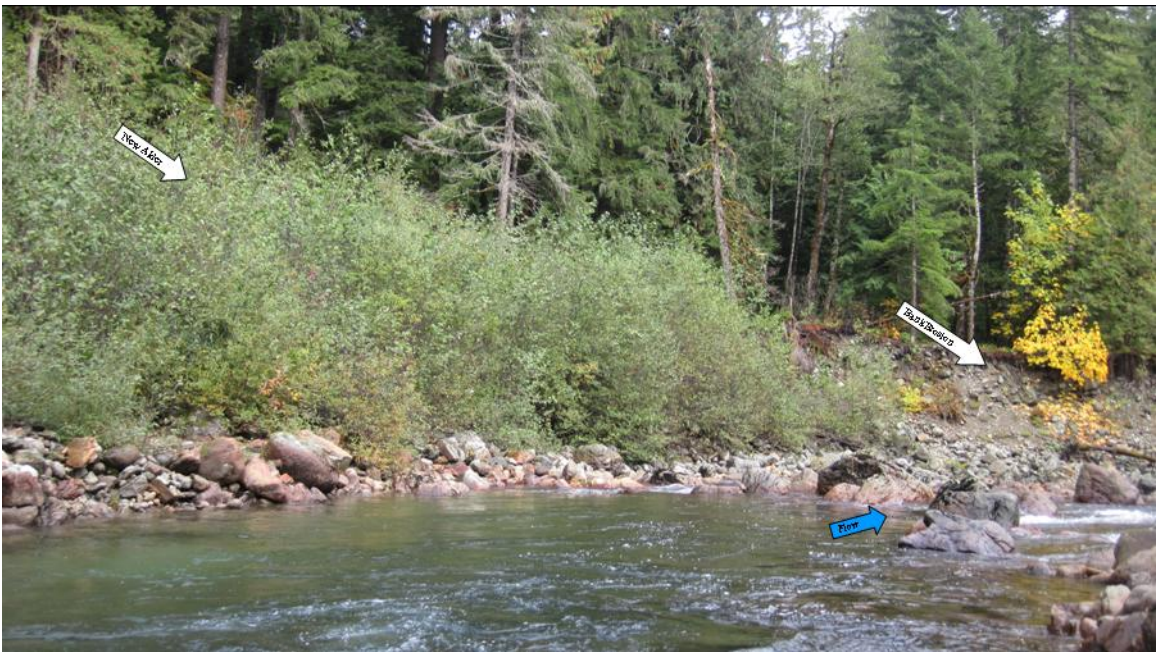
Photograph 8 – View of the large pool (along the left bank) at the upper end of the sampling reach.

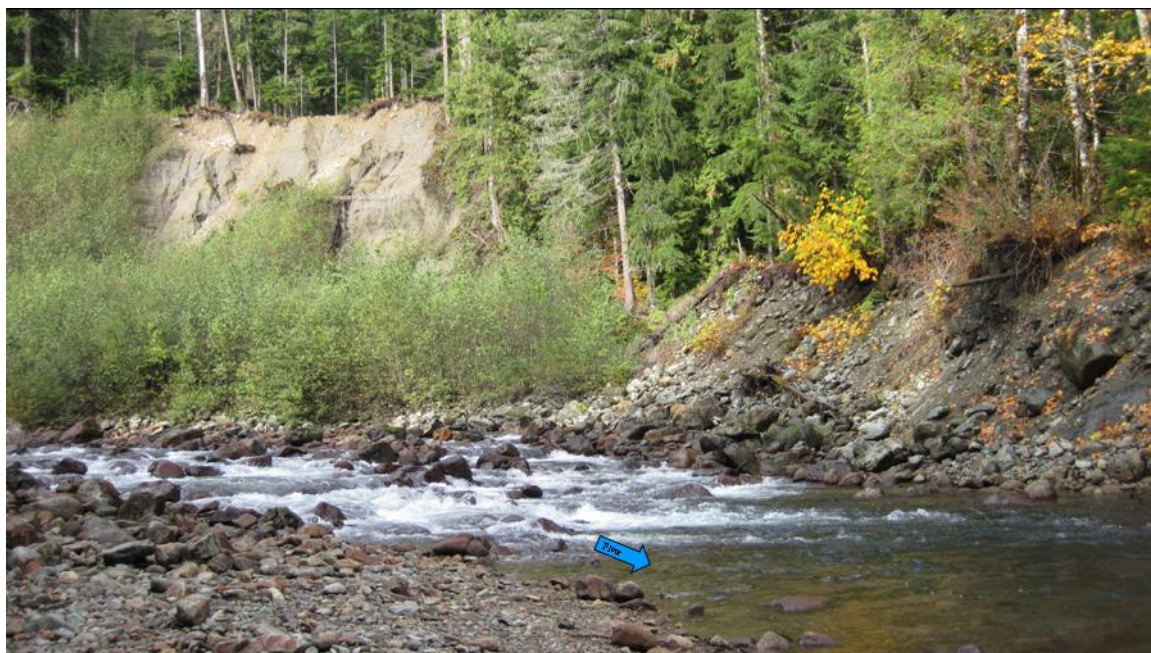
Photograph 10 – View of the lower portion of the sampling reach from the downstream end; eroding slope along the left bank.

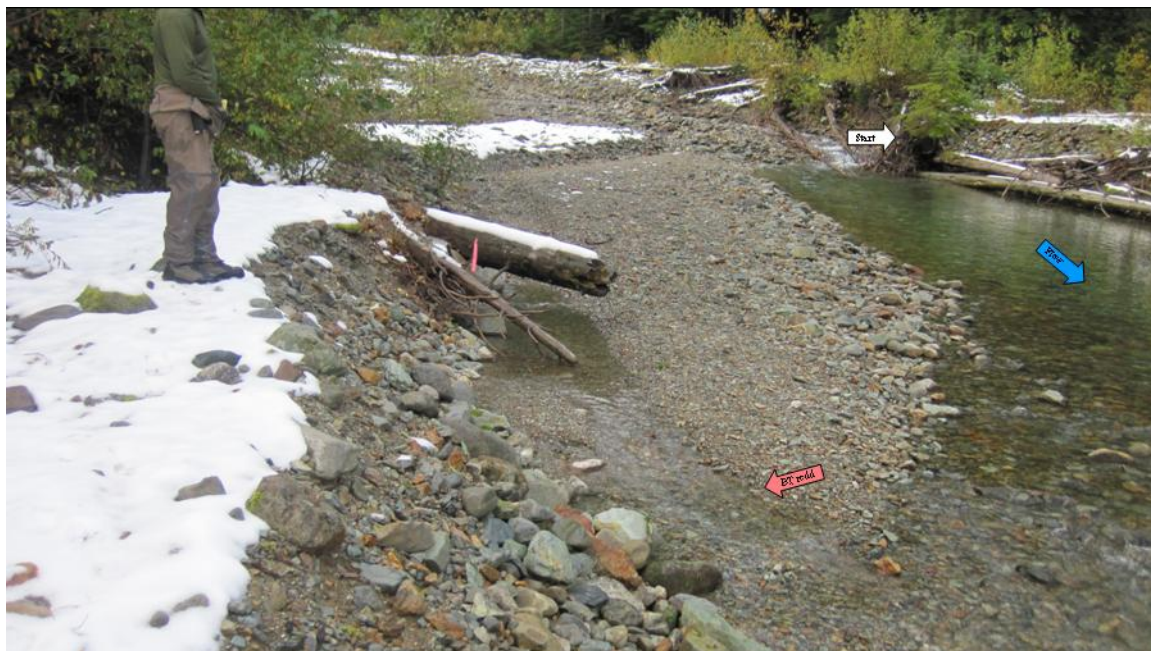
Photograph 19 – View of the bull trout red-flagged on 10/23/12; located on the right bank in the upper 30 meters of the sampling reach.

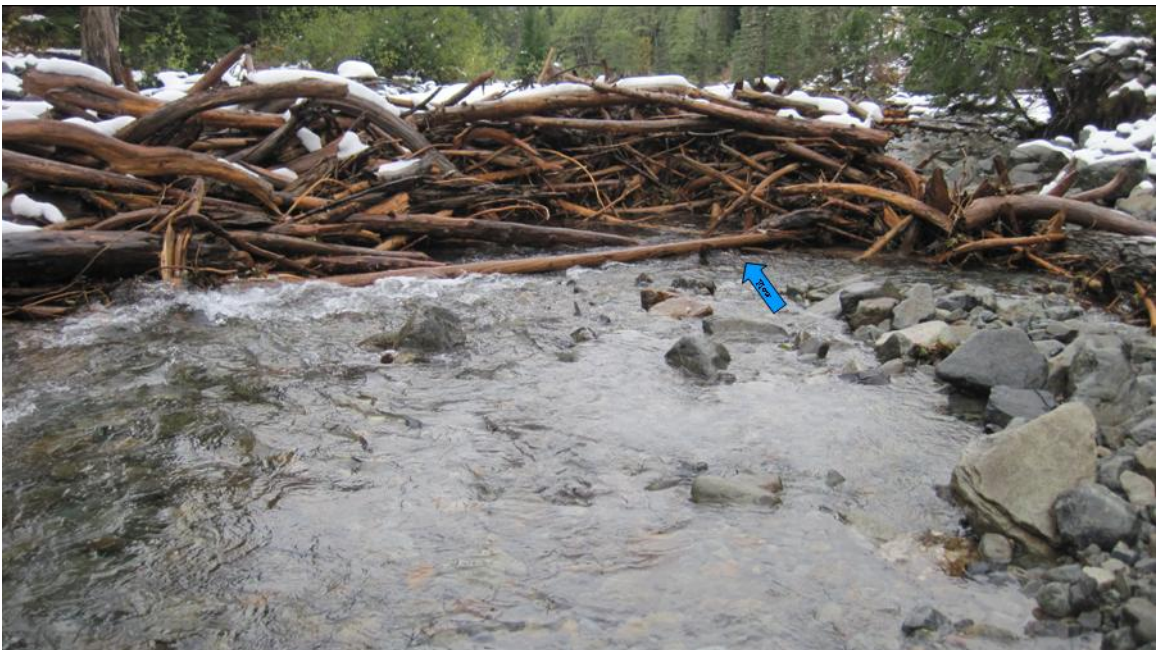
Photograph 21 – View of the large woody debris jam approximately 30 meters down from the upstream end of the reach.
